20th Congress of IABSE, New York City 2019

Contributing human and organizational factors for the failure of balconies in Maastricht

Karel C. Terwel

Delft University of Technology / IMd
Consulting Engineers

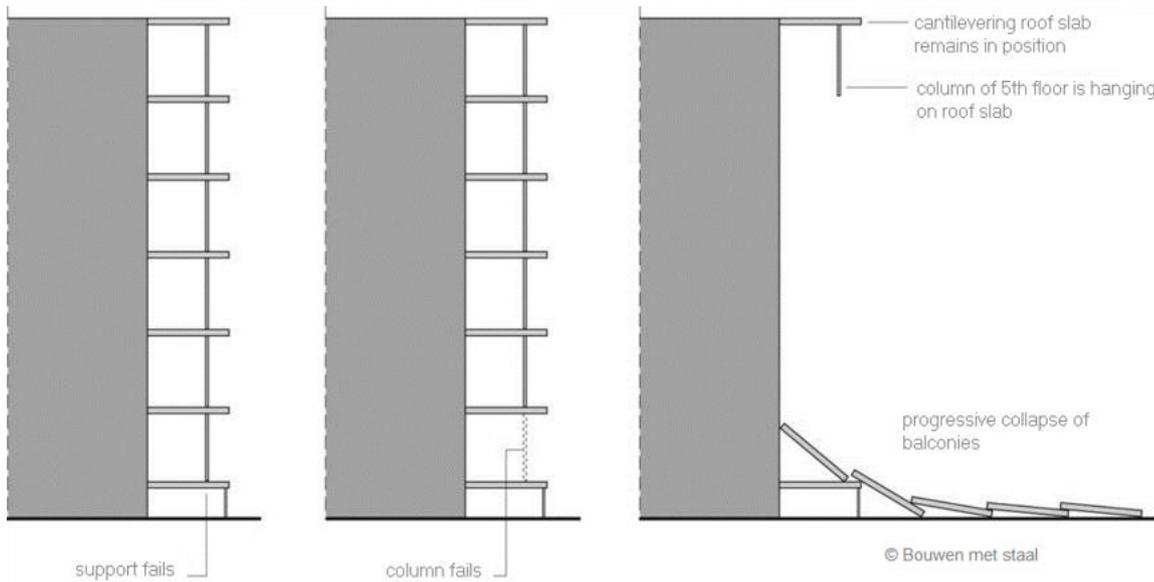
Finally, it was concluded by experts and court that that the combination of a bending moment and a concentrated force on the small ridge resulted in failure of the ridge on ground floor level. This resulted in a progressive collapse of the other balconies as the columns lacked support [3].

Figure 3: Side view of building: initial failure leading to progressive collapse (adapted from [11], with permission)
