Restoration of the Interior

Colour, Form and Space

3 / RESTORATION OF THE INTERIOR

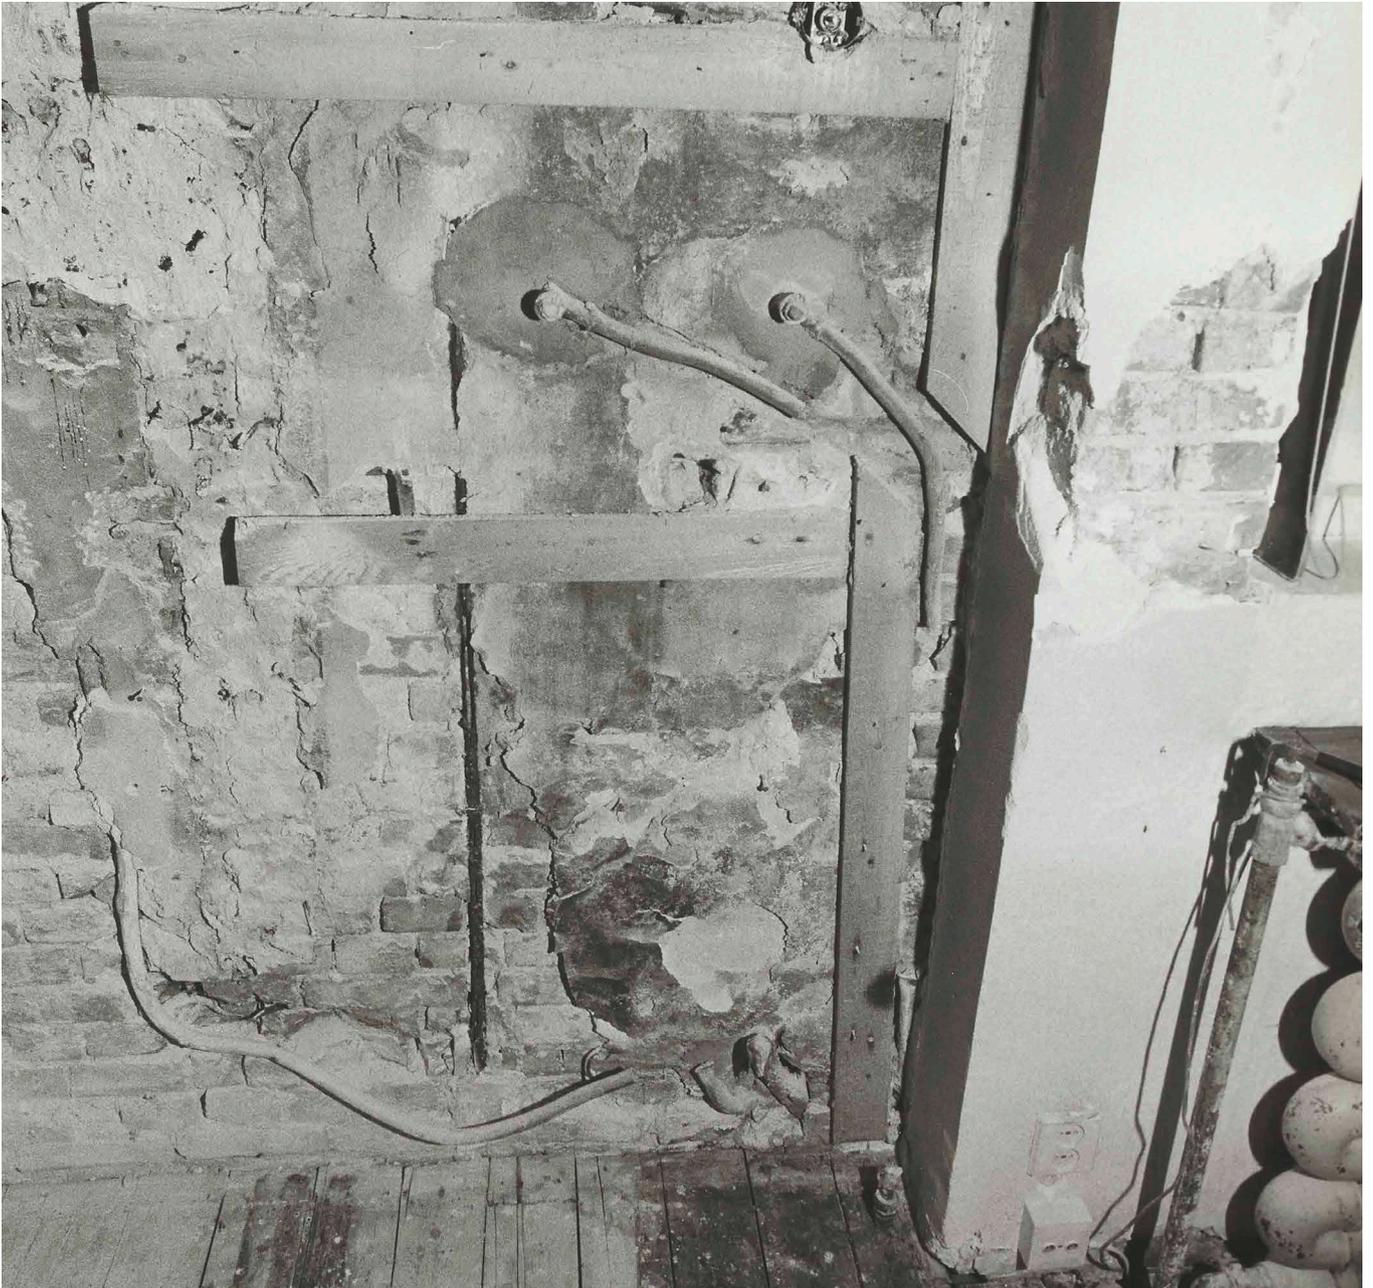
FIG. 3.1 The dismantling of wall, floors and ceiling yielded a lot of information about pipes, connection points and the attachment of furniture

The survey of the now stripped-back house yielded a lot of new information [FIG. 3.1].²¹ For example, pencilled lines and painted and stained areas were discovered on the floors, which provided insight into the division of the floor surface and the position and size of the beds [FIG. 3.2]. Holes in the walls indicated where cupboards and other items of furniture had been fixed to the walls. Mulder also recovered original parts of the former kitchen. And during the inspection of the electrical services, a 'strangely insulated hot water system' was discovered under the floor.

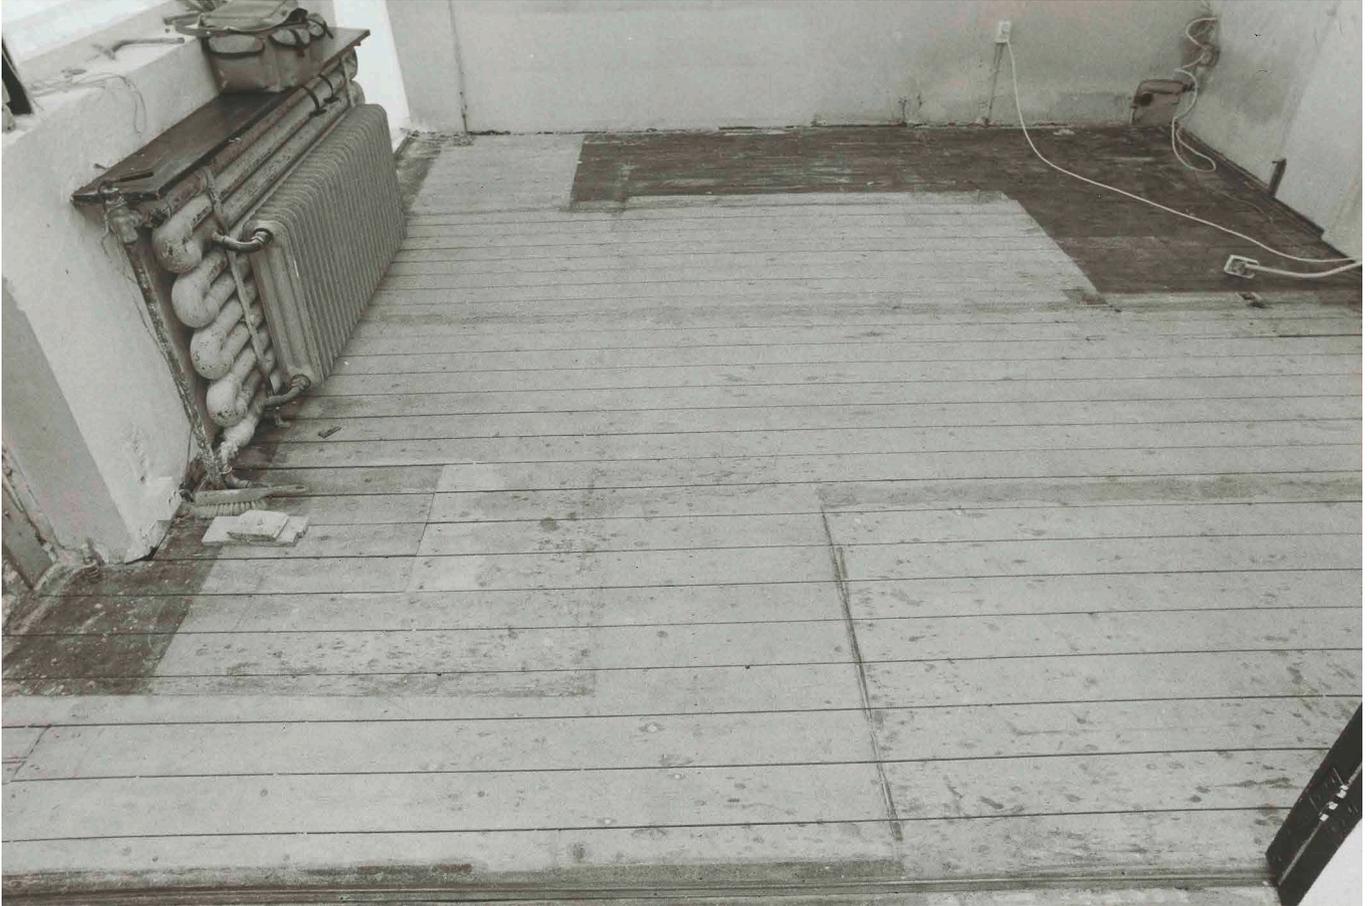
FIG. 3.2 The floor gave an indication of the division of the floor surface and the position of the beds

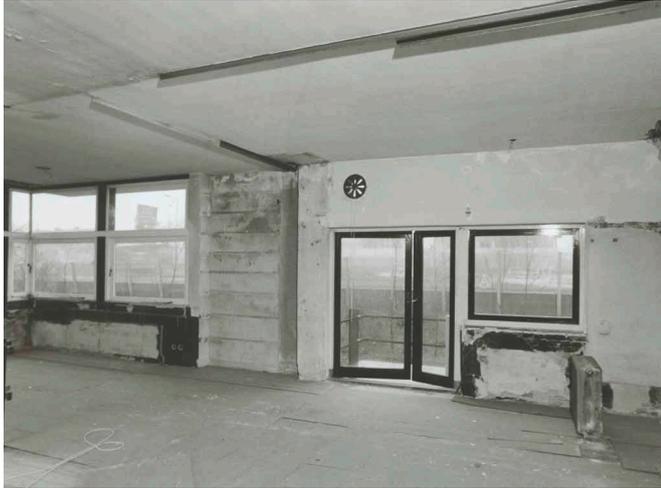
FIG. 3.3 The partially dismantled upper floor

The most visible and radical aspect of the restoration of the upper floor was the stripping of the walls and ceiling, the elements that were so crucial to the spatial picture [FIG. 3.3/3.4]. Stripped back they revealed only 'bare brickwork' and a bare soffit [FIG. 3.5/3.6/3.7]. 'The [foundation] and I were of the opinion that we would only be able to make the original spatial picture clearly and definitely tangible if the delimiting surfaces that determine that picture were once more of impeccable texture and colour,' Mulder later wrote. Even the possible withdrawal of the RDMZ's grant did not persuade the foundation to change its mind according to Mulder.²³ In 2016 Mulder still recalled a visit to his office by Ida van Zijl and Wim Denslagen. There was further discussion of the rigorous approach, which according to Denslagen did not correspond to what RDMZ was used to. Mulder explained once more that for him the original spatial experience went hand in hand with the restoration of space and surfaces. 'Denslagen disappeared, and that was the end of it'.²⁴ And so Mulder proceeded to reprise the reconstructive approach he had previously applied to the exterior.

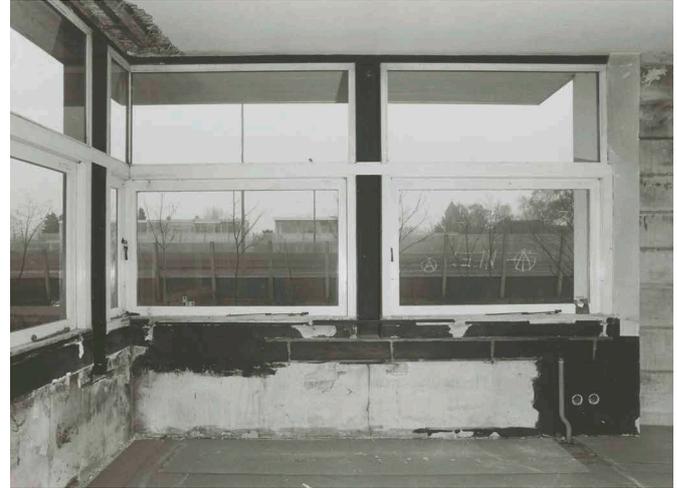
FIG. 3.4 The corner window during the restoration, with a view of the viaduct and the houses on Erasmuslaan

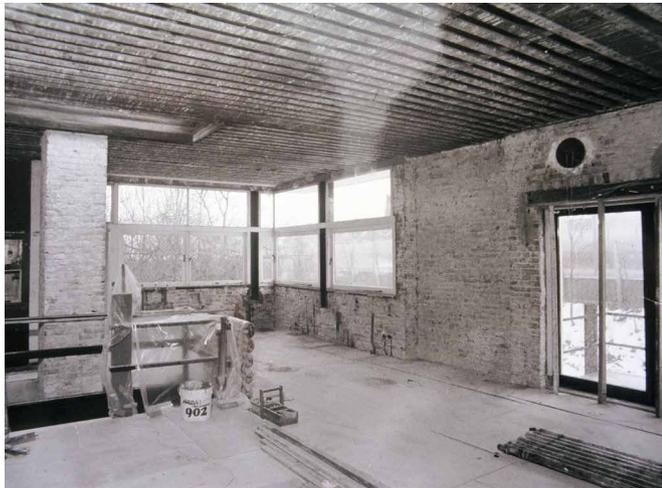
FIG. 3.5 The upper floor of the Rietveld Schröder House in dismantled state

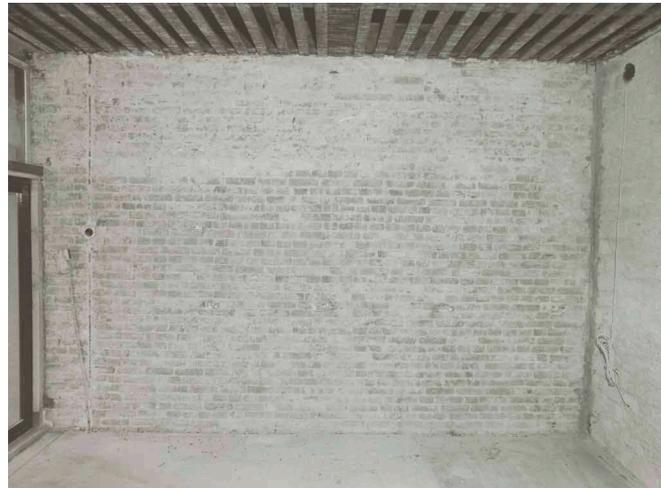
FIG. 3.6 Bare brick wall and stripped ceiling

Before the walls were replastered, the cracks in the brickwork were, like those in the exterior, filled with synthetic mortar. The new metal lath ceiling was suspended from the joists using a (floating) steel network in order to minimize the chance of cracks.²⁷ The plastering was carried out by the firm of H. van de Kant Afbouwbedrijf Zeist B.V. H. van de Kant recalled that the existing plaster had to be carefully removed and placed in bags in plastic trays, sorted according to wall area and colour. This enabled Mulder to carefully examine the plaster and layers of paint on top of it.²⁸ After that examination the old plaster was carried away and destroyed. Although the abovementioned memos from 1984 and 1985 refer to a specific plaster mix, Mulder and Van de Kant stated, when asked, that the exact proportions of cement, sand and lime were decided on site. Ultimately, it was the plasterer who determined this, just as in Rietveld's day. After applying the plaster, the plasterers had to sand the base coat 'with jute on a wooden board', to achieve the same effect as under Rietveld. It resulted in a smooth surface with here and there a stray grain of sand, but without any traces of repair work or restoration.

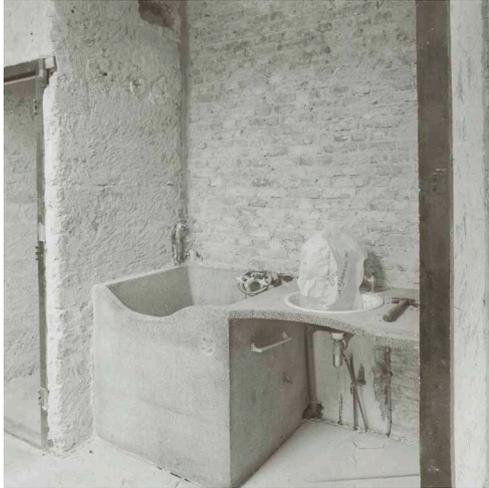
FIG. 3.7 Stripped bathroom with 'lavette'

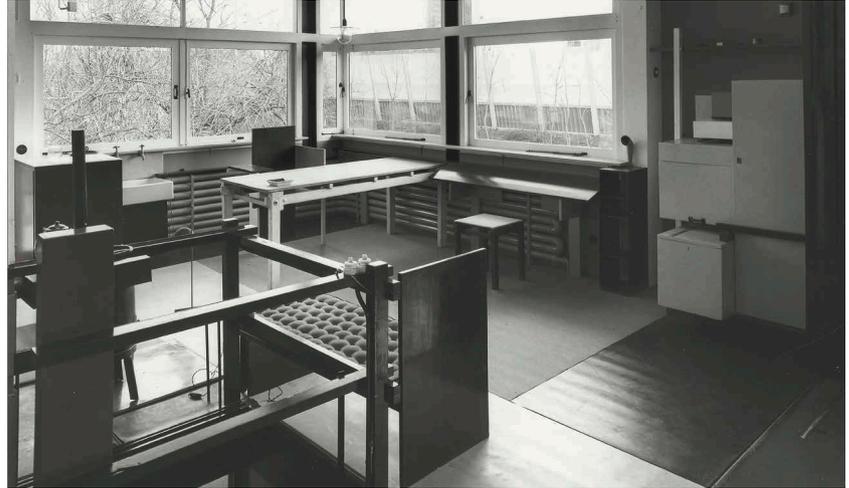
In the photographs taken in the 1970s and '80s, it is obvious that the plasterwork on the upper floor was at that moment painted white [FIG. 3.3/4.14/4.19/4.20]. The only exception was the chimney. The interior had been less frequently repainted than the exterior and significantly fewer different shades emerged when Mulder started to inspect and 'scrape' in search of underlying coats of paint. The greys were less bluish than those he had encountered on the exterior, while the red, blue and yellow were less vivid than on the exterior, especially the yellow, which was 'softer'.²⁹ On the plasterwork, and also on wooden and metal elements like the window seat in the living area, on cupboards, on the newel post, behind sliding walls, on the floor, on radiators and on the rails of the sliding walls, Mulder found the remains of what was very probably the original paintwork. These traces formed the basis for the new colour scheme in which the colours used to paint the plasterwork were white, yellow, blue and two shades of grey, while the woodwork and radiators were painted in white, black, red, yellow, yellowish green, blue and grey [FIG. 3.8].

FIG. 3.8 A black-and-white photograph of the upper floor after the restoration shows the new spatial composition and colour scheme

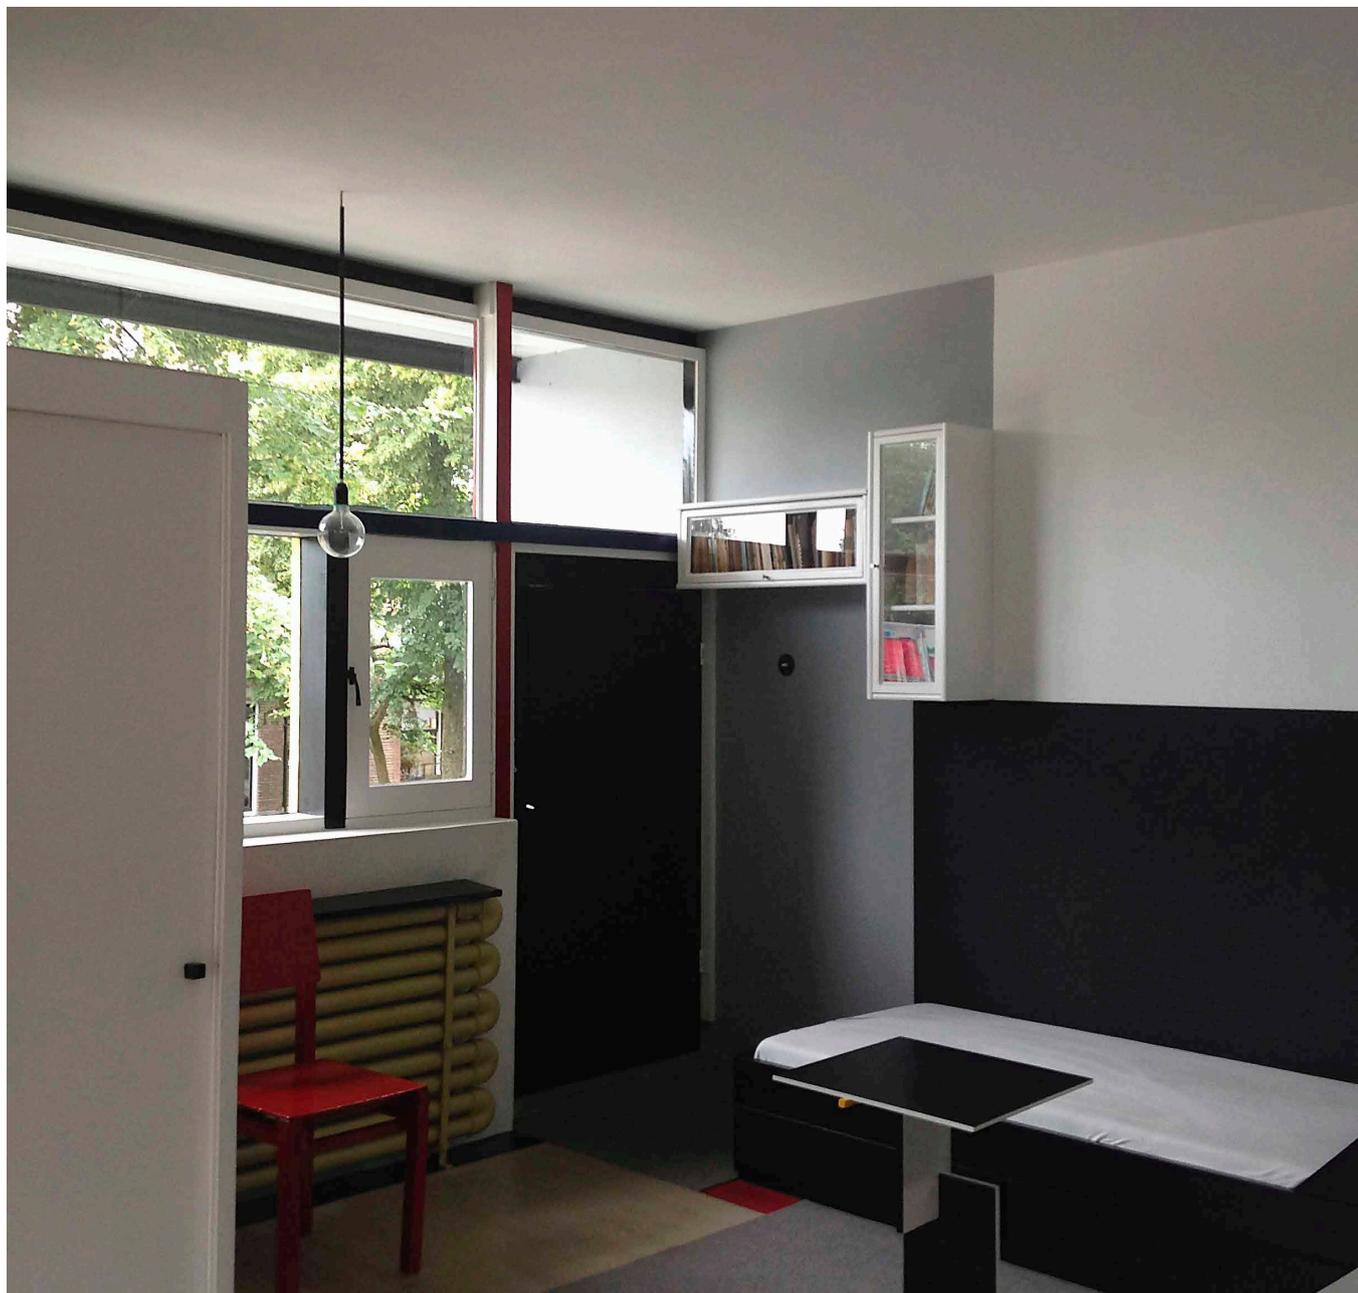
What mattered was the entire composition of colours and surfaces, which was supposed to restore the original spatial experience. During the removal of the plasterwork in the girls' bedroom, Mulder had discovered a grey that matched the compositional image of the space. The wall, which ran from inside to outside, had been white on the inside back when Mulder had devised the colour scheme of the exterior in the 1970s. When the painting of the interior was completed, however, it turned out that the grey on the inside of this wall was different from the grey of the exterior section. Because it was important for the overall image

FIG. 3.9 The wall in the girls' room runs from inside to outside, so B. Mulder had both the inner and outer sides of the wall painted in the same shade of grey, 2015

that the wall should be the same colour inside and out, Mulder had the exterior repainted [FIG. 3.9]. But it didn't end with the repainting of the balcony wall on Prins Hendriklaan; the entire composition of greys on the exterior had to be determined all over again.

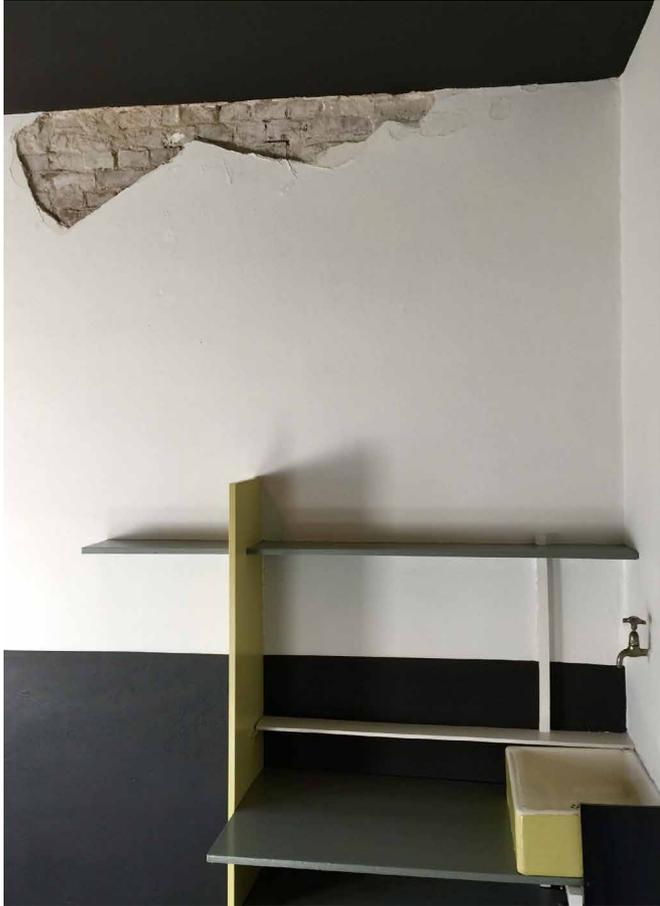
FIG. 3.13 The plasterwork at the top of the south wall of the study was damaged and came loose in October 2016

In October 2016 a piece of plaster came loose at the top of the south wall of the study [FIG. 3.13]. This provided an opportunity to have both the cause of the loosening and the composition of the plaster investigated by, respectively, TU Delft and TNO.³⁶ Quite by chance it was possible to show a sample of this plaster to Hans Geerken, who had been involved in the restoration of the exterior. He thought it looked as if it had been composed of coarse sharp sand from Buslo with putty lime and cement; he thought the sand dated from the 1970s. In addition, the top layer of paint was probably Alfatex IQ latex.³⁷ Thus it looked as if the plasterwork on this wall had been renewed. However, TNO's petrographic analysis indicated that the sample did not contain any cement and consisted of lime mortar base coats, lime mortar finishing coats plus two top coats. 'It's possible the sample was a fragment of the original plaster,' was TNO's conclusion.³⁸

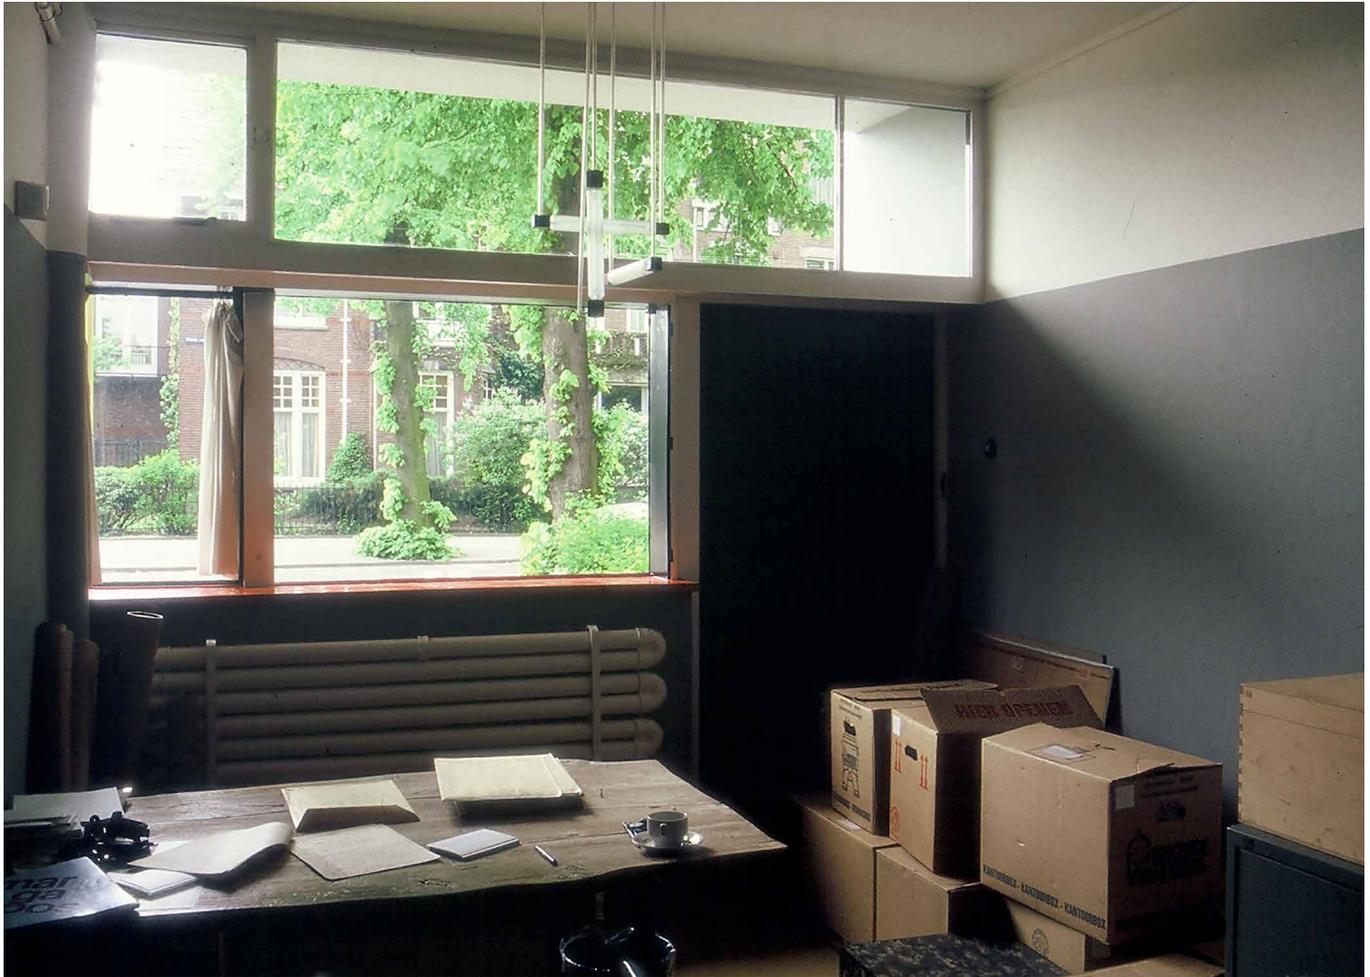
FIG. 3.15 In 1985 the lower sections of the studio walls are grey; the inner side of the door to Prins Hendriklaan is painted black

However, a photo taken in April 1985 shows the lower sections of the walls painted grey, and the inside of the door onto Prins Hendriklaan in black rather than white [FIG. 3.15]. Upon inquiry Mulder recalled that he had based the colour scheme of the ground floor on what he had encountered there.⁴⁰ The studio was therefore repainted in the colours of the top coat, without searching for traces of the original colours and also without

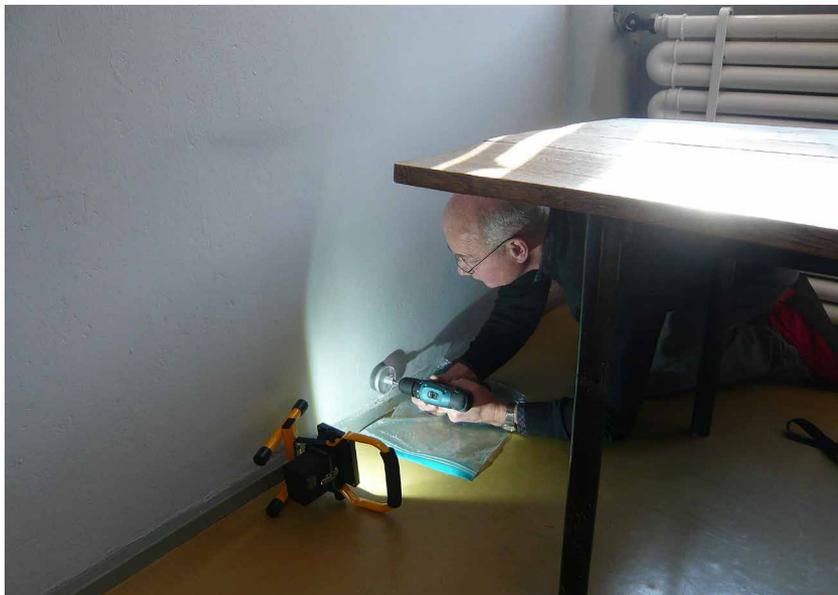
were asked to analyse the composition of the plaster and finish coats [FIG. 3.18/3.19]. On that occasion samples were also taken of the exterior; these have already been discussed in Chapter 1. Supplementing TNO's conclusions, the SRAL analysis confirmed that there were probably still traces of coloured layers of plaster in several places on the exterior, in two shades of grey. The visual composition and the properties of these layers seem to point in the direction of the stipulations in the Specifications for the Schröder House (1924).⁴²

FIG. 3.18 SRAL specialist taking a sample from the east wall of the studio

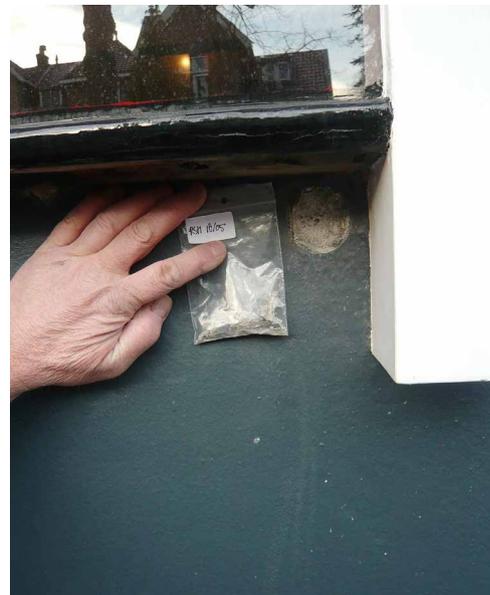
FIG. 3.19 Plaster sample from the wall below the studio window on Prins Hendriklaan

Samples were taken on the ground floor from the south wall of the study and from the east wall of the studio, and on the upper floor from the south wall of the girls' room. These provided insight into the possible differences in composition and finishing of the plasterwork, which turned out to be definitely not (upper floor), and possibly (ground floor) original. The TNO analysis produced one unexpected result: the two plaster samples proved to have the same stratigraphy, which would seem to indicate that both are instances of renovation plaster.
