Contributing human and organizational factors for the failure of balconies in Maastricht

In 2003 five balconies of an apartment building in Maastricht, the Netherlands, collapsed, resulting in two fatalities. The building was just completed.

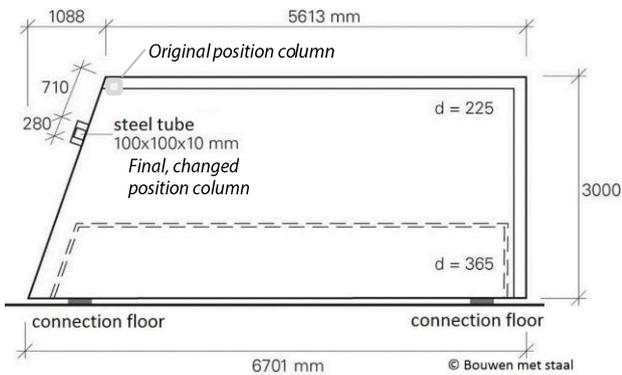
Figure 1: Top view of standard balcony with original and final position of column (adapted from [11,12] with permission). Mind that balcony slab level 1-5 is thicker than slab on ground level (figure 2).

During construction cracks were observed in the balcony of the ground floor. It appeared that this balcony was reduced in thickness, and that the position of the column was not aligned with the supporting wall, after a change in design. These

First, the column was repositioned towards the boundaries of the slab, to be able to integrate the column with the finishing structure (aesthetical reason [11]). Figure 1 clarifies the original position and the final, changed position of the column. To be able to support the balcony a ridge on the side of the balcony slab is required (see also figure 1). Second, during preliminary design the engineer designed two moment resisting connections, between floor of apartment and balcony. During technical design phase, this was changed by a supplier into two hinged connections [6].

These changes resulted in a solution with less robustness, that was more vulnerable to failure.

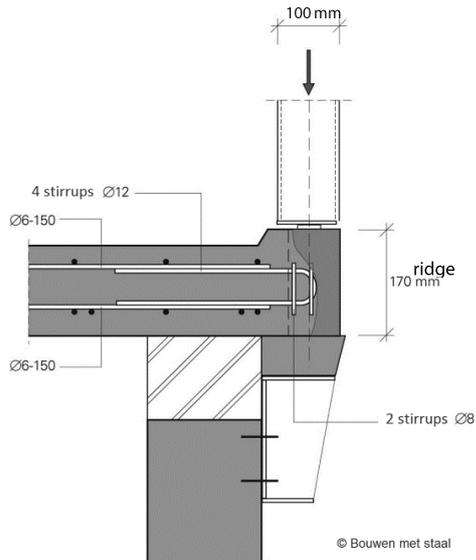
changes were not incorporated in the design. Therefore, the ridge on the ground floor underneath the column was not supported by the foundation wall. This inadequacy was fixed by applying a steel support underneath the concrete ridge (see figure 2). The height difference between the top of the steel support and slab was filled with masonry. In this way, it was assumed that the essential column 100*100 was adequately supported.

Figure 2: Detail of solution with steel support ground floor (adapted from [11,12] with permission)

Various parts of the structure were subject to the forensic investigations. Experts agreed that detailing of the reinforcement of the ridge at ground floor was inadequate and not according to the codes. Furthermore, the bolted connection of the steel support on the foundation wall was not properly constructed and the connection between the steel support and the concrete ridge was suboptimal.

Finally, it was concluded by experts and court that that the combination of a bending moment and a concentrated force on the small ridge resulted in failure of the ridge on ground floor level. This resulted in a progressive collapse of the other balconies as the columns lacked support [3].

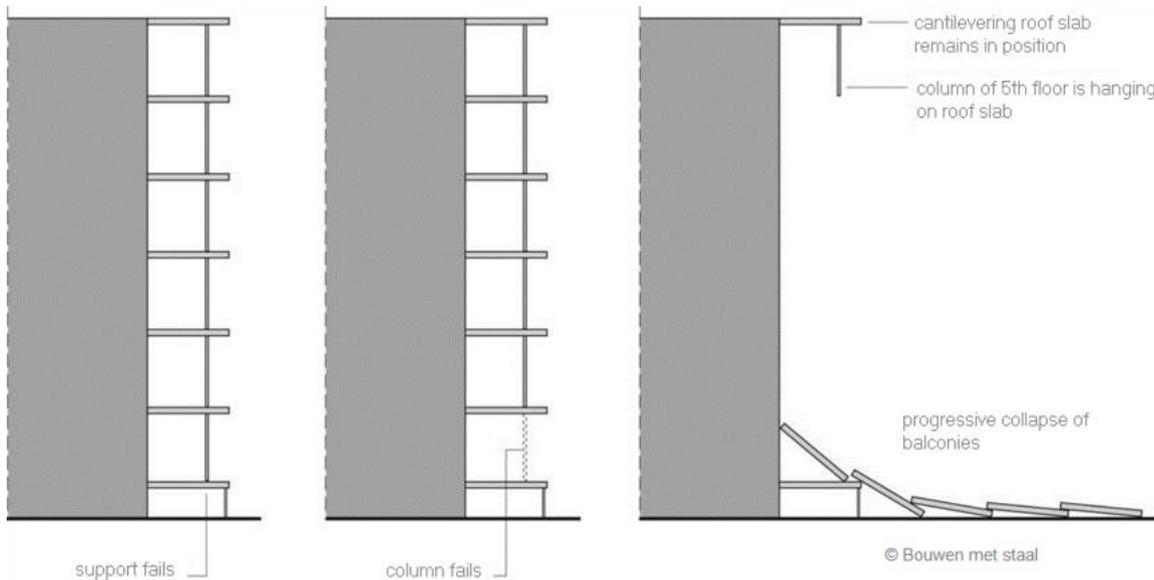
Figure 3: Side view of building: initial failure leading to progressive collapse (adapted from [11], with permission)
