Root cause analysis of surface cracks in heavy steel plates during the hot rolling process

Root Cause Analysis of Surface Cracks in Heavy Steel Plates during the Hot Rolling Process

² Hormozgan Steel Company (HOSCO), Bandar Abbas, Iran

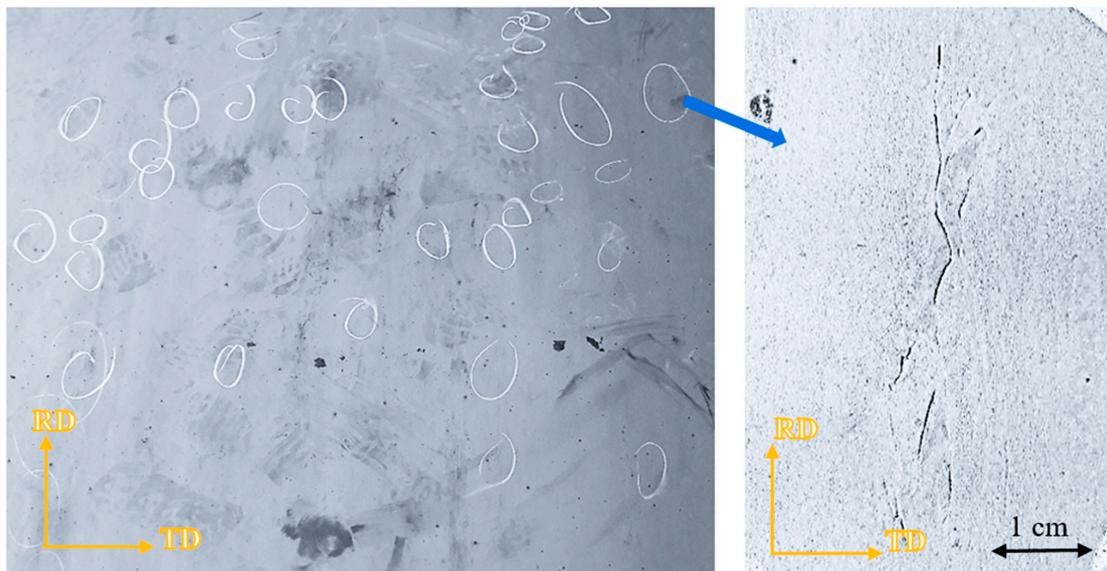
Surface cracks in this case are related to heavy plates of 30 cm thickness with average chemical composition 0.16 C–1.20 Mn–0.022 P–0.02 S–0.257 Si–0.045 Al–Fe (Bal.) (wt. %). Original slabs were made by continuous casting. Slabs were pre-heated at approximately 1250 °C up to 4 h, and were hot rolled to the final thickness of the heavy plate (30 cm) after approximately 16 passes in a reverse mill. Figure 2 shows the visual appearance of surface cracks on the heavy plate. Cracks are scattered all over the surface. There is no indication that cracks are more frequent at the side or the centre of plates. Spots, shown in Figure 2, are colonies of accumulated smaller cracks. The size of these crack colonies range from 5 to 30 cm. Cracks are all oriented along rolling direction. The depth of observed surface flaws in some cases are so high that plates are inevitably returned to the casting unit. In some cases, surface cracks can be eliminated by surface grinding. This causes major trouble in the rolling company, in the sense that these cracks need to be removed by grinding of the surface, which necessitates spending a lot of time as well as performing double inspection (one before grinding and the other one after grinding). This work aims at investigating the root cause of the problem.

Figure 2. Visual appearance of surface cracks on the surface of heavy plates.

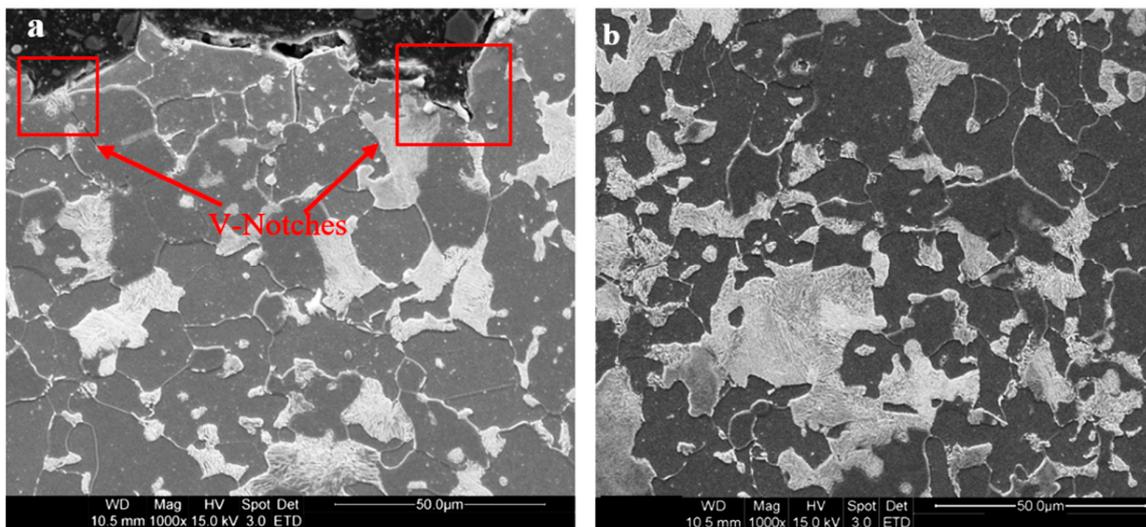
Figure 3 shows a SEM image of the typical ferritic–pearlitic microstructure of heavy plates in the bulk and surface of slabs (before hot rolling). There were not many inclusions found in the microstructure, inferring that the quality of the alloy in terms of secondary oxide/sulphide particles was overall very good. Typical features at the surface of the slab were surface V-notches, as marked in Figure 3a. These V-notches have depth in the order of a few tens of micro meters and are filled with surface oxide scales/phases. V-shaped grooves are possibly formed because of oscillation during the casting stage. Oscillation marks are a normal surface feature in continuously cast slabs. They periodically form at the meniscus because of mold oscillation. Yet, in case of improper control, the depth of these oscillation marks can increase to levels that they act as crack initiation sites [17,18].

Figure 3. Typical ferritic–pearlitic microstructure from (a) the surface and (b) the bulk of slabs.

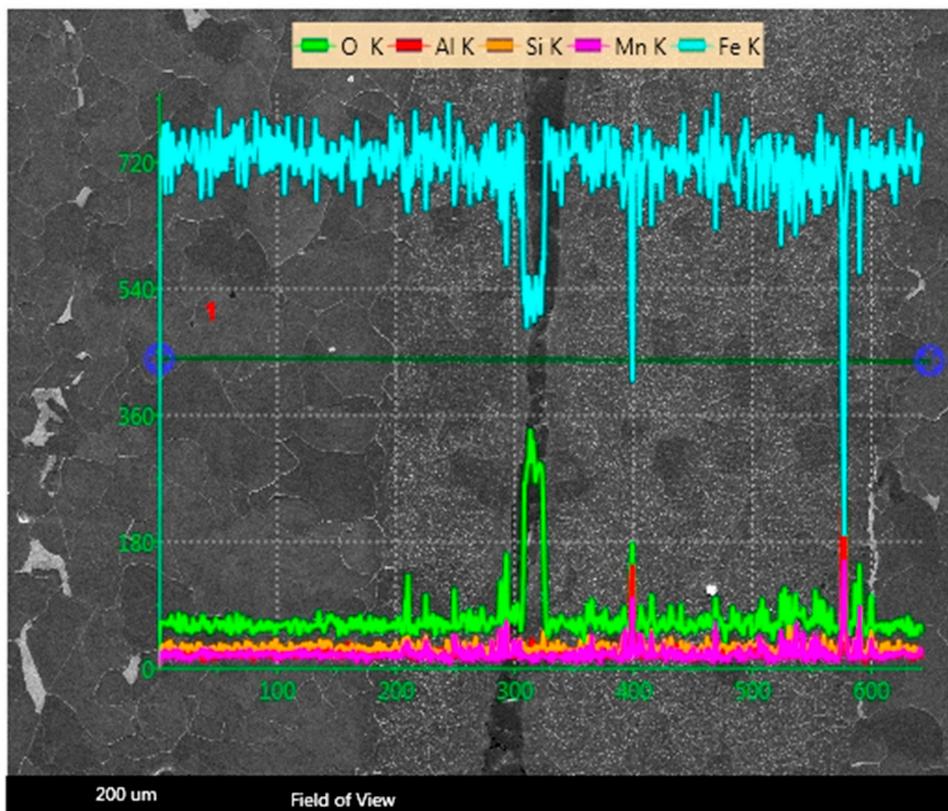
Figure 4 represents an elemental line scan on top of a crack. As can be seen in this figure, the concentration of oxygen at the crack is significantly higher than that in the vicinity of cracks, inferring that the crack is filled with an iron oxide phase.

Figure 4. Elemental line scan on top of a crack at the surface of the heavy plate.

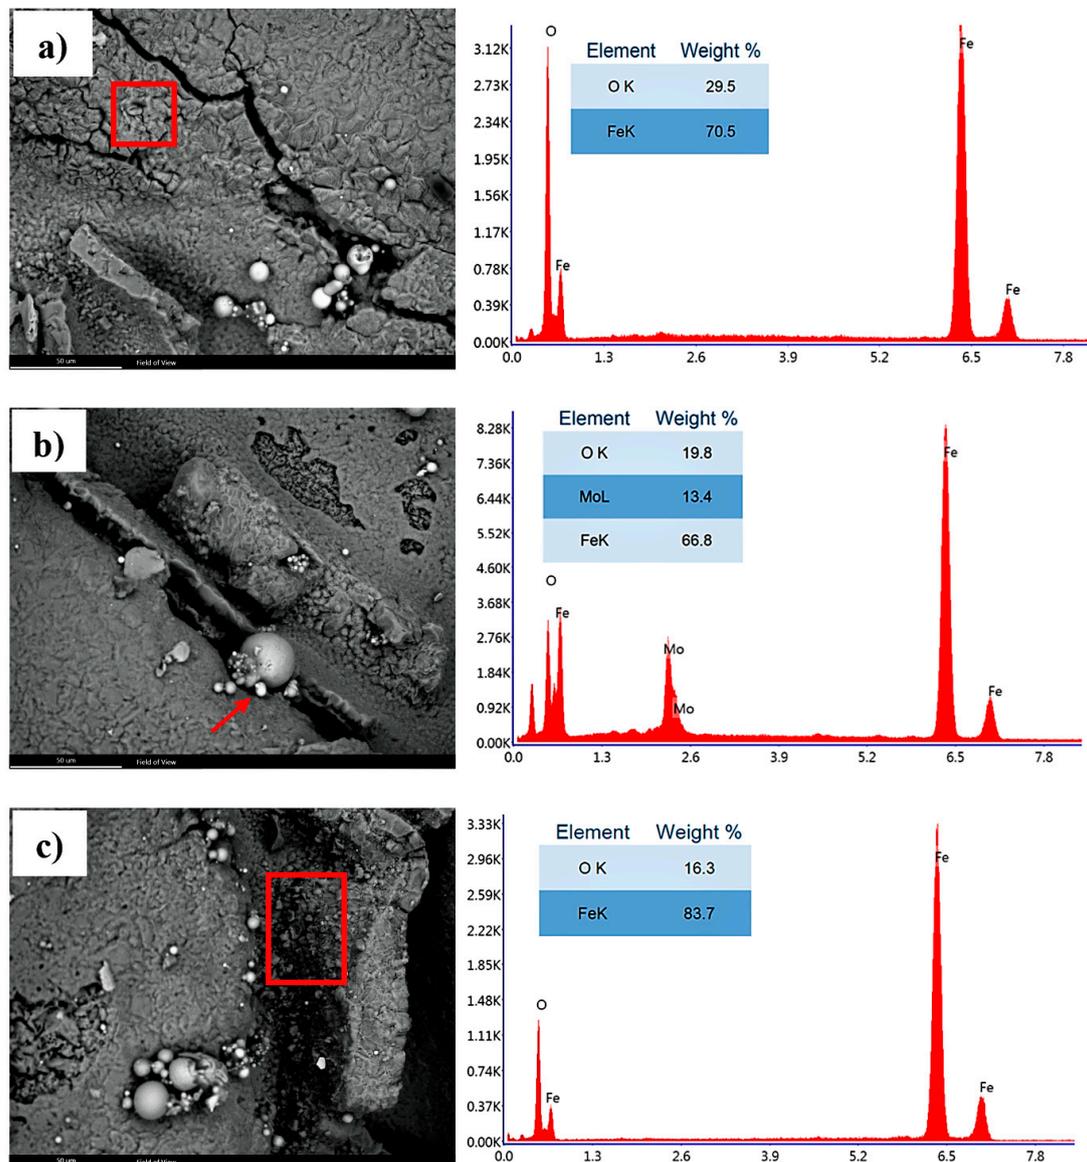
Figure 5 shows SEM images of a crack at the surface. It appears that the crack is formed due to the breakage of the oxide layer on the surface. Some rounded particles are also observed inside cracks and in areas in the vicinity of the cracks with their sizes ranging from a few microns up to 30 microns. Three different features were analyzed using EDS, i.e., the surface, as shown in Figure 5a, rounded

white particles, as shown in Figure 5b, and small particles inside cracks, as shown in Figure 5c. Results of EDS analyses indicate that rounded particles are either iron oxide particles or molybdenum-rich particles. Small molybdenum-rich particles are only in small percentages of rounded particles inside cracks. Most particles inside cracks are iron oxide particles. Given that the starting material is not expected to contain any molybdenum, and as molybdenum is not added to the melt, the only option left for the origin of these molybdenum-rich particles must be residues from the processing.

Figure 5. SEM images and energy dispersive X-ray spectroscopy (EDS) analysis of cracks on the surface of a hot-rolled heavy plate. The highlighted spot is analyzed by EDS. (a) Surface area surrounding crack, (b) rounded white particles, and (c) small particles inside cracks.

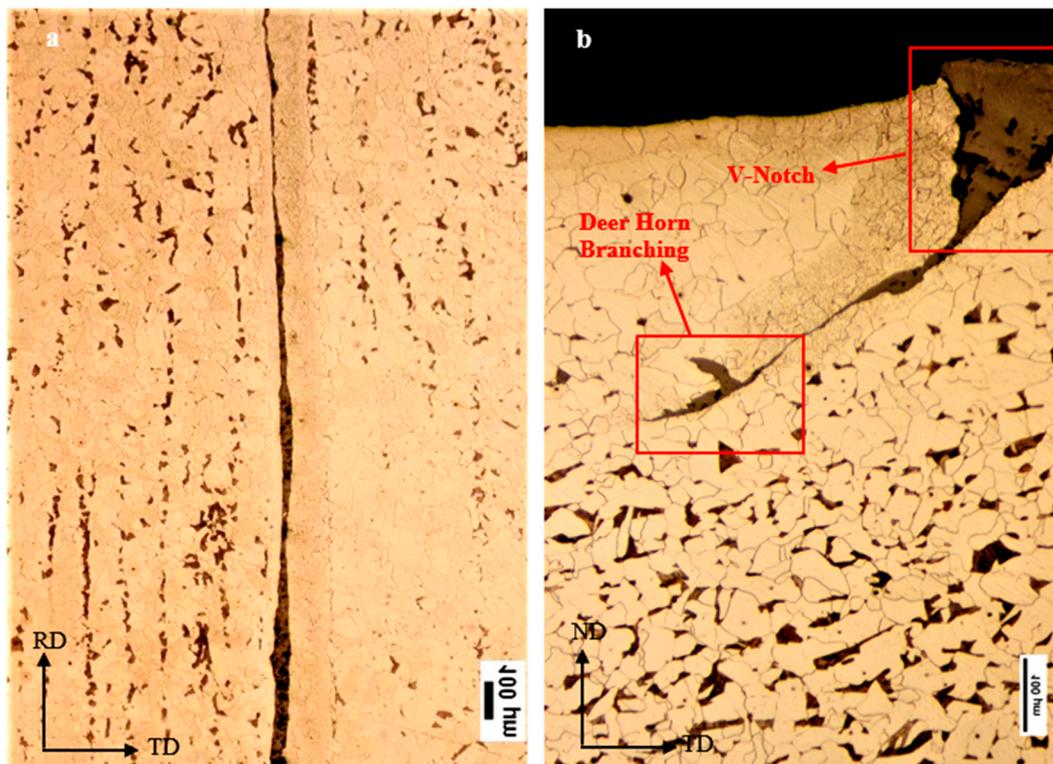
Figure 6 reveals optical microscope images of the microstructure around the crack. There are several features worth mentioning. First of all, the crack is completely filled with an iron oxide phase. The presence of this oxidizing environment inside the crack results in de-carburization in the vicinity of cracks, in such a way that there is a band of fully de-carburized ferritic microstructure alongside the crack. The microstructure of the steel away from the crack is ferritic–pearlitic as commonly observed in plain carbon steel plates. Other than this de-carburized layer, there is no other

microstructural abnormality, like excessive grain coarsening or deformed/elongated grains in either side of the surface crack.

Figure 6. Optical microscope images of cracks (a) from the top and (b) perpendicular to the crack.

To solve this problem, one needs to minimize the formation of surface V-grooves, given that these surface irregularities are spots, where cracks can nucleate. Presence of the oxide phase inside the crack is possibly to do with an improper pre-heating atmosphere. In case the oxygen/gas ratio in the pre-heating stage is not optimized, free excess oxygen can enter into surface notches and this results in the formation of an iron oxide phase inside cracks. The oxide phase is in nature a brittle phase which cannot accommodate plastic deformation. Besides, oxidization inside cracks is associated with de-carburization of the alloy in the vicinity of the cracks. In the worst case condition, this will result in a fully ferritic microstructure adjacent to the crack. This means that the area close to the crack is comparatively softer and undergoes a higher degree of deformation, which in turn has

implications for crack propagation. One way to tackle this problem is therefore trying to minimize oxidation during reheating. During reheating of the slab before rolling, oxygen present in the reheating furnace diffuses through the crack opening and reacts with the carbon of the steel, resulting in partial decarburization around the crack. Decreasing the oxygen/gas ratio in reheating furnaces could have a key positive impact.

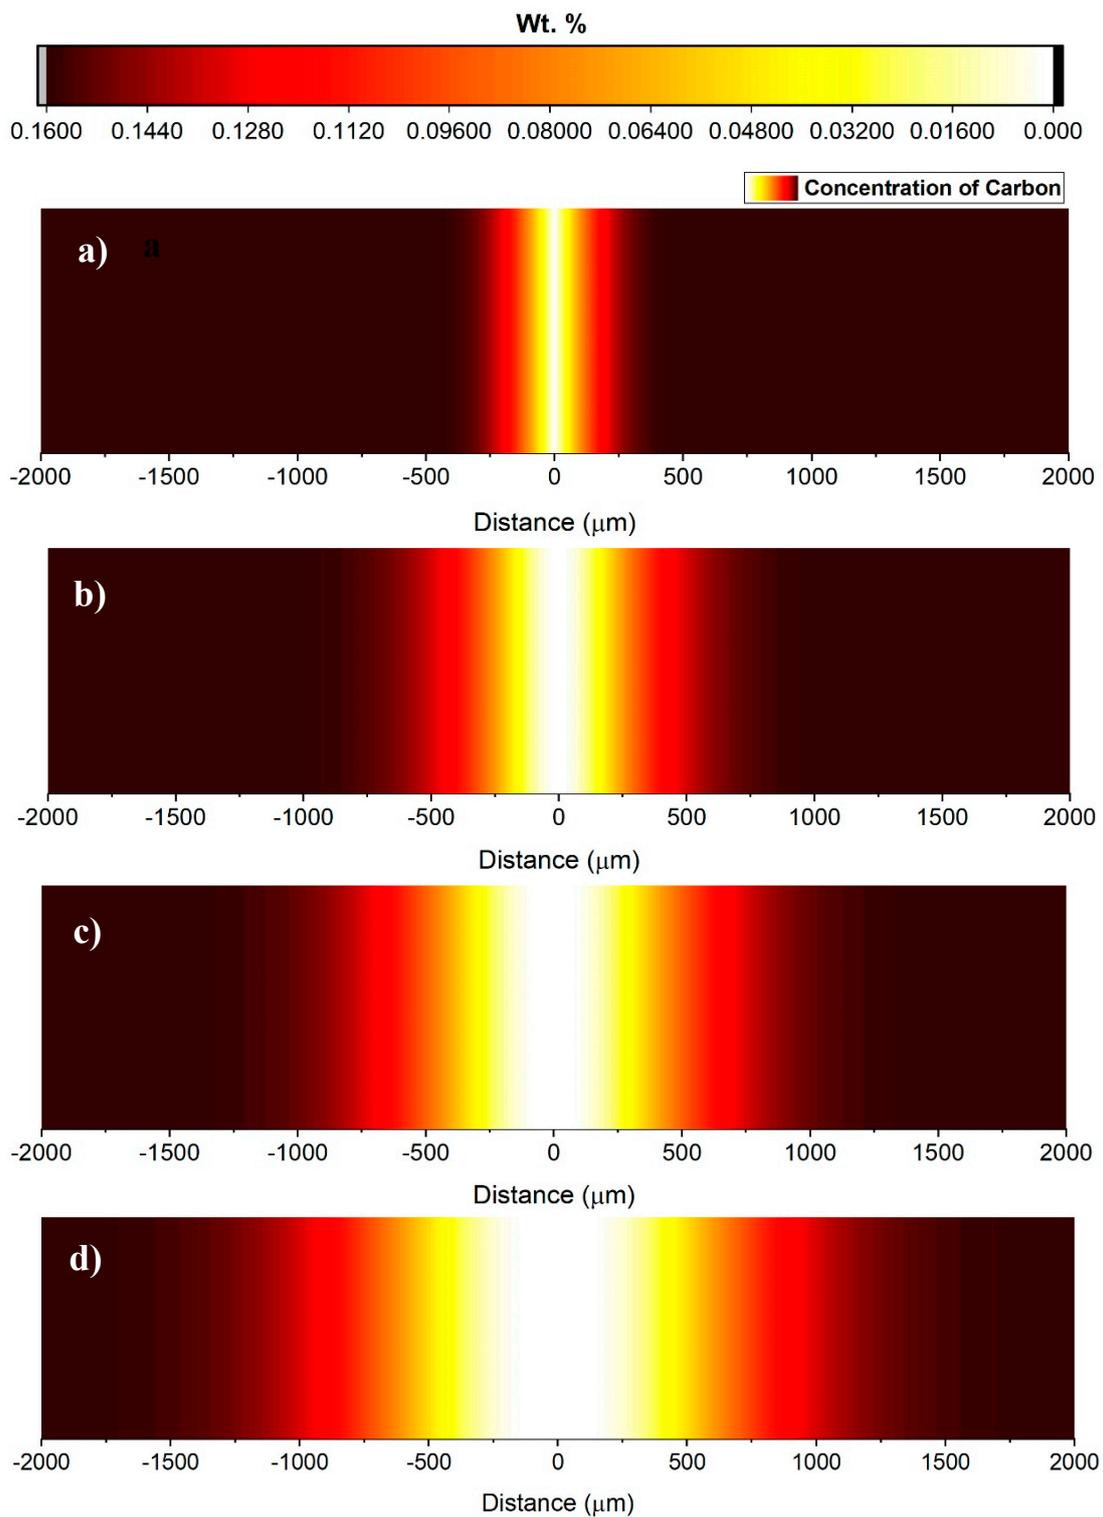
where $D_0 = 2.3 \times 10^{-5} \text{ m}^2/\text{s}$, $Q = 148 \text{ kJ/mol}$, and $R = 8.314 \text{ J/mol}\cdot\text{K}$ [20]. An average value of $1100 \text{ }^\circ\text{C}$ was assumed for the rolling temperature. Figure 7 shows the contour of carbon diffusion across the crack. Results show that after 16 passes carbon is heavily depleted in approximately $300\text{--}400 \text{ }\mu\text{m}$ distance from the crack. It is also seen that with increasing pass numbers, the depletion layer gets wider. According to Fe-C diagram, pearlite is not expected to form in carbon content less than $0.008 \text{ wt. } \%$. Results of this calculation is very well in accordance with the experimental results.

Figure 7. Contour of carbon diffusion in and around areas of a crack (a) after 1 pass of hot rolling, (b) after 5 passes, (c) after 10 passes, and (d) after 16 passes.

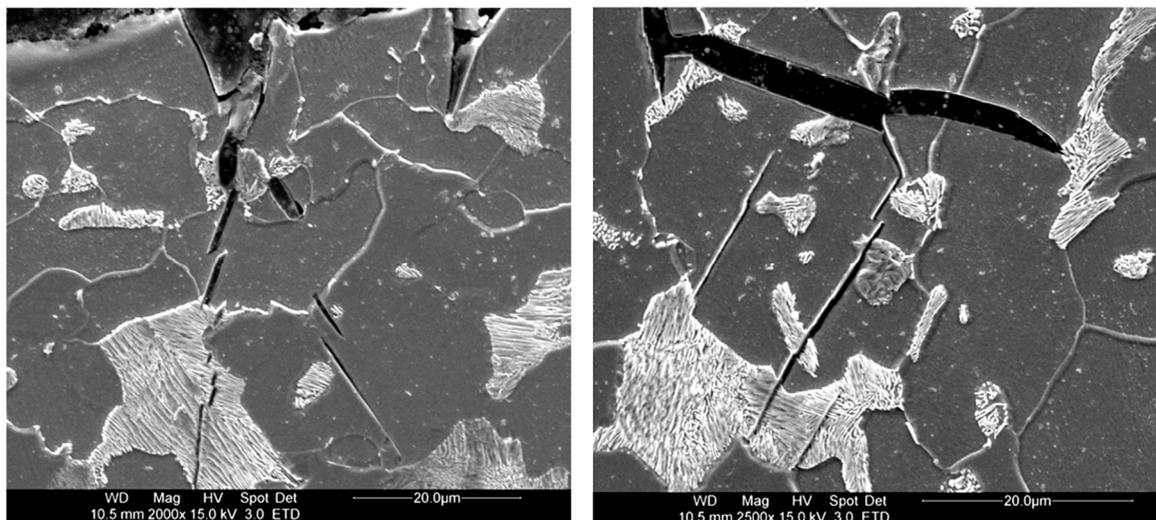
Figure 8 shows other examples of deer-horn crack end branching. It appears that surface cracks are initiated at the tip of V-grooves and are propagated during differential loading. The crack propagation

path is initially straight in the sense it does not seem that crack is following the grain boundary path. The last stages of rolling are associated with crack branching. The cracks must have developed in the initial rolling stages and branched during the subsequent rolling passes. There are many influencing factors that might result in surface cracking on hot-rolled steel heavy plates [10]. Defects of the surface are due to different reasons, but generally they are confined into two main categories: (1) primary defects existed on continuous casting process slabs which propagate or are inherited from defects generated by rolling processes and are originated from upstream rolling processes defects and (2) also these defects can occur because of incorrect rolling technologies and foreign bodies were unevenly rolled in the interface of the strip rolled [6]. In this case the origin of cracks is certainly V-notches. Any mitigation strategy needs to address this problem by trying to eliminate these V-grooves at the surface. Surface notch V-grooves have a very sharp end which obviously is a place where stress intensity goes up and this in turn results in the crack initiation and propagation.

Figure 8. Examples of crack ends branching.

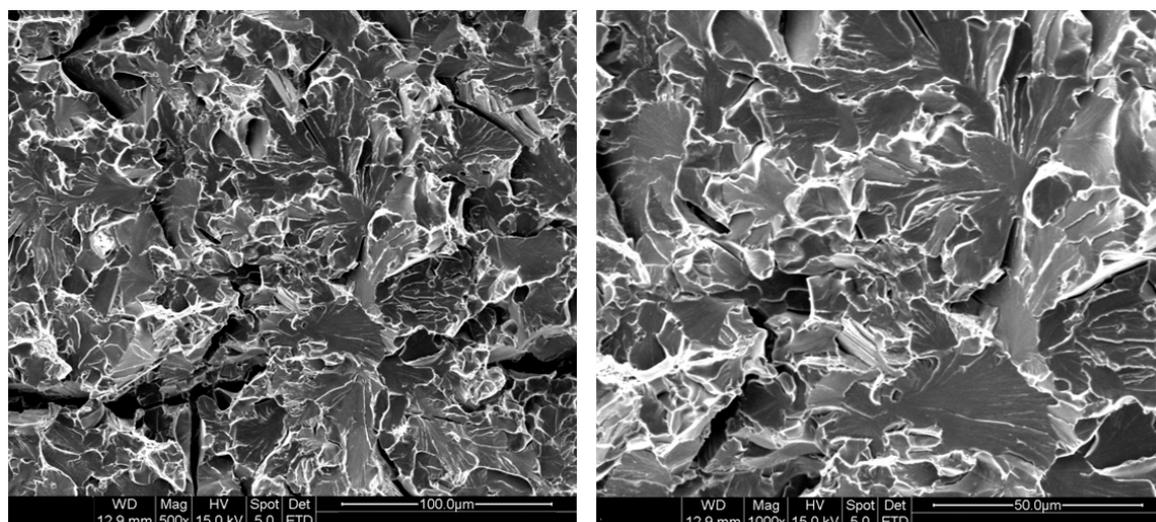
Figure 9 shows the fracture surface of the sample, taken from the surface of heavy plates, containing cracks. The fracture is typically transgranular in nature. As well, one can see de-cohesions and discontinuities at the fracture surface, which are due to the presence of surface cracks in the sample.

Figure 9. Examples of the fracture surface of the sample, containing surface cracks.

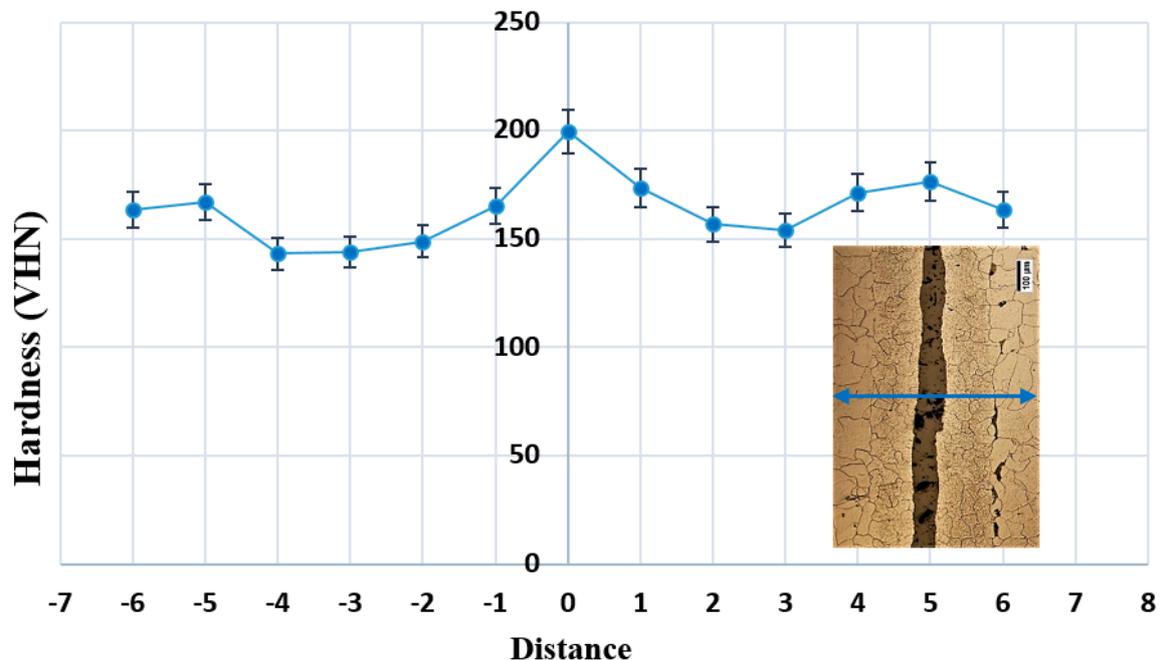
Figure 10 shows a typical hardness profilometry across the crack. As can be seen in this figure, the hardness at the center of the crack, where the oxide layer is present, has significantly increased. This is not surprising, since the layer inside the crack is heavily oxidized. Areas in close proximity to the oxide layer are clearly the weakest spots, which obviously has to do with the fact that the microstructure at the vicinity of the cracks is ferritic.

Figure 10. Hardness profilometry across the crack (distance between spots is 100 microns) (VHN: Vickers Hardness Number).
