Some learning cases in the Port of Rotterdam

De Gijt, J. G.; Brassinga, H. E.; Roubos, A. A.

IOP Conference Series: Materials Science and Engineering

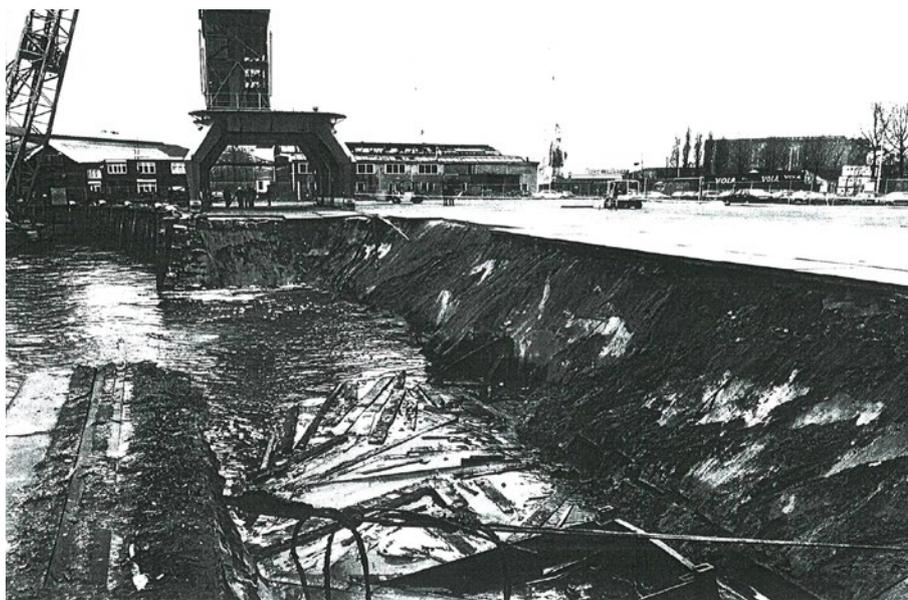
2” Katendrechtse haven ± 1980

Figure 4. Failed quay wall Katendrecht.

This quay wall, built in 1938 and consists of a foundation of wooden piles while the underwater slope was stabilized with fascine mattresses[7]. This quay wall failed in 1990 due to increased scour by propeller loads from the containerships and lack of inspection. The quay wall collapsed over a length of 100m. The design in 1938 was a proper design, however the scour effect of the ships propellers was underestimated. This caused the failure of the quay walls after 50 years.

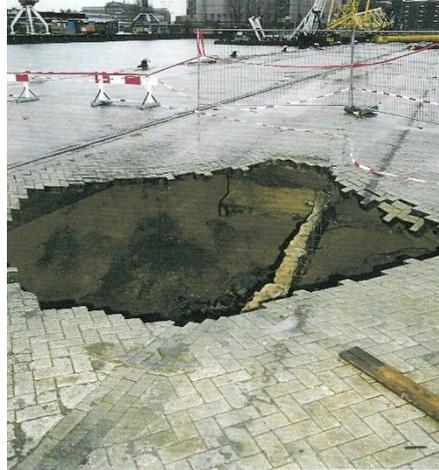
Figure 6. Hole in front wall of caisson quay wall.

damage was due to an failed mooring manoeuvre [7]. The captain of the ship could not get the machine in the reverse position in time. So the bulbous bow penetrated in the 0,25 m thick front wall of the caisson structure. So the front wall was damaged and the sand in caisson was washed out, creating a hole. This was a very dangerous situation as that area was used as parking area as well and high voltage electrical cables were present along the quay.

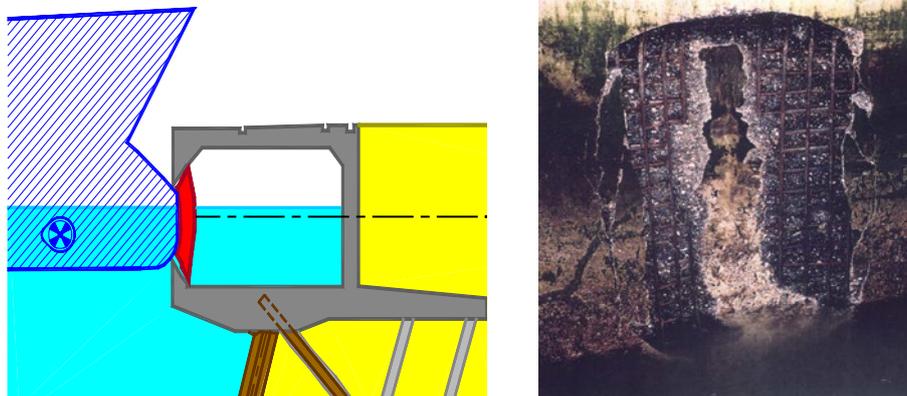
Figure 7. Damaged quay wall and impression of the damage of front of quay wall.

The ECT terminal on the Maasvlakte consists of a quay wall with a box structure founded on a comb wall and prefab concrete piles [7]. In 1992 a ship could not stop in time so the bulbous bow severely damaged the front wall. After inspection it was shown that only the front wall was displaced over ca 0,7 m. Due to the MV-piles the damage was limited to the front wall only. The rest of the structure remained intact.

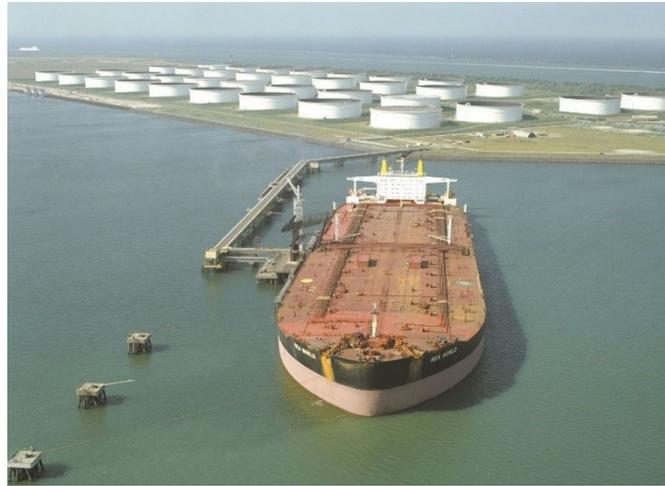
Figure 8. Damaged oil jetty.

The oil jetty at the Maasvlakte consists of a long concrete structure founded on steel piles, see figure 8 [7]. This jetty was severely damaged by a container ship which sailed through the jetty. The container ship was hardly damaged, however the jetty was severely damaged which is shown in figure 8. There was a considerable oil spill as well, which had to be cleaned up.

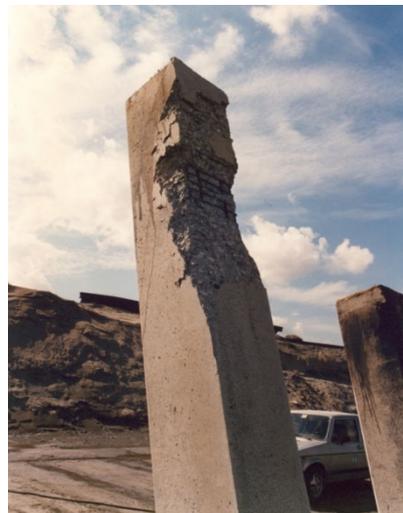
Figure 9. Pile damage.

Within structural design the foundation was first designed as mat foundation and later by wooden piles [7]. The wooden piles were replaced by prefab concrete piles and they are still used. However, on the Maasvlakte in 1990 severe damage was observed with prefab concrete piles both at the head the pile as well as at the tip. This damage was caused by heavy driving in very dense sand layers. Since then that vibro piles are mostly used in Rotterdam and recently even steel tubex piles are used to prevent damage a the pile tip.

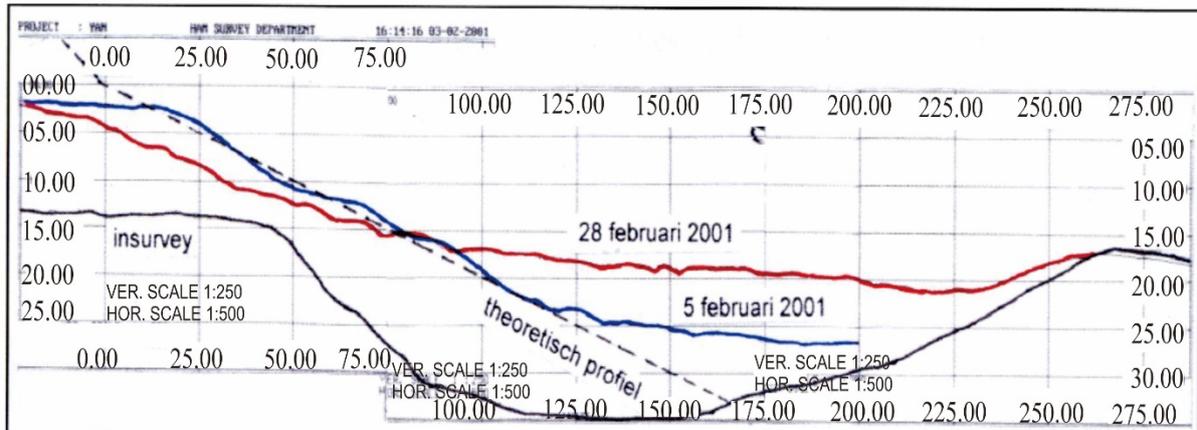
During the reclamation of the central area of Maasvlakte 1 by the method of hydraulic filling, the boundary dam, a bund of mine stone, failed [7]. This failure was initiated by the high speed of reclamation and an overlap which was too little within the mine tailing dam structure. In figure 11, it can be observed how the extent of the flow was developed.

Figure 11. Bund construction and failed slopes.

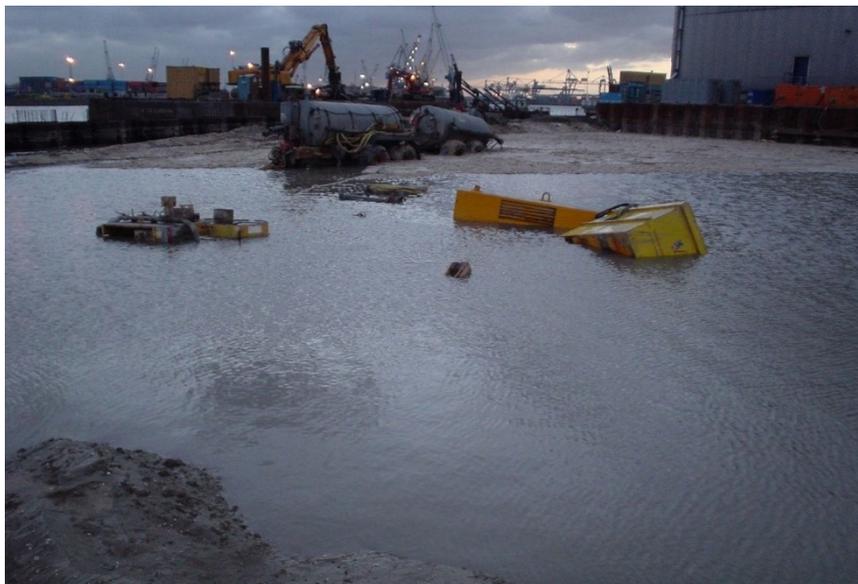
Figure 12. Flooded excavation.

This figure 12 shows a construction pit flooded due to high water at the riverside [7]. The contractor was warned and advised to construct a protecting wall at a higher level as in winter and springtime high water can be expected. However the contractor took the risk not to take these precautions and the result was a flooded construction pit and a lot of damage.

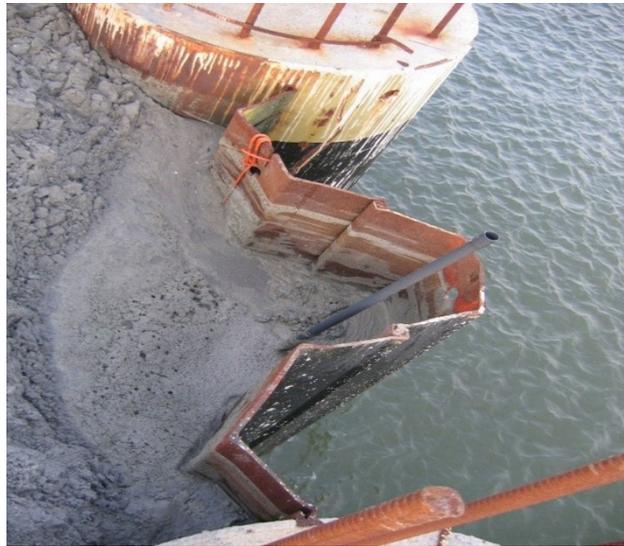
Figure 13. Failure due hydraulic fill behind quay wall.

The wall as shown in figure deformed too much due to high hydraulic loads during the construction period [7]. Thus due to time constraints the area at land side must be filled up. The sheet pile elements should be designed to make that possible.

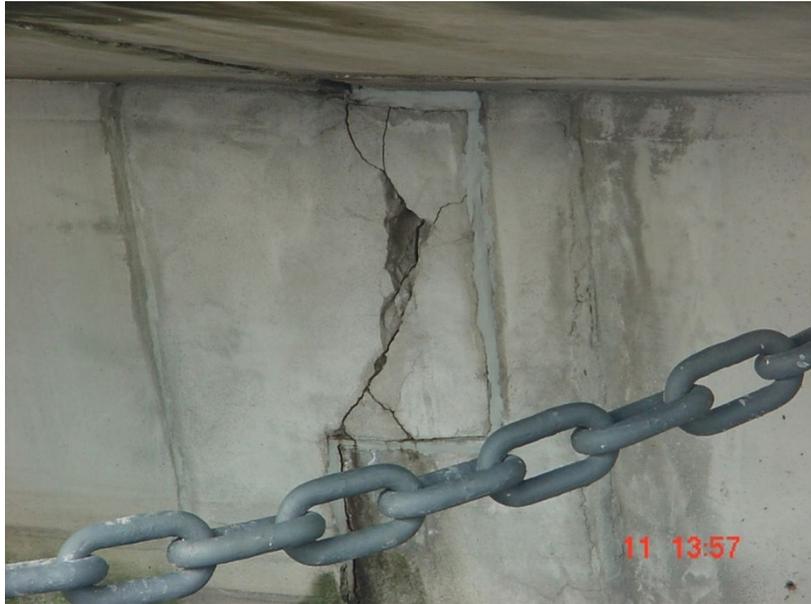
Figure 14. Cracking of concrete structure due to wrong connection.

This figure 14 shows a wrong connection of two sections of a quay wall in the Waalhaven [7]. Normally the sections of the super structure are only connected with teeth construction. However In this case the reinforcement was continued over the cross sections of the quay wall which initiated cracking due to uneven settlement.

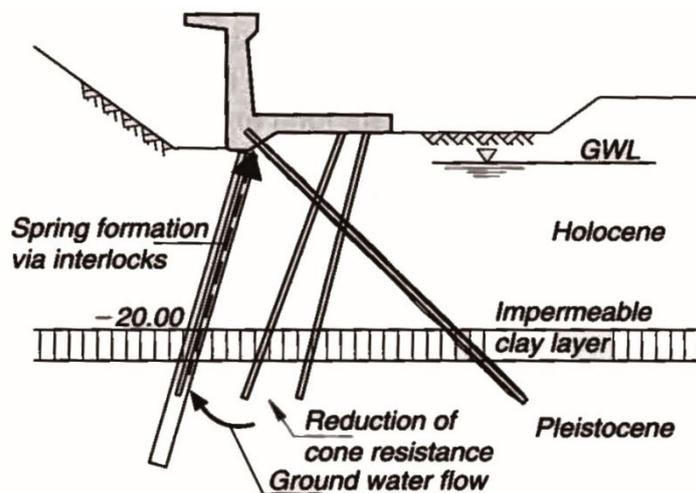
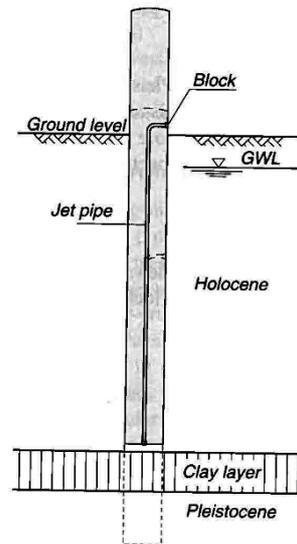
Figure 15 and figure 16 show the cross section of quay wall with the building pit [8]. The concrete piles were installed with a jetting device for easier driving. However it occurred that the jetting pipes were not closed before driving started in the foundation layer. In that case the water flowed through the jetting pipe in the building pit and also reducing the bearing capacity of the piles.

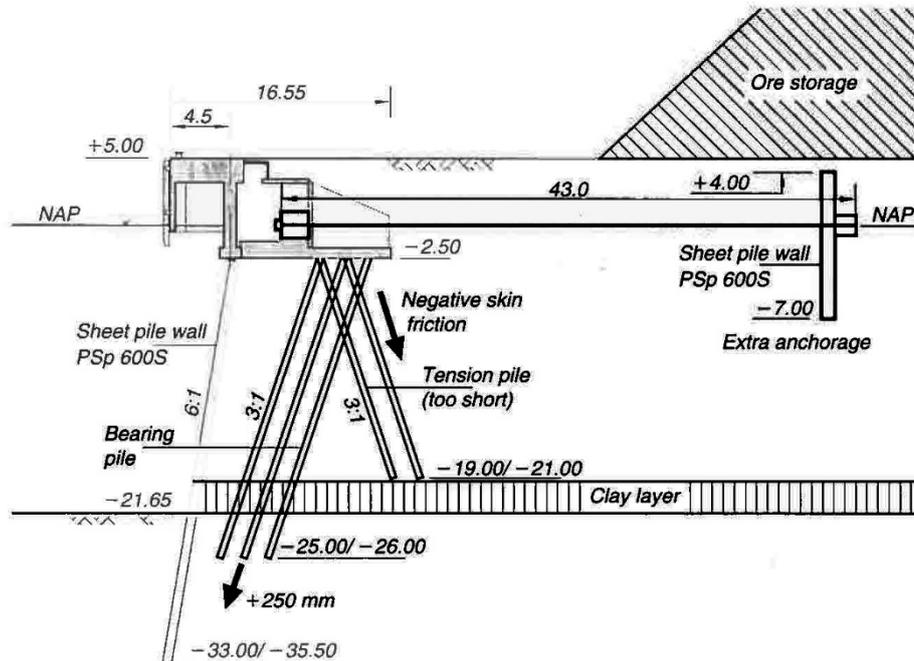
Figure 17. Quay wall with relieving floor.

Both figure 17 and figure 18 basically show the same structure [8]. However, in figure 17 the anchor force has to be taken by inclined concrete piles. However, they are so close together that the relieving floor in principle did not work. This caused a deformation of 30 cm in 20 years time. This required installation of an anchor screen.

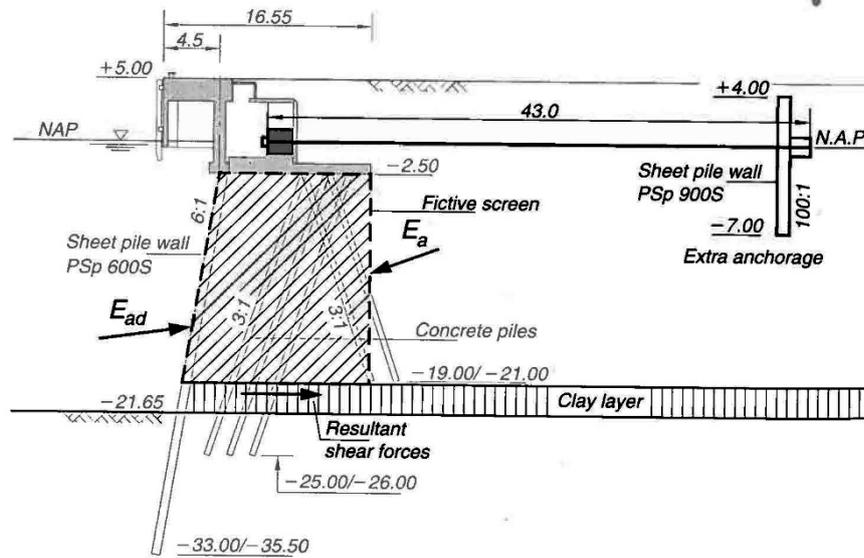
Figure 18. Quay wall with relieving floor.

The figure 18 shows the same structure. However, the concrete piles at the back site should have been driven deeper. As this was not realized due the very dense sand layer the structure showed too much deformation as well. It had to be anchored too with a horizontal anchor screen.

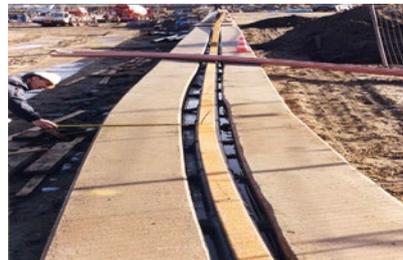
Figure 19. Deformed crane beam due too heavy densification of reclaimed sandfill.

This crane rail suffered too much deformation which was caused by too severe densification of the hydraulic fill [7]. Fortunately the crane could be properly installed without much extra work.

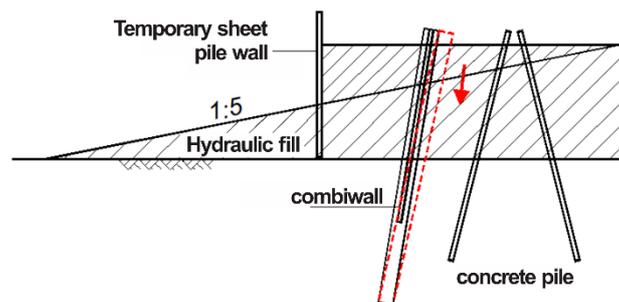
Figure 20. Deformation combi wall due to severe densification.

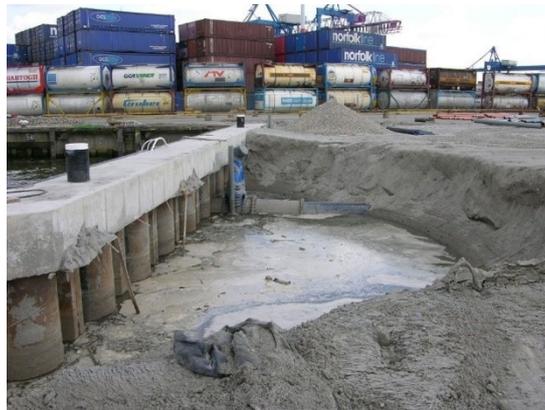
Figure 21. Hole due interlock opening in combi wall.
