# Wear Induced Failure of Automotive Disc Brakes—A Case Study

**Abstract:** This paper investigated a failure in a ventilated disc brake in an automobile. The failed brake disc had been in service for approximately 10 years. The observed failure was in the form of radial cracks that appeared to have initiated at the outer edge of the disc brake. The cracks were rather straight with no branching. Optical microscope, scanning electron microscope (SEM), and energy dispersive X-ray spectroscopy (EDS) were used to study the microstructure of the failed disc. Vickers microhardness test was also used to evaluate the hardness of the samples. Results showed that the root cause of crack formation, in this case, was related to the excessive wear in the brake disc. Different wear mechanisms, namely abrasive and adhesive wear, were recognized in the failed specimen. Moreover, the worn surface in some areas was covered with fine oxide particles. These particles appeared to have a significant contribution toward abrasion. To further understand the wear mechanisms, pin-on-disc experiments were also conducted on the samples. Results of the pin-on-disc experiments were compared and correlated to th

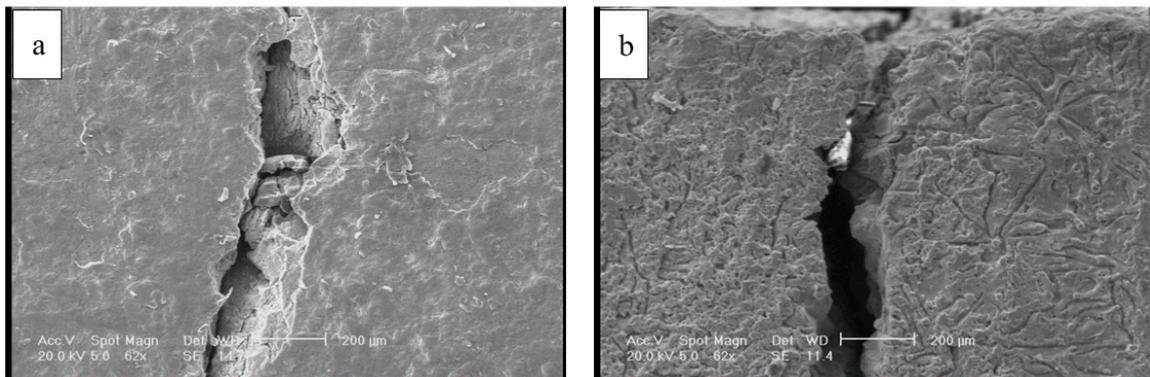
Figure 3. Scanning electron microscope (SEM) images of the crack, in (a) top view and (b) cross-section.

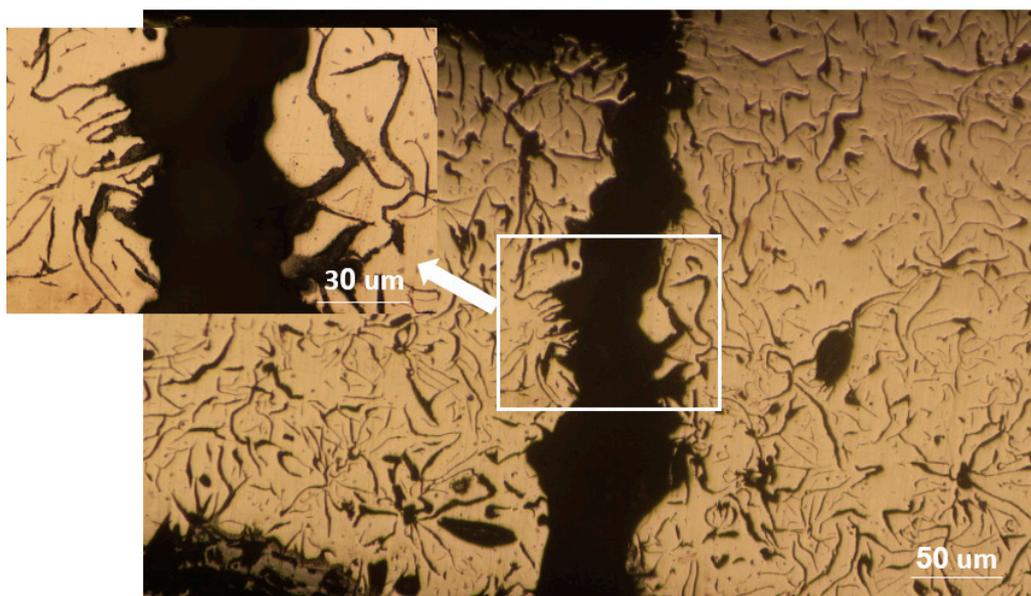
Figure 4. Optical microscope image of the cross-section of the crack.

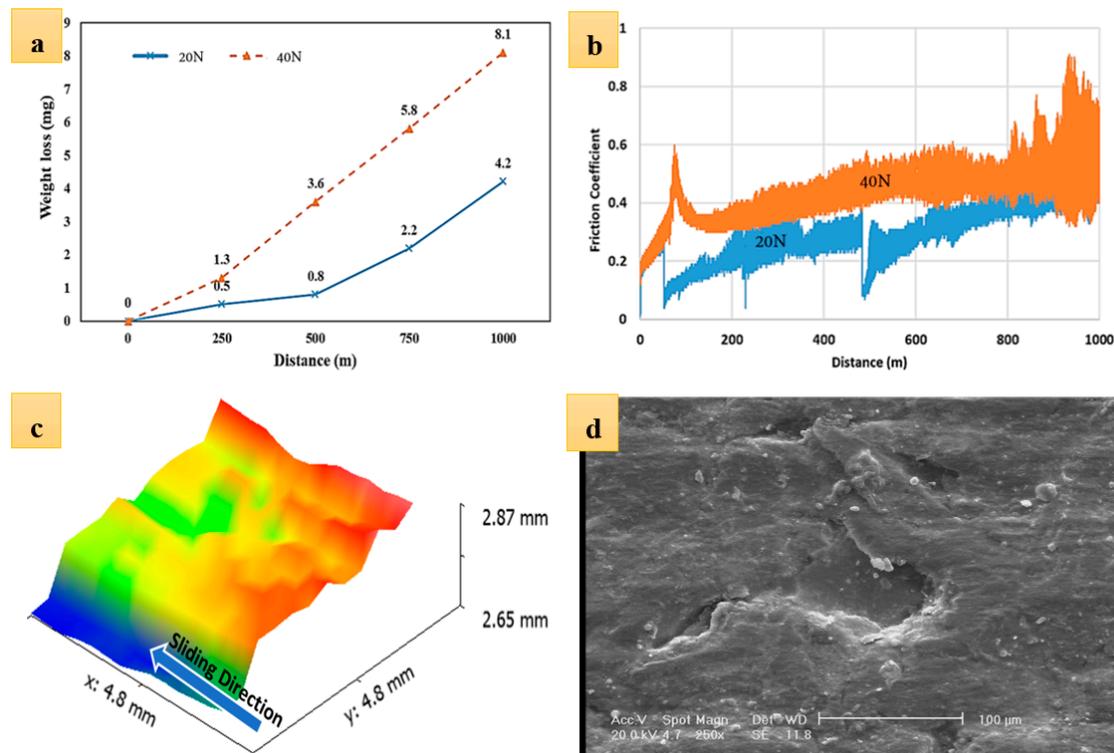
To further investigate wear mechanisms in gray cast iron, pin-on-disc wear tests were performed on discs of 50 mm diameter. The tests were conducted for 1000 m under 20 and 40 N loads. Figure 9 depicts the results of the wear tests. Figure 9a compares the weight loss during wear tests under 20 and 40 N loads. The higher the load, the higher the weight loss. In the case of a 40 N load, the weight loss linearly increased with the sliding distance. However, in the case of a 20 N load, it appeared that the weight loss had different kinetics during the test, in such a way that the kinetics of weight loss was much slower in the first 500 m of sliding. The kinetics of weight loss significantly increased from this point on. This could be due to the activation of a new wear mechanism. Given that oxide particles have a significant contribution to the wear [22], one can postulate that up to 500 m, not enough oxide particles were formed in between the pin and disc. This changed after 500 m of sliding. This argument follows the variation of the friction coefficient with sliding distance (see Figure 9b). We see that where the load was 20 N, the coefficient of friction increased with different kinetics after 500 m. Concerning the coefficient of friction, one can see that the coefficient of friction with a load of 40 N was comparatively larger than that with a load of 20 N. This had to do with the correlation of the applied load and the coefficient of friction. As the applied load increased during the wear test, the contact points between the asperities increased, which resulted in a higher coefficient of friction. The observed increase in the coefficient of friction with sliding distance in both cases could be attributed to the formation and fragmentation of oxide particles on the surface. More importantly, as the sliding distance increased, the chance of detachment and fragmentation of the graphite flakes increased. Given that graphite flakes have a self-lubricating effect, this detachment and fragmentation of graphite flakes can increase the coefficient of friction. Graphite detachment can also increase the surface roughness and this will have a negative implication on the coefficient of friction. Figure 9c,d show the laser profilometry of the surface topography and SEM image of the worn surface after 1000 m sliding under load 40 N. There were different features on the surface, with each being related to different wear mechanisms. First of all, there were some spots on the surface wherein the surface had clearly undergone severe plastic deformation. In some areas, this resulted in spallation on the surface (see Figure 9d). Other than that, there were some plowings on the surface related to the abrasion due to the relative movement of oxide particles on the surface. Moreover, some surface cutting was identified on the surface. Cutting was identified when there was material separating with negligible plastic deformation at the sides of the grooves.

**Figure 9.** Results of the wear test: (a) weight loss with sliding distance, (b) variation of friction coefficient with sliding distance, (c) laser profilometry of the sample after 1000 m wear test under 40 N load, and (d) SEM image of the same sample.
