Train Hunting Related Fast Degradation of a Railway Crossing—Condition Monitoring and Numerical Verification

Department of Engineering Structures, Delft University of Technology, 2628 CN Delft, The Netherlands

Abstract: This paper presents the investigation of the root causes of the fast degradation of a railway crossing. The dynamic performance of the crossing was assessed using the sensor-based crossing instrumentation, and the measurement results were verified using the multi-body system (MBS) vehicle-crossing model. Together with the field inspections, the measurement and simulation results indicate that the fast crossing degradation was caused by the high wheel-rail impact forces related to the hunting motion of the passing trains. Additionally, it was shown that the train hunting was activated by the track geometry misalignment in front of the crossing. The obtained results have not only explained the extreme values in the measured responses, but also shown that crossing degradation is not always caused by the problems in the crossing itself, but can also be caused by problems in the adjacent track structures. The findings of this study were implemented in the condition mon

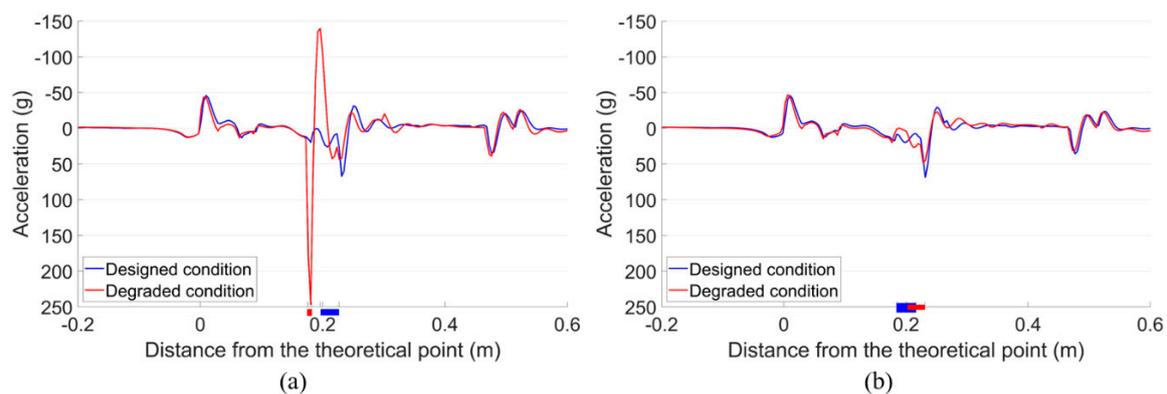
Figure 20. Vertical impact acceleration responses and transition regions. (a) Front wheel. (b) Rear wheel.

It can be seen from Figure 20a that with the lateral irregularity taken into account, the impact of the front wheel was dramatically increased to 247 g, which was 4 times higher than the reference value (around 62 g) in the designed condition. While for the rear wheel from the same bogie, the impact was 48 g, which was even lower than the reference value. Despite the slight difference in the absolute values, the simulation results were consistent with the measurement results (Figure 11). Meanwhile, the transition region of the front wheel was 0.176–0.182 m from the TP with a size of only 0.006 m. Compared with the reference level (0.196–0.217 m with a size of 0.031 m, [29]), it was much narrower and closer to the TP, indicating earlier wheel impact and much sharper wheel load transition in the crossing. For the rear wheel, although the transition region was located farther from the TP, the size was almost the same as the reference value.

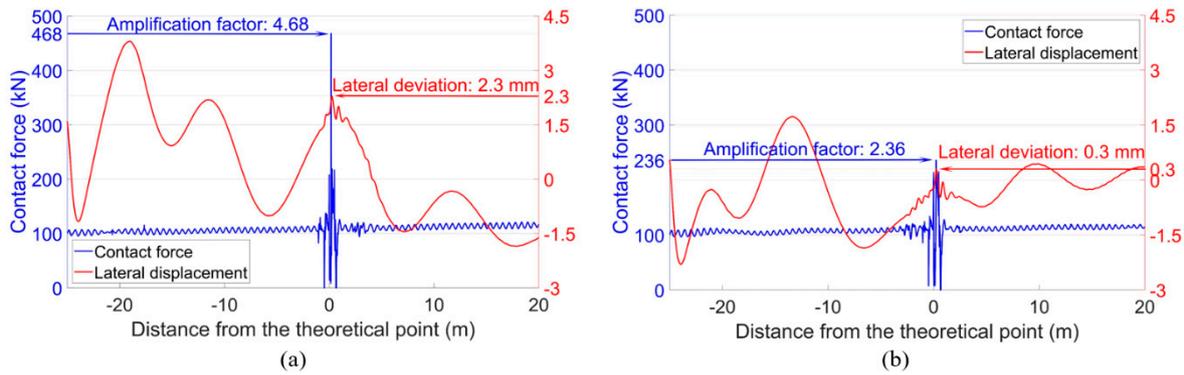
In the degraded condition with track lateral irregularities, the lateral displacements of the wheels were dramatically changed, as shown in Figure 23. It can be seen that both the front wheel and the rear wheel showed activated hunting oscillation before and after passing through the crossing, but the trajectories were quite different. For the front wheel, the lateral movement was more intense and ran toward the crossing nose rail near the TP. The maximum lateral displacement corresponding to the position with the highest contact force was 2.3 mm, which means that compared with that in the designed condition, the wheel flange was around 1.6 mm closer to the nose rail. Comparatively speaking, such displacement of the rear wheel was only 0.3 mm. Such results indicate that the wheel-rail impact was profoundly affected by the movement of the wheel. When the wheel approaches closer to the crossing nose, the wheel-rail impact is likely to be increased. It can be concluded that the train hunting activated by the lateral track misalignment in front of the crossing is the main cause of the extremely high wheel-rail impacts.

The train hunting effect also explains the unstable wheel-rail impacts. For the rear wheel, the lateral movement was affected not only by the track misalignment but also by the front wheel from the same bogie. As a result, these two wheels led to quite different wheel trajectories. It can be imagined that in the real-life situation, there are much more factors that may affect the hunting motion of each passing wheelset such as the initial position of the wheel when entering the misaligned track section, the mutual interaction between the adjacent wheelsets, the lateral resistance of the track, and even the weather condition [28], etc. The combined effect of all these factors ultimately resulted in the polarized distribution of the impact acceleration responses (Figure 11a).

Figure 23. Wheel-rail contact forces and wheel lateral displacements. (a) Front wheel. (b) Rear wheel.
