Re engineering history: Flight of the Phoenix, what can we learn from a movie crash?

AIAA SCITECH 2022 Forum

Michiel J. Schuurman*, Roeland De Breuker[†] and Christos Kassapoglou[‡]
Delft University of Technology, Faculty of Aerospace Engineering, Delft, 2629HS, The Netherlands

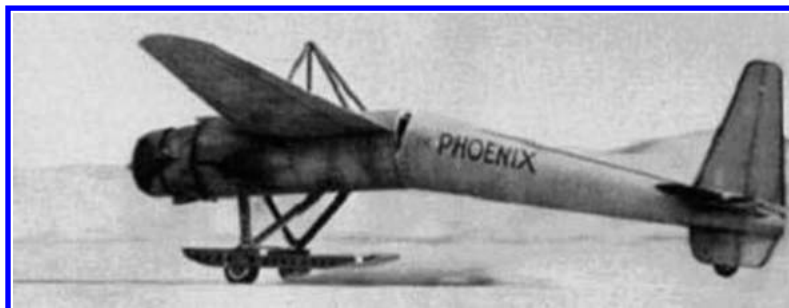
Fig. 3 Tallmantz P-1 side view of the tail section separation during 3rd pass in front of the camera's [23].

The pilot's first two passes over the flight course were too high, and he flew the third pass at a lower altitude and slower airspeed. As he approached the cameras he was advised the third pass "looked good," and it was continued. Shortly thereafter, the aircraft touched down relatively hard and in a level flight attitude about 200 ft. northeast of the eastern-most camera. After a roll of about 24 ft. the aircraft struck a small rise of soft sand which caused it to bounce about 3 ft. above the ground. At this time the wood-fabricated aft section of the fuselage was observed to separate from the metal forward section at the two top longeron wood-to-steel longeron attachment fittings.

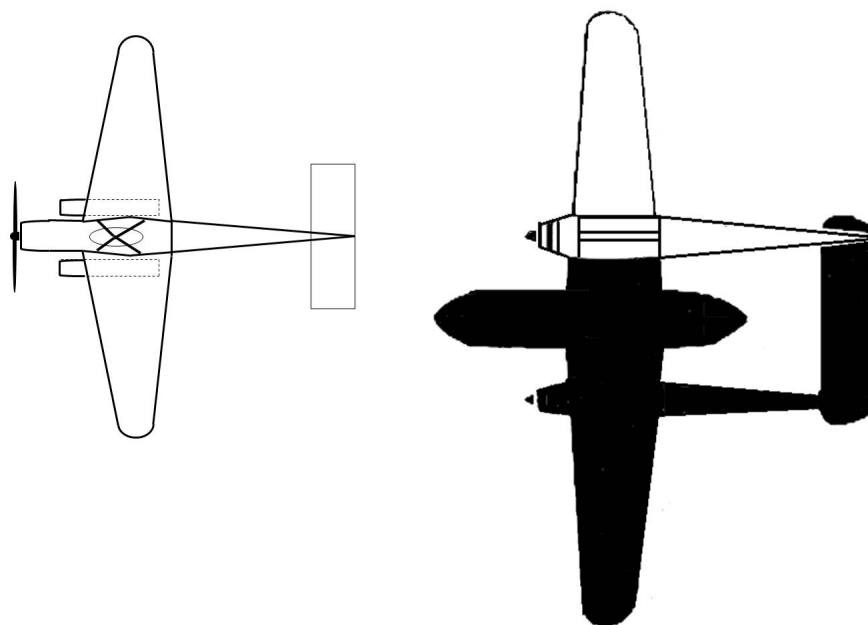
The C-82 the front fuselage section is 292 inches long and the tail boom assembly is approximately 440 inches long. The T-6 main fuselage section which was used for the Phoenix has an overall dimension of 192 inches. Taking the length of the P-1 front fuselage section and scaling this to the C-82 front fuselage would result in a scaling factor of 0.654. In other words the C-82 tail boom outline was scaled by 65% to create the appearance of the Phoenix. This means

Fig. 5 Contour drawing Fairchild C-82 Packet with the left tail-boom in white (top) and the Tallmantz P-1 "the Phoenix" outline (bottom).

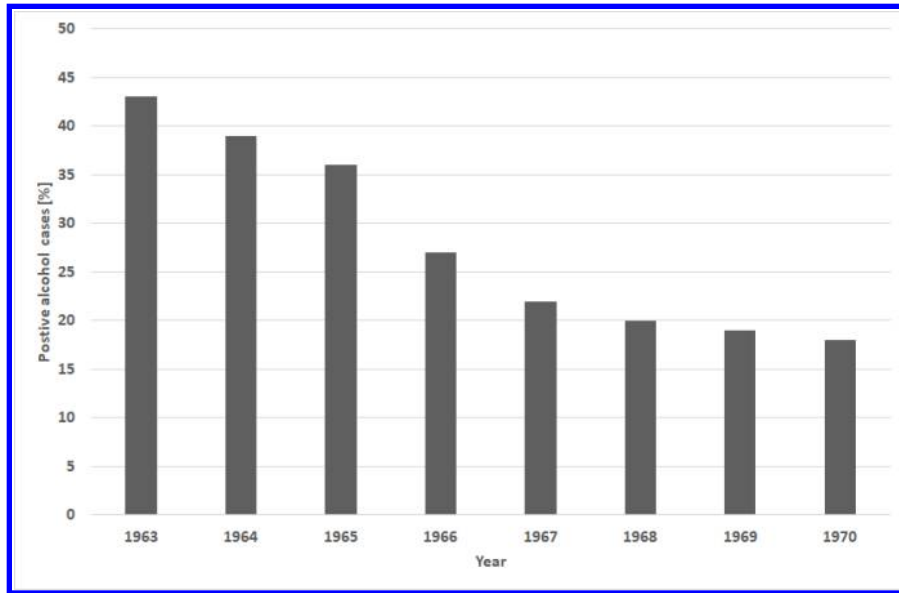
Fig. 6 General Aviation positive alcohol cases [%] [27]

Reviewing the general aviation accidents from 1963-1970 it is evident that alcohol was present in many accidents, see Figure 6. In a 1963 study a total of 35.4% pilots involved in general aviation accidents had measurable level of alcohol in their blood at the time of their crash [30]. This study however did not account for contamination of the blood and putrefaction. Subsequent studies which accounted for contamination revealed lower values [31][32][33]. Especially in case of extensive (abdominal) trauma, which is very likely in aviation disasters (e.g. rupture of the viscera), interpretation of blood alcohol values in autopsy specimens from the pilot and crew is highly contentious [34]. In recent studies the main conclusion is that care must be taken to reach a valid conclusion related to blood alcohol levels.
