## Re engineering history: Flight of the Phoenix, what can we learn from a movie crash?

AIAA SCITECH 2022 Forum

Michiel J. Schuurman\*, Roeland De Breuker<sup>†</sup> and Christos Kassapoglou<sup>‡</sup>

*Delft University of Technology, Faculty of Aerospace Engineering, Delft, 2629HS, The Netherlands*

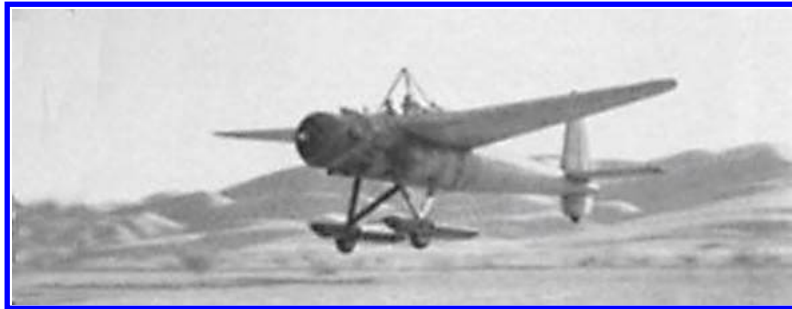
**Fig. 2 Tallmantz P-1 flying for the Flight of the Phoenix movie sequence [23].**

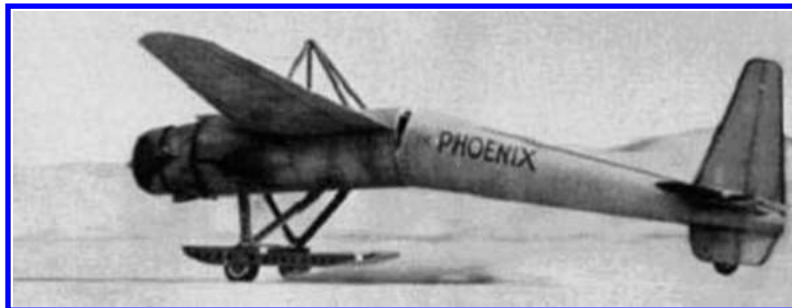
**Fig. 3 Tallmantz P-1 side view of the tail section separation during 3<sup>rd</sup> pass in front of the camera's [23].**

The pilot's first two passes over the flight course were too high, and he flew the third pass at a lower altitude and slower airspeed. As he approached the cameras he was advised the third pass "looked good," and it was continued. Shortly thereafter, the aircraft touched down relatively hard and in a level flight attitude about 200 ft. northeast of the eastern-most camera. After a roll of about 24 ft. the aircraft struck a small rise of soft sand which caused it to bounce about 3 ft. above the ground. At this time the wood-fabricated aft section of the fuselage was observed to separate from the metal forward section at the two top longeron wood-to-steel longeron attachment fittings.

Examinations by aeronautical and aerospace engineers of the steel-to-wood fuselage longeron fittings, where the failure occurred, showed the design and fabrication of the fittings were in accordance with good aeronautical engineering practice. They concluded that the wood longerons failed in tension due to overloads. The 60-lb. lead weight in the tail section was concluded to have contributed directly to the overload, as did the drag force transmitted to the fuselage by the landing gear when the wheels struck the rise of soft sand. The previous hard landing was considered to have possibly contributed to the failure.

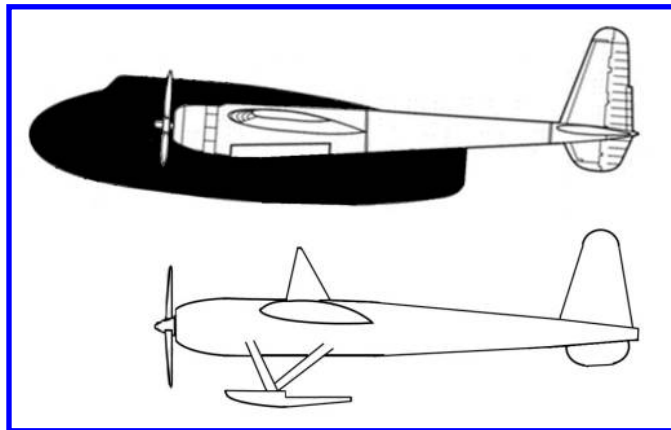
The 3-view drawing that was included with the experimental certification documentation a general layout of the Phoenix is given. However, some measurements do not match with design specifications. As an example, the overall length of the Tallmantz P-1 is given as  $42\frac{1}{2}$  feet. However, the three chain dimension on the same drawing add up to a total length of 40 feet. According to the FAA certification document the P-1 was equipped with a Hamilton Standard constant speed propeller. It is known and very likely that the propeller and engine (Pratt & Whitney R-1340 Wasp) combination were used from the T-6. The propeller diameter for the T-6 is 9 feet [26]. However, the propeller diameter in the 3-view drawing is shown as 11 feet. Further examination of Tallmantz P-1 photographs before and after the event show a different number of holes in the skids and struts compared to the 3-view drawing. Accident photos also show that the number of holes on the landing brace structure do not correspond with the 3-view drawing. Therefore, the validity of the 3-view drawing in the FAA certification documentation cannot be verified. Assuming that Otto Timm took the C-82 tail boom assembly outline as reference for the P-1 design. He would have tried to create an airplane which, for the camera could resemble the C-82 tail boom. The C-82 tail boom shape is a slender circular section which after the wing narrows to the rudder and tail section. In order to resemble the C-82 the P-1 should have a shoulder wing design. Examining the P-1 empennage section there is a ventral fin. Ventral fins are included to improve directional stability and enhance spin characteristics and recovery. It is unlikely that it would be necessary to increase the vertical tail surface area given the fact there is already a substantial rudder. Furthermore the P-1 was not designed to be a (trainer) aircraft where spins are allowed.

**Fig. 4 Top view contour drawing Fairchild C-82 Packet with the left tail-boom in white (left) and the Tallmantz P-1 "the Phoenix" outline (right).**

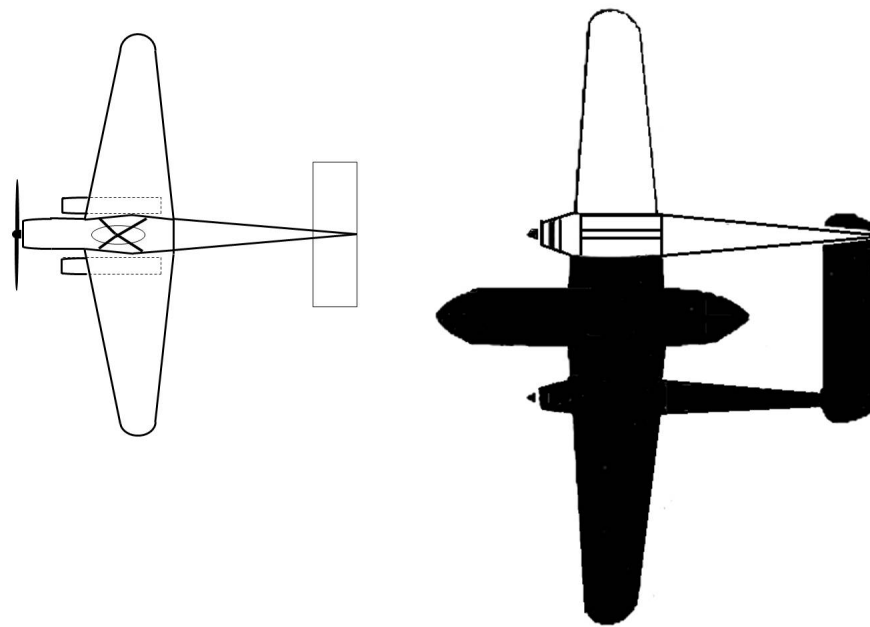
The C-82 the front fuselage section is 292 inches long and the tail boom assembly is approximately 440 inches long. The T-6 main fuselage section which was used for the Phoenix has an overall dimension of 192 inches. Taking the length of the P-1 front fuselage section and scaling this to the C-82 front fuselage would result in a scaling factor of 0.654. In other words the C-82 tail boom outline was scaled by 65% to create the appearance of the Phoenix. This means

**Fig. 5 Contour drawing Fairchild C-82 Packet with the left tail-boom in white (top) and the Tallmantz P-1 "the Phoenix" outline (bottom).**
