Re engineering history: Flight of the Phoenix, what can we learn from a movie crash?

Michiel J. Schuurman*, Roeland De Breuker[†] and Christos Kassapoglou[‡]
Delft University of Technology, Faculty of Aerospace Engineering, Delft, 2629HS, The Netherlands

On the 15th of December 1965 the motion picture “Flight of the Phoenix” was released in the United States of America theatres. In the closing movie credits the following text is shown: It should be remembered. . . that Paul Mantz, a fine man and a brilliant flyer gave his life in the making of this film. Who was Paul Mantz? What happened? And what can we learn from a movie crash? This paper will examine the Tallmantz Phoenix P-1 accident which was captured on film for the motion picture “Flight of the Phoenix”. This paper will study the “Flight of the Phoenix” story, the people involved and the special purpose aircraft build. Literature will be reviewed and analyses will be done to gain new insights to the crash of the Tallmantz Phoenix which occurred on July 8th 1965.

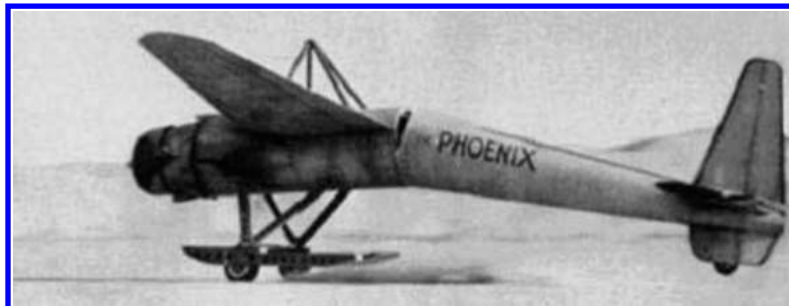
Fig. 3 Tallmantz P-1 side view of the tail section separation during 3rd pass in front of the camera's [23].

The pilot's first two passes over the flight course were too high, and he flew the third pass at a lower altitude and slower airspeed. As he approached the cameras he was advised the third pass "looked good," and it was continued. Shortly thereafter, the aircraft touched down relatively hard and in a level flight attitude about 200 ft. northeast of the eastern-most camera. After a roll of about 24 ft. the aircraft struck a small rise of soft sand which caused it to bounce about 3 ft. above the ground. At this time the wood-fabricated aft section of the fuselage was observed to separate from the metal forward section at the two top longeron wood-to-steel longeron attachment fittings.
