## Collapse of the Grimborgwal, a historic quay in Amsterdam, the Netherlands

# Collapse of the Grimborgwal, a historic quay in Amsterdam, the Netherlands

A quay wall directly next to a building, both dating from around 1870, collapsed along the Grimborgwal in Amsterdam, the Netherlands, on 1 September 2020. The historic quay wall consisted of a masonry wall, built of a timber deck supported by several rows of timber piles of about 12 m long. As over 200 km of such quays exists in Amsterdam and streets are usually very busy, the collapse triggered the question of the safety of the remaining quay walls in the city. A forensic investigation was carried out to determine the failure mechanisms and factors that contributed to the collapse. The investigation aimed to learn from this event and to prevent similar failures in the future. The main failure mechanisms and contributing factors were identified and confirmed using an integrated model of the quay, which is both simple and robust. The model was used to perform a sensitivity study taking all relevant uncertain factors into account. This work provided valuable insight into the main collapse mechanisms of the wall. Based on the resu

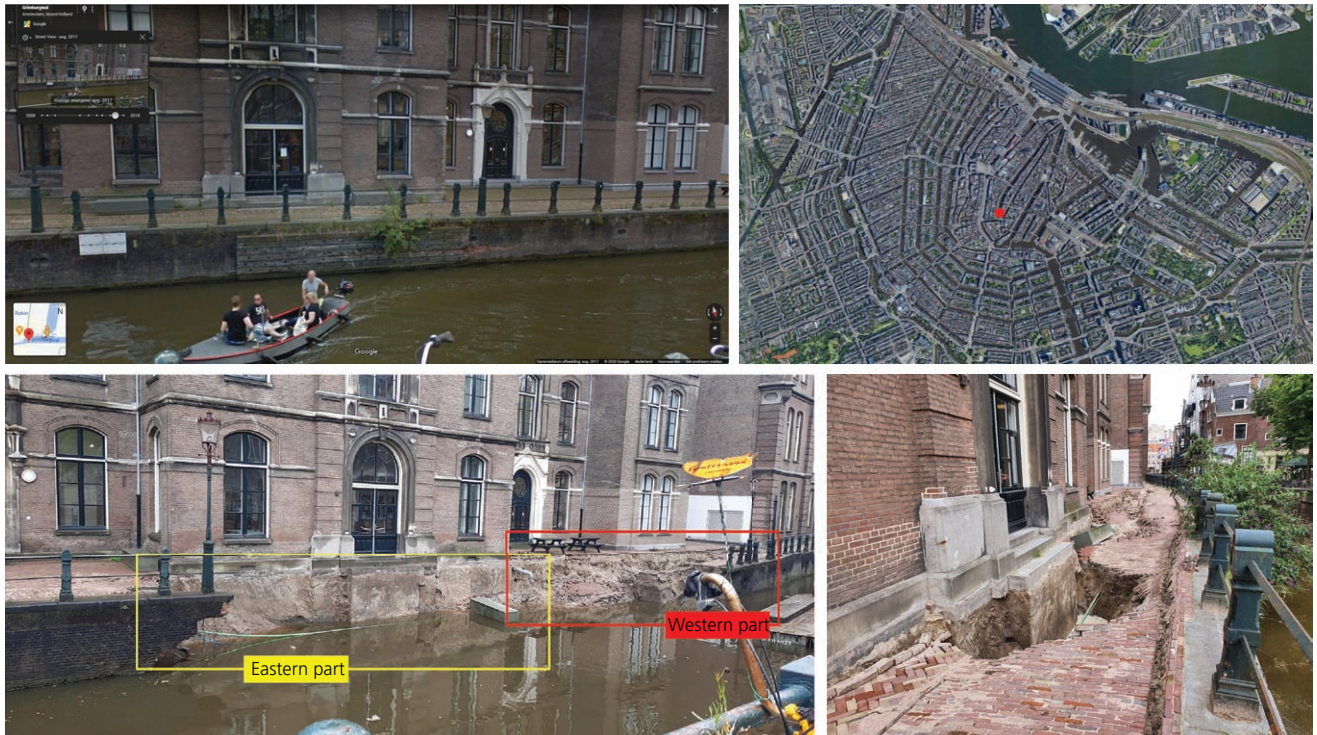
**Figure 1.** Collapsed quay and location in Amsterdam. Top left: initial condition of the quay in May 2019; picture from Google. © Google. Top right: location of GBW in Amsterdam at red dot. Bottom left: front view of quay just after collapse. Bottom right: surface view just before collapse

manoeuvre to turn and to steer into a narrow clearance under a historic bridge opposite of the failed quay. Signs of multiple ship collisions were found (see Figure 1). In old drawings, an older quay was found to cross the current quay near the site of the collapse. Also, the meteorological conditions just before the collapse were investigated. In 2014 the foundation of the building behind the quay was renewed. New piles were installed from the inside of the building. Interference with the foundation of the quay wall at the spot where the proximity of building and quay is closest could not be excluded.

observed that the depth of the canal increases in the direction of the bridge and then decreases again. The repeated collisions of the tour boats have weakened the quay. Ship traffic was a cause of masonry damage, which caused a precondition with less ability to distribute loads along the quay. The trigger for the collapse was believed to be the renewal of the pavement in May and August 2020. This repaving was necessary as a result of the deformation of the quay that occurred before. The effects of this repavement were clearly recognisable in the satellite measurements that show an increased settlement rate over time during repaving. Groundwater flow and drought/rain may also have played a role in accelerating the failure in combination with the horizontal quay deformation that had already occurred and the leakage path from behind the quay towards the canal for the formation of holes in the pavement as shown in Figure 1.

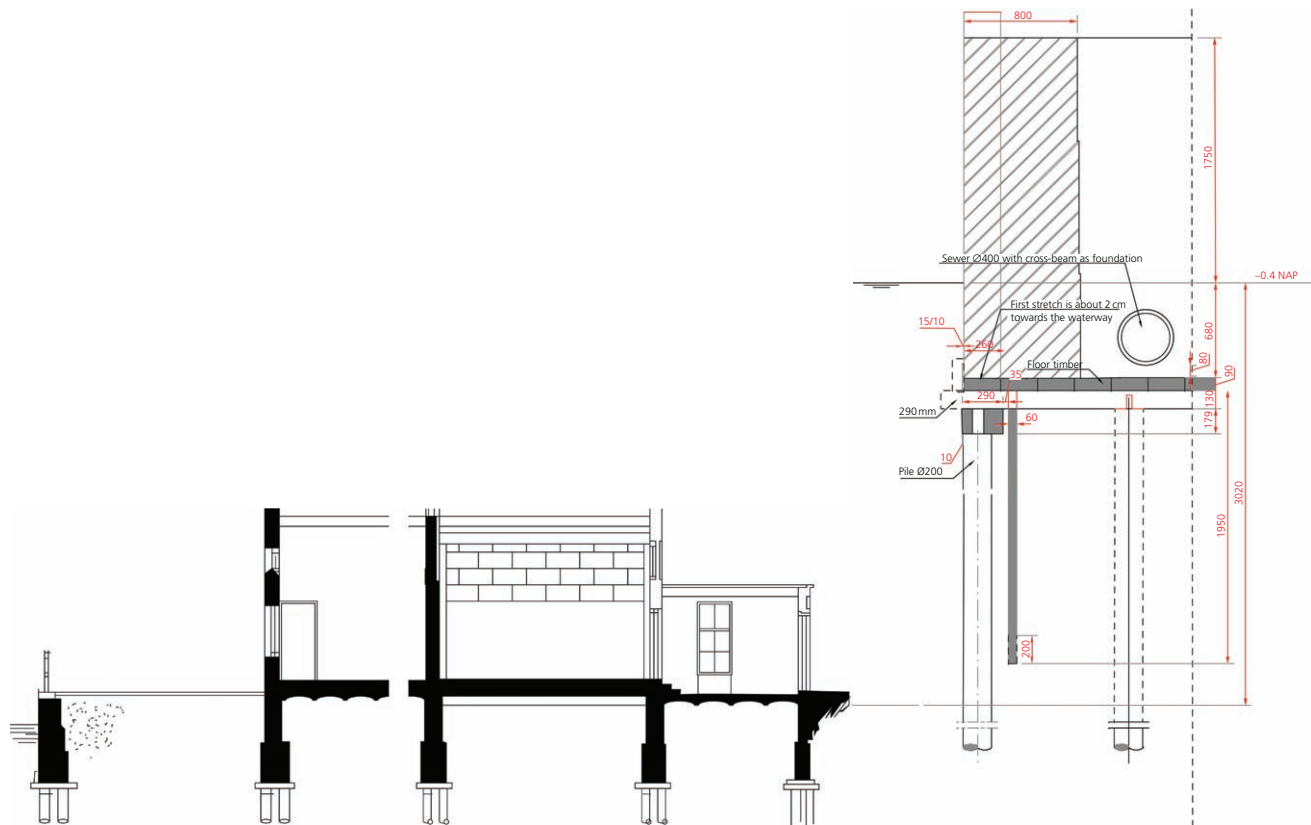
**Figure 2.** Cross-section of the quay wall according to historic evidence (the quay was built around 1875) on the left, and cross-section according to divers' inspection with dimensions on the right (dimensions are in mm). NAP, Amsterdam Ordnance Datum

The main failure mechanism was the horizontal bending of the piles as a result of a local deepening of the canal followed by breaking of the quay piles. This explanation assumes that only two rows of piles were present or functioned effectively over at least part of the quay. This is in accordance with the historic evidence and the underwater inspection and is also the most likely given the very short distance from the quay to the building behind it, where there is not enough space for a system with three piles. The long-existing cracks in the masonry wall reduced the possibility of redistribution of forces in the quay in the longitudinal direction, so that the loads could no longer be transferred to the stronger parts (with three rows of piles). The analyses were carried out with the assumption that the timber was not degraded, which to date needs to be confirmed. The presence

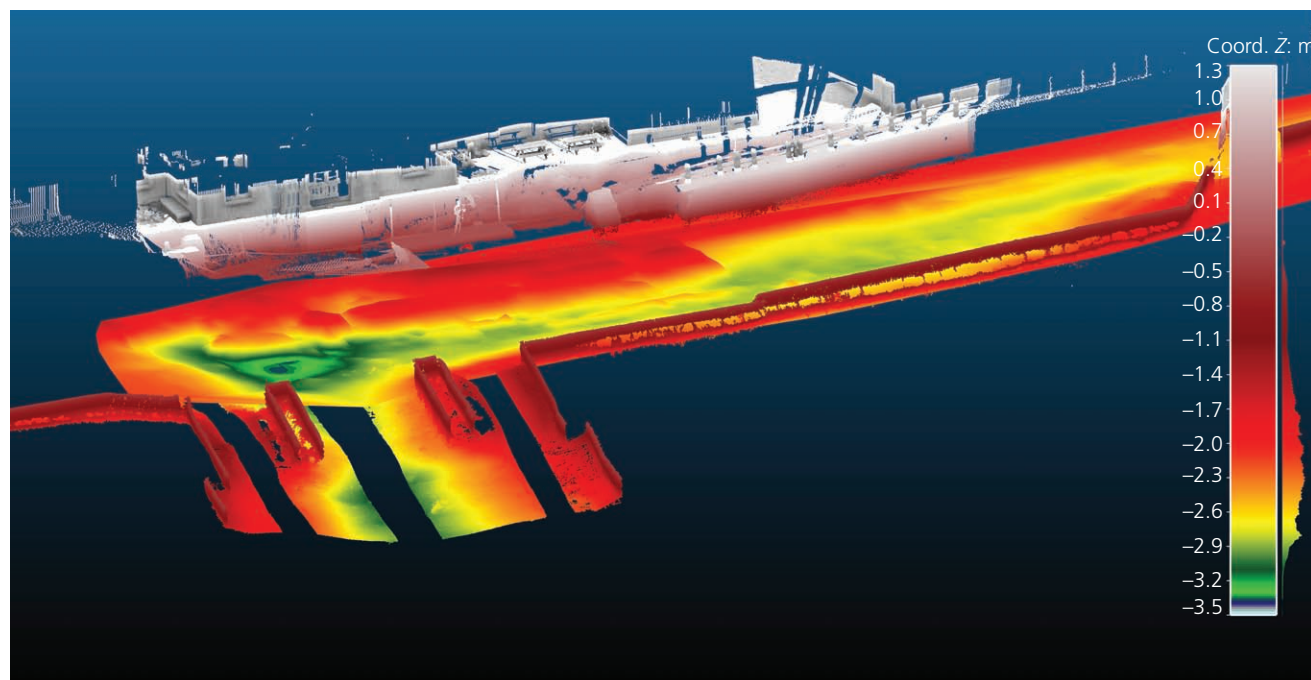
**Figure 4.** Visualisation of the multibeam and three-dimensional scan made after collapse of the quay by Van Gellecum (2021). The colour red refers to shallow bed levels, showing debris in canal and quays and bridge foundations opposite of collapsed stretch, and colours green to blue refer to the deepest canal bed level (NAP –3.25 m and locally to NAP –3.5 m)

The cause of the deeper canal bed is likely related to the fact that the canal is very narrow at this location and exactly at this spot the four boats turn sharply under a bridge. It has been

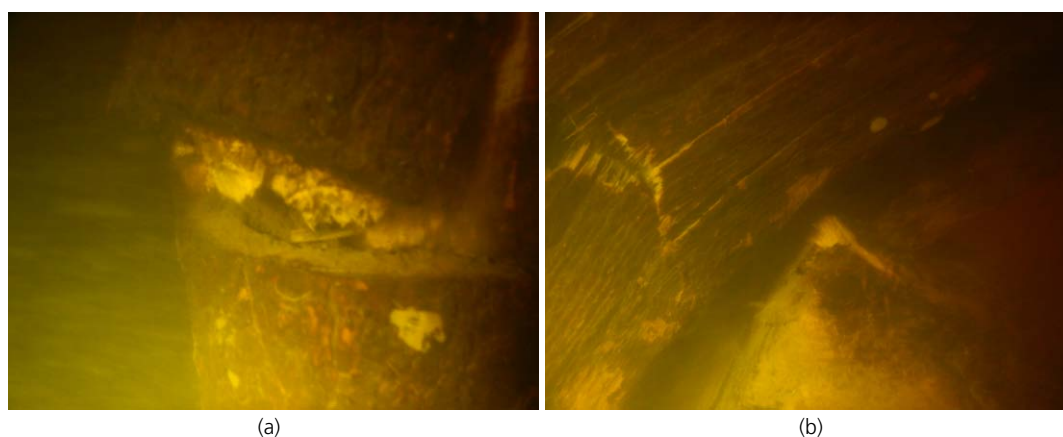
**Figure 5.** Pictures of the collapsed foundation under water by Van Gellecum (2021): (a) broken pile; (b) broken cross-beam

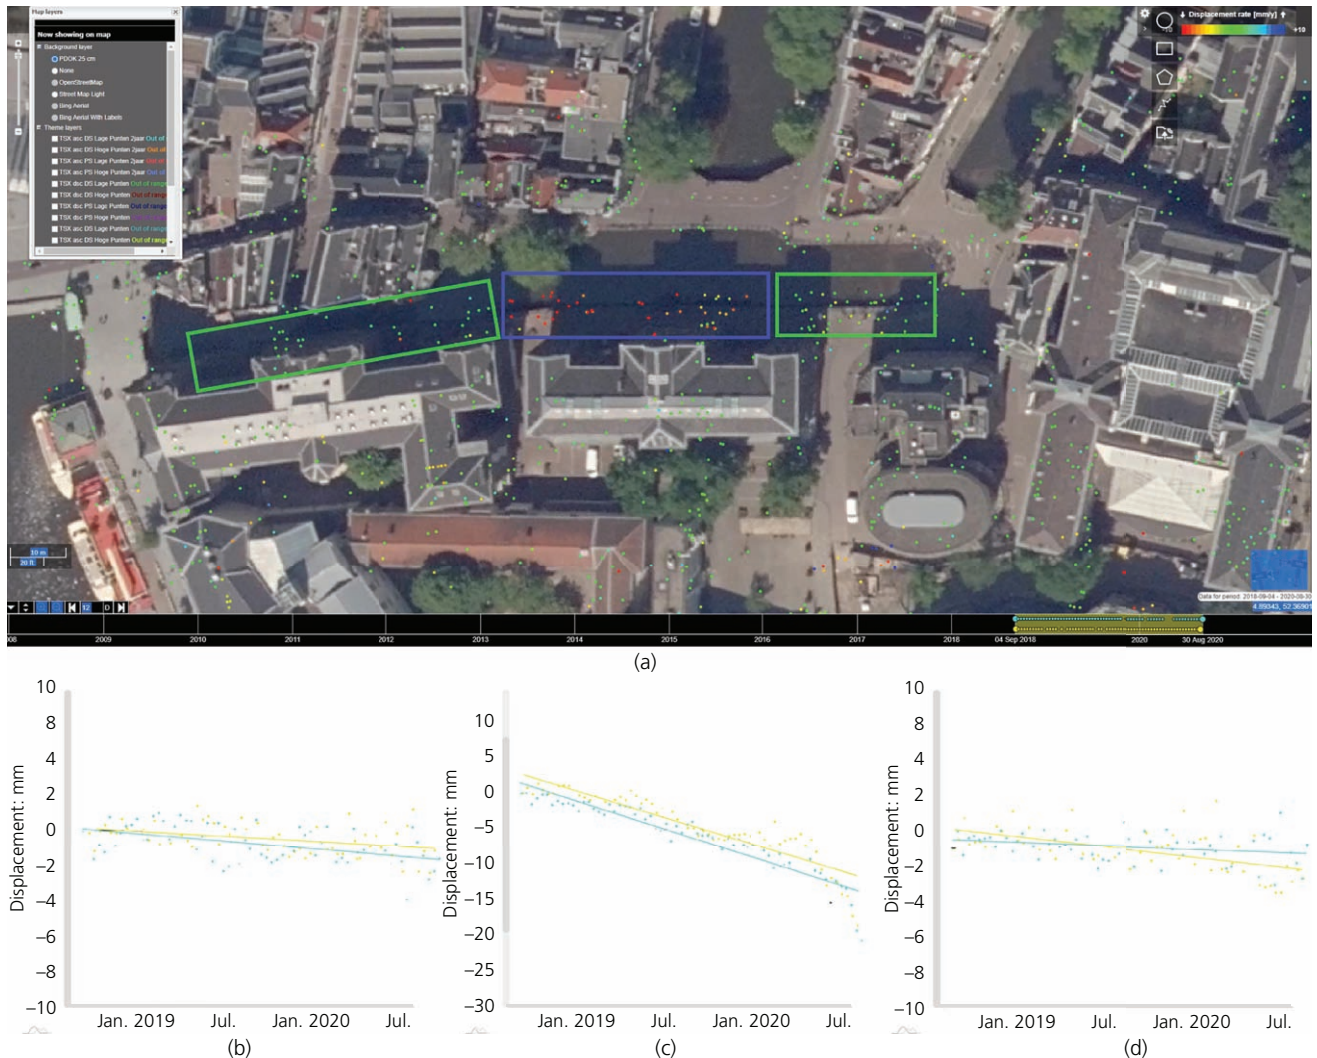
**Figure 6.** Satellite measurements with (a) overview of settlement reflection points over the 2 years before the collapse on a scale of  $-10$  mm in red to  $+10$  mm in blue. (b, d) Settlement point average of the zones on either side of the collapse in green rectangles in (a) and (c) settlement point average of the collapsed section in blue rectangle in (a); results from both ascending (yellow) and descending (blue) tracks are shown

Furthermore, it was found that interferometric synthetic aperture radar (InSar) measurements provided a good insight into the weakness of the quay wall section, as it was possible to identify deviating settlements of the street behind the quay already long before the collapse. The vertical settlements are a result of horizontal deformation of the quay, an indicator of possible collapse. It is thus possible to use InSar in the stress testing of quay walls and to reduce the risk of collapse by paying systematic attention to settlements behind the quays. Analysis of the subsidence of the quays with InSar measurements can help map other 'hotspots'. Additionally, a registration/notification system can be set up for the occurrence of subsidence on the quays or necessary street work. Also, it is advised to perform measurements of the quays (preferably not only horizontally on the quays but also vertically) and to investigate the relationship between the deformation and possible failure (numerical or experimental). Further analyses must be performed to determine which limit values indicate failure.

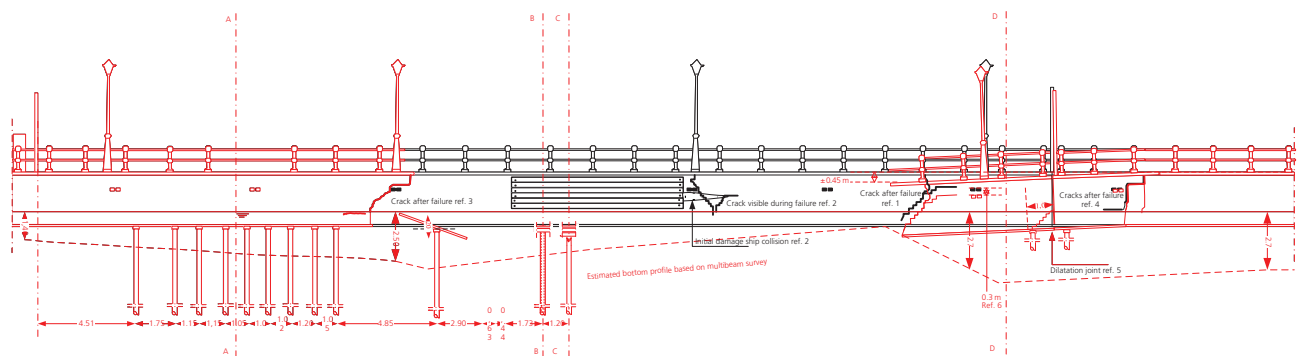
most western part. This crack is consistent with the vertical residual deformation recorded for the remaining part of the quay wall.

**Figure 7.** Front view of the wall. In black, the situation prior to collapse; in red, the situation found after collapse, including crack locations (dimensions are in m). East is on the left; west is on the right

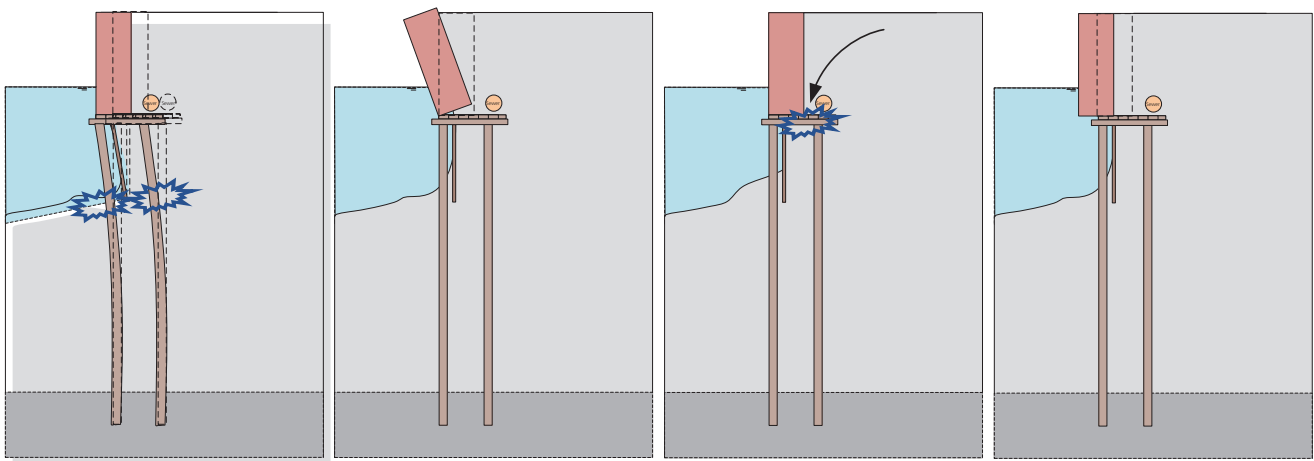
Some of the most important mechanisms are shown in Figure 9 and can be found in general sense in, for example, the handbook *Quay Walls* (De Gijt and Broeken, 2013) or the Dutch handbook of inner-city quay walls (Roubos and Grotegoed, 2014). From left to right, Figure 9 shows the horizontal bending of the piles and local geotechnical failure of soil around the piles, the overturning

of the masonry wall, cross-beam failure and horizontal sliding of the masonry from the deck. Other failure mechanisms investigated include the axial capacity of the foundation piles and the structural failure of the masonry wall.

Figure 9. Most relevant failure mechanisms for the quay wall from left to right: horizontal bending of the piles and local geotechnical failure of soil around the piles, overturning of the masonry wall, cross-beam failure and horizontal sliding of the masonry from the deck

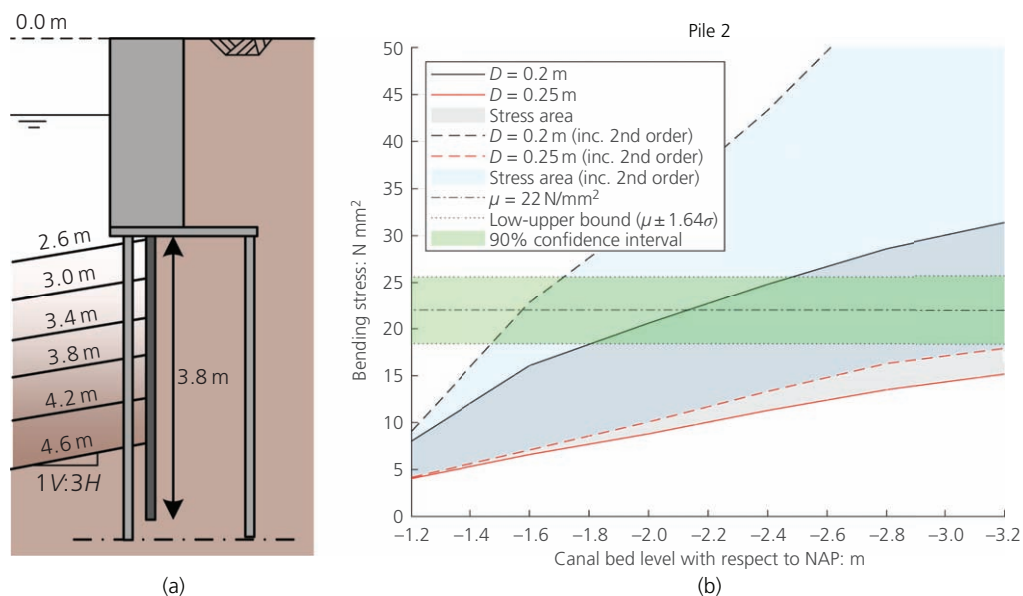
From Figure 11, it can be seen that for the two-row pile system, the bending stress in both pile rows exceeded the timber capacity (in green) for the smaller piles even for small increases in canal bed depths. For larger pile diameters, this was not the case nor for quays with three pile rows. Comparing the results of the bending of the piles with the initial horizontal movement of the quay as seen in Figure 1 and the deformations of the satellite measurements in Figure 6, as well as the broken foundation parts in Figure 5, leads to a consistent collapse mechanism.

**Figure 11.** Results of the bending stress in the piles (a) depending on the depth of the canal and (b) for different pile diameters, first- and second-order calculations and strength of the timber
