Shearography non-destructive testing of a composite ship hull section subjected to multiple impacts

Proceedings of the 20th European Conference on Composite Materials: Composites Meet Sustainability

Nan Tao^{a*}, Andrei G. Anisimov^a, Marcel Elenbaas^b, Roger M. Groves^a

a: TU Delft Structural Integrity & Composites b: Damen Shipyards *n.tao@tudelft.nl

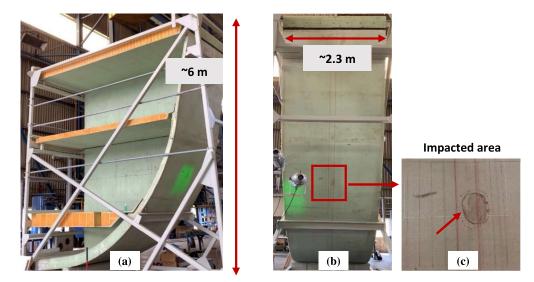
An overview of the composite ship hull section is shown in Fig. 1. The dimensions are about 6 meters in height and 2.3 meters in width. The structure is made from FRP laminate skins and foam cores. The composite ship hull section is a RAMSSES demonstrator [11,12] at Damen Shipyards. Before shearography inspection, multiple impact tests (https://vimeo.com/522716506) surpassing helicopter emergency landing loads have been performed on the hull shell and its composite helicopter deck for proving the resilience of composites to harsh marine environments. The impacted area on the hull shell is shown in Fig. 1(c).

Figure 1 The composite ship hull section at Damen Shipyards: (a) Overall view. (b) Front view. (c) The area with multiple impacts on the hull shell.

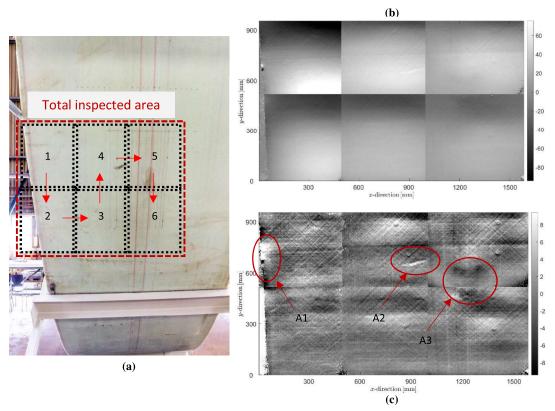
The experimental results with thermal loading are shown in Fig. 3. A total area of about 1500×900 mm² was inspected by stitching six FOVs of 600×600 mm² [Fig. 3(a), 2 in the vertical direction by 3 in the horizontal with about 20% overlap for stitching]. Phase-shifted sets of speckle images were captured continuously during cooling. All sets of the recorded images were analyzed and stitched together to produce built-up phase maps of the whole area [Fig. 3(b)] that represent the evolution of the surface out-of-plane strain during cooling. The resultant phase map was further processed to obtain the compensated phase map [Fig. 3(c)], where the defect-induced deformation was extracted [10]. This compensated phase map reports the presence of damage in the structure. The stitching process can be further improved by considering the shape of the surface, the positions of the camera and the laser [13]. The damage in the impacted region is not obvious, this can be because its position is close to the edge of the FOVs no.5 and no.6, which makes it difficult to extract actual defect deformation.

Figure 3 Stitched inspection results for six FOVs with thermal loading: (a) Total inspected area (FOVs no. 1-6). (b) Origin phase map. (c) Compensated phase map, A1 - skin-to-core debonding, A2 - heat damage, A3 - impact damage of interest. [Unit of phase is radian]
