Roof of FC Twente Stadium

Case Studies on Failure Investigations in Structural and Geotechnical Engineering

Karel C. Terwel

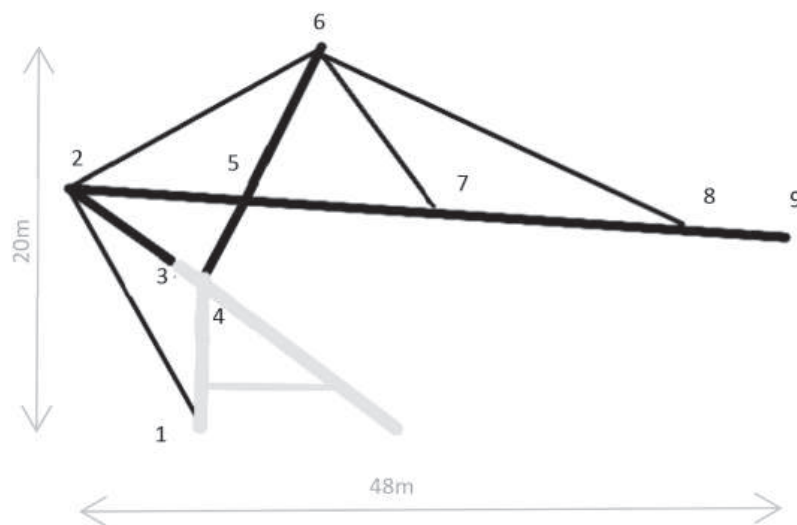
Figure 8.1 Schematic overview of bearing frame (Based on [2]).

The structure for the extension of the roof in 2011 consisted of 11 bearing frames. Each bearing frame had a length of approximately 48 m and a height of approximately 20 m (see Figure 8.1). The bearing frame was constructed out of steel tubes. These were mounted on the concrete grandstand structure.

The engineers created stability out of plane by coupling bars and braces at the positions of 2, 5, 6, 7, and 8. The roof, a steel structure with steel sheeting, was positioned below position 2, 5, 7, 8, and 9. All frames were erected when the structure collapsed (Figure 8.2).

However, the structure appeared not to be fully assembled at the moment of collapse. One coupling bar between the nodes 6 of two frames was lacking. Furthermore, several

couplings between nodes 2 of various frames were missing to enable easier construction with the tower cranes. Temporary braces were removed to apply safety nets. Part of the steel roofing was already assembled.

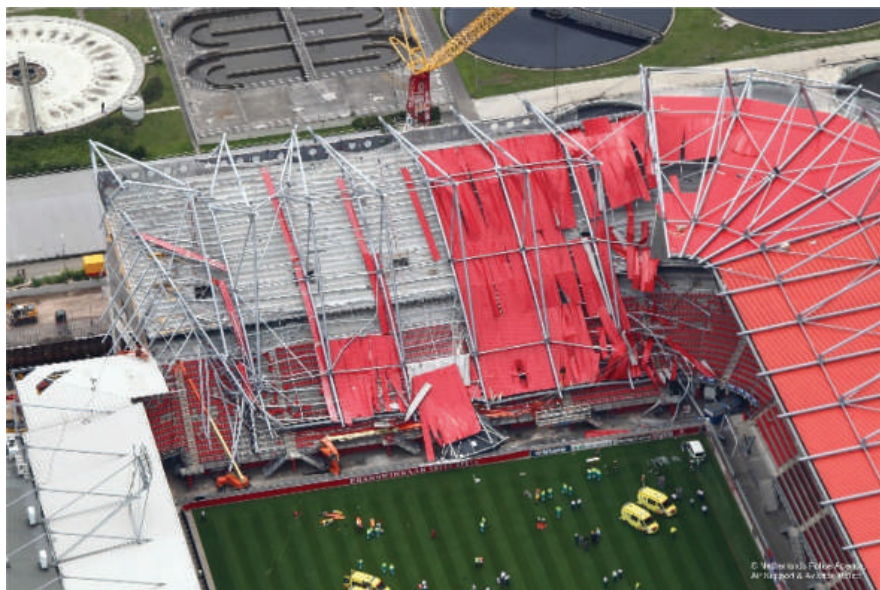
Figure 8.2 Roof of FC Twente stadium after collapse. Reproduced by permission of Netherlands Police Agency, Air support and Aviation Police.

- the frame where the video-wall was connected collapsed first;
- the main cause of failure was out-of-plane buckling of the outer parts of two frames where the connecting bar at position 2 was missing.

Instability of the structure during construction can be regarded as a sufficient technical cause. TNO calculated a buckling factor $n=1.67$ for the situation without coupling bars [2, p.74 and annex]. The buckling factor was calculated here as the ratio between the buckling capacity load (Eulers's critical load of a perfect structure) over the actually applied load (no load factors used)[1]. If $n>10$ no instability issues are to be expected. If $n<1$ instability is to be expected. A factor of 1.67 means that the structure is very vulnerable for instability, although it will not necessarily result in a collapse if there is hidden capacity. TNO also calculated that without the loads of video-wall etc., the buckling factor of this structure still would be around 2.

In case the coupling bars would have been present, this would result in a buckling factor of $n=12$. Thus, the presence of these coupling bars would have significantly increased the capacity against buckling as the buckling length would have been reduced. The absence of these bars was therefore regarded to be a major contributing factor.
