## Combining Architectural Conservation and Seismic Strengthening in the Wood-Based Retrofitting of a Monumental Timber Roof

### The Case Study of St. Andrew's Church in Ceto, Brescia, Italy

International Journal of Architectural Heritage

# Combining Architectural Conservation and Seismic Strengthening in the Wood-Based Retrofitting of a Monumental Timber Roof: The Case Study of St. Andrew's Church in Ceto, Brescia, Italy

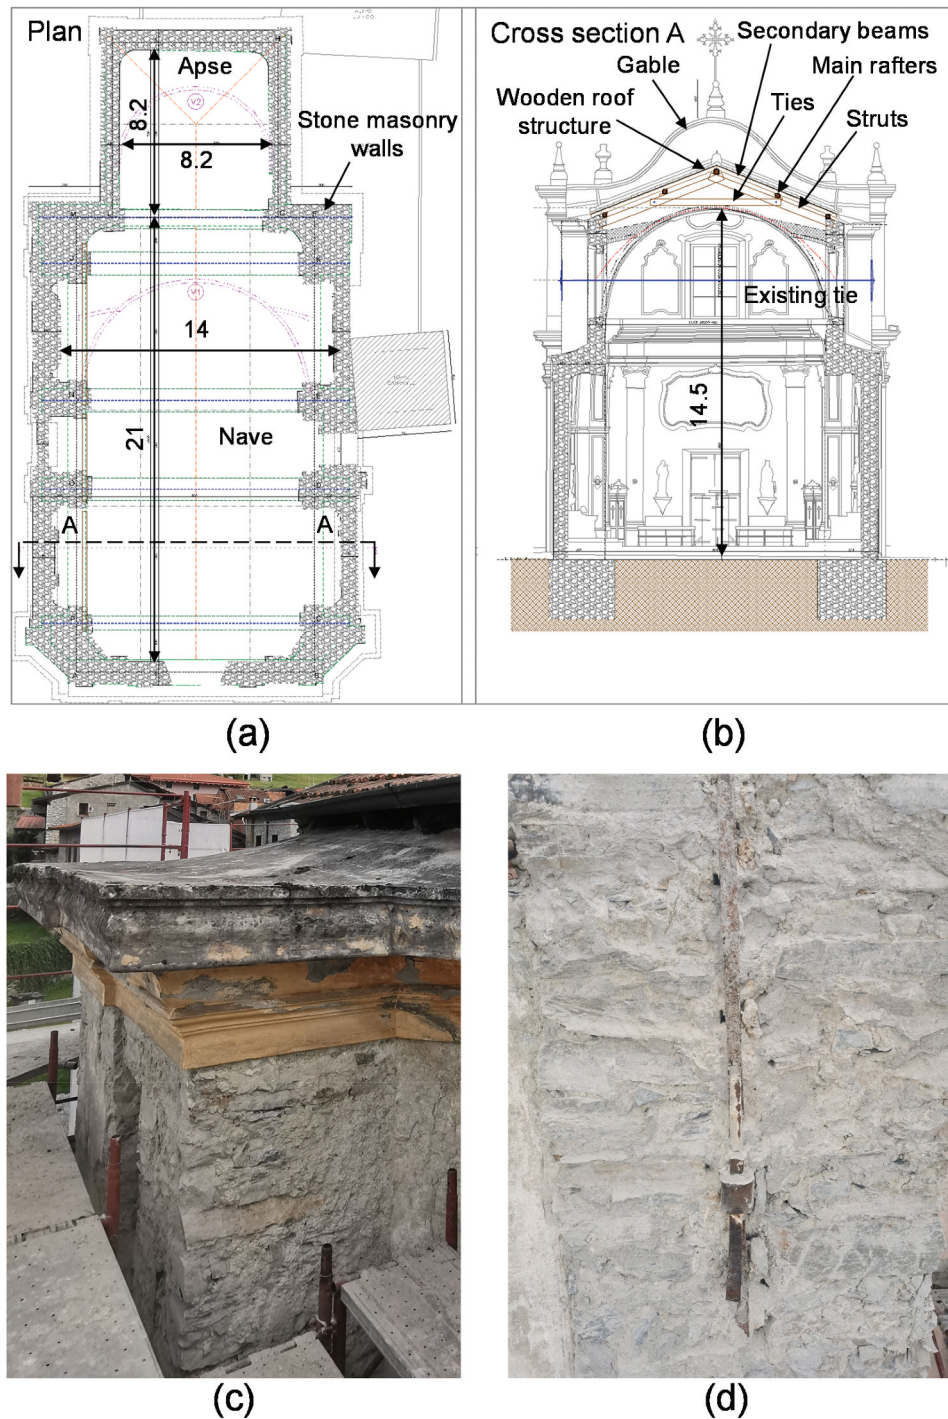
**Figure 3.** Plan (a) and cross section (b) of the case-study church (dimensions in m); particulars of a stone masonry wall (c) and of an existing metal tie (d).

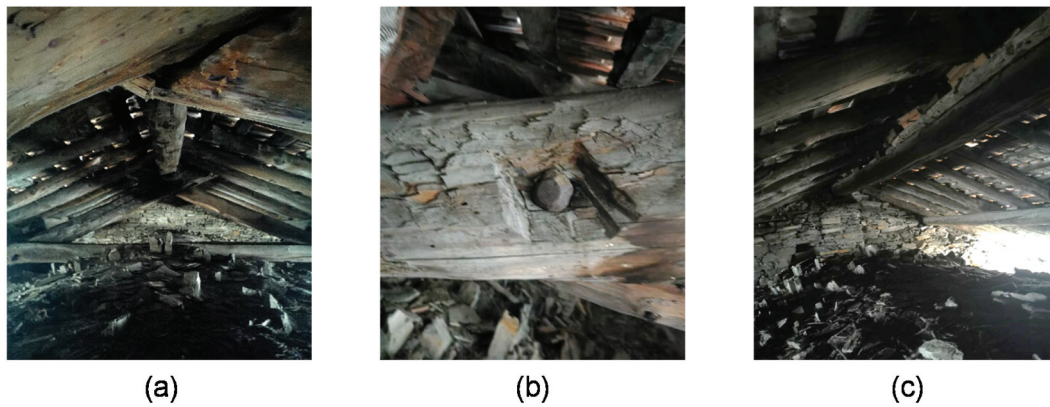
**Figure 4.** (a) Existing wooden roof structure; (b) existing metal pin between timber struts and ties; (c) ridge beam undergoing excessive deflection.

The wooden roof structure was found in fair state of conservation but was very difficult to inspect, as the attic of the nave and the apse is narrow and normally not accessible. The main rafters, including the ridge beam (Figure 4c), appeared to be very undersized, also considering the spans involved, up to 8 m: large deflections could be observed, which had been compensated over time by additional wooden blocks, to keep the support for the secondary beams as horizontal as possible. These secondary elements seemed better dimensioned and sound, but a small number of joists (approximately 15% of the total) were locally affected by biological degradation, caused by slight water infiltrations. The main wooden struts and ties were sound as well, and according to the static calculations performed, had adequate dimensions for their structural purpose. Yet, the existing connections with metal pins (Figure 4b) were not effective, because the holes in which they were located had become too large over time: thus, the ties could not fully absorb the horizontal thrusts induced by the struts, which seemed to be partly taken by the masonry buttresses.

The few joists and planks damaged by water infiltrations were integrated with newly supplied C24 joists, laid alongside the existing ones, and featuring their same geometry and wood species. Besides, the longitudinal rafters, which appeared to be very

undersized, were provided with an adequate flexural reinforcement, by placing additional C24 wooden beams clamped to the main ones by means of steel plates and threaded bars (Figure 8). These newly supplied beams had again the same geometrical

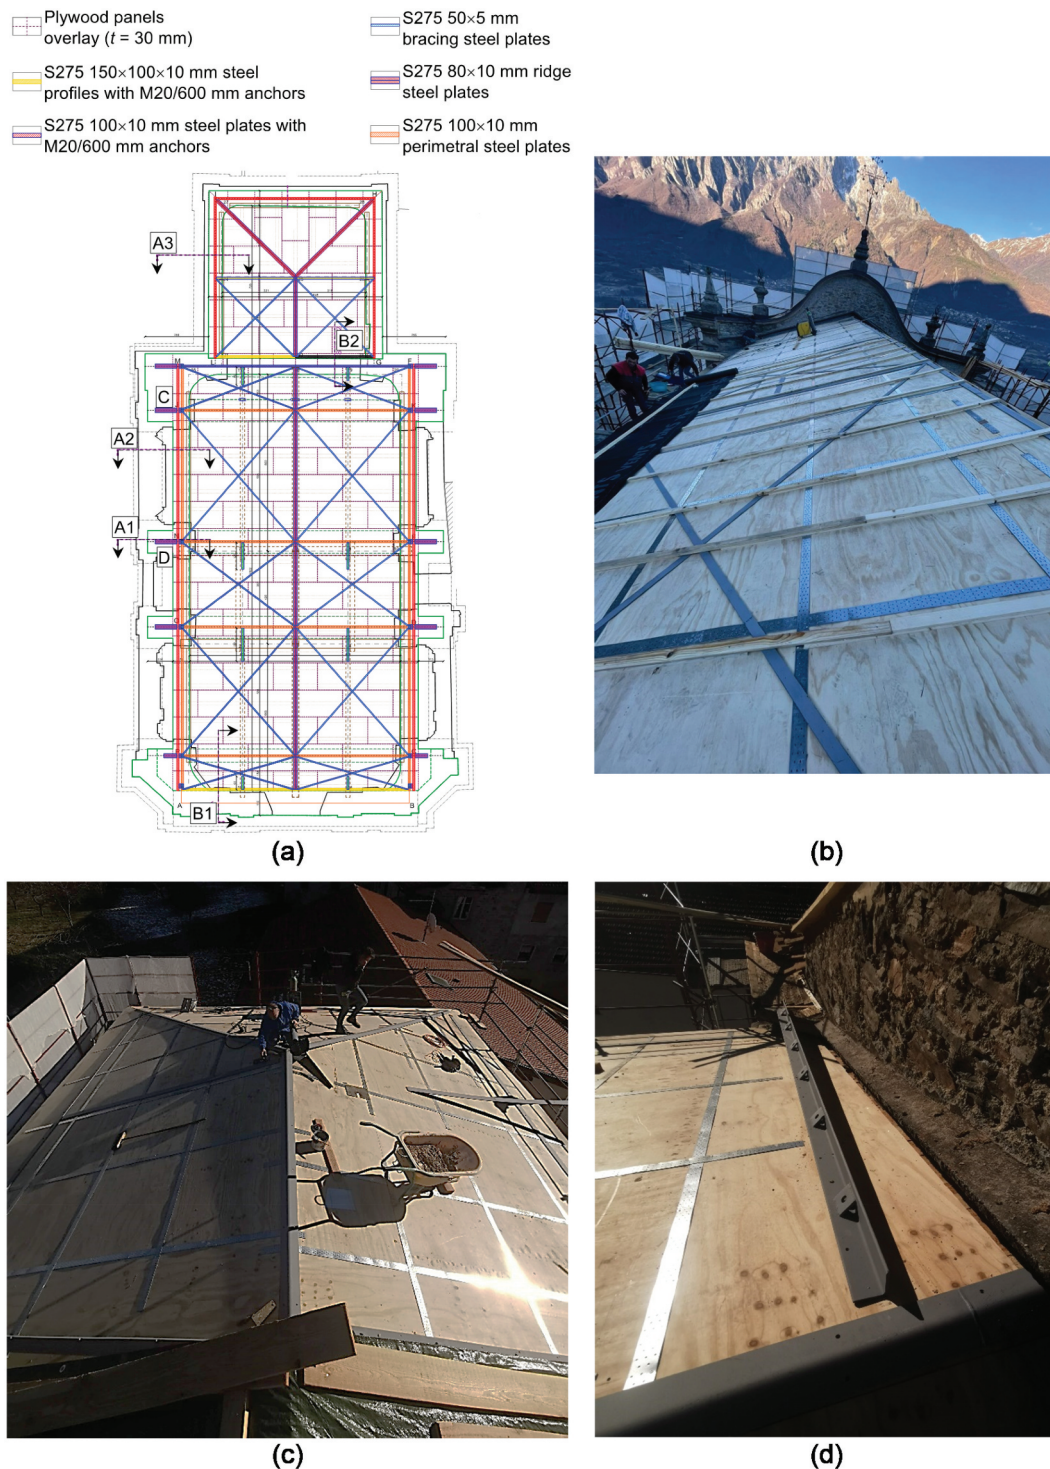
**Figure 5.** (a) Overview of the seismic retrofitting interventions; plywood panels overlay above the nave (b) and the apse (c); steel profile for the connection to masonry (d).

In order to meet the requirement of seismic improvement, retrofitting interventions were applied to the structural element responsible for most vulnerabilities, i.e. the wooden roof, seizing also the opportunity to combine both strengthening and architectural conservation. Taking into consideration the improvement of seismic shear transfer and redistribution of the existing roof, the main retrofitting intervention consisted of transforming it in a diaphragm. To this end, an overlay of 30-mm-thick C24 structural plywood panels fastened to the existing sheathing with  $4 \times 60 \text{ mm}$  Anker nails at 80 mm spacing, was realized (Figure 5). The plywood panels overlay was designed considering each roof pitch as a shear wall. Since the panels have a standard width of  $b_i = 1200 \text{ mm}$ , 15 nails were present on each panel's short side, following the adopted spacing  $s = 80 \text{ mm}$ . The long side of the roof above the barrel vault featured 16 rows of panels (see Figure 5), thus the total strength was derived as the design shear strength  $F_{v,Rd}$  of a single

On top of the plywood panels overlay, as an extra safety measure, an additional light bracing system consisting of  $5 \times 80 \text{ mm}$  S275 steel plates was designed, to promptly prevent local overturning mechanisms of the gable and the other walls, by directly transferring the pertaining shear forces to the buttresses (Figure 5). Besides, to enable an effective and distributed transfer of shear and tensile stresses, an adequate connection system between the new diaphragm and the wall had to be designed. Because the existing joists at the supports of the roof structure rested on the masonry for only 75% of their thickness (Section 2.2, Figures 6–7), the realization of anchors directly crossing them would not have been fully effective in preventing overturning mechanisms. Therefore, along the perimeter of the church, in correspondence to the eaves channels, a steel curb was realized in the position of the centre of mass of the wall (Figures 6–7). To allow the transfer of the shear and tensile forces between the plywood panels overlay and the curb, a connection with steel plates was created, in combination with a cable bracing system (Figure 6). The steel curb was then connected to the walls and the buttresses with M20 anchors ( $80\text{--}120 \text{ mm}$  depth). The global seismic retrofitting intervention was particularly appreciated by the Superintendence for Architectural Heritage, since it allowed to avoid more invasive solutions and preserve at most the original wooden roof structure.

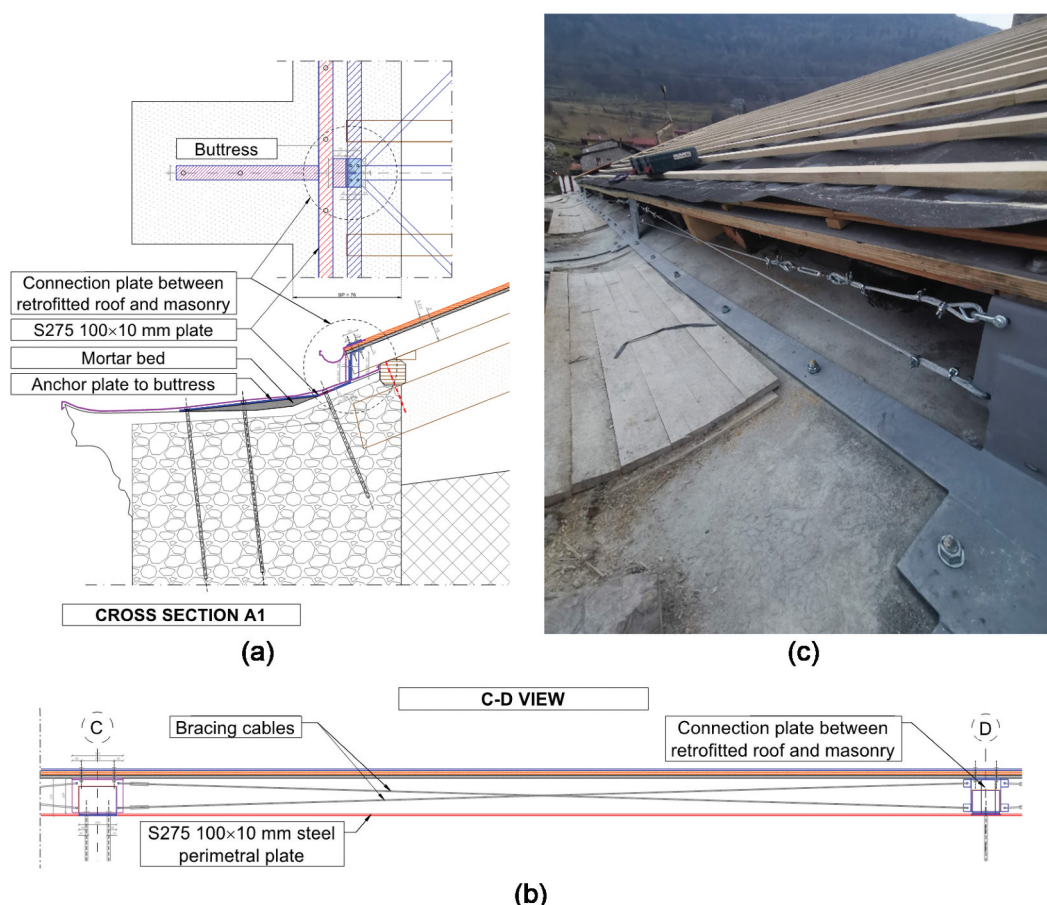
**Figure 6.** Connection between retrofitted roof diaphragm and masonry walls, with reference to the plan of figure 5: (a) cross section of the joint system in correspondence of the buttriss; (b) system of bracing cable between buttrisses; (c) realization of the intervention on site.

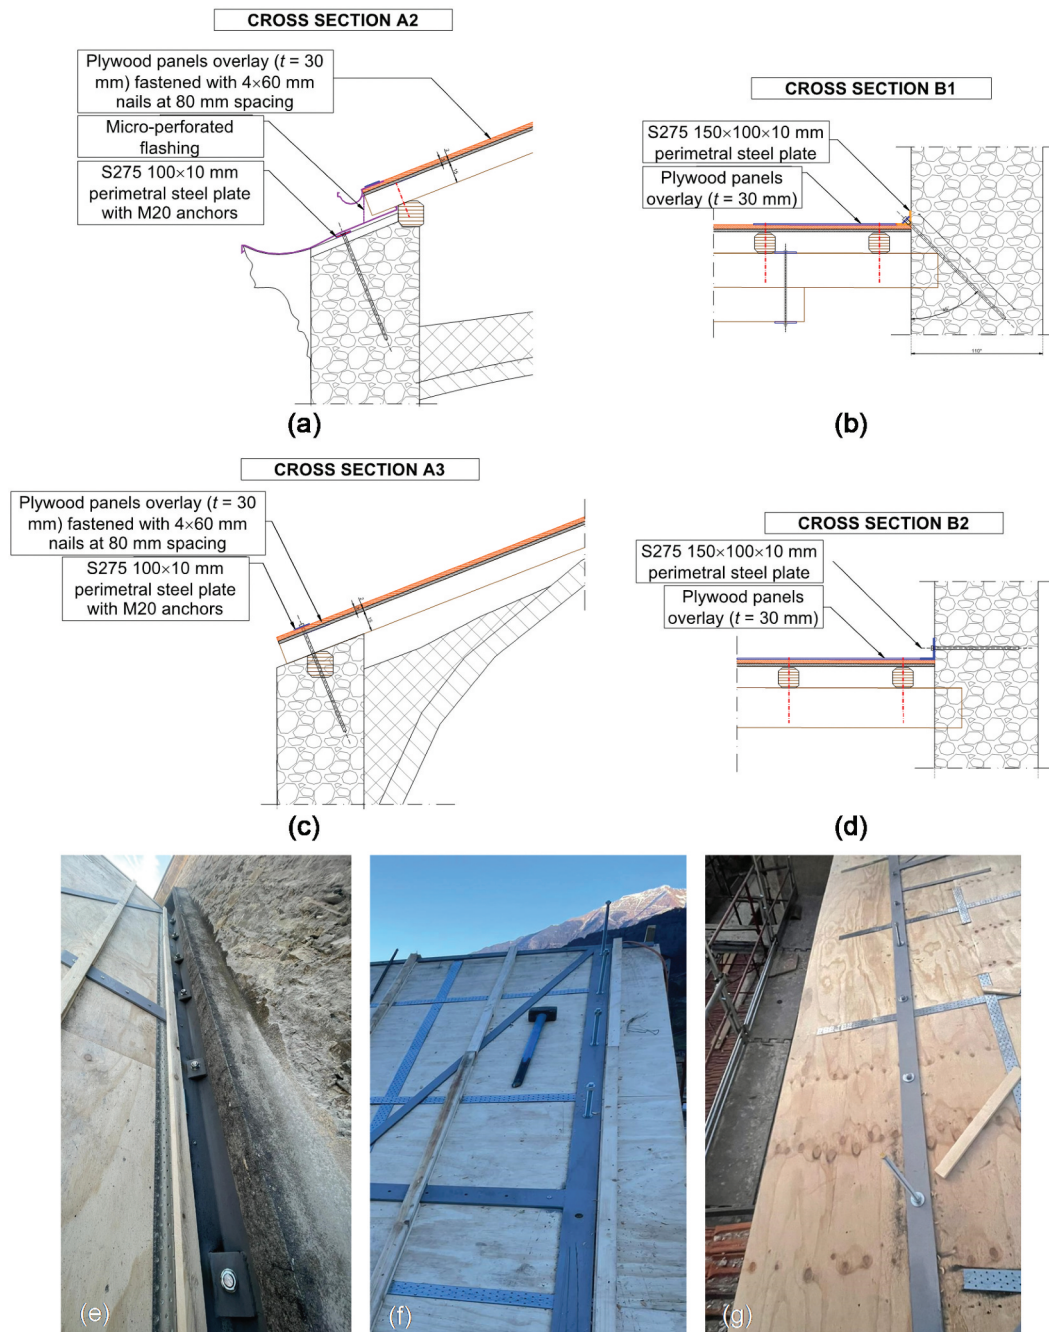
**Figure 7.** Connection between retrofitted roof diaphragm and masonry walls, with reference to the plan of figure 5: (a) cross section of connection system along the nave walls; (b) cross section of connection system in the main façade; (c) cross section of connection system along the apse walls; (d) cross section of connection system in the wall separating nave and apse; (e-g) examples of realized joints.

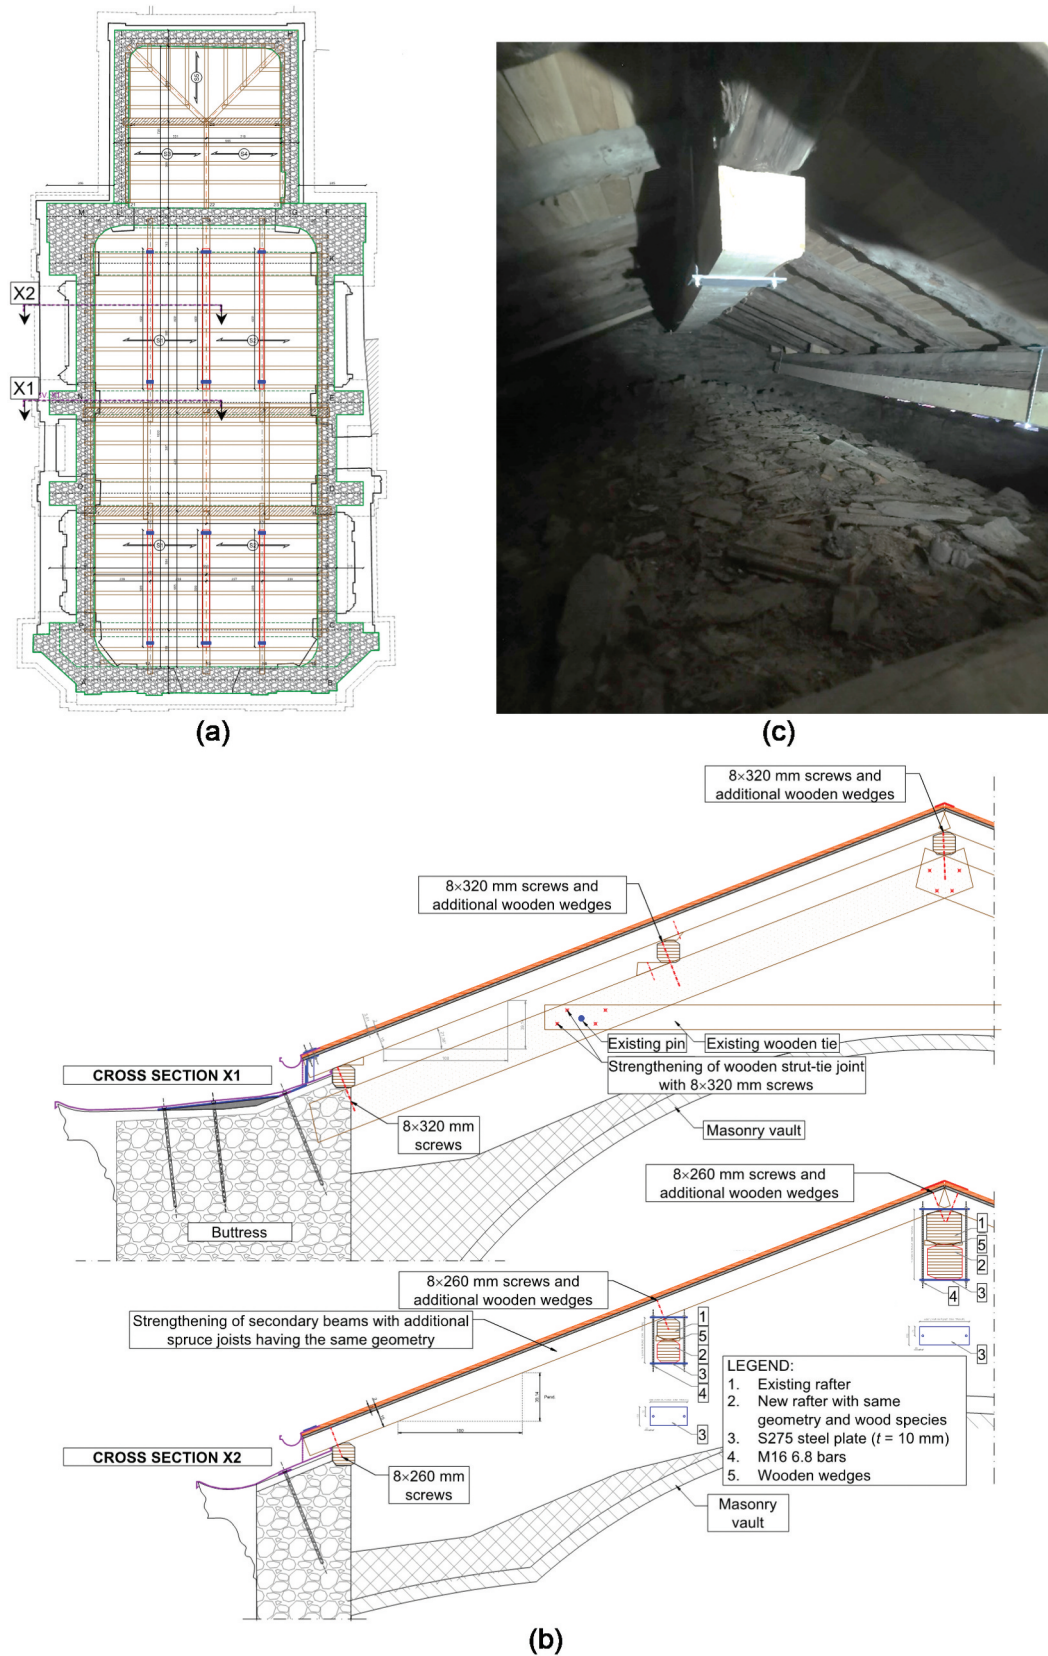
**Figure 8.** Plan (a) and cross sections (b) of the flexural reinforcement interventions on the roof; (c) realization of the interventions on site.

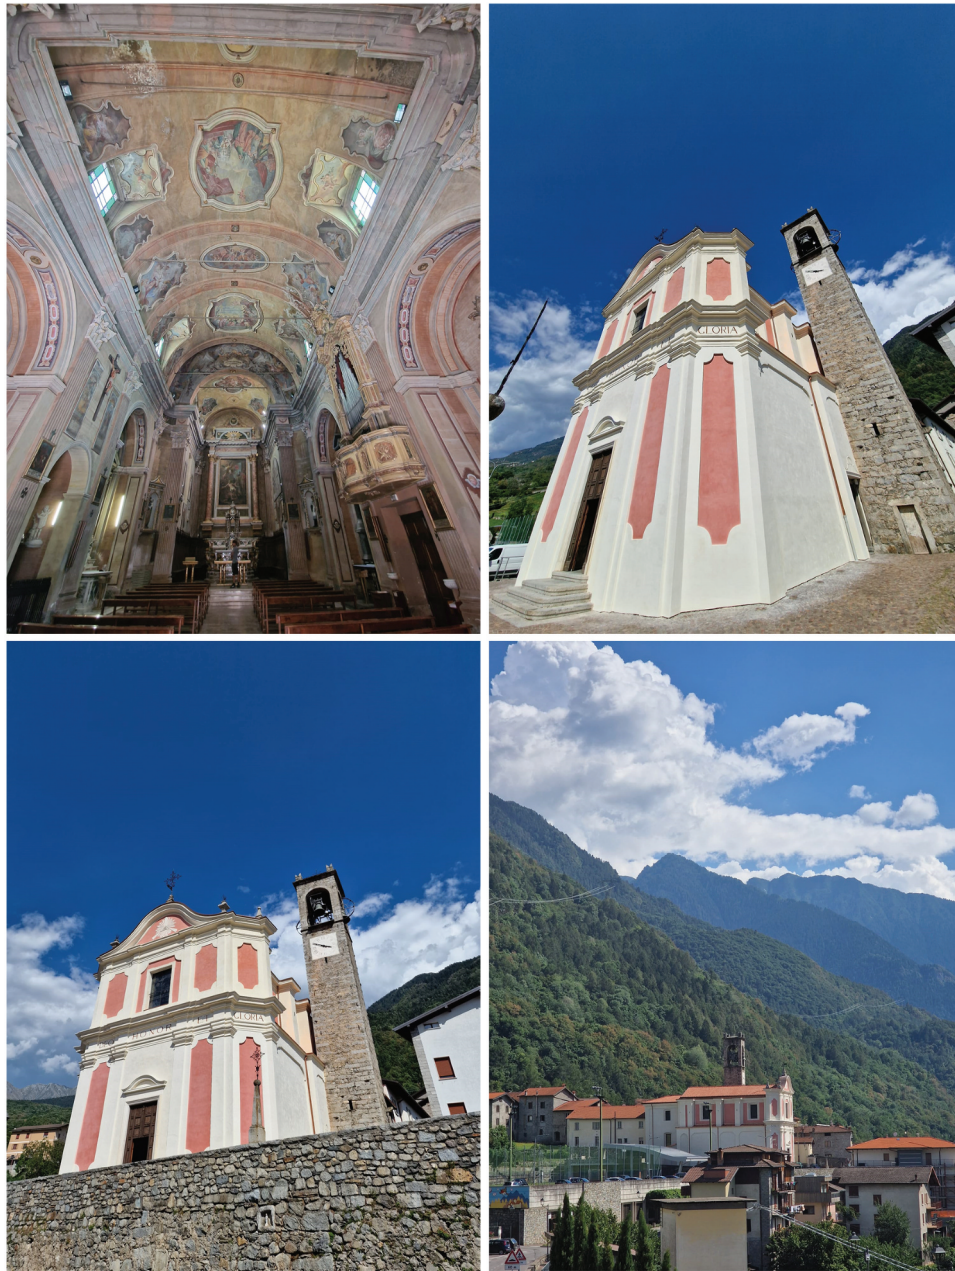
**Figure 9.** Views of the church of Ceto after the seismic retrofitting and restoration work.
