## Contributing human and organizational factors for damage of Bos and Lommer plaza in Amsterdam

39th IABSE Symposium – Engineering the Future

## Contributing human and organizational factors for damage of Bos & Lommer plaza in Amsterdam

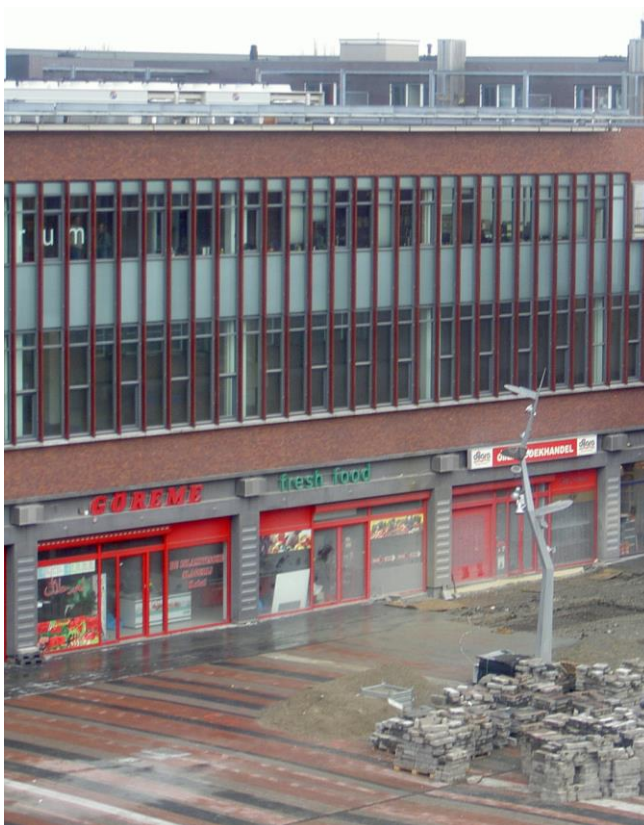
The Bos & Lommer plaza complex in Amsterdam was completed in 2004. This complex consisted of apartments, shops and a parking for over 500 cars. In 2006, an 11 ton truck was positioned on the plaza deck and caused structural damage. Part of the load bearing structure had failed and the apartments were evacuated, until the deck was strutted.

Forensic investigations showed that detailing of the reinforcement was questionable and the amount of reinforcement was insufficient, or deviated from drawings. The whole complex was evacuated until measures were taken. Subsequently, investigations of the shops and apartments above the parking showed that the design of a 1 m thick transfer floor might have been erroneous.

Figure 7.1 Recovery activities at Bos & Lommer Plaza (photo: Dick Hordijk)
