## The Restoration of the Exterior

Colour, Form and Space

# 1 / THE RESTORATION OF THE EXTERIOR

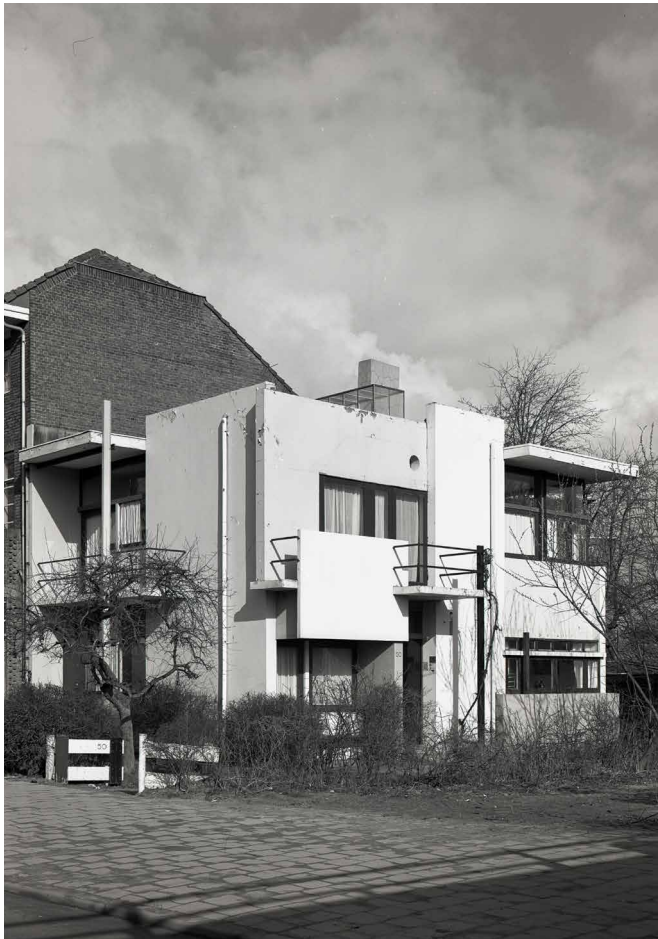
FIG. 1.1 In the beginning of the 1970s the state of repair of the Schröder House left a lot to be desired

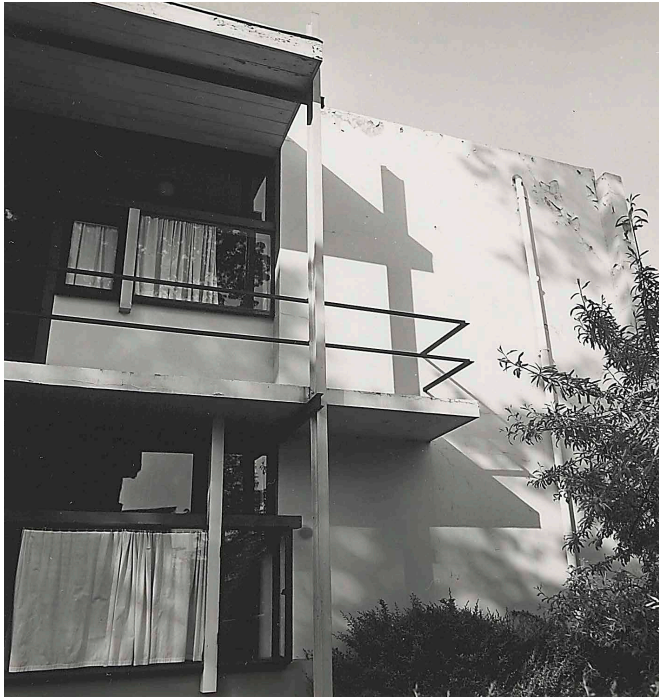
FIG. 1.2 Damage to the house became increasingly visible

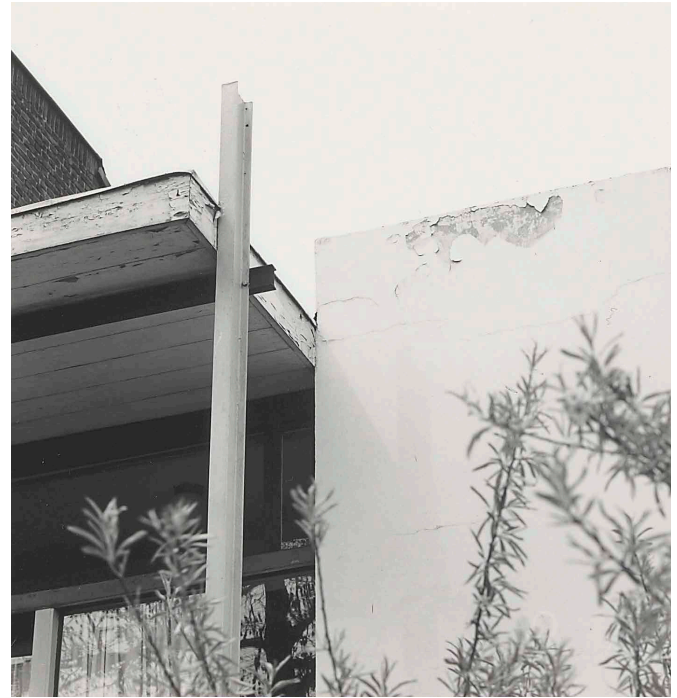
FIG. 1.3 Plasterwork and wood exhibited serious blemishes

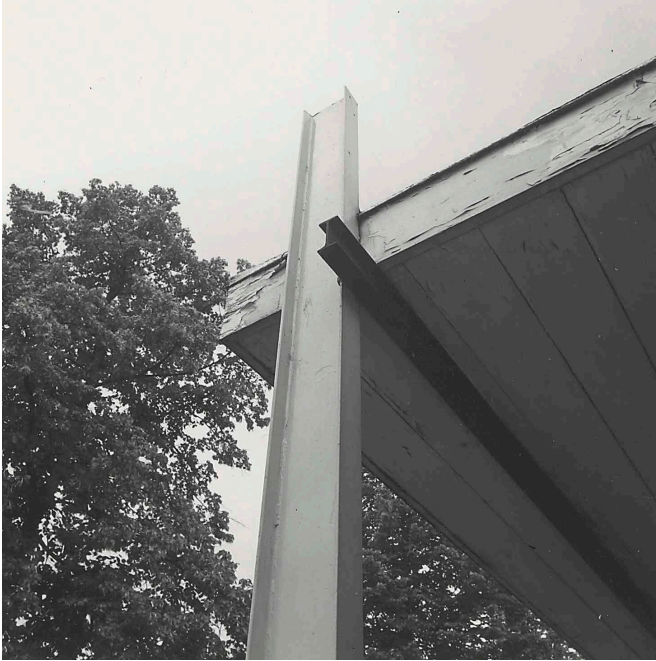
FIG. 1.4 Unconventional constructions made the house vulnerable

This was mainly because Rietveld considered the spatial effect and associated appearance, and the optical effect, more important than a stable and sound construction [FIG. 1.4]. This had resulted in unusual combinations of traditional and modern materials (and their properties) and techniques which, after the passage of so many years had started to exhibit all manner of defects. For example, the way the steel beams had been tailed into the (single-skin) brickwork had led, through the action of moisture, to rust and hence to cracks in both brickwork and plaster. At Rietveld's insistence, the concrete slabs used for the balconies had to be very thin so that here, too, moisture had been able to corrode the steel edges, which had started to rust, and the concrete had begun to display cracks [FIG. 1.5].

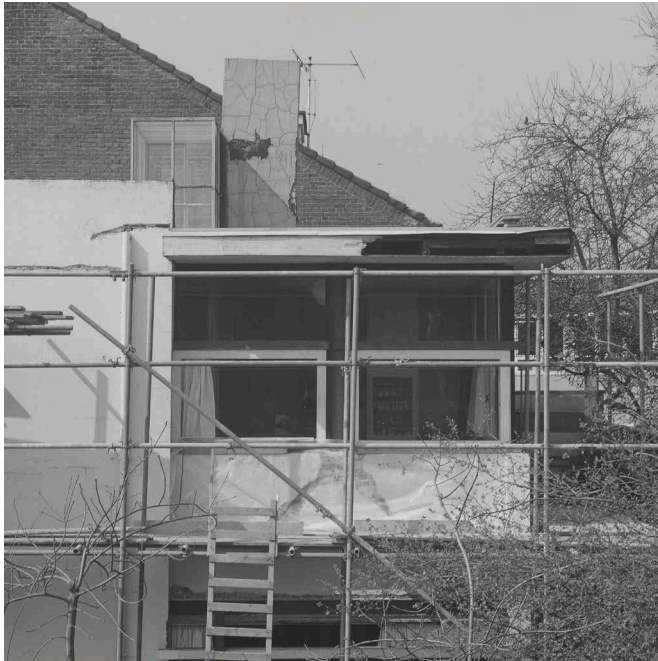
FIG. 1.7 The roof required extensive repairs to prevent further sagging and leaks

The roof construction and finishing employed had given rise to sagging, resulting in numerous leaks [FIG. 1.7]. The skylight needed to be replaced. Likewise, much of the timber used in windows and doors, which Rietveld had dictated should be flush with internal and external walls, in other words without sills or projecting edges, was due for replacement. This was especially true of the windows and balcony door in the east elevation, followed by Truus's room. The damage and defects were treated invasively by Mulder, using contemporary materials and techniques, in order '[to] achieve the durability desired by Truus Schröder [FIG. 1.8]. Not through restoration according to traditional standards, but to a large extent through reconstruction of the form using a new, technically superior method.' According to Mulder this was the result of the RDMZ's 'wise decision' to keep the agency's officials well away from the work.<sup>28</sup>

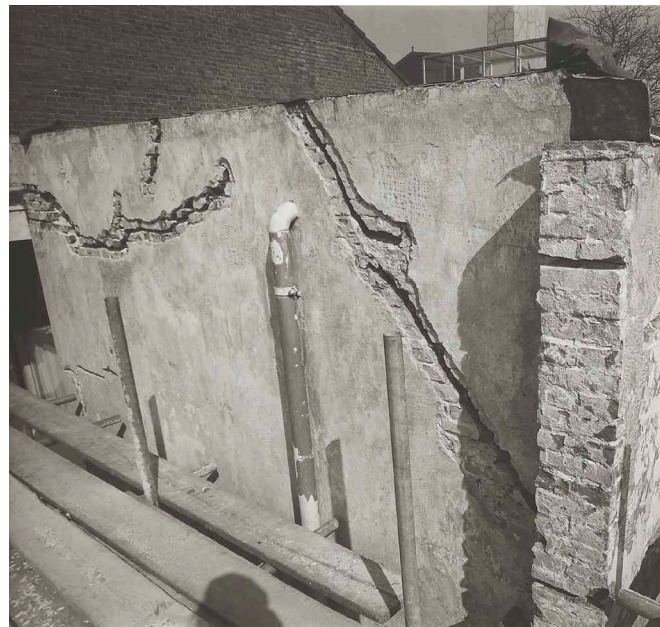
The restoration of the exterior was carried out between March and September 1974. The cracks in the plasterwork were mainly in the east and south elevations and once that plaster had been chipped away cracks were also discovered in the brickwork behind it [FIG. 1.9].<sup>29</sup> The Stichting Onderzoek en Voorlichting (Foundation for Research and Information, SOV) of a firm specializing in plastering, terrazzo and plasterboard (STS) had been asked for advice and in February it had provided detailed instructions for the repair and treatment of damaged sections of brickwork and plaster, for the joints between plasterwork and wood, and for the concrete. SOV's J.F. (Hans) Geerken provided advice on the method as well as on the specific composition of the materials to be used. In accordance with this advice, Mulder

FIG. 1.9 The brickwork displayed deep cracks

had the cracks in the brickwork treated with a synthetic mortar that was then coated with a synthetic dispersion to ensure that the rendering coat would adhere. Where the cracks were only in the plasterwork, the mortar layer was re-rendered and then plastered to the same level as the existing plasterwork, on which the existing layers of paint were still present. Instead of applying a fine render to the base coat, Rietveld had the plasterer impart texture directly to the (hardened) rendering coat. The circular motion of the trowel produced a grainy effect.<sup>30</sup> Geerken saw to it that the various stages of this work were carried out according to instructions.

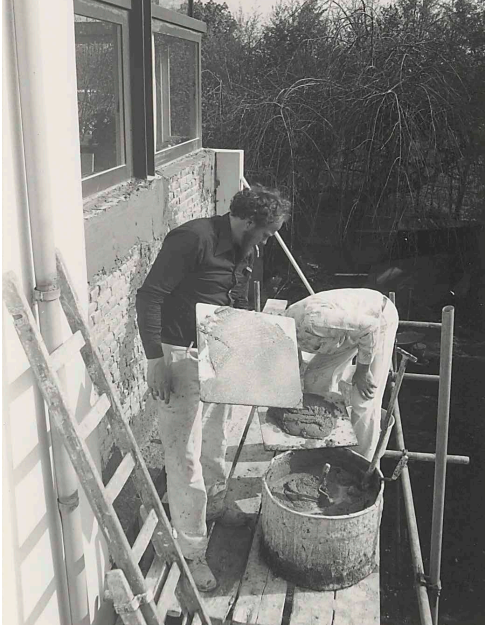
FIG. 1.10 Plasterers at work on the wall between corner window and kitchen

Work started at the end of April and after the removal of the layer of mortar it was discovered that the repairs to the brickwork using synthetic mortar had held up well. The substrate was homogeneous, and according to Geerken the brickwork was of reasonably good quality.<sup>39</sup> Thus the problems lay with the rendering. Even more radical decisions were then taken on site. 'The render that had remained in place during the restoration also had to be removed in order to achieve a single homogeneous plaster coat and to avoid problems with joins between old and new work [FIG. 1.10/1.11].'<sup>40</sup> Whether this literally meant that all the

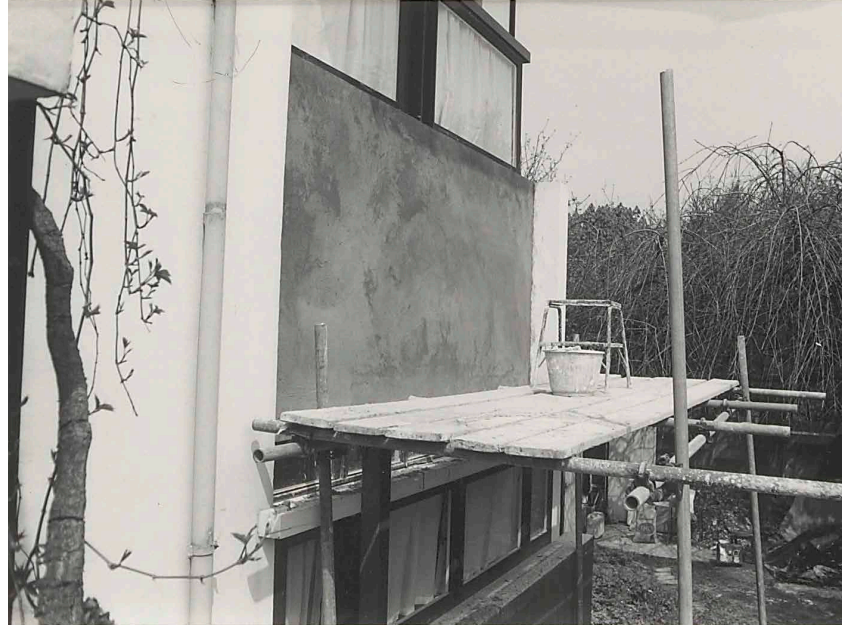
FIG. 1.11 After the plaster with hairline cracks was removed, the new render was applied in a single homogeneous coat

All kinds of repairs had been carried out, and the house was also a melange of different materials and constructions. It was consequently decided that it would be best to limit the number of materials and adhesive surfaces as much as possible. The new coat would be applied in one operation.<sup>38</sup>

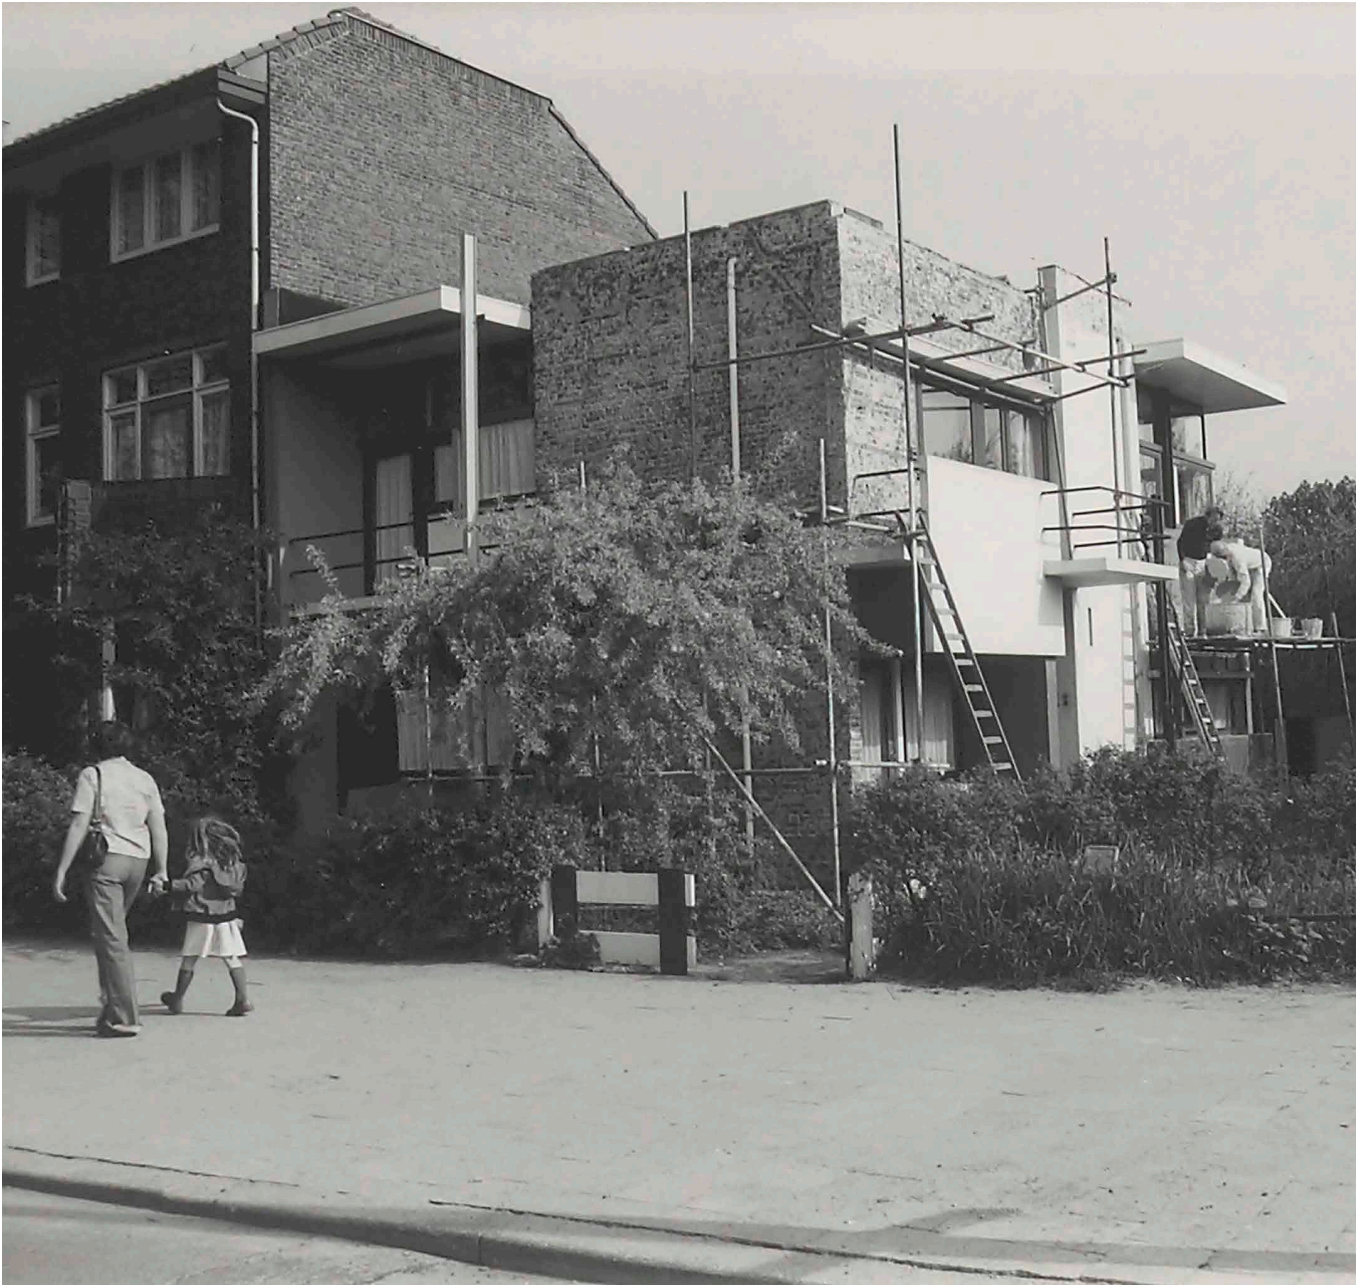
walls of the house should be replastered or just the walls with problems is not entirely clear from the report. Photographs taken during the restoration show bare brick walls but also sections with the render still intact, such as the surfaces below the kitchen window and the studio on Prins Hendriklaan [FIG. 1.12/1.13/1.14]. Because the photographs are undated it is difficult to determine whether the areas of render still visible in the photos were retained or perhaps also removed. When asked about this, Mulder was initially unable to recall precisely what had happened. However, in 2018 he wrote: 'Only on smaller surfaces that had not been repaired did the original render remain in place, such as the ground-floor walls below the windows in the kitchen and on Prins Hendriklaan. Large sections also remained in place on the white surfaces in the entrance elevation and the rear elevation.'<sup>41</sup>

FIG. 1.12 South elevation (Prins Hendriklaan) with bare brickwork

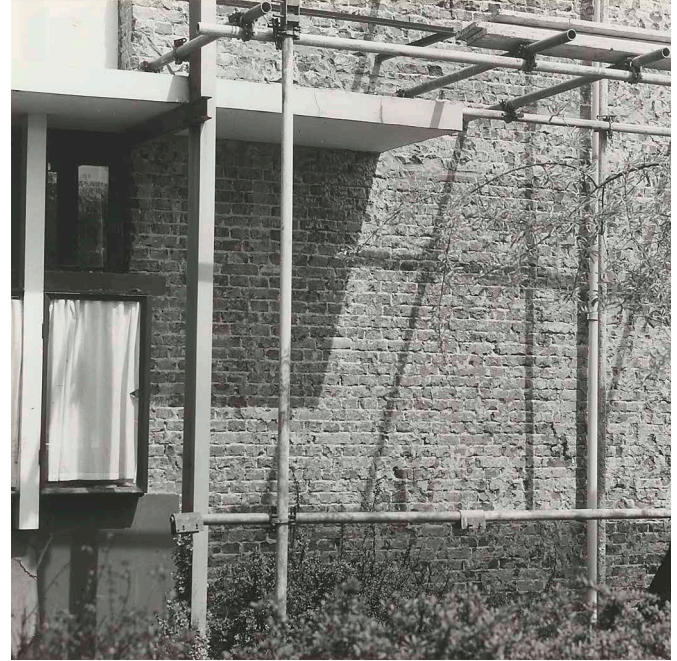
FIG. 1.14 Traces of plaster still visible on the wall below the studio window on Prins Hendriklaan
