# Creep Failure of Reformer Tubes in a Petrochemical Plant

**Abstract:** This paper investigates a failure in HP-Mod radiant tubes in a petrochemical plant. Tubes fail after 90,000 h of working at 950 °C. Observed failure is in the form of excessive bulging and longitudinal cracking in reformer tubes. Cracks are also largely branched. The microstructure of service-exposed tubes was evaluated using optical and scanning electron microscopes (SEM). Energy-dispersive X-ray spectroscopy (EDS) was used to analyze and characterize different phases in the microstructure. The results of this study showed that carbides are coarsened at both the inner and the outer surface due to the long exposure to a carburizing environment. Metallography examinations also revealed that there are many creep voids that are nucleated on carbide phases and scattered in between dendrites. Cracks appeared to form as a result of creep void coalescence. Failure is therefore attributed to creep due to a long exposure to a high temperature.

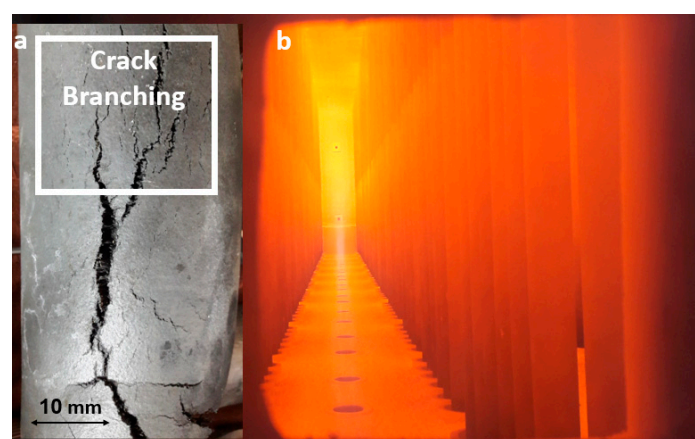
Figure 1 shows an example of failed reformer tubes together with an image, showing how tubes are installed in a reforming unit. As can be seen, cracks have propagated longitudinally. Extensive branching is also observed overall on the outer surface. It is also noticeable that in some parts tubes are largely deformed in such a way that a clear bulging is observed. Cracks are often seen in areas of localized deformation/bulging.

**Figure 1.** (a) Example of failed tubes and (b) an image of tubes in service.

- When it comes to creep failure, the most important factor that controls the lifetime of the components during a high temperature service is temperature. Improper control of temperature and overheating can dramatically decrease the creep lifetime of reformer tubes.

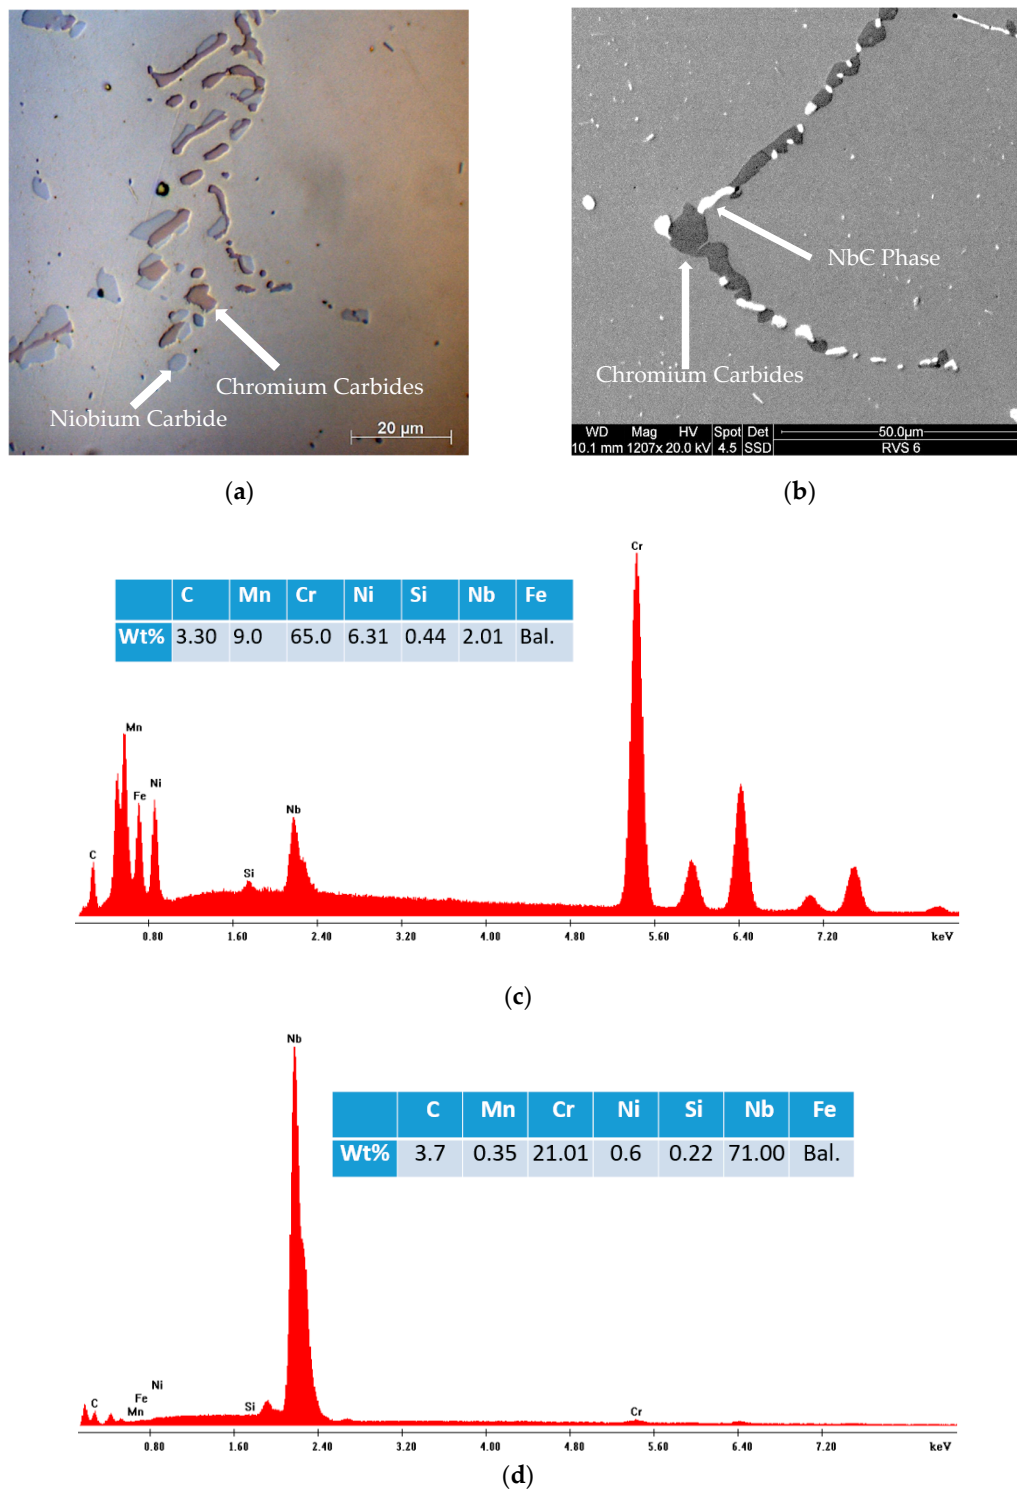
Optical and SEM micrographs of service-exposed tubes are shown in Figure 2. As can be seen, there are two types of morphologies for primary eutectic phases in the matrix. Primary eutectic phases can be categorized into “Chinese script” morphology (see Figure 2a) and a rather continuous grain boundary phase morphology (see Figure 2b). EDS analyses show that the eutectic phase is a mixture of dark and white phases, with the former ones being chromium carbides (Figure 2c), and more

specifically  $M_{23}C_6$  and  $M_7C_3$  carbides ( $M = Fe, Cr$ ) ( $M_{23}C_6$  carbides reportedly gradually transform to  $M_7C_3$  carbides during the service due to carbon diffusion/carburization [6,7]), with the latter being niobium carbide (Figure 2d).

**Figure 2.** (a) Optical and (b) SEM images of the microstructure in failed tubes, together with EDS analyses of the (c) black phase (chromium carbide) and (d) white phase (NbC).

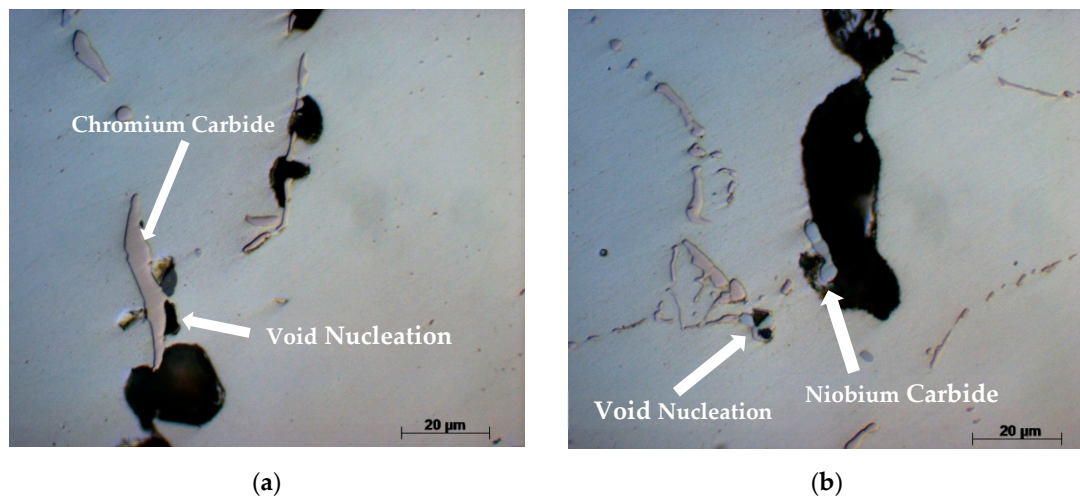
**Figure 5.** Void nucleation on (a) chromium carbide and (b) niobium carbide particles.

- Creep voids were nucleated on both chromium and niobium carbides. Cracks were formed due to the growth and coalescence of voids.
- The root cause analysis of the concerned failure showed that tubes failed due to creep failure.

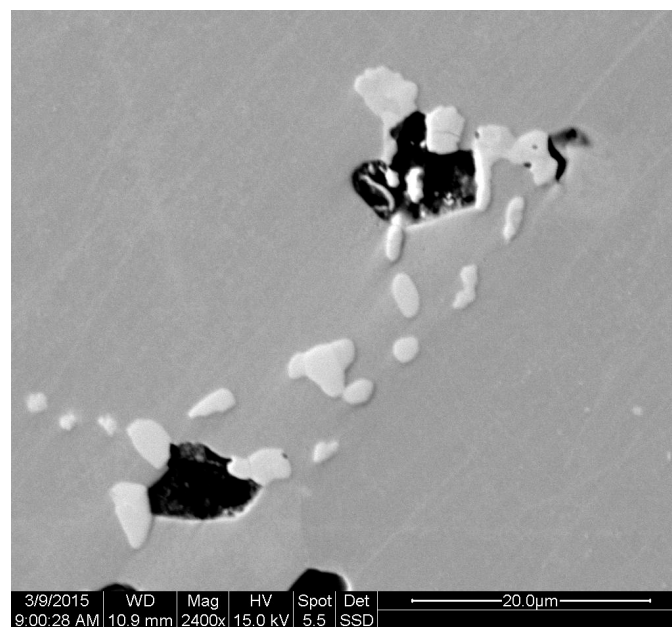
**Figure 6.** Creep voids are often nucleated in-between particles.

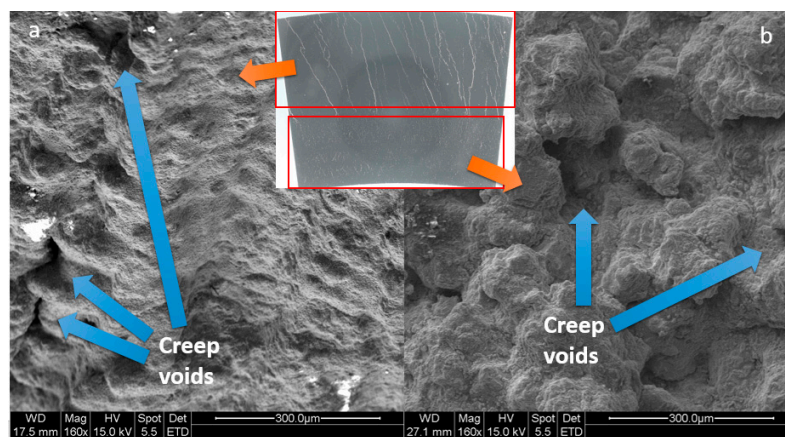
argument of creep-induced embrittlement in failed tubes [17]. However, the pictures do not show ordinary intergranular or interdendritic fractures. It is likely that the fracture surface was altered by the interaction with the steam/hydrocarbon/hydrogen atmosphere.

**Figure 7.** Fracture surface in (a) dendritic and (b) equiaxed grain regions.
