# Root Cause Analysis of Surface Cracks in Heavy Steel Plates during the Hot Rolling Process

<sup>2</sup> Hormozgan Steel Company (HOSCO), Bandar Abbas, Iran

**Abstract:** This paper investigates the root cause of the formation of surface cracks on hot-rolled C–Mn constructional steel heavy plates. Cracks are rather evenly distributed over the surface in the form of colonies of cracks. Samples were cut from the heavy plate. The microstructure of samples in the as-cast and hot-rolled states were studied using optical and electron microscopes as well as energy dispersive X-ray spectroscopy (EDS). Results show that cracks are heavily oxidized. De-carburized areas are also seen alongside cracks. The crack tip is in the form of a deer-horn, indicating that crack branching has taken place during deformation. The crack initiation sites are V-shaped grooves on the surface of as-cast slabs. Correlations between microstructures, processing parameters, and crack formation are discussed.

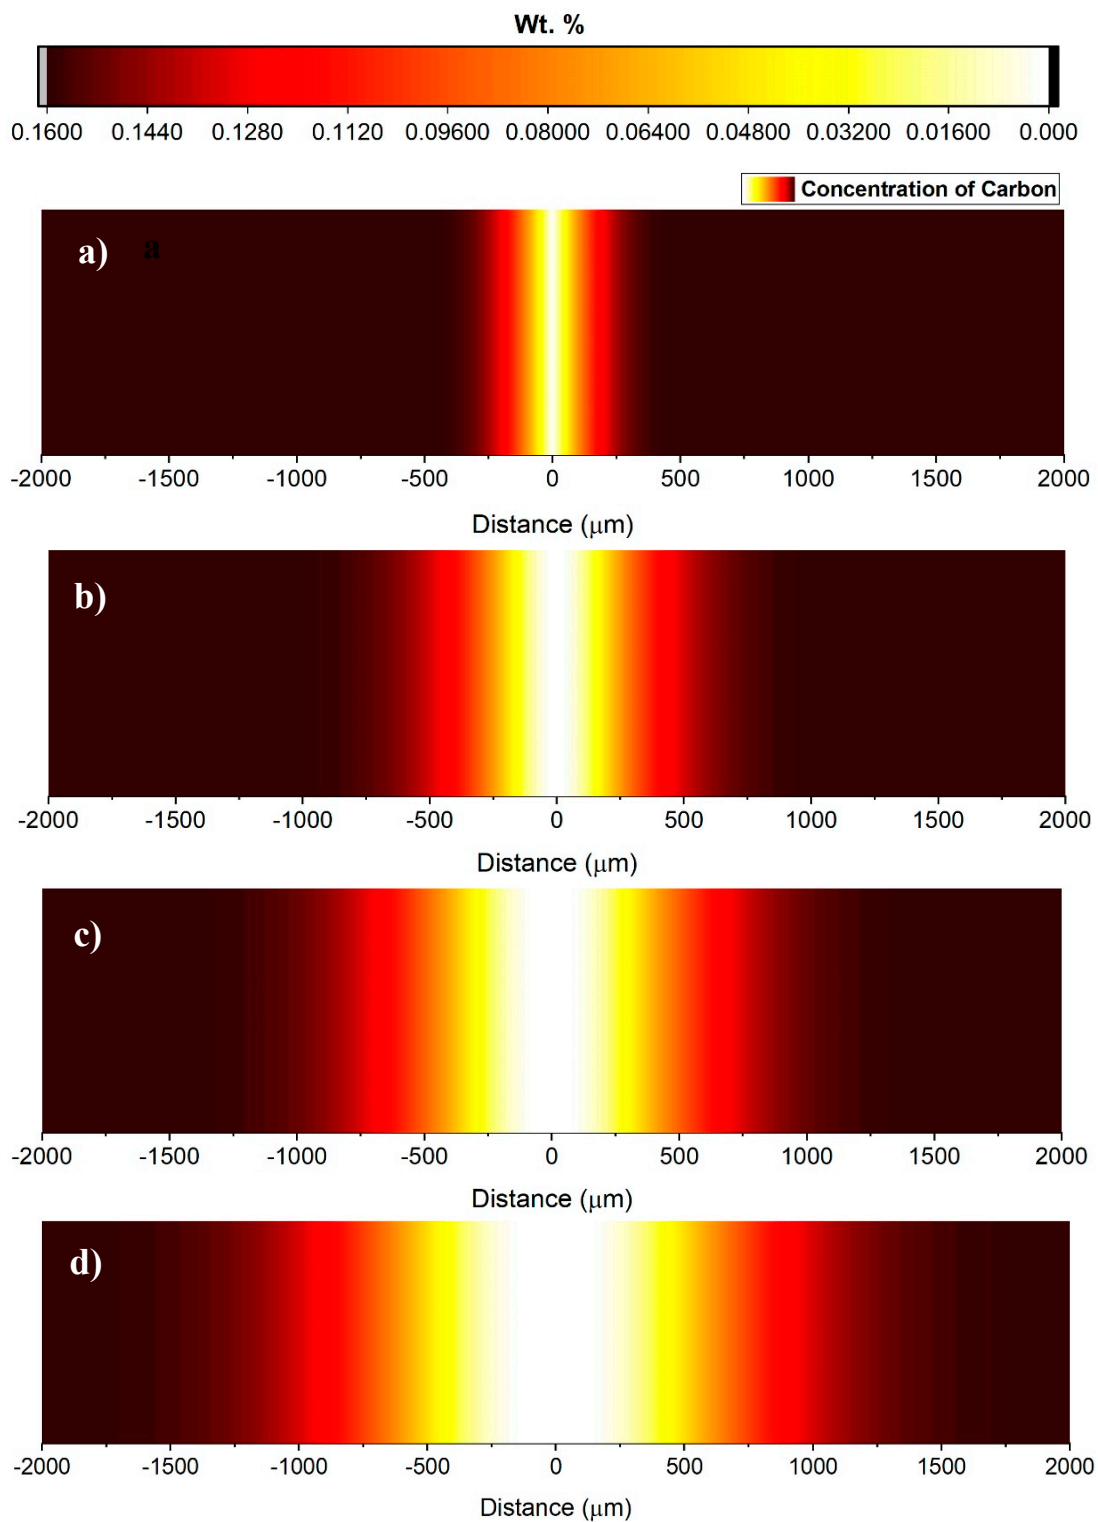
where  $D_0 = 2.3 \times 10^{-5} \text{ m}^2/\text{s}$ ,  $Q = 148 \text{ kJ/mol}$ , and  $R = 8.314 \text{ J/mol}\cdot\text{K}$  [20]. An average value of  $1100^\circ\text{C}$  was assumed for the rolling temperature. Figure 7 shows the contour of carbon diffusion across the crack. Results show that after 16 passes carbon is heavily depleted in approximately  $300\text{--}400 \text{ }\mu\text{m}$  distance from the crack. It is also seen that with increasing pass numbers, the depletion layer gets wider. According to Fe-C diagram, pearlite is not expected to form in carbon content less than  $0.008 \text{ wt. \%}$ . Results of this calculation is very well in accordance with the experimental results.

**Figure 7.** Contour of carbon diffusion in and around areas of a crack (a) after 1 pass of hot rolling, (b) after 5 passes, (c) after 10 passes, and (d) after 16 passes.
