## Corrosion-Fatigue Failure of Gas-Turbine Blades in an Oil and Gas Production Plant

# Corrosion-Fatigue Failure of Gas-Turbine Blades in an Oil and Gas Production Plant

**Abstract:** This paper investigates the root cause of a failure in gas-turbine blades, made of Nimonic-105 nickel-based superalloy. The failure was reported in two blades in the second stage of a turbine-compressor of a gas turbine in the hot section. Two failed blades were broken from the root and from the airfoil. The failure took place after 20 k h of service exposure in the temperature range 700–850 °C, with the rotating speed being in the range 15,000–16,000 rpm. The microstructures of the failed blades were studied using optical/electron microscopes. Energy dispersive X-ray spectroscopy (EDS) was employed for phase identification. Results showed that failure first initiated from the root. The dominant failure mechanism in the root was concluded to be corrosion-fatigue. The failure scenario was suggested based on the results obtained.

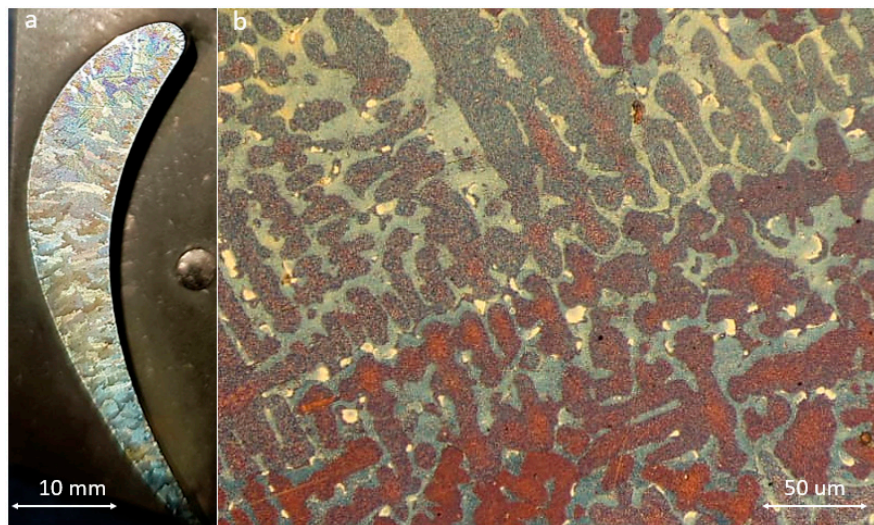
Figure 2 depicts the typical microstructure in the failed blades. The microstructure is a typical dendritic cast structure where dendrites have grown from two sides towards the centerline of the blade, as expected. Fine white particles in-between dendrites are carbide particles.

**Figure 2.** (a) Macro and (b) optical microscope images of failed blades.

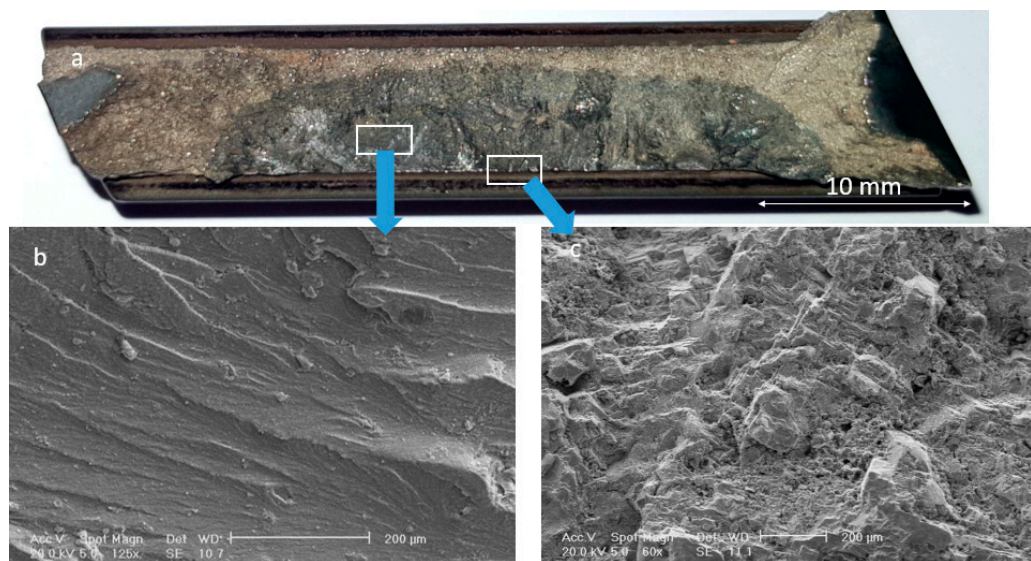
Figure 3 shows stereomicroscope and SEM micrographs of the fracture surface from the blade that failed from the root. As shown in Figure 3a, the fracture surface has two areas: the dominant grayish area and the rest of the surface. This is a typical fracture surface when fatigue is the governing damage mechanism. Figure 3b,c show SEM micrographs of two areas, highlighted in Figure 3a. The former image (Figure 3b) shows typical beach marks, indicating that fatigue is an active mechanism. Further down to the edge, there is a clear change in the fracture surface (Figure 3c). The surface at the edge of the failed blade is covered with some deposits, which were analyzed by EDS. Results of EDS analysis of the microstructure at the edge (presented in Figure 4) showed that surface deposits are rich in Cl, K, Na, and Ca. This, together with the fact that there is a high concentration of oxygen in the analysis, indicates that these deposits are in fact corrosion products. It is highly likely that the aforementioned elements come from the fuel/gas.

**Figure 3.** (a) Stereomicroscope and (b,c) scanning electron microscope (SEM) micrographs of the fracture surface of the blade, failed from the root.

From the results obtained, it can be concluded that the failure in the blade, broken from the root, was controlled by the simultaneous activation of corrosion and fatigue. Corrosion-fatigue is a common degradation mechanism in moving components exposed to high-temperature harsh working conditions [21]. Corrosion fatigue essentially takes place under the synergistic activation of corrosion and dynamic loading. This degradation mechanism is one of the most common reasons for the failure of turbine blades [22]. Corrosion fatigue is undoubtedly one of the most complex failure mechanisms. Both mechanical and chemical aspects of failure in this case are equally important. Any mitigation measure to avoid this failure necessitates a multi-disciplinary approach. Corrosion-fatigue failure of the blade root in this case has possibly originated from corrosion pits/products deposited at the root/airfoil interface. The results showed that corrosion products/deposits in this case mostly contained CaO, Na<sub>2</sub>O, KCl, and NaCl. The sensitivity of turbine blades to corrosion-fatigue initiation largely depends on the integrity of the passive film on the surface [22]. The breakdown of this passive film

together with the deposition of oxide/corrosion deposits create an ideal condition for corrosion-fatigue crack initiation. The film breakdown and deposition of corrosion products causes anodic/cathodic sites, leading to an accelerated localized anodic dissolution reaction and, hence, localized corrosion [23]. The formation of corrosion-induced surface irregularities creates stress riser centers on the surface [24]. In case these surface irregularities exceed a critical size, a fatigue crack is likely to initiate. The crack then propagates under dynamic loading condition, finally leading the failure of the turbine blade.

- Given that both corrosion and fatigue mechanisms were involved in this failure, it is important to minimize mechanical vibrations and to reduce contaminants in the system. The latter necessitates further investigation on the origins of the Cl, Na, and Ca-containing residues and how they can be controlled/eliminated from the system.

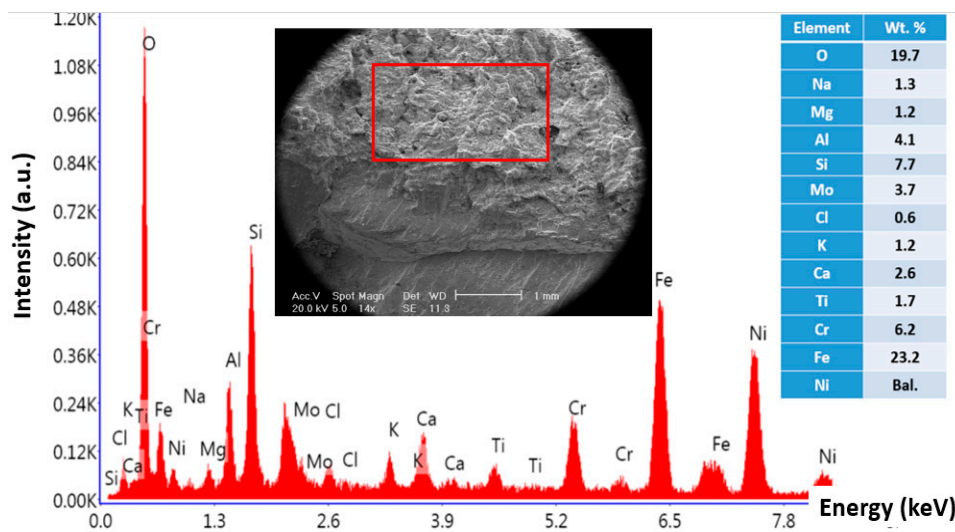
**Figure 4.** Energy dispersive X-ray spectroscopy (EDS) analysis of corrosion products at the edge of broken blade.

- Results showed that corrosion fatigue is the governing failure mechanism in the blade that failed from the root. In this case, there are corrosion deposits at the edge of the blade, rich in Cl, Ca, O, Na, and K. Fatigue cracks have initiated from corroded spots at the edge of the blade.

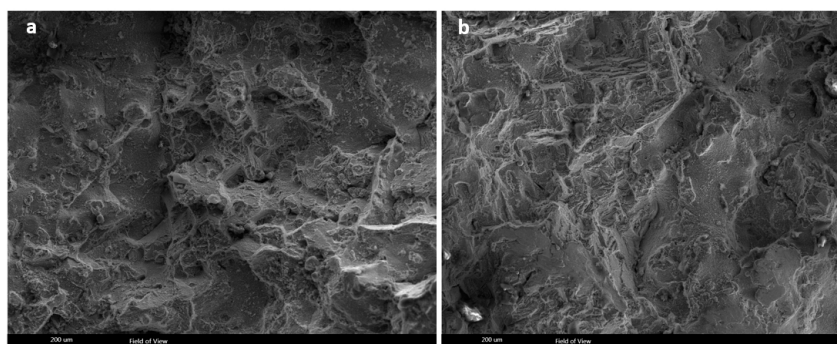
**Figure 7.** (a,b) SEM micrographs of fracture surface of the blade, broken from the airfoil.

- Fractography of the blade that failed from the airfoil showed that, contrary to the former case, there is hardly any fatigue involved in the failure of this blade.
