**Structural behaviour of a calcium silicate brick masonry assemblage
Quasi-static cyclic pushover and dynamic identification test (C31B60-7)**

<i>Project number</i>	C31B60
<i>File reference</i>	C31B60-7
<i>Date</i>	21 October 2016
<i>Corresponding author</i>	Geert Ravenshorst (g.j.p.ravenshorst@tudelft.nl) Rita Esposito (r.esposito@tudelft.nl)

STRUCTURAL BEHAVIOUR OF A CALCIUM SILICATE BRICK MASONRY ASSEMBLAGE: QUASI-STATIC CYCLIC PUSHOVER AND DYNAMIC IDENTIFICATION TEST

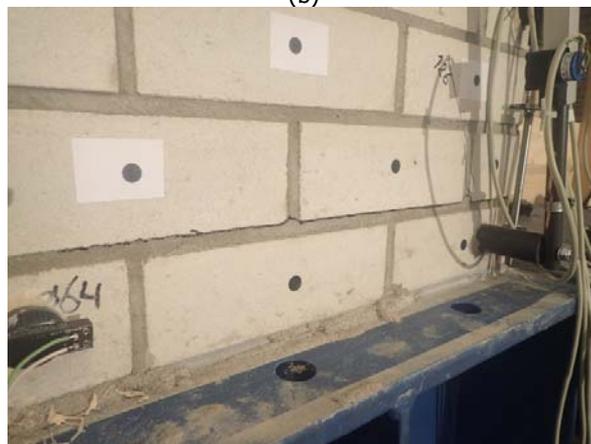
Figure 4.13 – Visual inspection after **cycle 9**: (a) Backbone curve; (b) Crack pattern (existing cracks in black, new cracks in red); (c) Crack at the bottom of pier P1 (1_C9-GF-P1). See also Figure E.2.

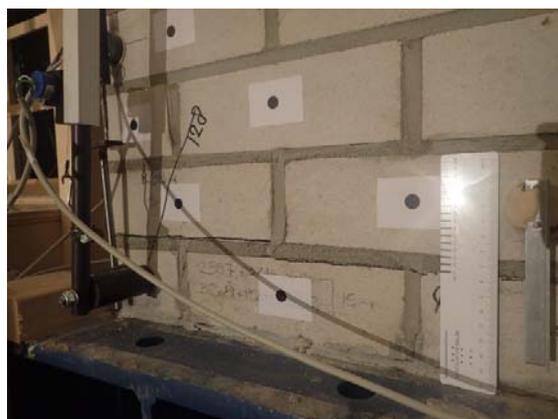
Figure 4.14 – Visual inspection after cycle 12: (a) Backbone curve; (b) Crack pattern (existing cracks in black, new cracks in red); (c) Crack at the bottom of pier P1 (2_C12-GF-P1); (d) Crack at the bottom of pier P2 (4_C12-GF-P1). See also from Figure E.3 to Figure E.5.

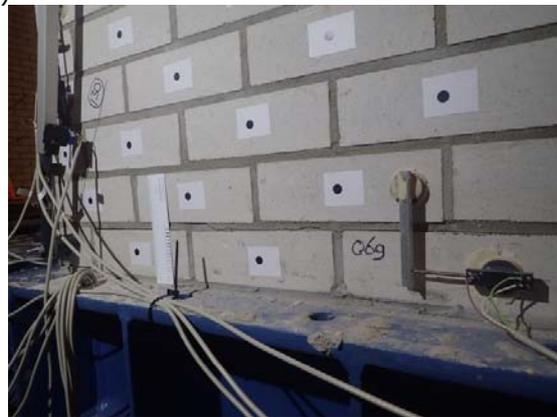
Figure 4.15 – Visual inspection after cycle 13 (last negative displacement): (a) Backbone curve; (b) Crack pattern (existing cracks in black, new cracks in red); (c) Crack at the bottom of pier P1 (7_C13-GF-P1); (d) Crack at the bottom of pier P3 (8_C13-GF-P3). See also Figure E.6.

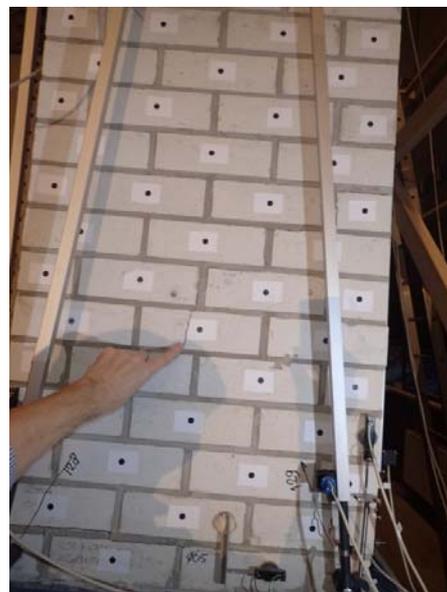
Figure 4.17 – Visual inspection after **cycle 14 (last negative displacement)**: (a) Backbone curve; (b) Crack pattern (existing cracks in black, new cracks in red); (c) Crack between second floor slab and pier P3 (15_C14-FF-P3); (d) Crack in pier P2 (12_C14-GF-P2). See also from Figure E.7 to Figure E.10.

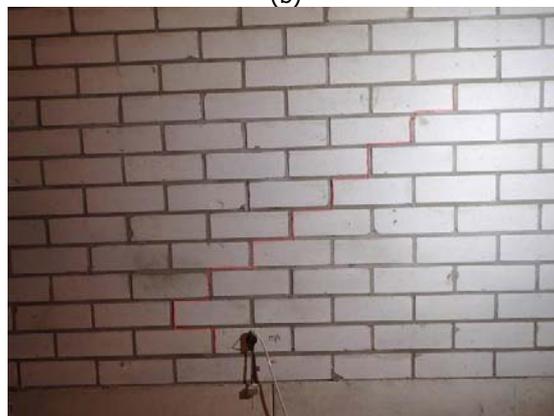
Figure 4.18 – Visual inspection after **cycle 14 (last positive displacement)**: (a) Backbone curve; (b) Crack pattern (existing cracks in black, new cracks in red); (c) Diagonal cracks on west wall (outside) at the first floor (16_C14-FF-W). See also Figure E.11.

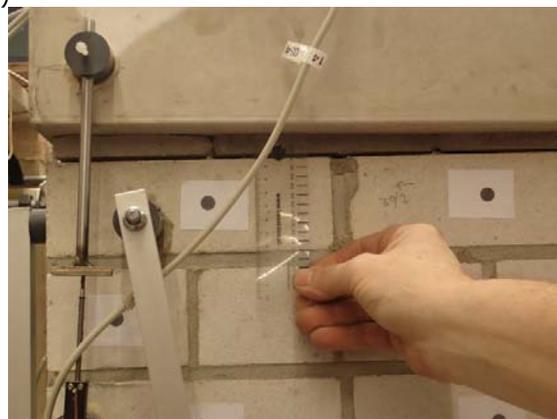
Figure 4.20 – Visual inspection after **cycle 15 (last negative displacement)**: (a) Backbone curve; (b) Crack pattern (existing cracks in black, new cracks in red); (c) Crack between first floor slab and west wall at corner with pier P1 (18_C15-GF-WP1); (d) Crack between second floor slab and pier P1 (outside) (23_C15-FF-P1). See also from Figure E.12 to Figure E.16.

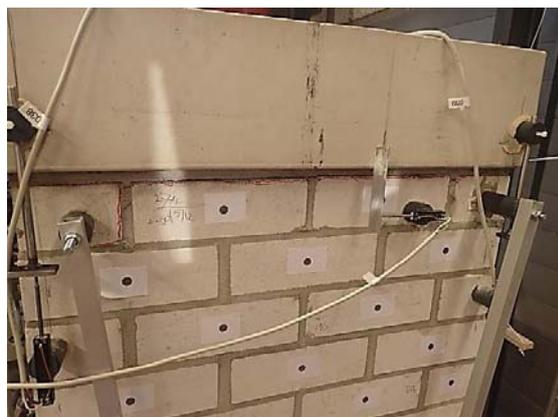
Figure 4.21 – Visual inspection after **cycle 15 (last positive displacement)**: (a) Backbone curve; (b) Crack pattern (existing cracks in black, new cracks in red); (c) Crack at the corner between west wall and pier P1 (30_C14-GF-P1W); (d) Crack between second floor slab pier P2 (28_C15-FF-P2). See also from Figure E.17 to Figure E.18.

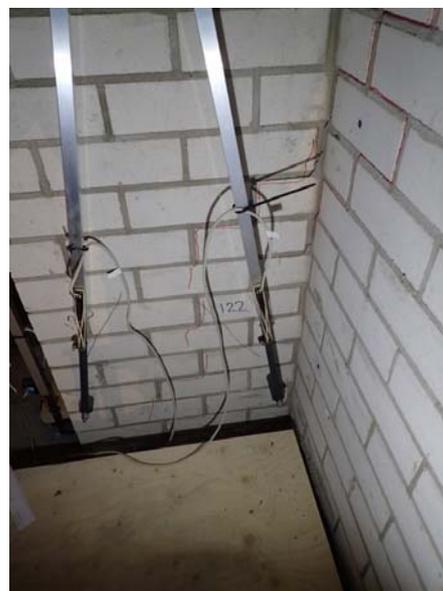
After the peak, the capacity and stiffness substantially reduced for positive displacements. This phenomenon was mainly governed by the diagonal/vertical cracks occurring first in pier P3 during cycle 17 ($d_2 = \pm 38.5$ mm, Figure 4.22) and subsequently in pier P1 during cycle 18 ($d_2 = \pm 50.0$ mm, Figure 4.24). Due to the extensive cracking of these piers, part of pier P3 was removed for safety reasons after cycle 19 ($d_2 = \pm 60.0$ mm, Figure 4.25). For negative displacements, the maximum base shear force of 41.6 kN was reached in cycle 19 for displacement of $d_2 = -60$ mm. This event corresponded to the formation of a secondary diagonal/vertical crack in pier P3 (Figure 4.25).

Figure 4.22 – Visual inspection after cycle 17 (last negative displacement): (a) Backbone curve; (b) Crack pattern (existing cracks in black, new cracks in red); (c) Crack on pier P3 at the ground floor (31_C17-GF-P3); (d) Cracks on pier P4 at the corner with east wall (35_C17_GF_P4E). See also from Figure E.19 to Figure E.24.

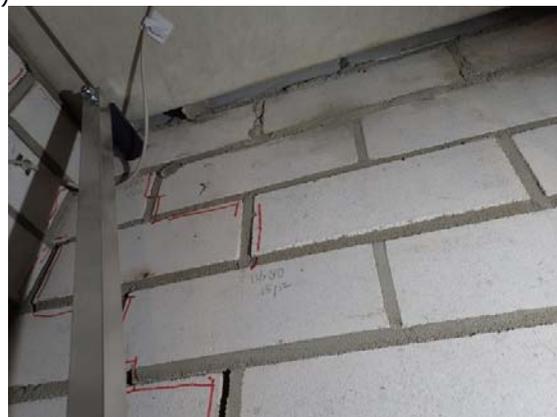
Figure 4.23 – Visual inspection after **cycle 17 (last positive displacement)**: (a) Backbone curve; (b) Crack pattern (existing cracks in black, new cracks in red); (c) Diagonal crack at the bottom of pier P2 at the ground floor (41_C17-GF-P2); (d) Crack on pier P3 at the side with west wall (42_C17-GF-P3). See also Figure E.25.

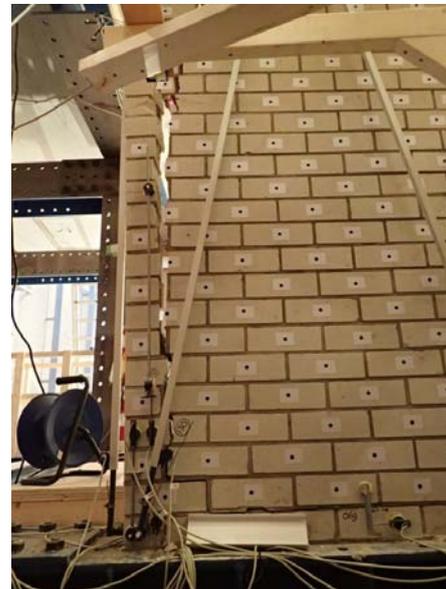
Figure 4.24 – Visual inspection after cycle 18: (a) Backbone curve; (b) Crack pattern (existing cracks in black, new cracks in red); (c) Diagonal crack on pier P1 at the ground floor (a): Outside (43_C18-GF-P1); (d) Diagonal crack on pier P3 at the ground floor (outside): (a) Bottom part (45_C18-GF-P3). See also from Figure E.27 to Figure E.29.

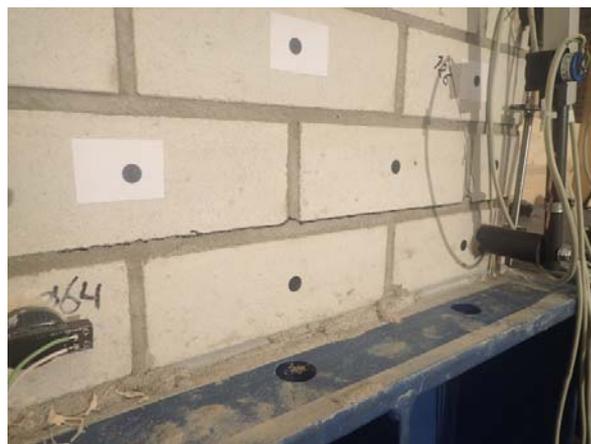
Figure E.2 – Pre-peak phase cycle 9 – ground floor: Crack at the bottom of pier P1 (1_C9-GF-P1).

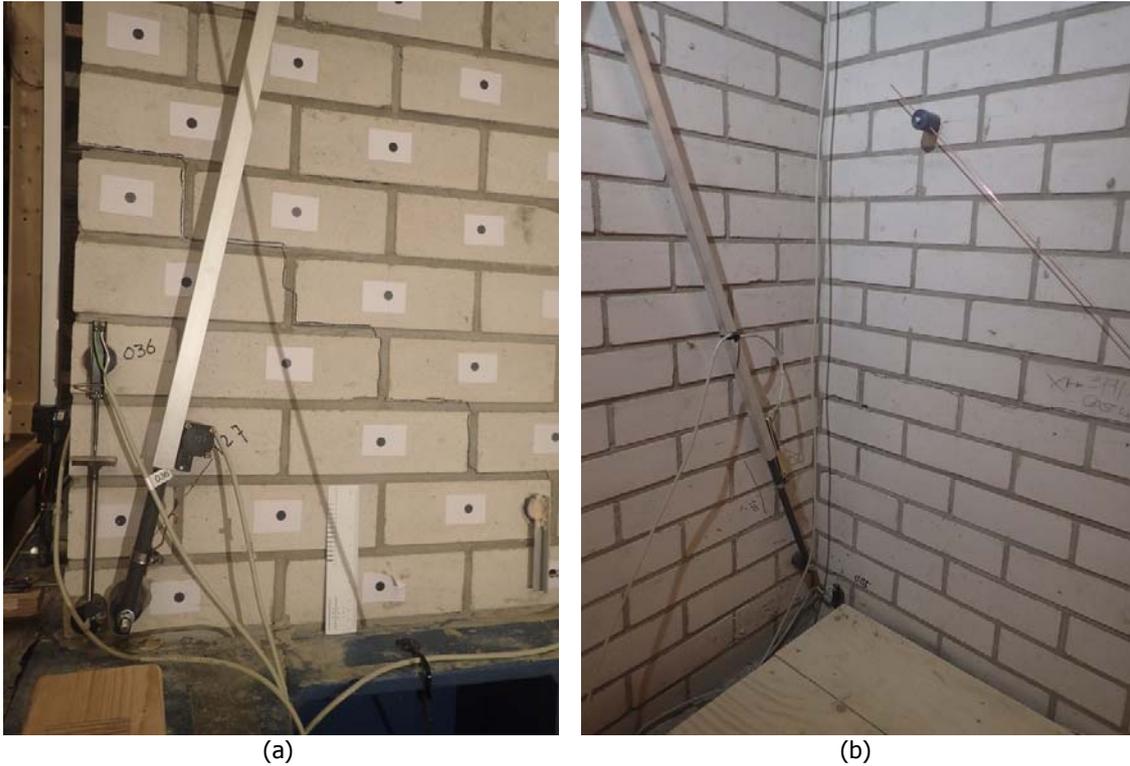
Figure E.3 – Pre-peak phase **cycle 12** – ground floor: (a) Crack at the bottom of pier P1 (2_C12-GF-P1); (b) Crack at the corner between the west wall and pier P1 (3_C12-GF-P1W).

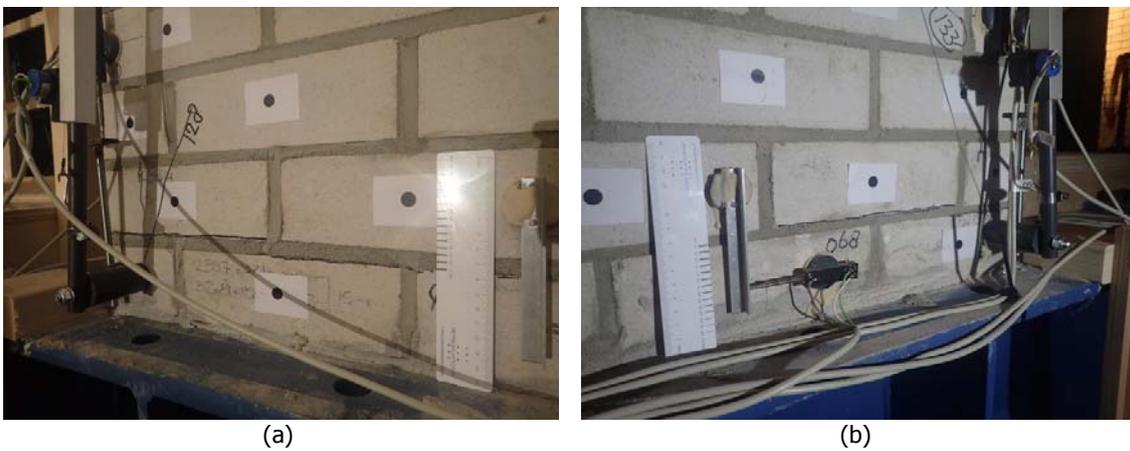
Figure E.4 – Pre-peak phase **cycle 12** – ground floor: (a) Crack at the bottom of pier P2 (4_C12-GF-P1); (b) Crack at the bottom of pier P4 (5_C12-GF-P4).

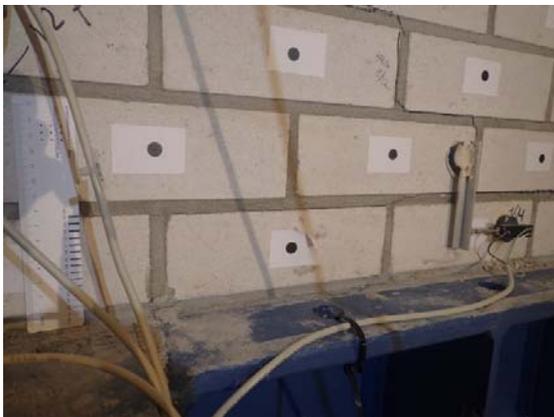
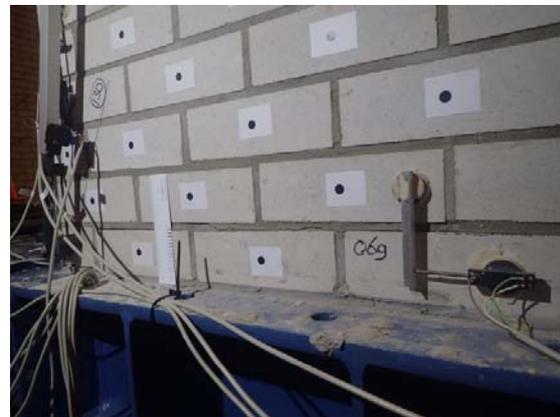
Figure E.6 – Pre-peak phase **cycle 13** – ground floor: (a) Crack at the bottom of pier P1 (7_C13-GF-P1); (b) Crack at the bottom of pier P3 (8_C13-GF-P3). Compare with Figure E.2.

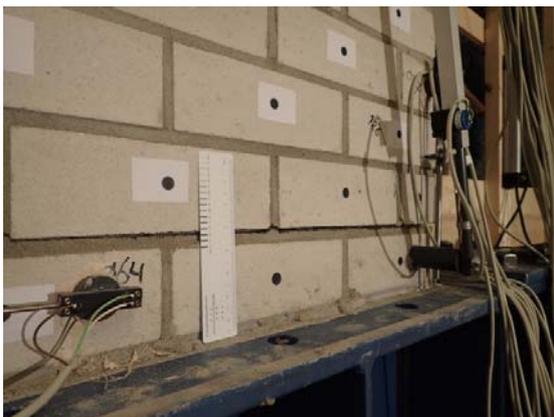
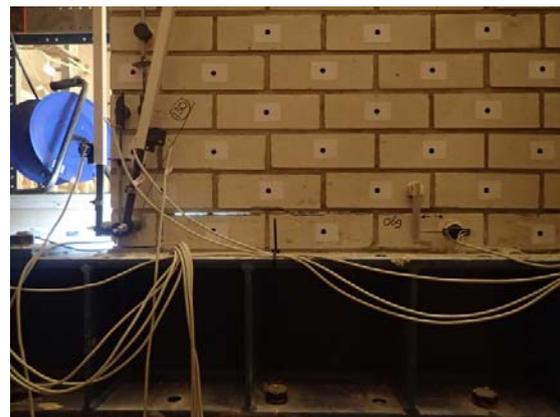
Figure E.7 – Pre-peak phase **cycle 14 (negative displacement)** – ground floor: (a) Crack at the bottom of pier P1 (9_C14-GF-P1); (b) Crack at the bottom of pier P3 (10_C14-GF-P3). Compare with Figure E.6.

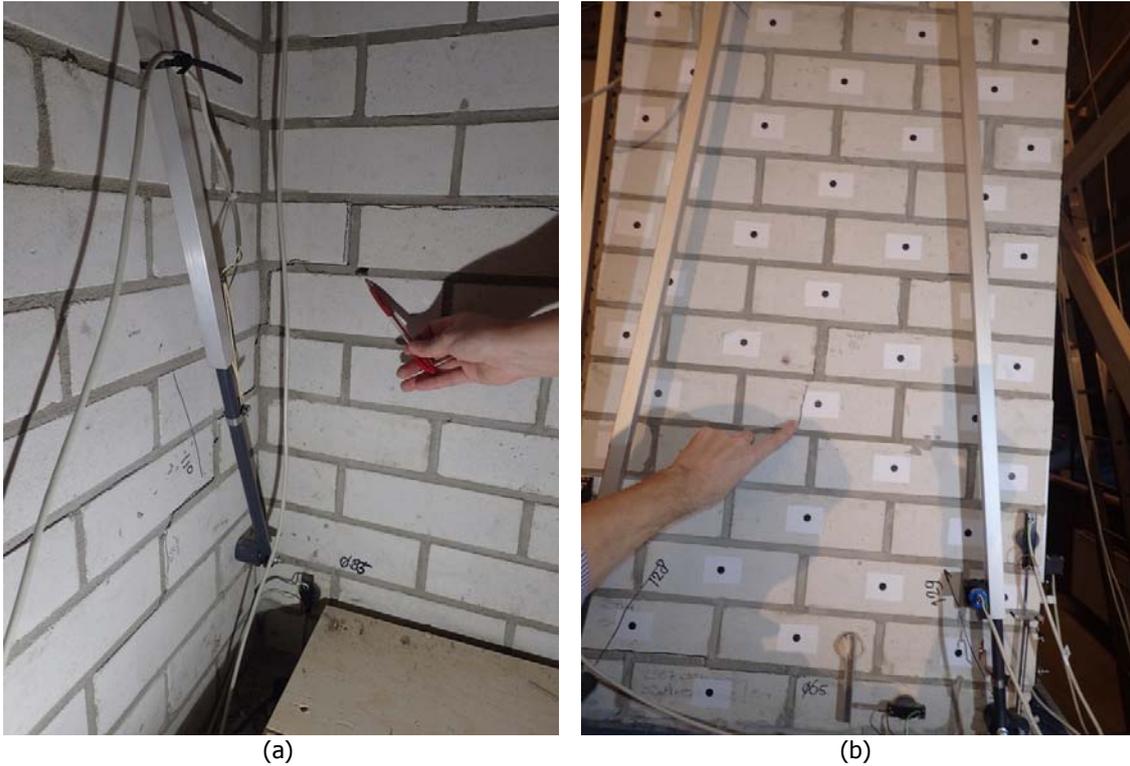
Figure E.8 – Pre-peak phase **cycle 14 (negative displacement)** – ground floor: (a) Crack at the corner between west wall and pier P1 (11_C14-GF-P1W); (b) Crack in pier P2 (12_C14-GF-P2). Compare with Figure E.6.

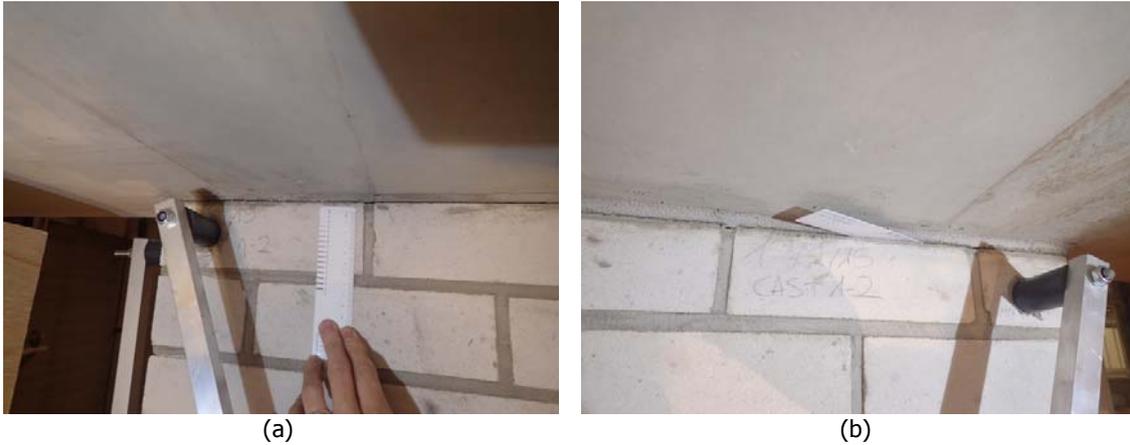
Figure E.10 – Pre-peak phase **cycle 14 (negative displacement)** – first floor: (a) Crack between second floor slab and pier P1 (14_C14-FF-P1); (b) Crack between second floor slab and pier P3 (15_C14-FF-P3).

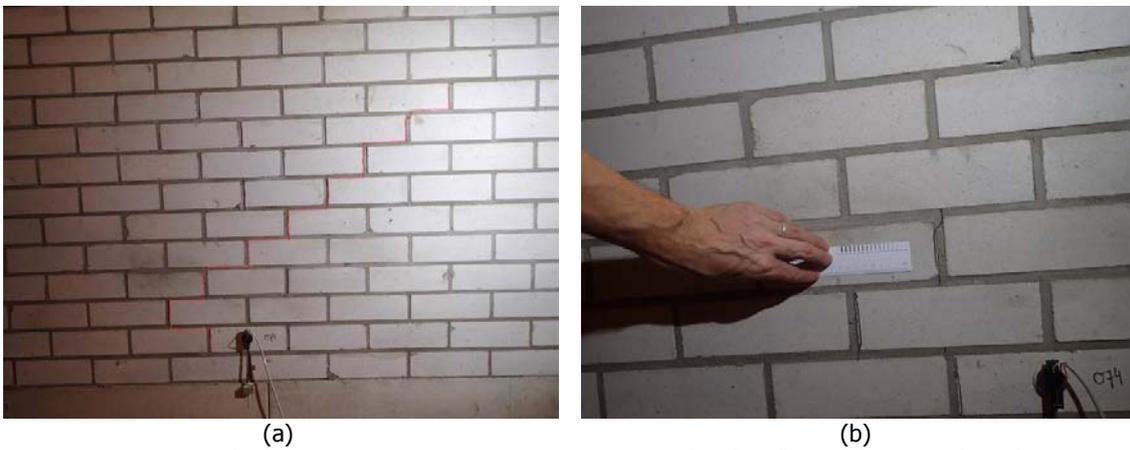
Figure E.11 – Pre-peak phase **cycle 14 (positive displacement)** – first floor: (a) Diagonal cracks on west wall (outside) at the first floor (16_C14-FF-W); (b) Detail of picture (a) (17_C14-FF-W).

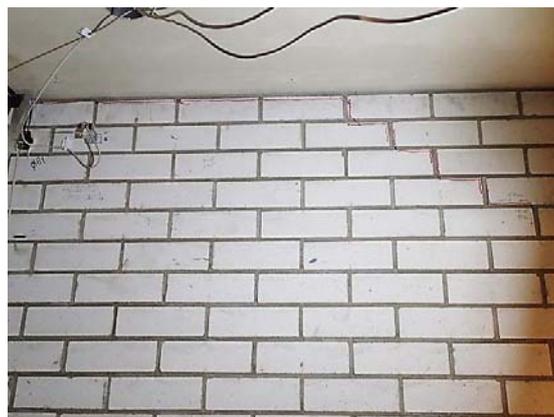
Figure E.12 – Post-peak phase **cycle 15 (negative displacement)** – ground floor: Crack between first floor slab and west wall at corner with pier P1 (18_C15-GF-WP1).

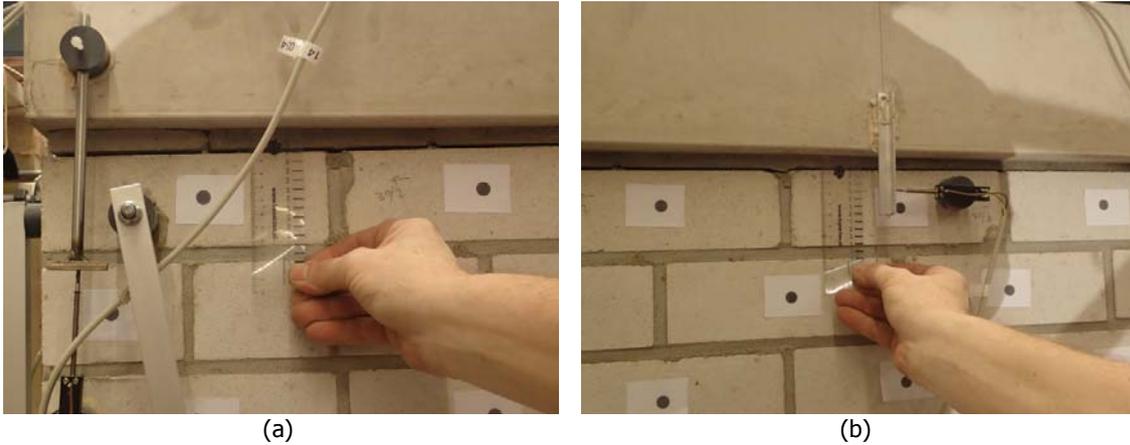
Figure E.15 – Post-peak phase **cycle 15 (negative displacement)** – first floor: (a) Crack between second floor slab and pier P1 (outside) (23_C15-FF-P1); (b) Detail of (a) (24_C15-FF-P1).

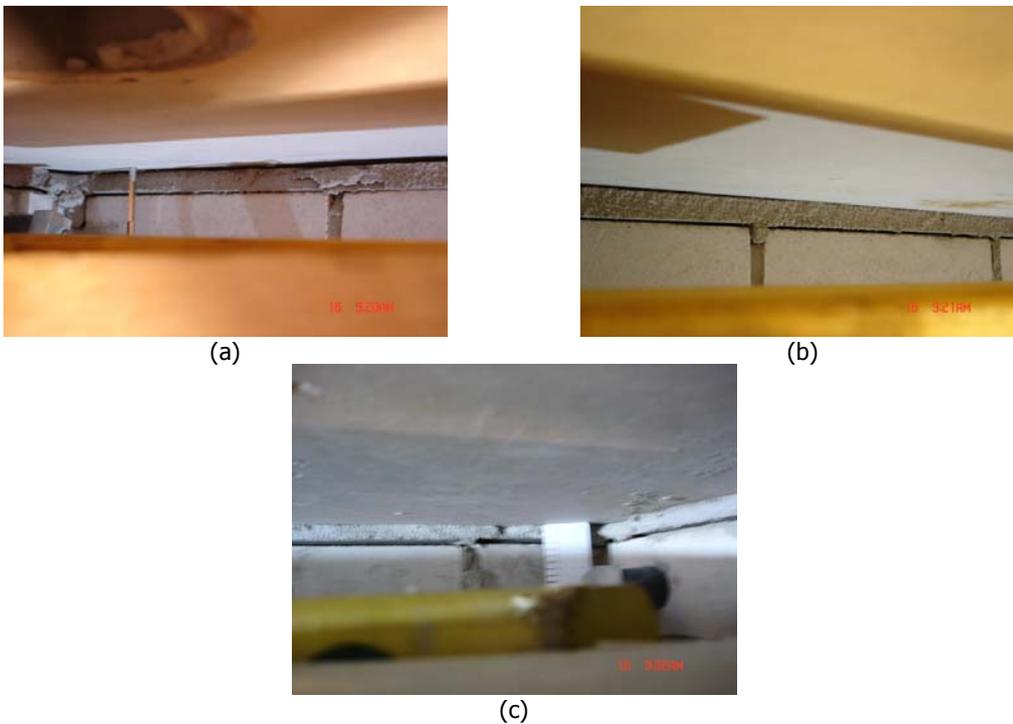
Figure E.16 – Post-peak phase **cycle 15 (negative displacement)** – first floor: Crack between second floor slab and west wall (a) at corner with pier P1 (2_C15-FF-WP1), (b) at the centre (26_C15-FF-W) and (c) at corner with pier P3 (27_C15-FF-WP3).

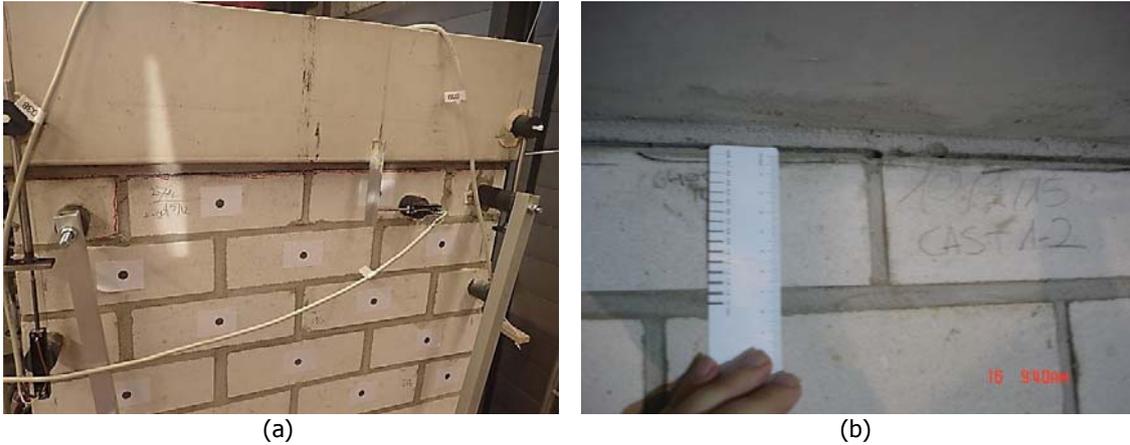
Figure E.17 – Post-peak phase **cycle 15 (positive displacement)** – first floor: (a) Crack between second floor slab pier P2 (28_C15-FF-P2); (b) Detail of (a) (29_C15-FF-P2).

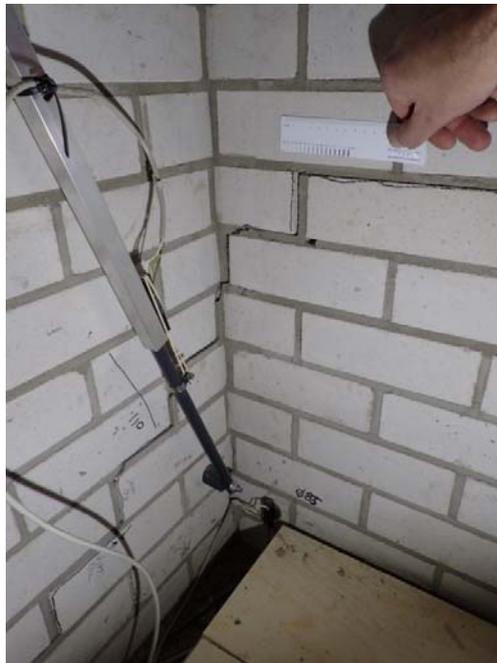
Figure E.18 – Post-peak phase **cycle 15 (positive displacement)** – ground floor: Crack at the corner between west wall and pier P1 (30_C14-GF-P1W). Compare with Figure E.8.

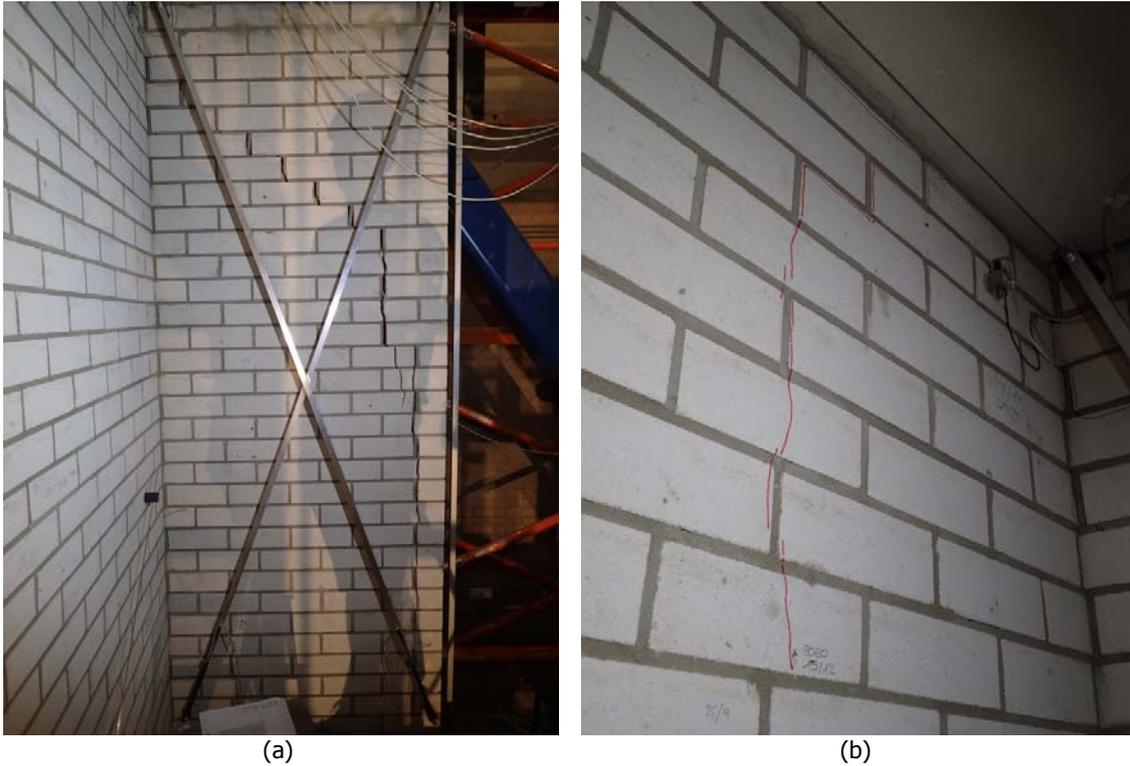
Figure E.19 – Post-peak phase **cycle 17 (negative displacement)** – ground floor: (a) Crack on pier P3 at the ground floor (31_C17-GF-P3); (b) Crack on west wall at the side with pier P3 (32_C17-GF-W).

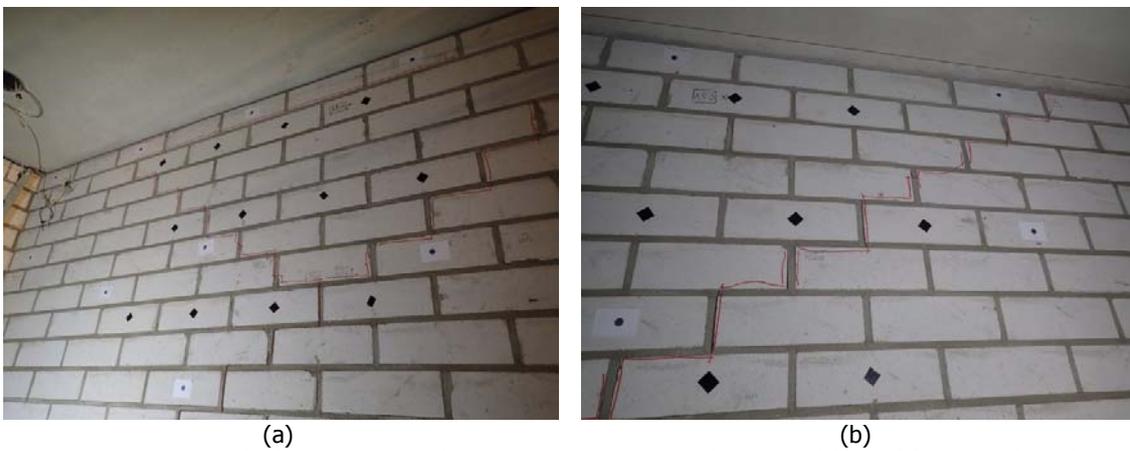
Figure E.20 – Post-peak phase **cycle 17 (negative displacement)** – ground floor: (a) Diagonal cracks on east wall at the ground floor (33_C17-GF-E); (b) Detail of the left diagonal crack in figure (a) (34_C17-GF-E).

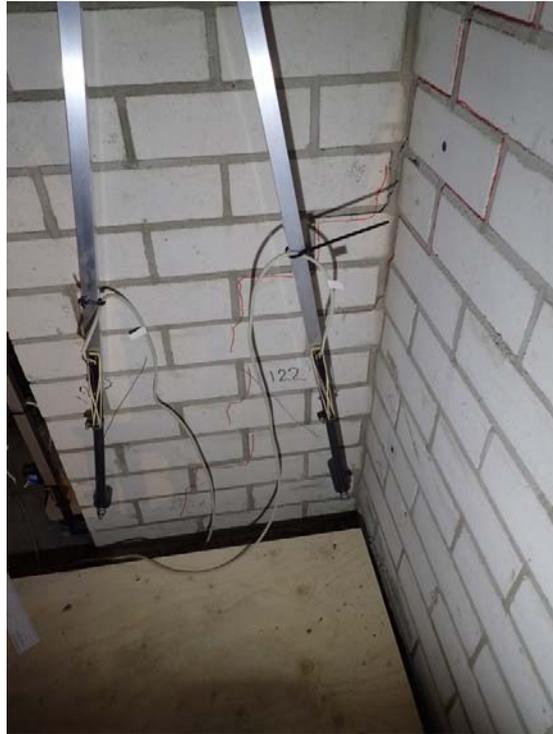
Figure E.21 – Post-peak phase **cycle 17 (negative displacement)** – ground floor: Cracks on pier P4 at the corner with east wall (35_C17_GF_P4E).

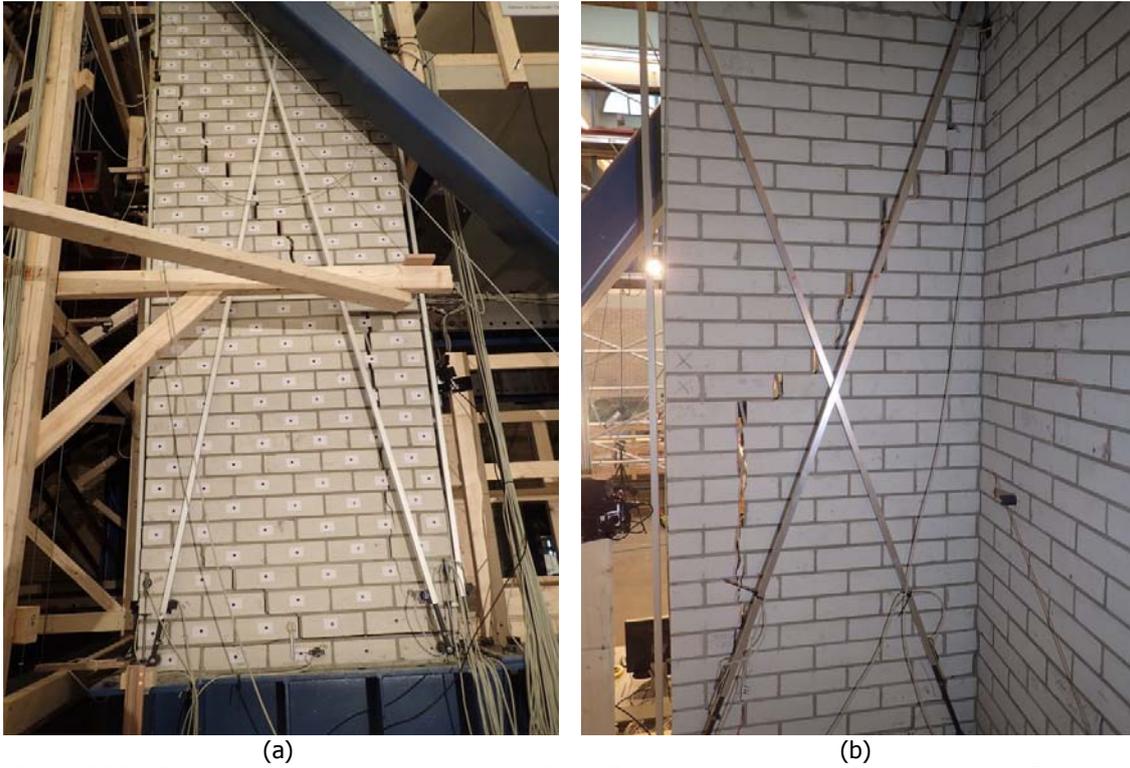
Figure E.27 – Post-peak phase **cycle 18** – ground floor - Diagonal crack on pier P1 at the ground floor (a): Outside (43_C18-GF-P1); (b) Inside (44_C18-GF-P1).

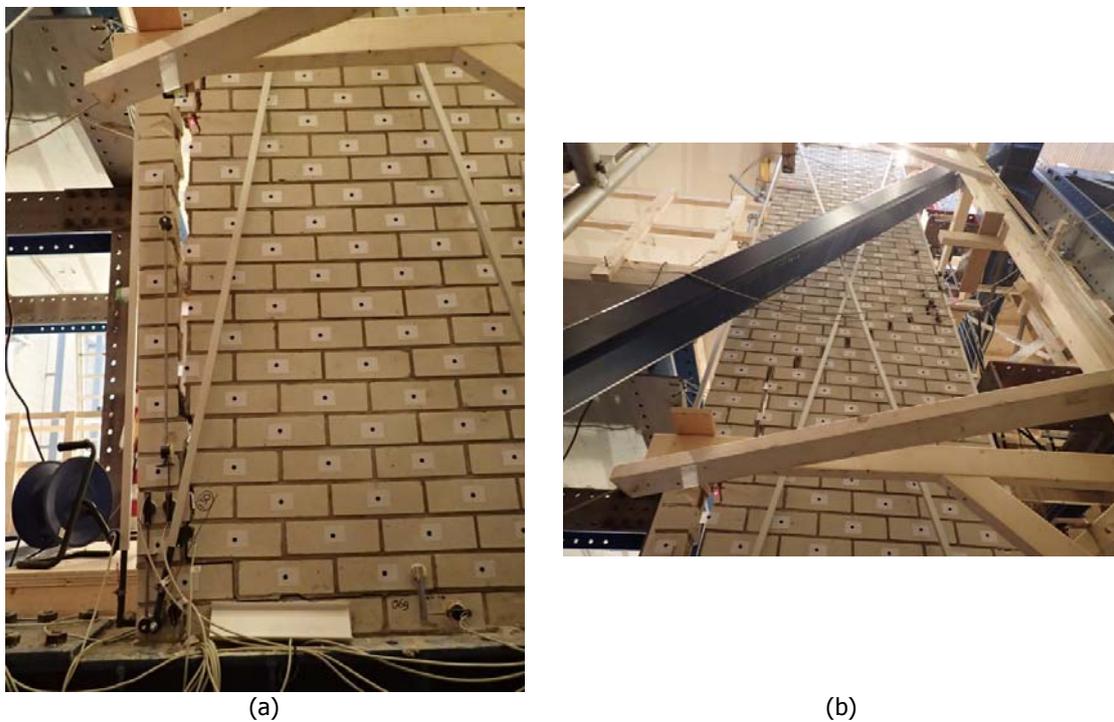
Figure E.28 – Post-peak phase **cycle 18** – ground floor - Diagonal crack on pier P3 at the ground floor (outside): (a) Bottom part (45_C18-GF-P3); (b) Upper part (46_C18-GF-P3). Compare with Figure E.19(a).

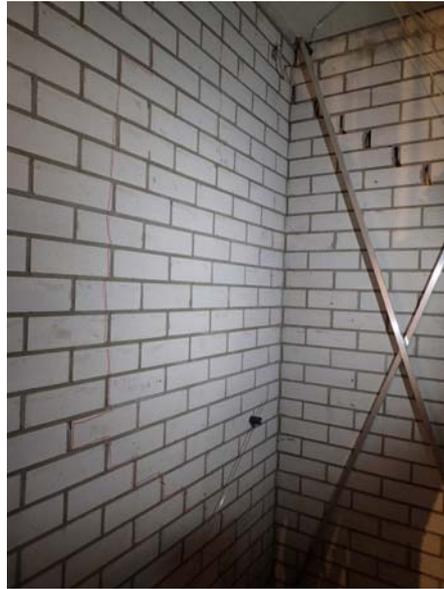
Figure E.29 – Post-peak phase cycle 18 – ground floor: Vertical crack on west wall at the side with pier P3 (47_C18-GF-WP3). Compare upper part of the photo with Figure E.19(b).

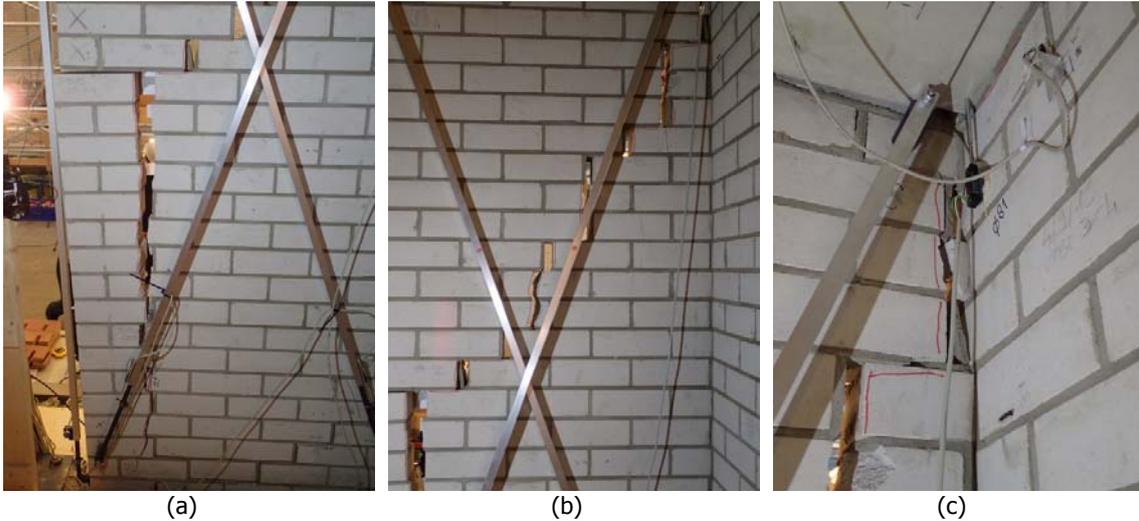
Figure E.31 – Post-peak phase **cycle 19** – ground floor – Vertical/diagonal crack on pier P1 at ground floor: (a) Bottom (48_C19-GF-P1); (b) Centre (49_C19-GF-P1); (c) Top (50_C19-GF-P1). Compare with Figure E.20.

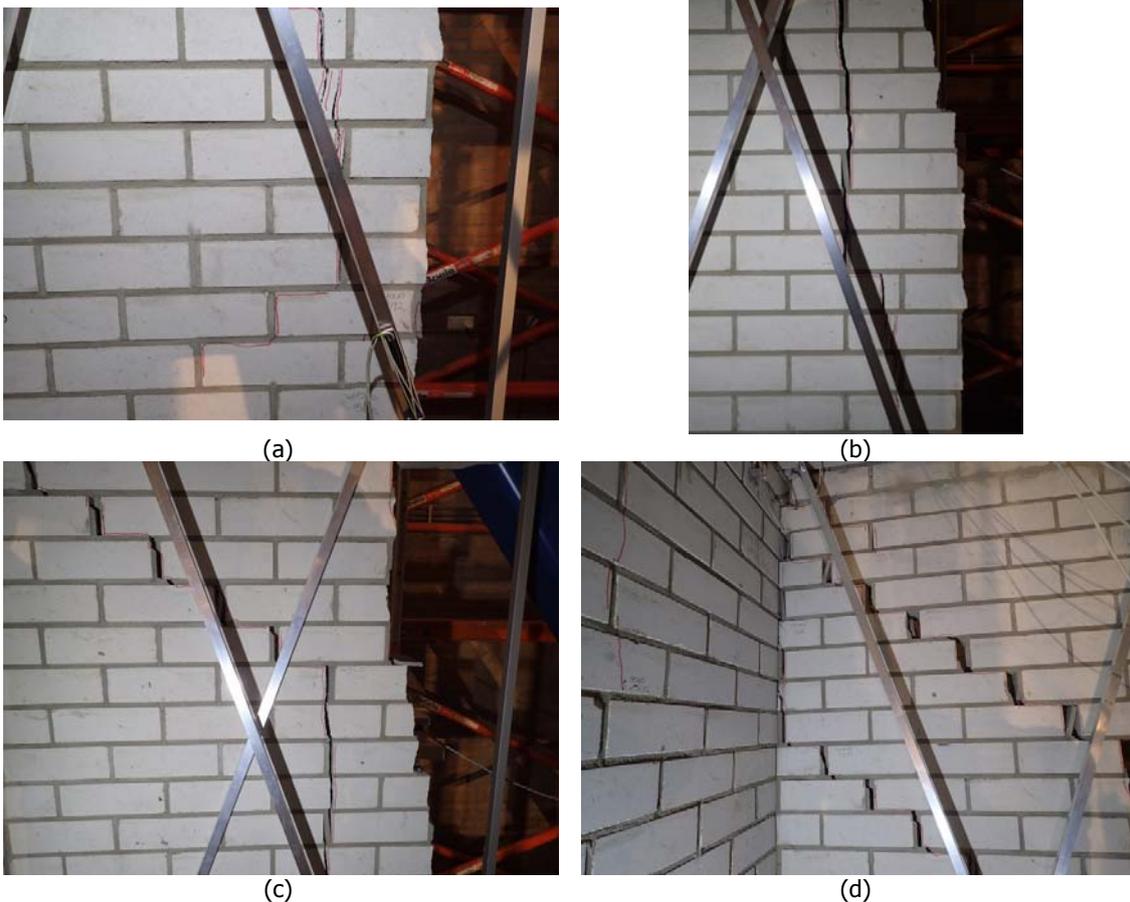
Figure E.32 – Post-peak phase **cycle 19** – ground floor – Vertical/diagonal crack on pier P3 at the ground floor: (a) Lower part (51_C19-GF-P3); (b) Mid-lower part (52_C19-GF-P3); (c) Mid-upper part (53_C19-GF-P3); (d) Upper part (54_C19-GF-P3). Compare with Figure E.28.

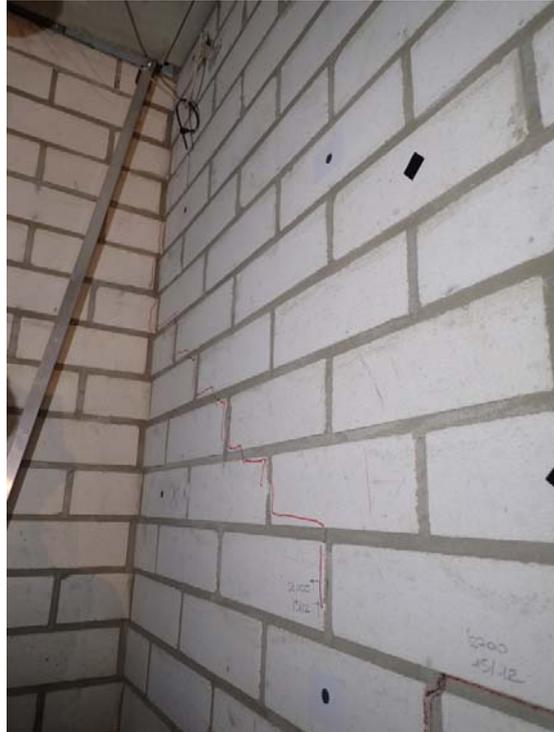
Figure E.33 – Post-peak phase cycle 19 – ground floor: Crack on east wall at the side with pier P4 at the ground floor (55_C19-GF-WP4).

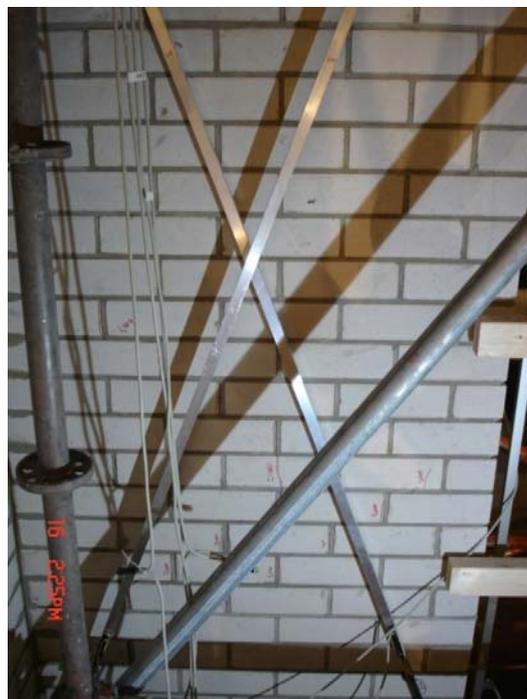
Figure E.34 – Post-peak phase cycle 19 – first floor: Crack pier P3 at the first floor (56_C19-FF-P3).

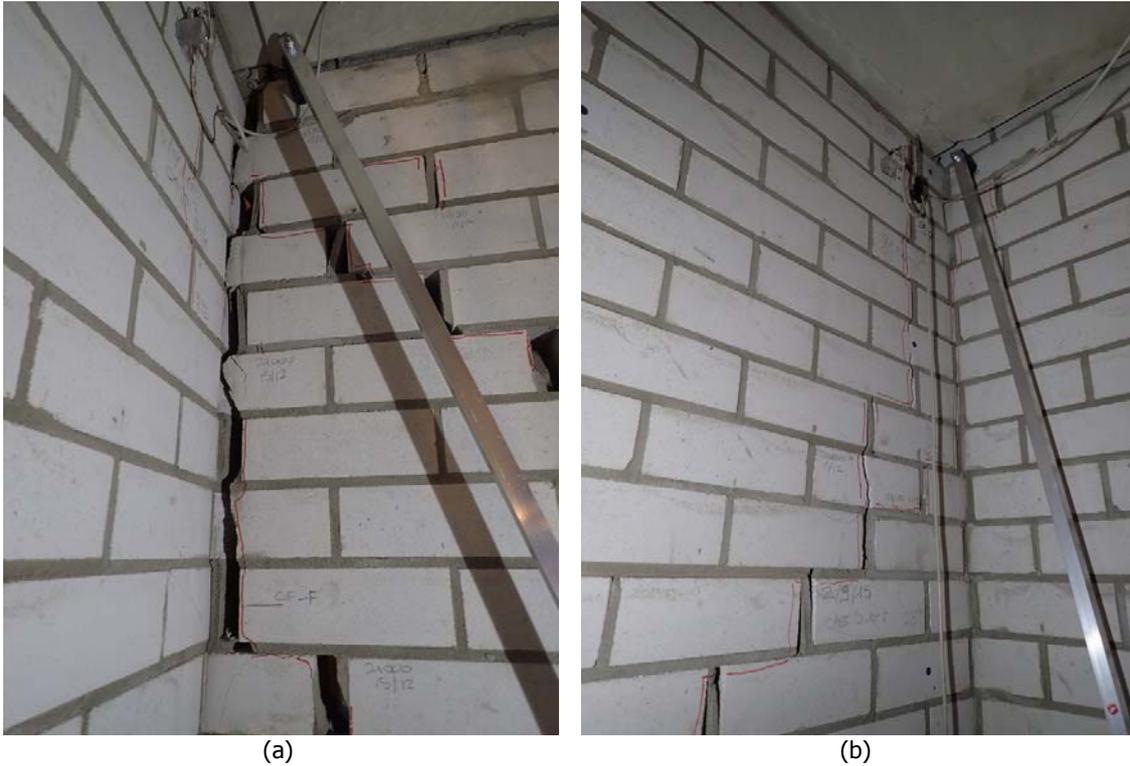
Figure E.39 – Post-peak phase **cycle 20**: (a) Crack between west wall and pier P3 (64_C20-GF-WP3); (b) crack between east wall and pier P2 (65_C20-GF-EP2).

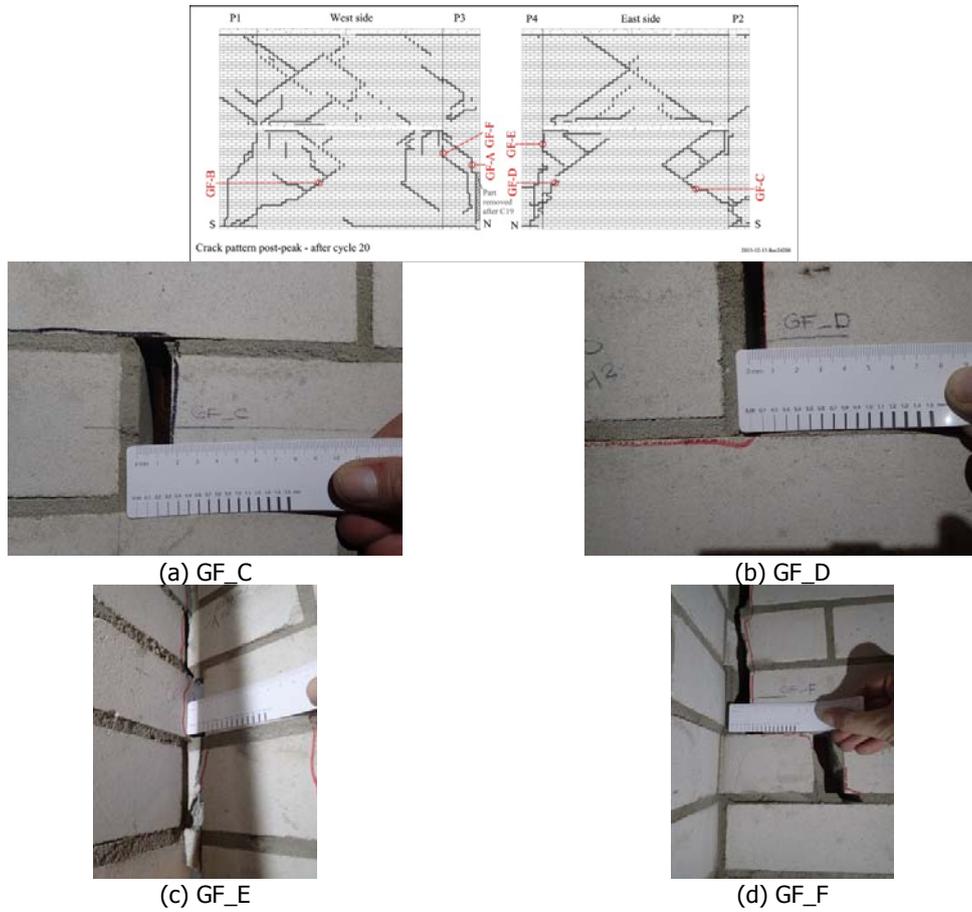
Figure E.40 – Post-peak phase cycle 20 – Crack width. Compare with Figure E.35.

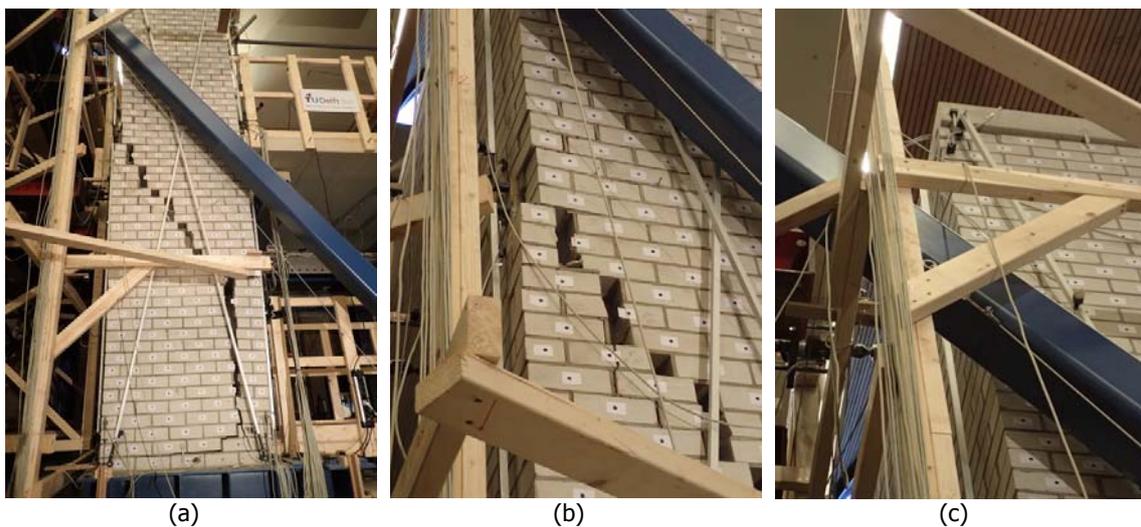
Figure E.41 – Post-peak phase cycle 21 – Vertical/diagonal crack on pier P1 (outside): (a) Overview (66_C21-P1); (b) Detail at the first floor slab (67_C21-GF-P1); (c) Detail at the second floor slab (68_C21-FF-P1). Compare with Figure E.36.

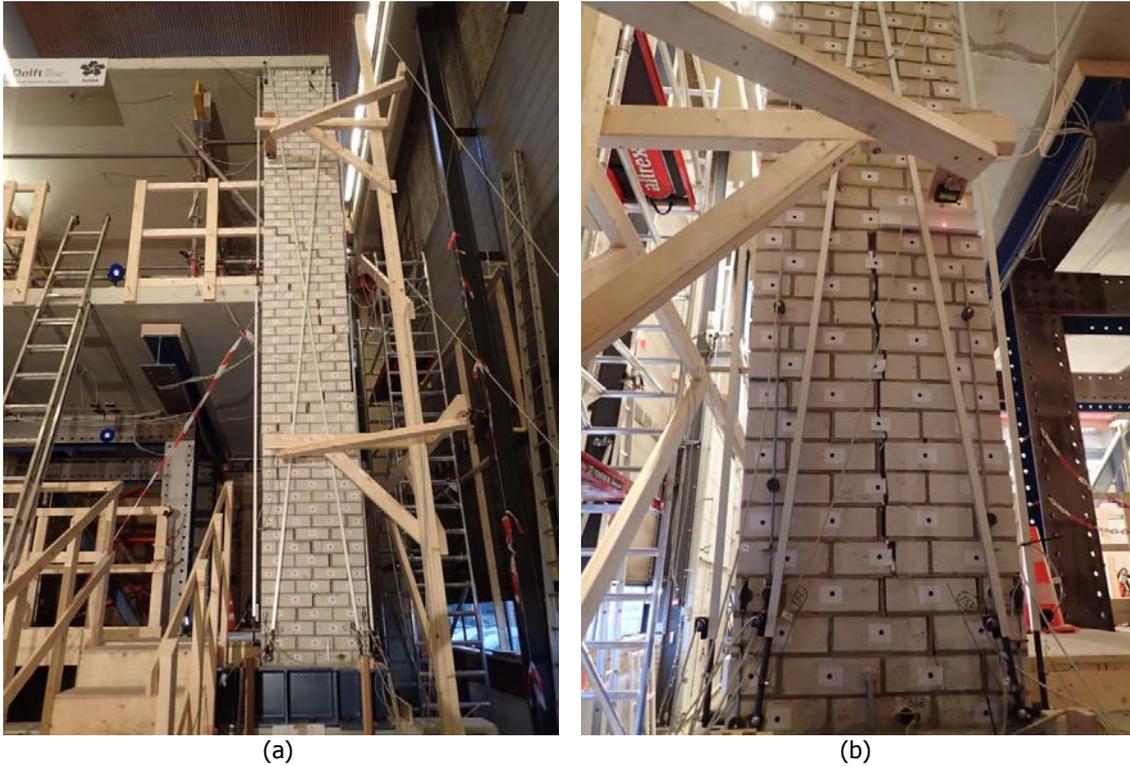
Figure E.42 – Post-peak phase **cycle 21**: (a) Cracks on pier P2 (69_C21-P2); (b) Crack on pier P4 (70_C20-P4). Compare with Figure E.37.

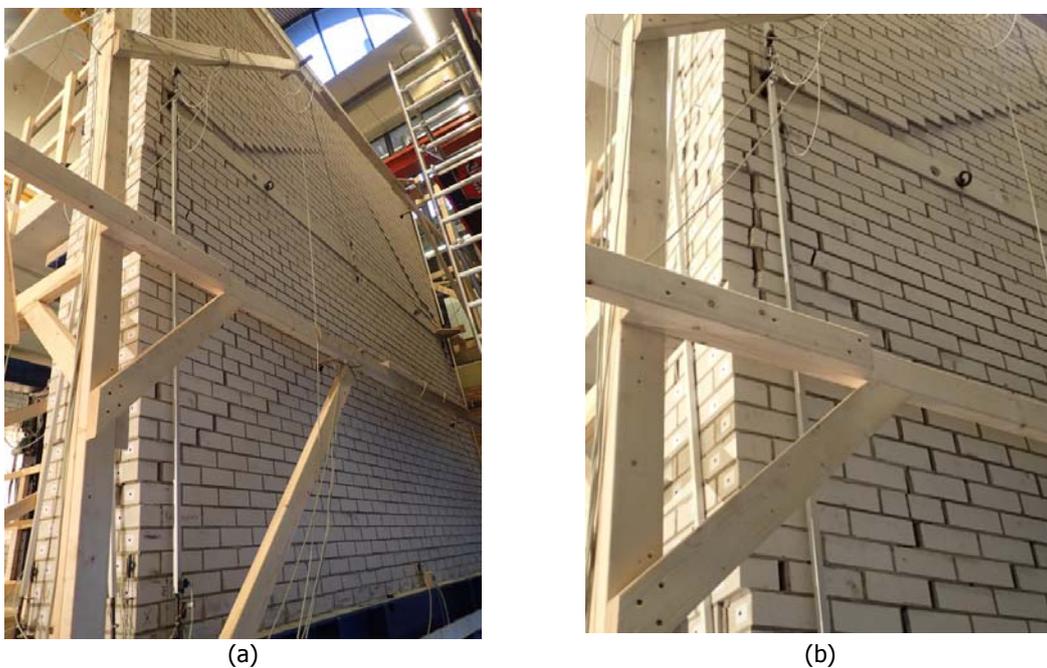
Figure E.43 – Post-peak phase **cycle 21**: (a) Cracks on east wall (71_C21-E); (b) Detail of figure (a) (72_C21-E).
