Demonstration of the Structural Resiliency of Damaged Sentryglas Laminated Heat Strengthened Glass Fins in Full Scale Testing

Abstract: A unique structural design was made for the glass façade of the Co-Creation Center building in Delft. The roof is completely carried by the glass fins. The fins are laterally stabilized by being included in the triple glazed façade. To certify the safety of the design full scale tests on the fins were done at Delft University of Technology. Due to a transportation accident the fins were damaged at one end. This allowed an additional study into the effect of this pre-test damage on the residual compressive stresses induced by the tempering. It was found that the residual stresses were not significantly affected by the damage. During the compression tests no cracks developed at the damaged ends. A load of 200 kN, more than double the maximum design load did not produce failure in the prototypes. After intentionally seriously damaging all plies of the fins, the fins could still carry the 200 kN load for 30 min without buckling or other failures being noted. Measurement of the residual stress in the outer plies of the fins after damage showed that suf

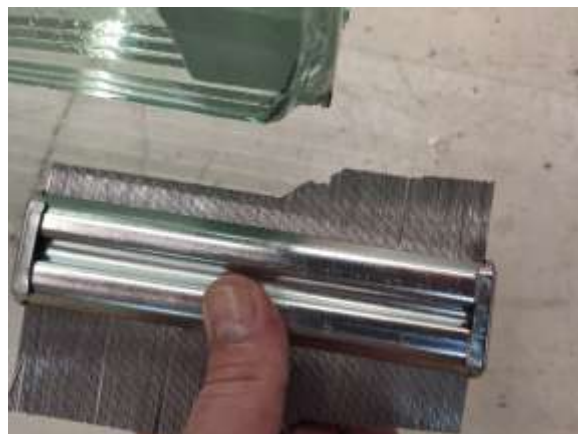
Unfortunately the glass fins were damaged at one end when they were moved into the laboratory by staff not specifically trained to handle glass. The damage is shown in Fig. 4. The damage was measured using a contour gauge as shown in Fig. 5 to determine the depth of the damage. Essentially at the bottom corners of the specimens a triangular bite was taken out of the outer ply over a length of some 24 mm as shown in Fig. 5. This

Fig. 5: Measurement of damage using a contour gauge

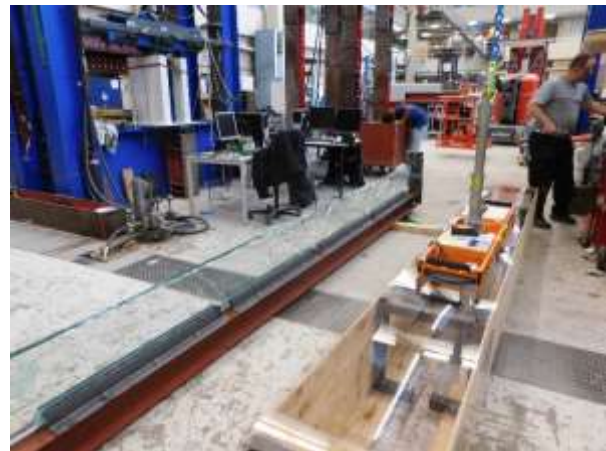
Fig. 6: Damaged specimen siliconed into steel profile which simulates the lateral support of the façade glazing in the real structure

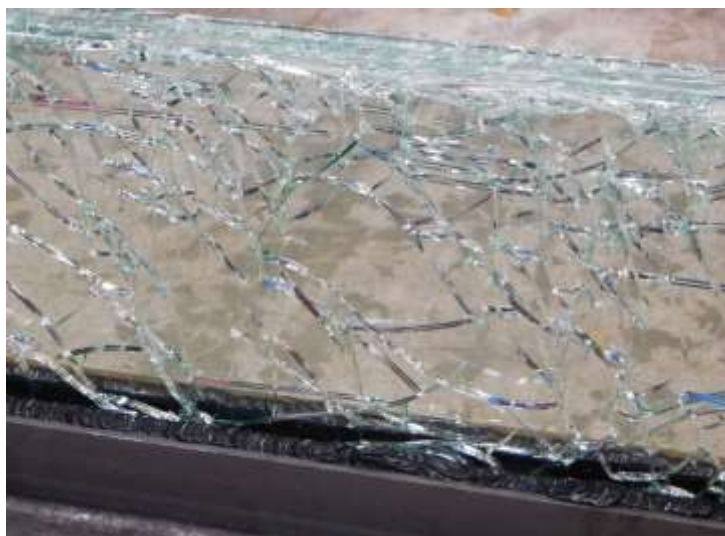
The damage did not result in short term creep, as is shown in Fig. 12, as holding the load constant did not result in additional displacement. Considering the significant levels of damage inflicted on the specimens, as shown in Fig. 13, this result is significant as the interlayer plays a significant role in transmitting forces in damaged specimen.

Fig. 13: Part of specimen 2 after having 3 plies damaged. Note the overlapping cracks in successive plies

- The use of heat strengthened glass which breaks into large fragments. These large fragments still maintain a level of compressive surface pre-stress after cracking of the glass and form an overlapping pattern allowing for stress transfer. In essence the cracking of the heat strengthened monolithic fin, turns it into a segmented spliced overlapping fin. As shown by (Trösch, 2015), this can be almost as efficient structurally as monolithic elements with proper lamination
- The use of Sentryglass foil as the laminating agent. The stiffer and stronger Sentryglass foil keeps the glass fragments together very well and the higher stiffness helps prevent buckling
