## Investigation of the formation of corrugation-induced rail squats based on extensive field monitoring

Deng, Xiangyun; Qian, Zhiwei; Li, Zili; Dollevoet, Rolf

Published in International Journal of Fatigue

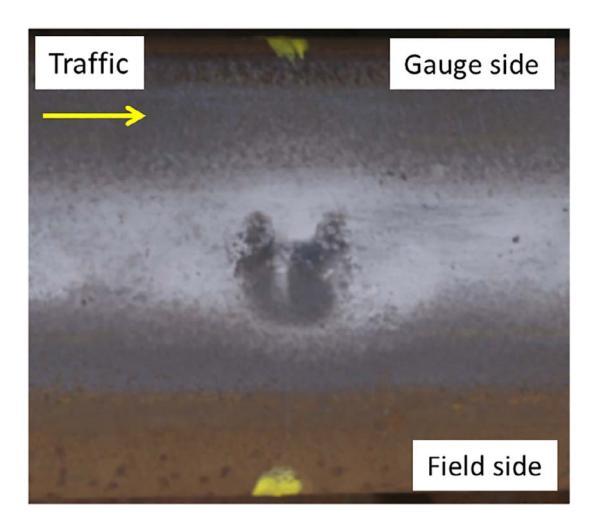
Fig. 1. A typical squat in a two-lung shape with cracks at the monitored site.

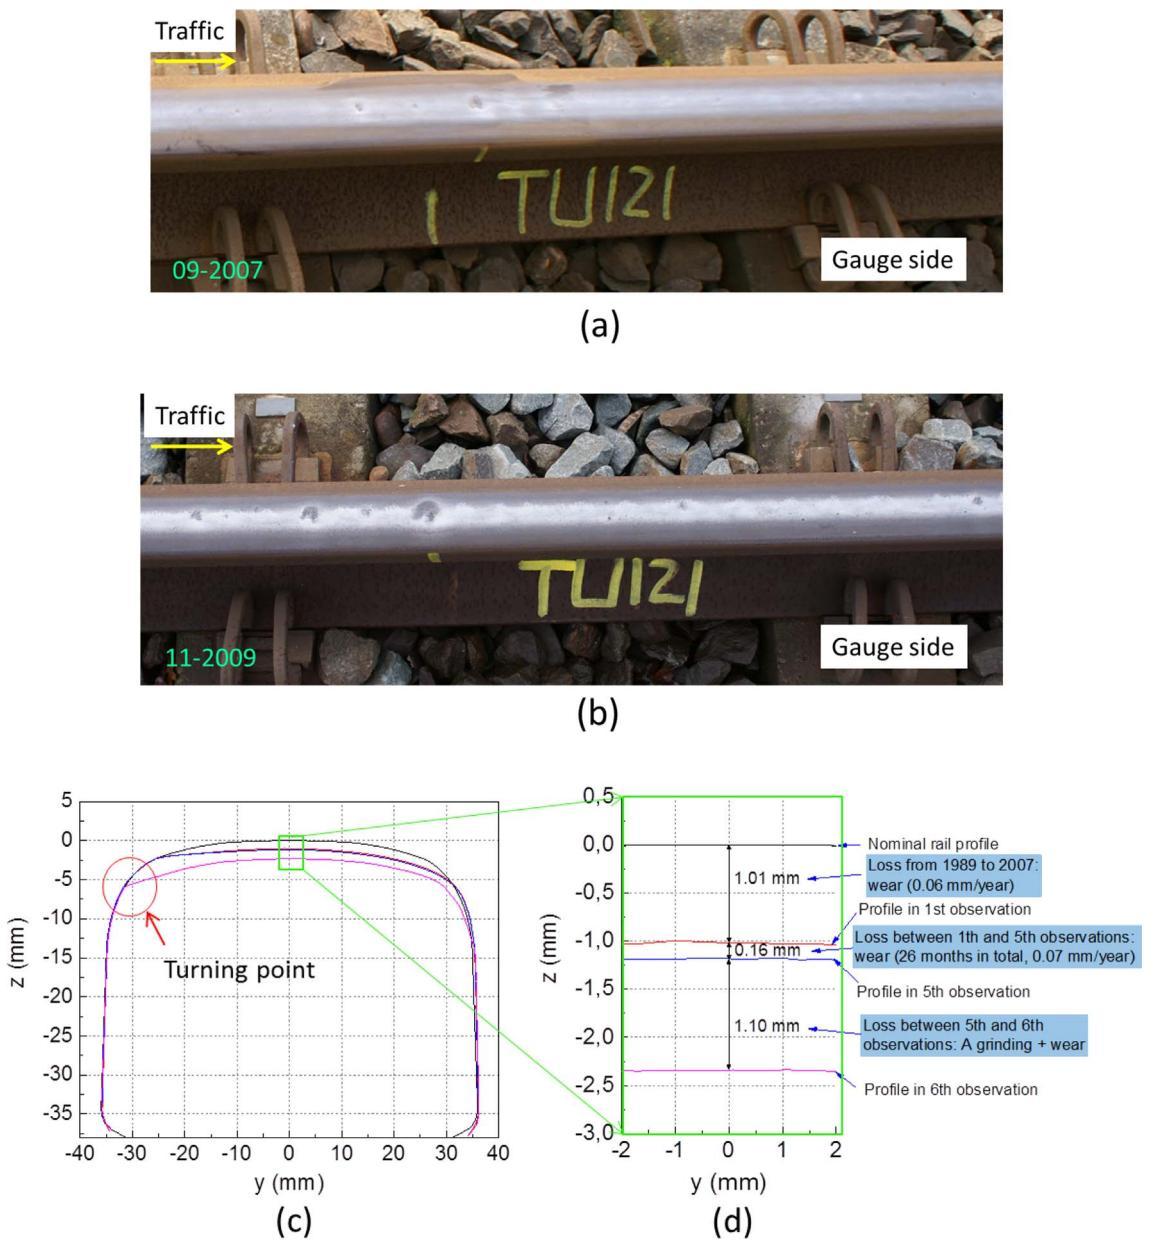
The section of track was selected for monitoring because of the following reasons. First, some corrugation and resulting squats of various severities were observed at the beginning of the monitoring, as shown in Fig. 3(a). In view of the active nature of corrugation-induced squats, it was predictable where new squats would initiate and grow from the developing corrugation. This makes a fruitful selection of monitoring locations possible. The second reason is that there were no visible defects or residual cracks in the rail surface other than the intended corrugation and squats. The third reason is that the rails had not been ground. To prove that any grinding was not performed before the start of the monitoring, the rail profiles measured during the monitoring at a number of defect-free locations were analyzed. It was found that the average rail head loss due to the natural wear was 0.07 mm/ year between the first and fifth observations, and the average rail head height loss was 0.06 mm/year between 1989 and 2007. The height loss of 0.06 mm/year would have not been possible if any corrective grinding had taken place. This was further confirmed by looking at the measured profiles, as shown in Fig. 3(c) and (d), where the measured profiles are aligned with the nominal profile (in black) on the field side (the left side). The measurements show good repeatability. The profile (in magenta) measured immediately after a corrective grinding at the sixth observation is as smooth as the other profiles on the gauge side. In contrast, the ground profile has a larger rail head height loss (see Fig. 3(d)) and a sharp turning point at the field side (indicated in Fig. 3(c)), apparently it is different from other profiles. If there was any

Fig. 3. Typical corrugation with several squats of various severities adjacent to a monitored squat and measured rail profiles for analysis of grinding: (a) in the first observation, corrugation and some squats already existed adjacent to a monitored squat; (b) in the fifth observation, the corrugation and squats in (a) had become severe and new squats of different severity appeared; (c) measured rail profiles by MiniProf in the vicinity of one squat: from top to down they were the nominal (black) and those measured in the first (red), fifth (blue) and sixth (magenta) observations, respectively; (d) zoom-in of (c) in the middle of the profiles. (For interpretation of the references to color in this figure legend, the reader is referred to the web version of this article.)

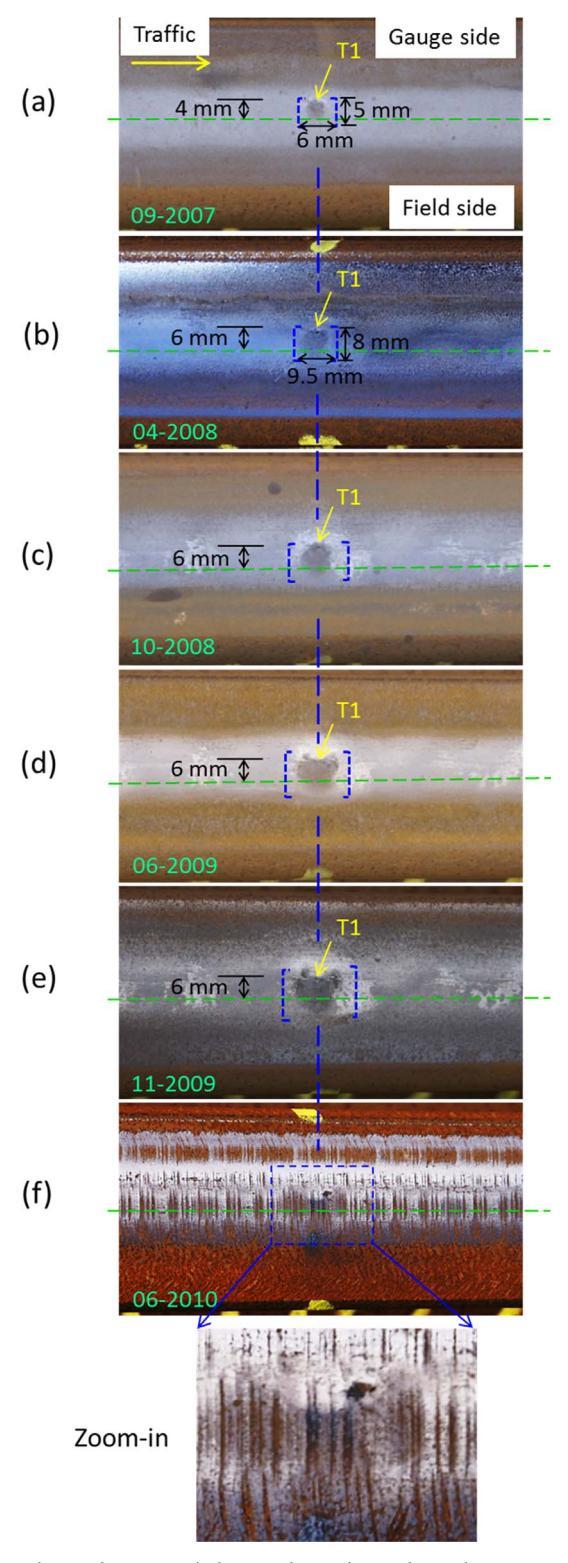
The series of photographs in Fig. 4, which were obtained during the first six field observations, show the evolution of a squat. The changes in size and in the bright running band near the squat can be seen. At the time of the first observation, the squat was a small black depression in an approximately elliptical shape with a size of approximately 5 mm in the lateral direction and 6 mm in the traffic direction. The position of T1 is approximately 4 mm from the rail centerline. This black depression did not have visible surface cracks. It was growing in size until the fifth observation, shortly before the rail grinding. The squat eventually evolved into a kidney-like shape with its concave part resembling a shallow U, as seen in Fig. 4(d) and (e). As will be shown later, this shallow U developed into a full U that was the primary surface crack of the squats. Thus, this concave part is referred to hereafter as U-shaped. At the time of the fifth observation, the running band at the squat was widened on the gauge side, as indicated by the shining part above point T1, indicating that the depression broadened the running band.

Although it was hard to confirm the presence of surface macrocracks by visual inspection during the first five observations, eddy current tests showed that a crack began to appear as of the second observation. At this time, T1 of the depression was approximately 6 mm from the rail centerline, and the dimension of the depression was approximately 8 mm in the lateral direction and 9.5 mm in the traffic direction. These results indicate that cracks initiated when the black depression grew to a certain size. This finding was confirmed by the observations of another 5 squats of the 30 selected squats, which did not have macrocracks in the beginning, but cracks were observed at the sixth observation. This finding is in line with the critical size of squat initiation that was numerically derived in [13] by comparing the maximal von Mises stress with tensile strength, and the material was also R260Mn.

After the crack had appeared, the shape of the depression began to change into a kidney-like shape, and the location of T1 remained approximately 6 mm from the rail centerline. Eddy current tests and ultrasonic tests showed that the crack continued to grow after their initiation. The phenomenon of crack growth with the fixed location of T1 relative to the rail center was observed with all the other monitored squats.

After the rail grinding to a depth of 1.1 mm, the black depression was removed, and a shallow U-shaped crack was exposed, as shown in Fig. 4(f). This observation shows that the crack had propagated into the rail deeper than 1.1 mm and that the depth of the black depression was less than 1.1 mm. This finding confirmed the presence of the cracks measured by the eddy current tests and ultrasonic tests. The removal of the black depression and the exposure of the residual cracks were also observed at the other monitored squats with cracks deeper than 1.1 mm.

**Fig. 4.** Evolution of a squat with the critical size of 8 mm for crack initiation and subsequent cracking (the dashed straight green line represents the rail centerline): (a)–(e) Before rail grinding to a depth of 1.1 mm; (f) after the rail grinding, revealing a shallow Ushaped crack, as seen in the zoom-in. (For interpretation of the references to color in this figure legend, the reader is referred to the web version of this article.)

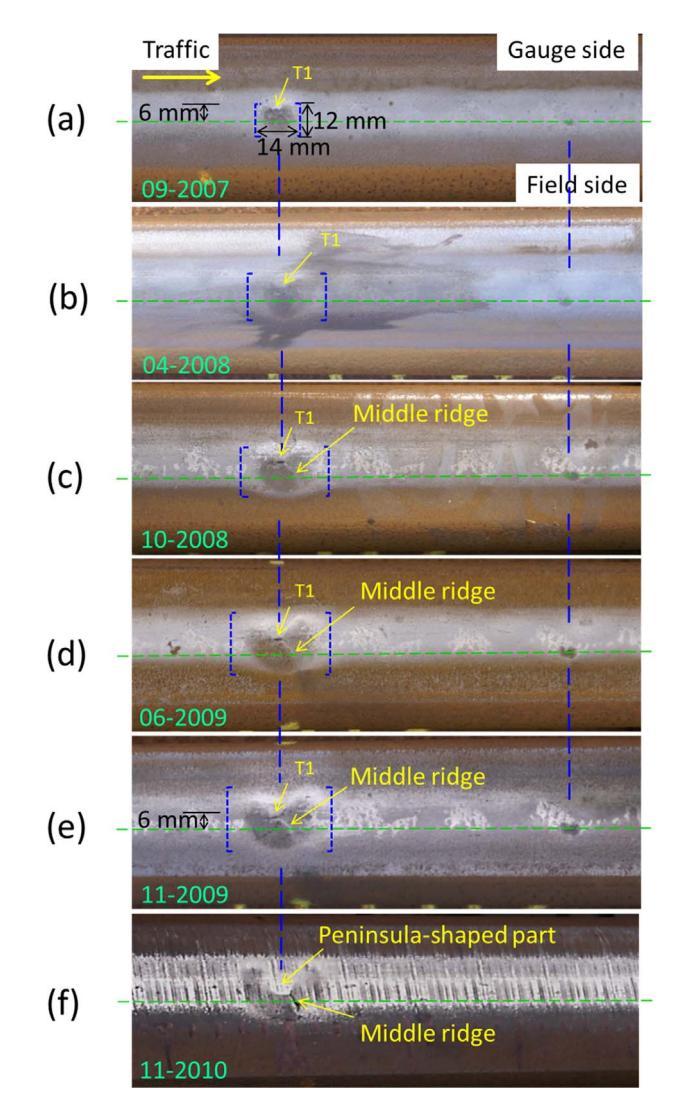
Fig. 5 illustrates the development process with another squat. The figure consists of six photographs from the first five consecutive observations before the rail grinding and from the seventh observation after the grinding; the photo from the sixth observation was not sufficiently clear. These photographs show that T1 was the bottom point of the U shape and that its position stayed fixed not only in the lateral direction, as demonstrated with Fig. 4, but also in the traffic direction. The latter concluded as follows: the rail head has a constant width of 72.2 mm. With this value, the sizes of the depressions and cracks were derived from the photos for this paper. In Fig. 5, there is, beside the squat, another small black spot. With the known rail head width, the

distance between the small black spot and point T1 is determined, and it can be seen in Fig. 5 that T1 remained at a constant distance from the small black spot.

With T1 aligned according to the blue dashed lines, Fig. 5 shows that the squat grew longitudinally in both the traffic and opposite-

**Fig. 5.** Confirmation of the crack initiation point according to the relative positions of the black spot and point T1 (the green line represents the rail centerline): (a)–(e) Before rail grinding; (f) after rail grinding to a depth of 1.1 mm. (For interpretation of the references to color in this figure legend, the reader is referred to the web version of this article.)

traffic directions as well as laterally toward the gauge side and field side simultaneously. This growth pattern was observed at all 21 of the moderate and severe squats. The squat in Fig. 5 first grew into a kidney-like shape with the concave part of the kidney bounded by a U-shaped crack, and then it gradually evolved into a two-lung shape with a middle ridge (Fig. 5(c)–(f)). After the grinding, the part bounded by the full U-shaped crack took on a peninsula-like shape, as seen in Fig. 5(f). A more detailed discussion about the formation of the middle ridge and the peninsula-shaped part is in Sections 3.4.1 and 3.4.2. Notably, the typical two-lung shape and the peninsula-like shape were not clearly observable at the squat in Fig. 4 because the squat was still in a relatively early stage; the crack and geometry had not yet grown into the typical shape.

The very small black spot in Fig. 5(a), barely visible to the naked eye, was growing before the grinding. At the fifth observation, it turned into an obvious surface depression; its size was already comparable to that of Fig. 4(a), and it should have been able to develop into a squat if not removed. The initiation and growth of black spots are, in the very beginning, driven by the corrugation. At the same time, the black spots are rail surface irregularities that excite (additional) dynamic contact force; the larger the black spot, the larger the dynamic force, creating a positive feedback loop that promotes the continuous and accelerates

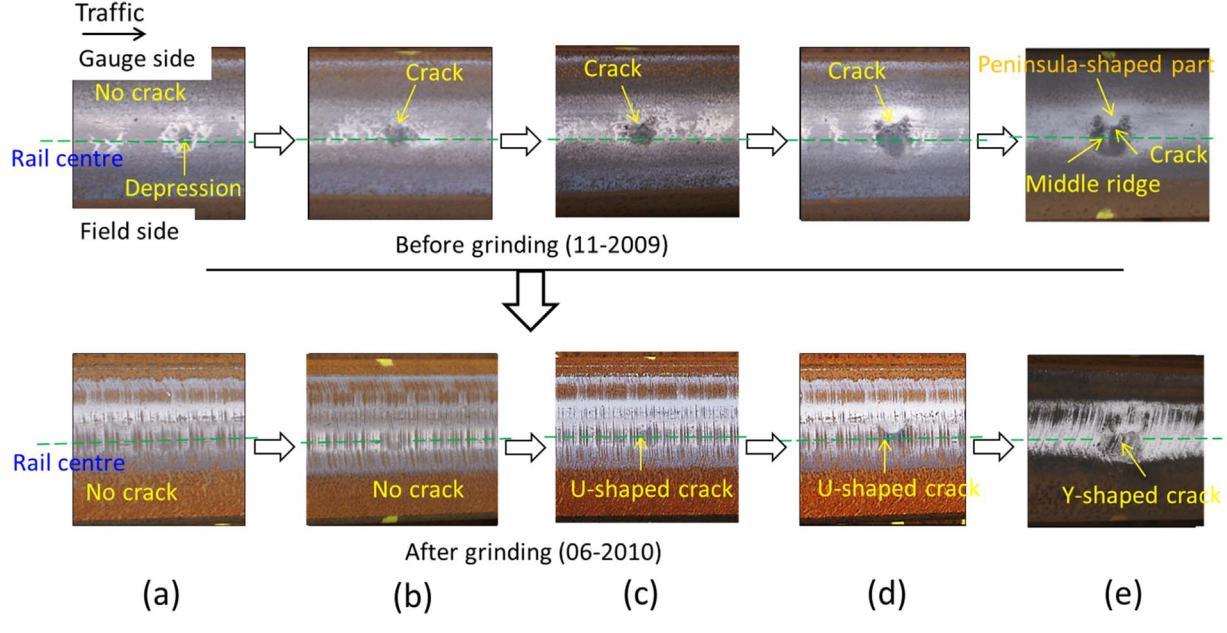
Fig. 6. Different squats at various severities: earlier stages to later stages.

In (a), the black depression was still significantly smaller than the critical size of 8 mm; no crack was observed in the rail surface either before or after the rail grinding, as seen in Fig. 6(a). It is reasonable to assume that the macrocrack had not yet initiated at this time. In (b), the size of the depression (10 mm (in the lateral direction)  $\times$  14 mm (in the traffic direction)) was larger than the critical size of crack initiation; a small surface primary crack became visible at this stage prior to the rail

grinding (see the arrow in Fig. 6(b)). After the grinding, the crack was removed. This observation suggested that the crack was shallower than 1.1 mm. In (c) and (d), the squats were in a kidney-like shape before the grinding, and a U-shaped crack became visible after the grinding. The length of the U-shaped crack continued to grow from the bottom along the U in both directions, i.e., in the traffic and the opposite-traffic directions, with the evolution of the squat. These observations confirm that the bottom of the U-shaped cracks was the initiation point of the cracks in or near the rail surface on the gauge side of the depression. The point of the crack initiation corresponded to position T1 in Figs. 4 and 5. After initiation, the crack propagated along the U shape, as well as into the rail toward the field side, as discussed in Sections 3.3 and 3.4. Moreover, the crack grew more rapidly in the traffic direction than in the opposite-traffic direction; see the discussion in Section 4.3. In (e), the squats reached a more severe stage: they evolved into the two-lung shape with a middle ridge, and an I-shaped crack appeared at this ridge after the grinding. More details about the I-shaped crack are provided in Section 3.4.

was not very clearly visible, as shown in Fig. 6(a), the convex part of the kidney-shaped depression was elliptical, as seem in Fig. 6(b)–(d), and this elliptical shape most likely originated from the elliptical contact area between the wheel tread and the rail crown. The elliptical shape is more clearly visible in Fig. 4, especially in Fig. 4(a) and (b). Therefore, the small black depression in (a) should have been approximately elliptical in shape.

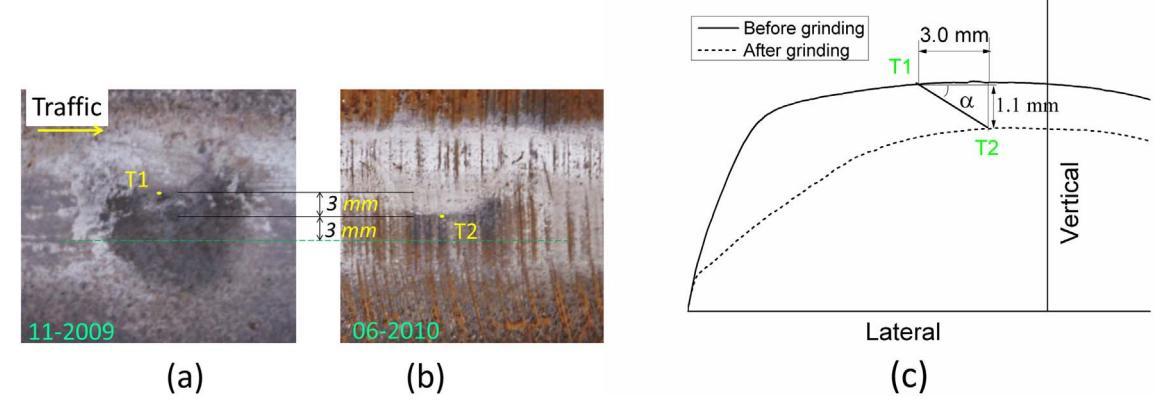
Fig. 7. Determination of the cracking angle relative to the rail surface in the vertical-lateral cross-section (the green line represents the rail centerline; T1 and T2 denote the bottom of the U-shaped crack): (a) Before rail grinding; (b) after rail grinding to a depth of 1.1 mm; (c) cross-sectional profiles of the rail. (For interpretation of the references to color in this figure legend, the reader is referred to the web version of this article.)

A moderate squat with a U-shaped surface crack was examined to determine its cracking angle in the vertical-lateral cross-section, which passes through the bottom of the U shape, as shown in Fig. 7. In Fig. 7(a), bottom point T1 of the crack was the crack initiation point, and it was located on the gauge side at a distance of 6 mm from the rail centerline. After the rail grinding to a depth of 1.1 mm, the bottom of U-shaped crack T2 shifted 3 mm toward the field side, as shown in Fig. 7(b). The cracking angle  $\alpha$  was then approximately 20°, as illustrated in Fig. 7(c), indicating that the surface crack propagated into the rail at an angle of approximately 20° toward the field side. This finding agrees with the findings in the computed tomography investigation in [20].

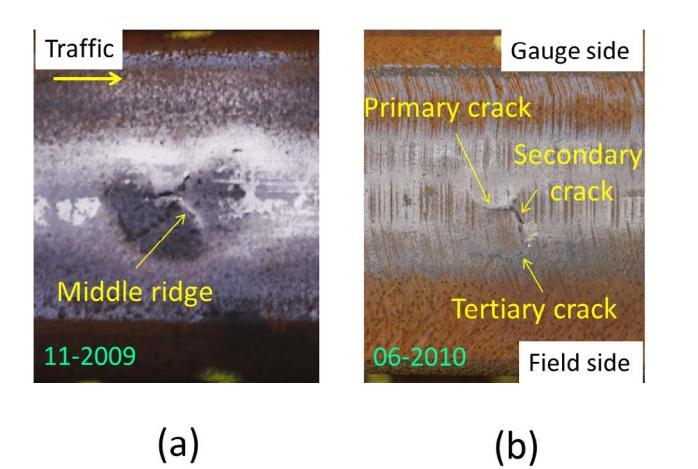
**Fig. 9.** A typical two-lung-shaped squat with a Y-shaped crack and a semi-circular tertiary crack (the same squat as in Fig. 5): (a) Before rail grinding; (b) after rail grinding to a depth of 1.1 mm.

The two impacts at the peninsula-shaped part punched and pushed the depressed rail material so that a "ridge" was formed in the middle of the black depression, as indicated in Fig. 9(a). This ridge is clearly shown on the surface in Figs. 1, 5(c)-(f), 6(e), 9, 10 and 15. Cracks can develop at the middle ridge, as seen in Figs. 5(f), 6(e) and 8-10, especially in severe squats. This crack is the secondary I-shaped crack. The I-shaped crack is also shown in the 3D geometry of the crack in Fig. 8(b).

When the U-shaped crack and I-shaped crack occur simultaneously, they together become a Y-shaped crack, as shown in Figs. 9 and 10. The Y divides the elliptical shape into the shape of two lungs, which occurs with the typical shape of severe squats.

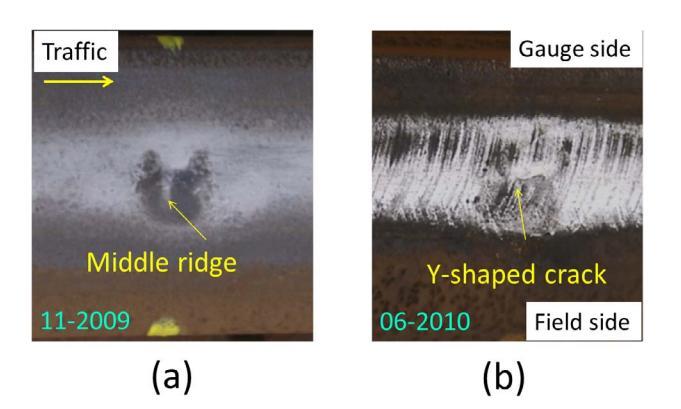
**Fig. 10.** Another typical two-lung-shaped squat with a Y-shaped crack (the same squat as in Fig. 6(e)): (a) Before rail grinding; (b) after rail grinding to a depth of 1.1 mm.

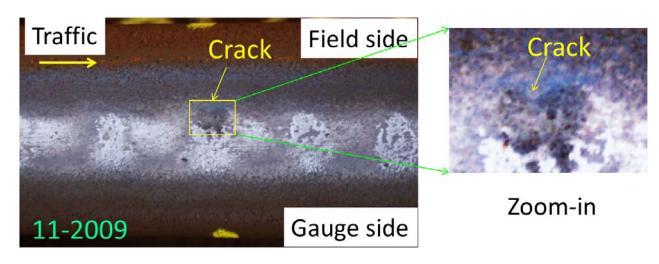
Fig. 14. A squat with a primary crack on the field side edge of the black depression.

When the rail inclination is at the nominal value of 1/40, as shown in Fig. 13(a), the presence of the black depression shifts the main contact area to the gauge side. This shift is determined by the contact geometry, namely the profiles of the wheel and the rail, as illustrated in Fig. 12(b) and, especially, Fig. 12(e): the wheel-rail profiles are more conforming to each other on the gauge side than on the field side so that, when there is a depression, the main contact area is usually on the gauge side. As a result, the crack tends to initiate and propagate into a U shape on the gauge side edge of the black depression. This scenario in which the location of the primary crack is on the gauge side (schematically shown in Fig. 12) occurs at most of the monitored squats, such as those squats shown in Figs. 1, 3–10, 15 and 17, the only exception is the case shown in Fig. 14 corresponding to the situation in Fig. 13(c).

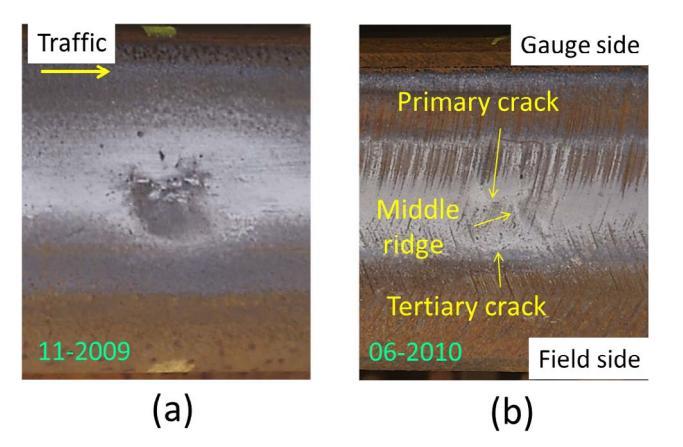
**Fig. 15.** A squat with two cracks, i.e., a primary crack and a tertiary crack: (a) Before rail grinding; (b) after rail grinding to a depth of 1.1 mm.

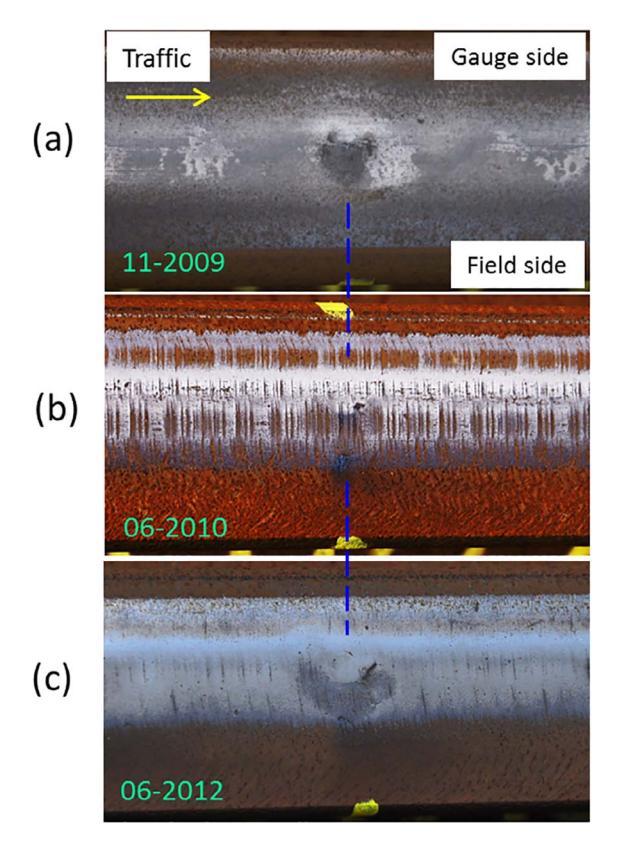
**Fig. 17.** Squat (the same as in Fig. 4) development after rail grinding: (a) Fifth observation before rail grinding; (b) sixth observation after grinding to a depth of 1.1 mm; (c) tenth observation after another grinding of approximately 0.3 mm between the seventh and eighth observations.

During the ten continual observations, rail grinding to a depth of 1.1 mm was performed after the fifth observation. Some of the squat cracks had already propagated more than 1.1 mm into the rails; therefore, the rail grinding did not remove the cracks completely. The remaining cracks grew further and developed into a new squat, as shown in Fig. 17.
