## Restoration of the Interior

van Thoor, M.-T. (2019). Restoration of the Interior. In M.-T. van Thoor (Ed.), *Colour, Form and Space: Rietveld Schröder House Challenging the Future* (pp. 34-53). Delft University of Technology.

# 3 / RESTORATION OF THE INTERIOR

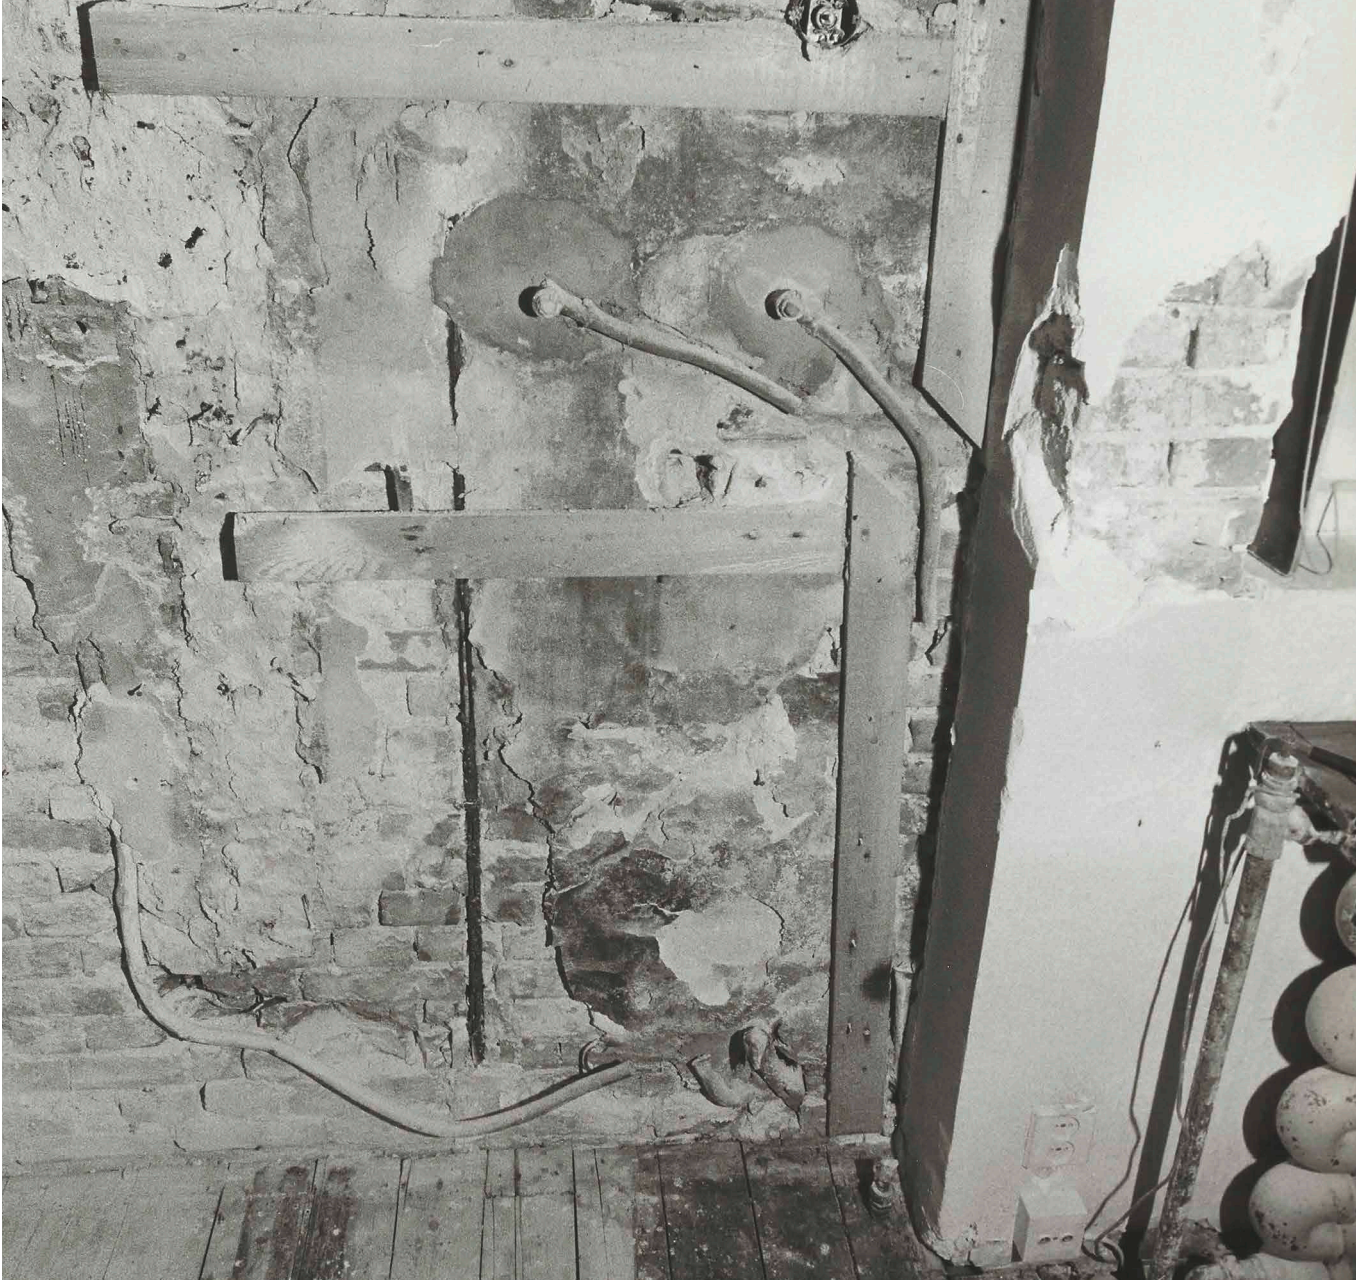
FIG. 3.1 The dismantling of wall, floors and ceiling yielded a lot of information about pipes, connection points and the attachment of furniture

The survey of the now stripped-back house yielded a lot of new information [FIG. 3.1].<sup>21</sup> For example, pencilled lines and painted and stained areas were discovered on the floors, which provided insight into the division of the floor surface and the position and size of the beds [FIG. 3.2]. Holes in the walls indicated where cupboards and other items of furniture had been fixed to the walls. Mulder also recovered original parts of the former kitchen. And during the inspection of the electrical services, a 'strangely insulated hot water system' was discovered under the floor.

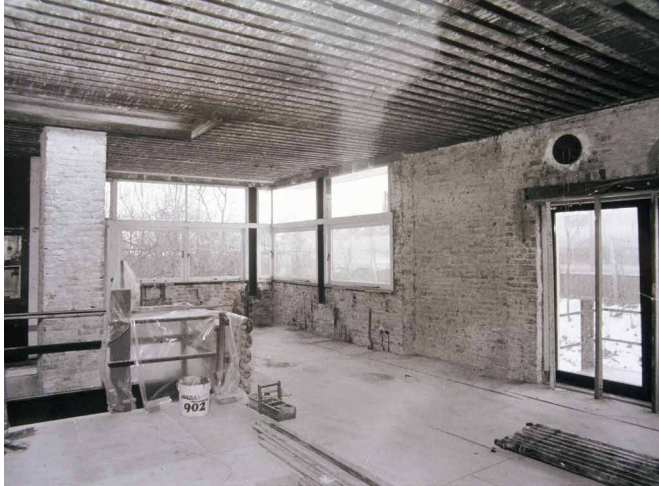
FIG. 3.5 The upper floor of the Rietveld Schröder House in dismantled state

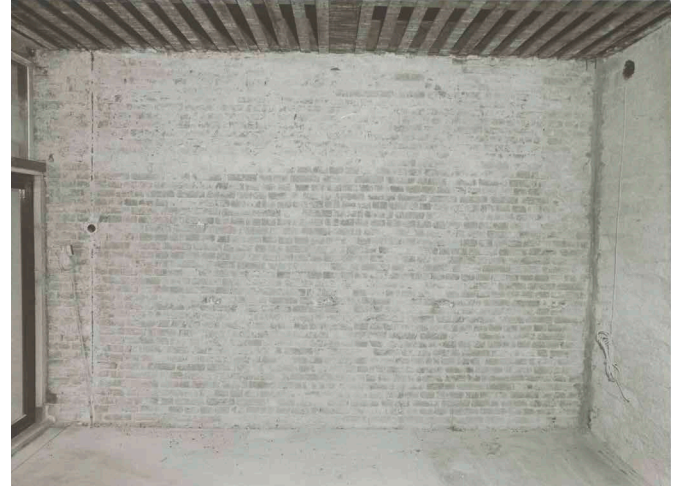
FIG. 3.6 Bare brick wall and stripped ceiling

Before the walls were replastered, the cracks in the brickwork were, like those in the exterior, filled with synthetic mortar. The new metal lath ceiling was suspended from the joists using a (floating) steel network in order to minimize the chance of cracks.<sup>27</sup> The plastering was carried out by the firm of H. van de Kant Afbouwbedrijf Zeist B.V. H. van de Kant recalled that the existing plaster had to be carefully removed and placed in bags in plastic trays, sorted according to wall area and colour. This enabled Mulder to carefully examine the plaster and layers of paint on top of it.<sup>28</sup> After that examination the old plaster was carried away and destroyed. Although the abovementioned memos from 1984 and 1985 refer to a specific plaster mix, Mulder and Van de Kant stated, when asked, that the exact proportions of cement, sand and lime were decided on site. Ultimately, it was the plasterer who determined this, just as in Rietveld's day. After applying the plaster, the plasterers had to sand the base coat 'with jute on a wooden board', to achieve the same effect as under Rietveld. It resulted in a smooth surface with here and there a stray grain of sand, but without any traces of repair work or restoration.

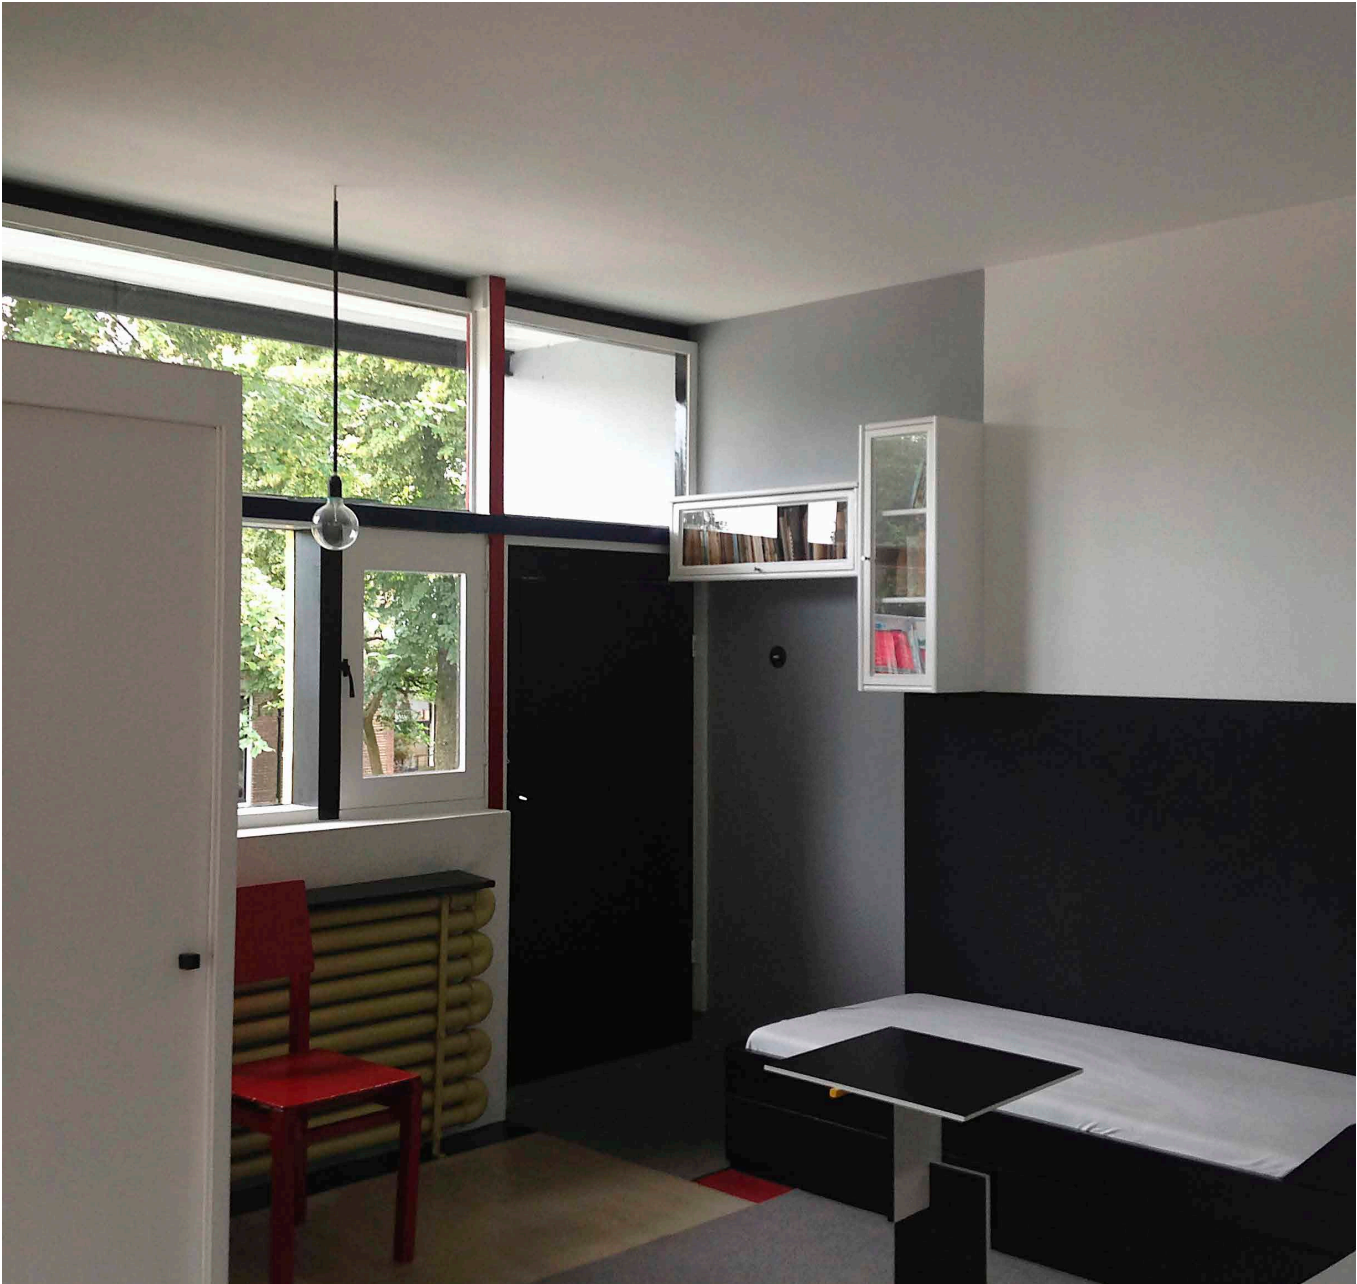
What mattered was the entire composition of colours and surfaces, which was supposed to restore the original spatial experience. During the removal of the plasterwork in the girls' bedroom, Mulder had discovered a grey that matched the compositional image of the space. The wall, which ran from inside to outside, had been white on the inside back when Mulder had devised the colour scheme of the exterior in the 1970s. When the painting of the interior was completed, however, it turned out that the grey on the inside of this wall was different from the grey of the exterior section. Because it was important for the overall image

FIG. 3.9 The wall in the girls' room runs from inside to outside, so B. Mulder had both the inner and outer sides of the wall painted in the same shade of grey, 2015

that the wall should be the same colour inside and out, Mulder had the exterior repainted [FIG. 3.9]. But it didn't end with the repainting of the balcony wall on Prins Hendriklaan; the entire composition of greys on the exterior had to be determined all over again.

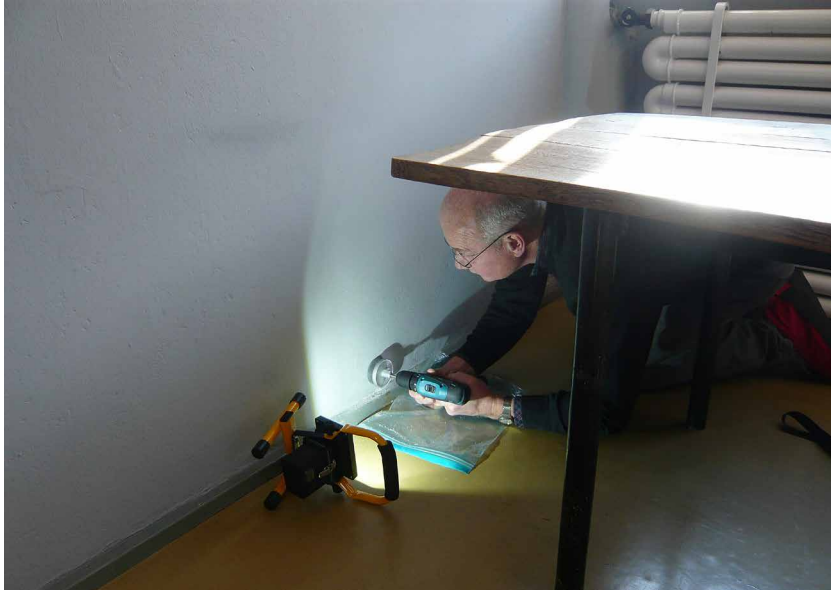
were asked to analyse the composition of the plaster and finish coats [FIG. 3.18/3.19]. On that occasion samples were also taken of the exterior; these have already been discussed in Chapter 1. Supplementing TNO's conclusions, the SRAL analysis confirmed that there were probably still traces of coloured layers of plaster in several places on the exterior, in two shades of grey. The visual composition and the properties of these layers seem to point in the direction of the stipulations in the Specifications for the Schröder House (1924).<sup>42</sup>

FIG. 3.18 SRAL specialist taking a sample from the east wall of the studio

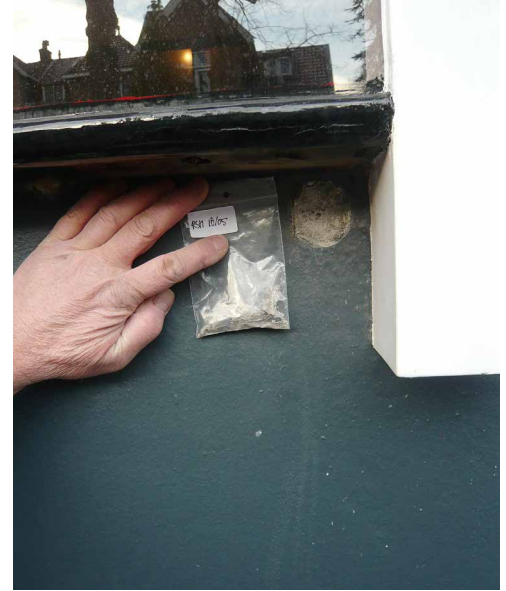
FIG. 3.19 Plaster sample from the wall below the studio window on Prins Hendriklaan

Samples were taken on the ground floor from the south wall of the study and from the east wall of the studio, and on the upper floor from the south wall of the girls' room. These provided insight into the possible differences in composition and finishing of the plasterwork, which turned out to be definitely not (upper floor), and possibly (ground floor) original. The TNO analysis produced one unexpected result: the two plaster samples proved to have the same stratigraphy, which would seem to indicate that both are instances of renovation plaster.
