Case Study: Wenduine, Belgium
Vulnerability of buildings on a coastal dike

CASE STUDY: WENDUINE, BELGIUM

VULNERABILITY OF BUILDINGS ON A COASTAL DIKE

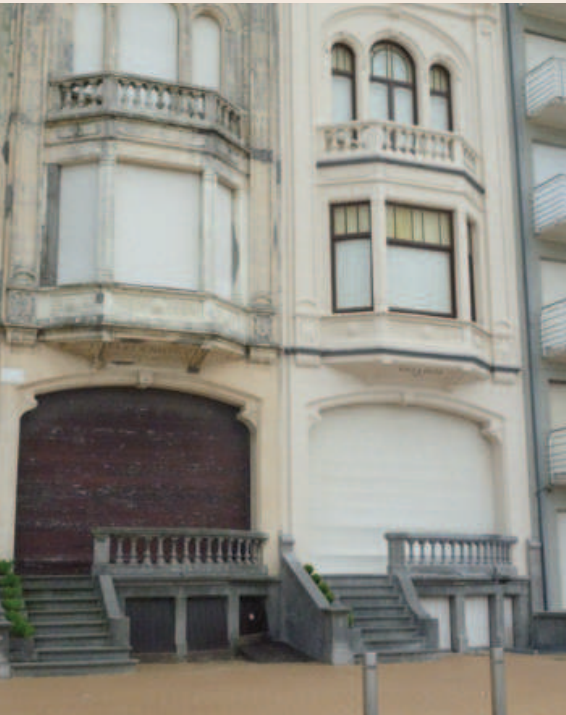
Figure 1 (left). Villa on coastal dike in Wenduine, Belgium (Photo courtesy Koen Trouw).

On coastal dikes in Belgium, many residential buildings are found. Most of the old buildings are masonry structures with two to three floors (Figure 1). The ground floors are always elevated (Figure 2), and the entrances of the basements are closed by shutters (Figure 3). The most modern buildings are concrete reinforcement structures with concrete piles/columns as foundations. These buildings are 5 to 9 floors high. Some of the ground floors are elevated, and some are used as cafe, restaurant or store. The ground floors are equipped with large glass windows and doors.
