## Induction healing of concrete reinforced by bitumen-coated steel fibres

9th International Conference on Fracture Mechanics of Concrete and Concrete Structures

Claudia Romero Rodríguez<sup>1,2,\*</sup>, Stefan Chaves Figueiredo<sup>2</sup>, Bernardino Chiaia<sup>1</sup>, Erik Schlangen<sup>2</sup>

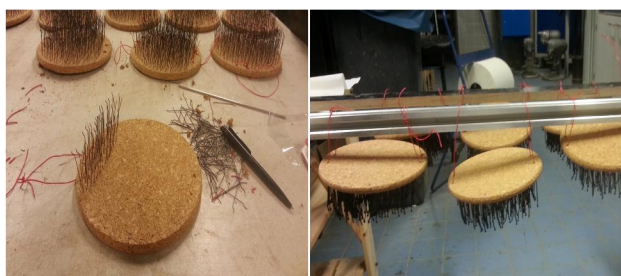
The steel fibres were embedded within one hooked extremity (10mm) in cork slabs. Kuwait 40/60 penetration class bitumen was heated in the oven at 160°C for 2 hours and poured into a basin inside which the slabs were sank and then hanged till bitumen got cold. The process can be seen in Figure 1.

Figure 1: Bitumen coating of steel fibres.

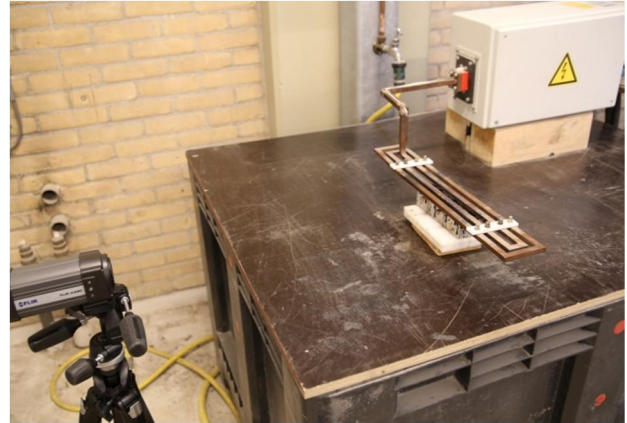
A full colour infrared camera FLIR, Type A320, was used to record temperature distribution on the samples surface (Figure 3). ThermaCAM™ Researcher Pro 2.10 was used for the treatment, processing and analysis of the recorded images.

Figure 3: Set-up of induction heating and infrared camera measurements.

Immediately after the introduction of cracking, the specimens were subjected to the healing intervention. An induction heating generator from HÜTTINGER Electronic Germany was used to heat the fibers inside the specimens; the cracked bottom was placed at 10mm from the coil. Frequency of the magnetic field was fixed at 70kHz and the capacity of the generator was 50kW. Such parameters have a tremendous influence on the heating rates [7], but they weren't studied within this research.

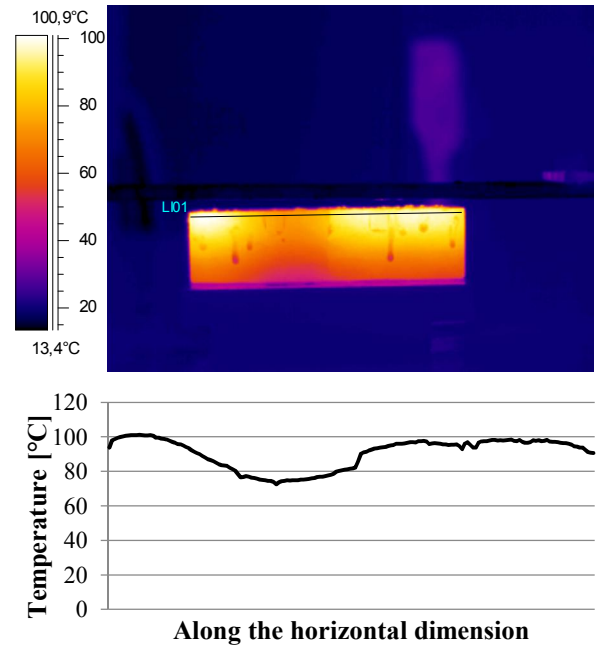
The average temperature of the line L01 near to the cracked bottom side of the beams (upside down in Figure 6) was measured during heating.

If the fibres distribution is not uniform, the heating speed won’t be constant along the line, as it can be observed in Figure 6. A uniform horizontal distribution of temperature should be expected because the distance from the coil to the line along which the measurement was made, remains constant and so the intensity of the alternating magnetic field. Each fibre develops Joule’s heat in direct proportion to it [7] but since the conductive filler is dispersed within the concrete matrix, the heat transfer from fibres towards concrete surface depends upon the fibres concentration near to it.

Figure 6: Thermal image of a b3fcon2 specimen after induction heating.

As expected, the temperature values went from higher to lower along the vertical dimension as a consequence of the increasing distance from the coil.

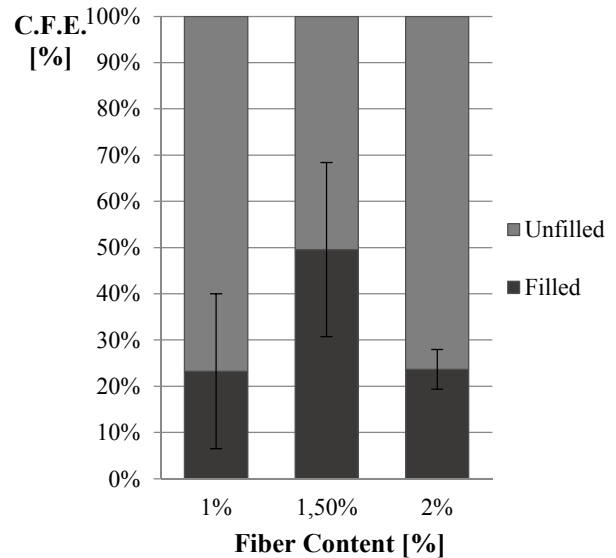
The histogram in Figure 9 shows the average Crack Filling Efficiency (C.F.E.) for b1fcon2, b2fcon2 and b3fcon2.

Figure 9: Average C.F.E. for b1fcon2, b2fcon2 and b3fcon2, corresponding to a fiber content of 1.0%, 1.5% and 2.0%, respectively.

Bitumen filling the crack occupied a 23% to 49.7% of the total area of the crack. The healed portion of the crack was approximately contained within the inferior half part of the specimen, located nearer to the coil. This is due to both the existence of higher temperatures and the larger width of the crack near to the coil. In farer zones the combination of high viscosity of bitumen due to a lower heating temperature and

On the other hand, an increment on the crack filling percentage of almost a 50% occurred when fibres amount was increased from 1.0% to 1.5%. In fact, fibres are randomly distributed in the concrete element and so the crack will be bridged by an increasing amount of fibres by increasing the fibre content, which implies a higher amount of bitumen flowing towards the crack. In spite of this, a decrease of the C.F.E. was obtained by further increasing the amount of fibres from 1.5% to 2.0% coherently with what was found in 4.1. regarding the distribution of fibres.

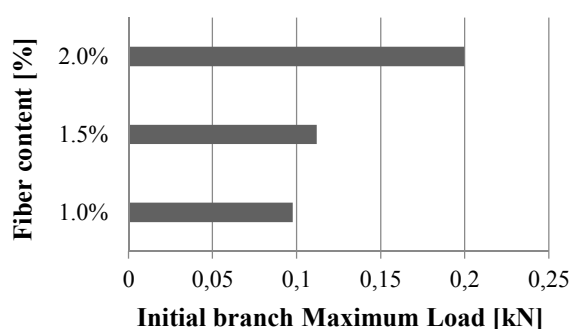
The area of bitumen observed on the crack surfaces was also found to be proportional to the entity of the initial branch maximum load for each specimen. Still, the thickness of the bitumen layer wasn't taken into account to throw such conclusion, thus some reservations should be kept. The average initial branch maximum loads for each fibre content is shown in the bar graph in Figure 12.

Figure 12: Initial branch maximum load for b1fcon1, b2fcon2 and b3fcon2.
