Transformation of vacant office buildings into housing

A NEW LIFE: TRANSFORMATION OF VACANT OFFICE BUILDINGS INTO HOUSING

Hilde T. Remøy, Theo J.M. van der Voordt, Delft University of Technology.
h.t.remoy@tudelft.nl; d.j.m.vandervoordt@tudelft.nl

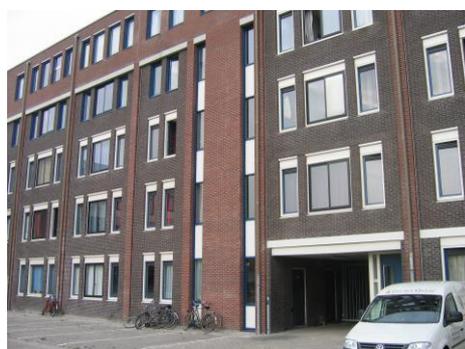
The façade of the building has not been altered

Little was done about the design of the building. The entrance was refurbished, as to allow for 83 students to use it on a daily basis. In the wall, 83 post-boxes were placed, together with 83 doorbells. A program was set up in agreement with the mayor student organisation in Groningen. This resulted in rooms of 20-25 square meters, with an own kitchen and bathroom and an own address, mailbox and doorbell. Dividing walls between the units were made sound- and fireproof by using layers of gypsum plates. In this way, as little as possible weight was added to the construction. The transformed building is an anonymous one, little was changed physically, but the use of the building is radically transformed.

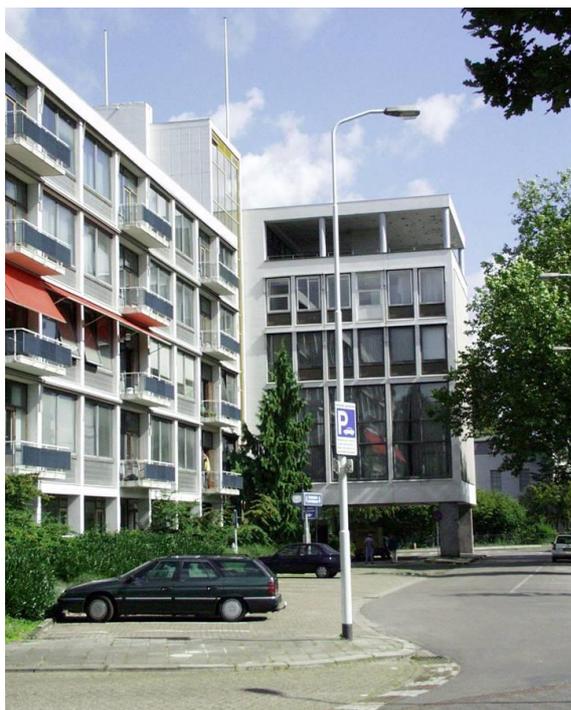
Office building in use as office

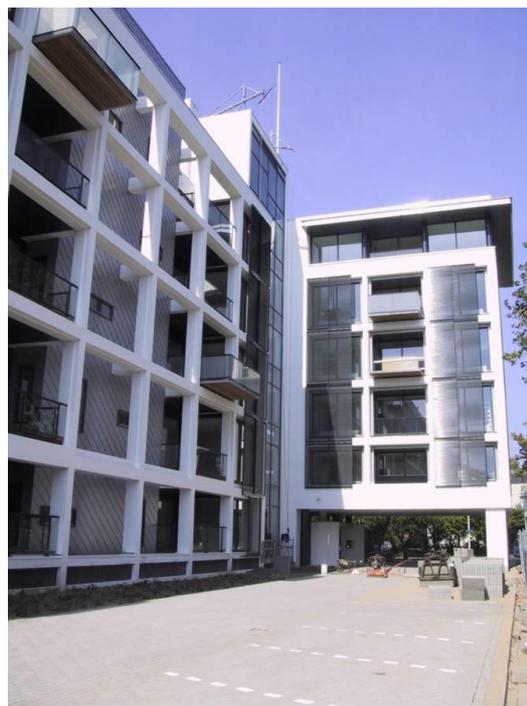
Office building transformed into housing

The existing building had various technical disadvantages, for instance the façade was outdated and not energy efficient. The floors were too thin to function well as the division between two apartments. There were several possibilities to solve these problems. Finally one concept was chosen that would solve all the technical problems; each apartment was designed as a box that was placed in the existing structure like a drawer in a chest of drawers. This solved as well the isolation of the interior walls and floors as the façade. During construction though, it became clear that the building also wasn't built to modern standards. The measurements of the columns and the distances between varied from floor to floor. The 'drawers' had to be manufactured specially for each unit. This was causing high extra costs. Another factor adding up to the construction costs was the state of the existing construction. Although the façade was radically altered, the characteristic structure of the building and its identity were kept. (Photo's 1 and 2) The large scale left over spaces that this building comprises, are kept public and open. This is one of the obvious qualities that are provided by the existing structure and which could not be provided for through a new building built specific for its use.
