# Eemdijk full-scale field test programme: ground dike and sheet pile dike failure test

## Programme d'essai terrain à taille réelle Eemdijk: essais de déformation et de rupture pour une digue standard en terre et une digue renforcée avec palplanches

**ABSTRACT:** Dikes in the Netherlands have traditionally been constructed with soil. Climate change and subsidence requires heightening and or reinforcing these existing dikes. Traditional reinforcements demand additional space, which in some cases conflicts with existing buildings. Applying sheet pile walls in dikes allows for strengthening while minimizing the increase in footprint. However, a validated design approach that complies with relevant regulations lacks. To enable the validation of a proposed design approach, a full-scale field test programme (Eemdijkproef) was performed near the town of Eemdijk, The Netherlands. It consisted of a step wise approach: 1) sheet pile pullover tests, 2) ground dike stability test, 3) sheet pile dike stability test. All tests were loaded until failure occurred. The two similar test dikes were constructed at full scale (5m high, 25m wide, 60m long). In one dike an 18m long sheet pile wall was

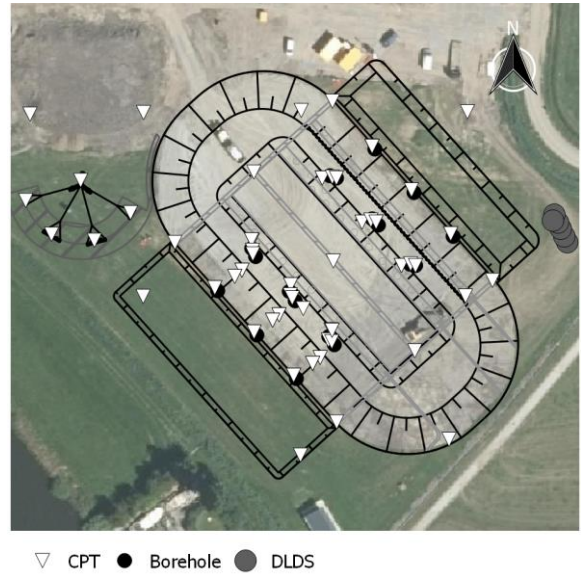
Figure 1 Topview FST site with soil investigation points.

Figure 1 shows the FST site with the sheet pile dike at the NE-side and the ground dike at the SW-side. The POT is located at the W-side. Furthermore the soil investigation points are

presented with the Deltares Large Diameter Samples (DLDS) at the E-side.

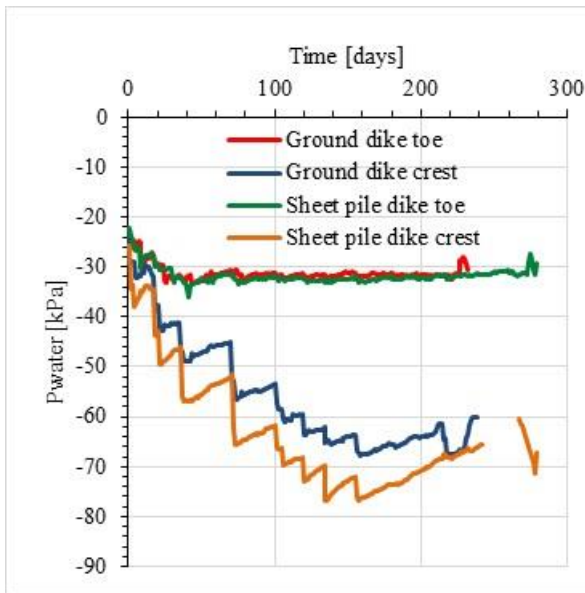
Figure 5 Development of pore pressures during construction.

Figure 5 presents the pore pressures at the toe and below the crest of both dikes (in the middle section). Each stage is clearly visible, in particular below the crest.

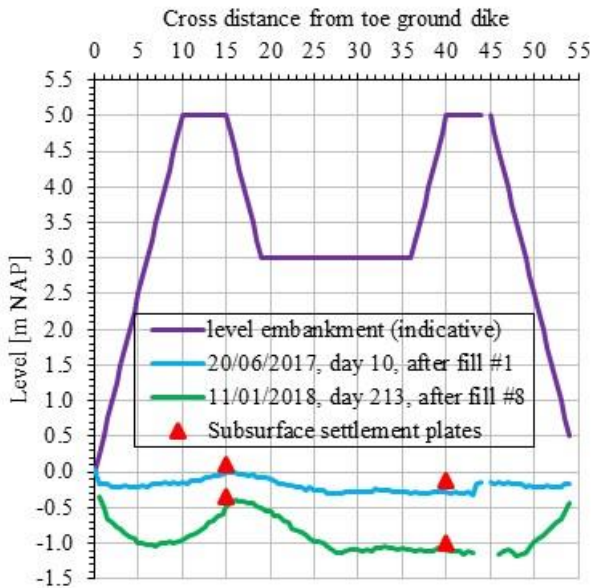
Figure 6 Settlements of the south section after the 1st and 8<sup>th</sup> fill stage.

Figure 6 presents the settlements along a cross section of the dike, after the 1st and 8<sup>th</sup> fill stage. The maximum settlement is about 1.1m. The settlement at the old berm location (located under the ground dike crest) is typically half of that due to the preloading. Also the pore pressures at the

ground dike crest are lower than at the sheet pile dike crest. The settlement at both the toes is about 0.3m. The horizontal deformations at the toe are about 0.3m at the end of construction. Deformations in the upper 2m were larger at the toe of the ground dike due to the soft silty clay (3a).

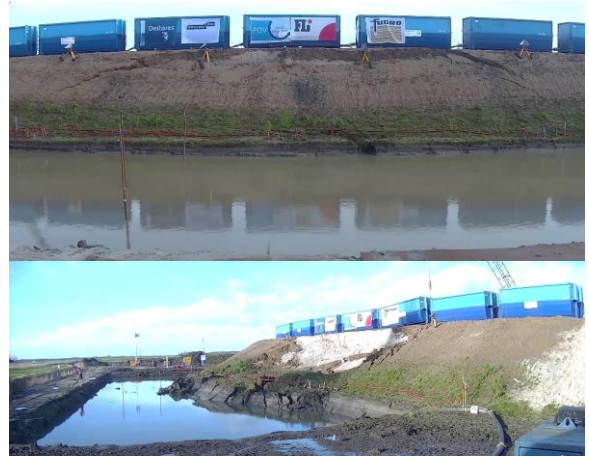
Figure 9 Photo's of ground during failure (a) and after failure (b).

Failure became visually clear due to large cracks developing at the transition of slope and crest, accompanied with horizontal

displacements at the toe of the dike. The failure occurred over approximately the middle 30 m of the ground dike, see figure 9a. A large part of the total deformations (several meters) developed in the first hour after the first signs of failure, and steadily increase to its final position, see figure 9b.

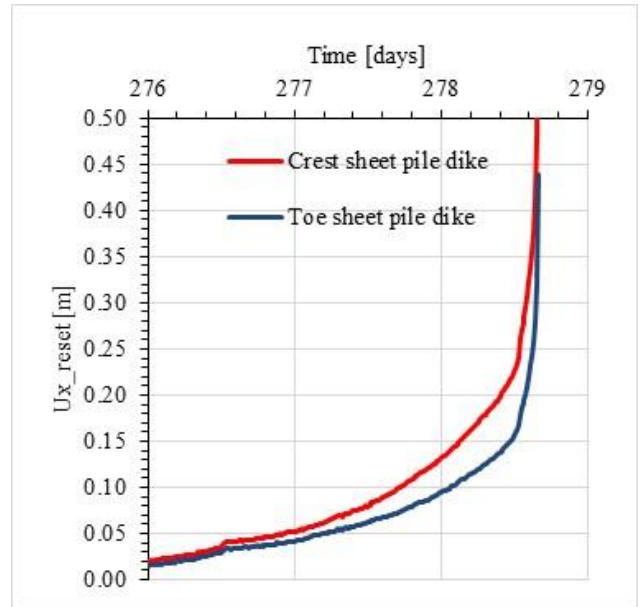
Figure 10 Horizontal displacements of the Prism at the top of the sheet pile and the toe of the ground dike.

Figure 10 presents the horizontal deformations at the top of the sheet pile and toe of the dike during the last 3 days of the sheet pile FST. The deformations at the top are generally 1.5 times larger than at the toe and became clearly visible by eye one day before failure. Failure of the slope started typically at 0.1 to 0.2m displacement.

Deformations of the sheet pile ground dike are initially also limited, but at higher water levels the deformations at the top of the sheet pile are

generally 1.5 times larger than at the toe, providing more (visual) information on the state of the dike compared to the ground dike.

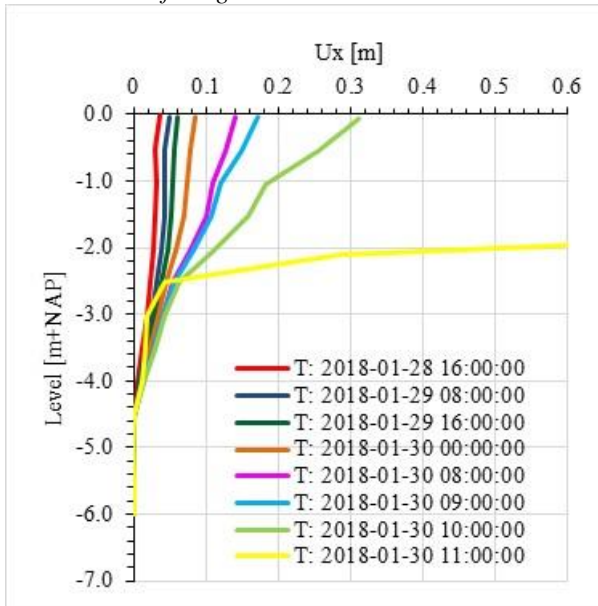
Figure 8 Horizontal displacements over depth of the SAAF at the toe, at multiple times during the ground dike FST.

Figure 8 presents the SAAF measurements at several times. Failure of the slope continues rapidly after 0.1-0.2m horizontal displacement. The slip surface is at -2.0m NAP. Excavations performed afterwards confirm a horizontal slip surface in the soft silty clay (3a), and typically circular slip surface in the layers above.

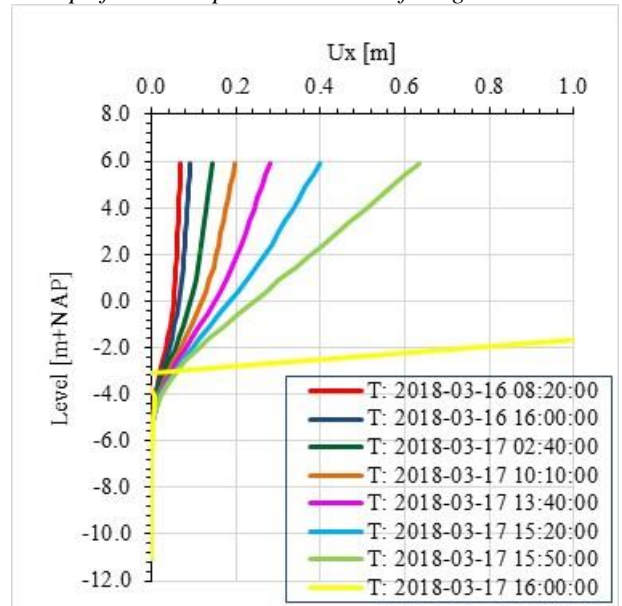
Figure 11 Horizontal displacements over depth of the SAAF at the sheet pile, at multiple times during the sheet pile dike FST.

Figure 11 presents the SAAF measurements at several times. At the early stages the slope provided enough support such that the cantilever wall deflected backwards at the top. Failure of the sheet pile starts after exceeding the maximum bending moment capacity which corresponds with a displacement of typically 0.5m at the top. After failure of the sheet pile, the large deflection finally caused flooding of the FST site (see figure 12b).

The SAAF measurements at the toe and slope indicate that the slip surface at the toe of the dike

is located at the bottom of the peat layer. Halfway the slope the slip surface is less profound and can

beter be described as a failure zone over the thickness of the peat layer. At the sheet pile there is no failure plane because all deformations are imposed by the sheet pile.
