# Eemdijk full-scale field test programme: ground dike and sheet pile dike failure test

## Programme d'essai terrain à taille réelle Eemdijk: essais de déformation et de rupture pour une digue standard en terre et une digue renforcée avec palplanches

H.J. Lengkeek

**Keywords:** Levee, Dike, Sheet pile, Full-scale failure test, Monitoring instrumentation.

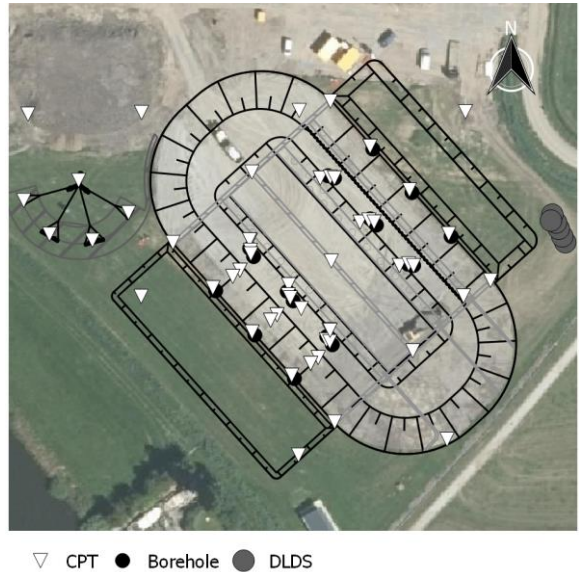
Figure 1 Topview FST site with soil investigation points.

Figure 1 shows the FST site with the sheet pile dike at the NE-side and the ground dike at the SW-side. The POT is located at the W-side. Furthermore the soil investigation points are

presented with the Deltares Large Diameter Samples (DLDS) at the E-side.

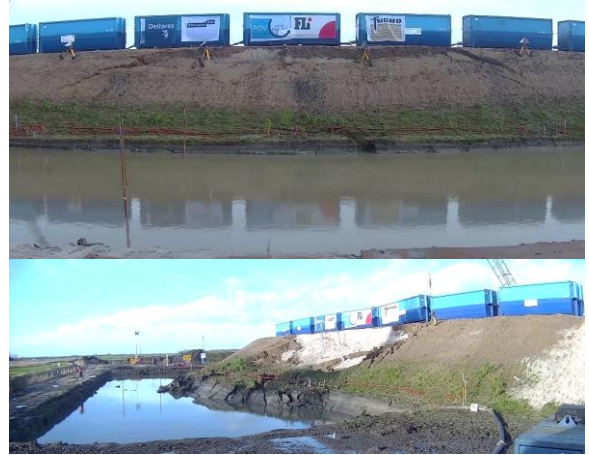
Figure 9 Photo's of ground during failure (a) and after failure (b).

Failure became visually clear due to large cracks developing at the transition of slope and crest, accompanied with horizontal

displacements at the toe of the dike. The failure occurred over approximately the middle 30 m of the ground dike, see figure 9a. A large part of the total deformations (several meters) developed in the first hour after the first signs of failure, and steadily increase to its final position, see figure 9b.

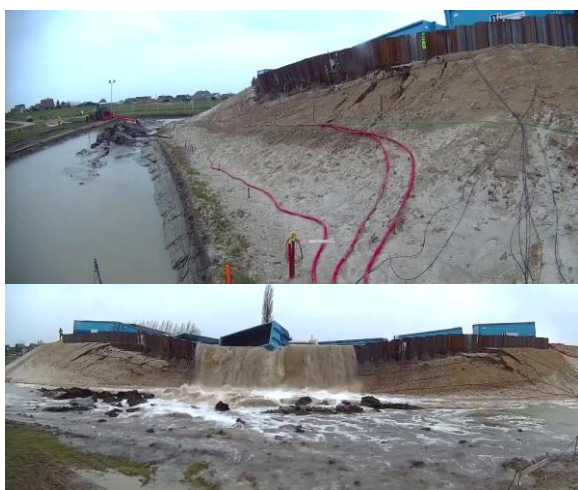
Figure 12 Photo's of sheet pile dike during failure, just before (a) and during (b) flooding.

The deformations accelerated once the sheet pile failed due to local buckling. The slip surface exited in the bottom of the ditch, approximately 5m from the toe of the dike. The sliding ground mass was pushed upward even above the water level in the ditch, see figure 12a. Deformations stopped once the top of sheet pile was pushed over by 6m and down by 2m.

Figure 11 presents the SAAF measurements at several times. At the early stages the slope provided enough support such that the cantilever wall deflected backwards at the top. Failure of the sheet pile starts after exceeding the maximum bending moment capacity which corresponds with a displacement of typically 0.5m at the top. After failure of the sheet pile, the large deflection finally caused flooding of the FST site (see figure 12b).
