Proceedings of the XVII ECSMGE-2019

Impact of the Eemdijk full-scale test programme

Keywords: sheet pile wall; levee reinforcement; full-scale test; validation; Eemdijkproef;

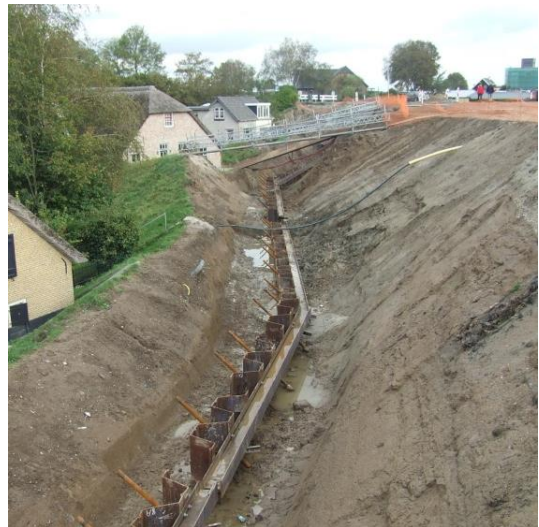
Figure 1: Installation of discontinuous sheet pile wall as reinforcement of Lekdijk Krimpenerwaard

Unlike a soil structure levee, the structurally reinforced levee is required to apply to strict deformation requirements. In the serviceability limit state both crest settlement and horizontal wall displacement need to be smaller than 0.10 m; in the ultimate limit state the wall deflection is not allowed to exceed 2% of the wall length (with a maximum of 0.5 m). Also, in contrast to what in (EN 1993-5, 2007) is allowed, if class 1 and class 2 profiles are applied, only the elastic (thus not the plastic) capacity of the steel wall may be taken into account according to the design guideline. Finally, the structure is not allowed to obstruct groundwater flow within the levee. This generally leads to a discontinuous wall from panels of several sheet piles, connected with a waling (see Figure 1).
