Micro-drilling resistance measurements of dense hardwoods for hydraulic structures

Gard, W. F.; Van De Kuilen, J. W.

WCTE 2018 - World Conference on Timber Engineering

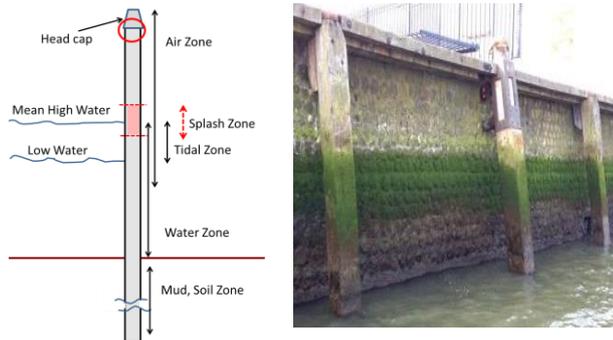
Figure 1: Mooring pole with critical zones and fender at a quay wall

Timber in marine structures is mostly exposed to harsh conditions in the tidal-, splash zones and around the head cap (Figure 1). Due to anisotropic shrinkage and swelling the wood cracks at the surface and deeper inside of the timber element. Furthermore the cross section of the timber element could be reduced caused by impact actions of chips, but also by fungi decay and marine organisms (Figure 2).

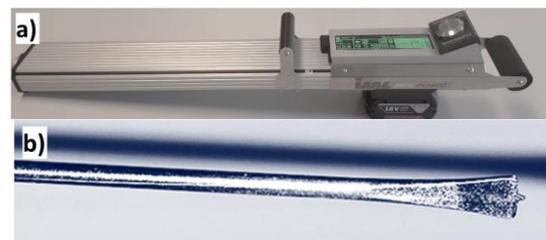
Figure 4: IML-RESI PD drill equipment (a), drill needle (b)

The micro-drilling was applied with the IML-RESI PD (Figure 4). The drilling frequency through the cross section should give information about internal defects (cracks, decay) and juvenile wood. The micro drill is slender (\varnothing 1.5mm), 400mm in length and has a drilling head with a diameter of 3mm (Figure 4). The drilling resistance is given by an amplitude of electrical power. Feed and drilling speed are separately controlled by two engines. The drill needle has a tip diameter of 3mm and a shaft diameter of 1.5mm (Figure 6). The thinner shaft diameter ensures the transportation of the cut chips from the inside to the surface.

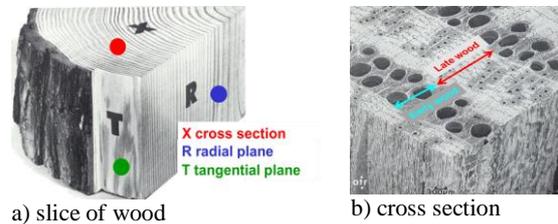
Figure 7: Anatomical directions of wood (a), microscopic view of growth rhyme (early and late wood) of a ring-pore wood species (b).

Natural variations in density of wood are due to growth rhyme and anatomical directions (Figure 7). In the present study, drillings are conducted exclusively in the radial and tangential direction, i.e. perpendicular to the fibre direction.

Types of wood with ring-pore structure show significant density scatter in radial direction compared to tangential direction (Figure 7).

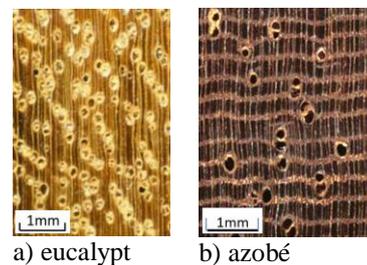
Figure 8: Microscopic cross section of diffuse-pore wood species (a),(b)

From own research (unpublished) it can be concluded that in diffuse-pore wood species the scatter of density in tangential relative to radial direction is marginal (Figure 8).

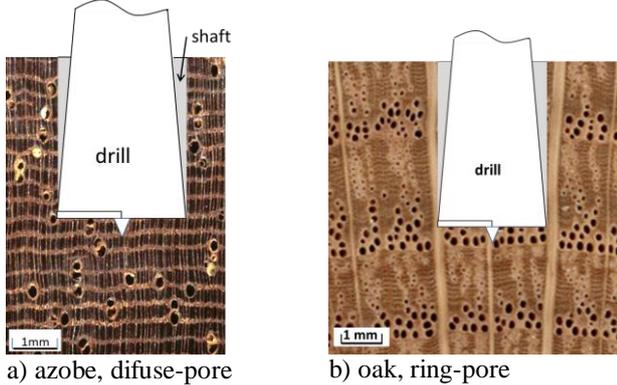
Figure 9: Microscopic cross section with drill resolution at scale.

in the case of oak (Figure 9) where the vessels are arranged in wide bands in the early wood, this low resistance areas are clearly distinct in the resistance curves.

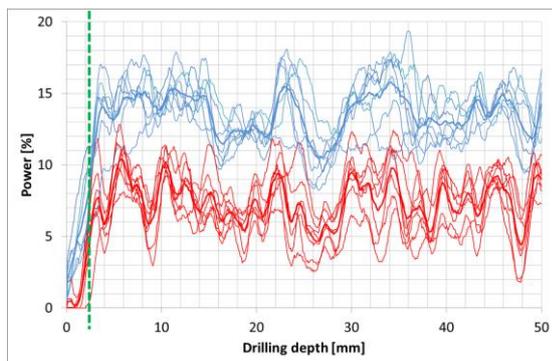
Figure 10: Micro-drilling chart(8 specimens): feed speed at 500mm/min (red line), drill speed at 5000r/min (blue line); the darker thick lines are the average of the individual measurements; offset depth (dashed green line)

Needle and feed speed have to be phased with each other. High feed speed can lead to a deformation of the needle and damage the needle tip. Low rotation speed of the needle can lead to deformations of the drill head in particular in hardwoods with a high drilling resistance (high density). In the present study with eucalypt and azobé the optimal drill speed was found at 5000r/min and feed speed 500mm/min. The offset is about 0.2mm (Figure 10).

From the graphs (Figure 10) it can be seen that both amplitudes are almost synchronized.

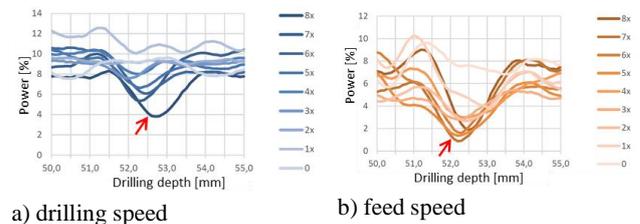
Figure 11: Micro-drilling with an artificial gap/crack in a sample; lowest energy consumption is pointed by the red arrow; light colours represent small gaps, dark colours thicker gaps.

An artificial gap between two specimens was created with a thickness of 0.08mm and the drilling was performed. The gap was increased by a multiple of the initial gap.

Neither the feed speed nor the drilling speed reach the limit value '0' (Figure 11). The feed speed shows a greater sensitivity than the drilling speed.

After statistical analyses, it seems that a gap/crack can be recognized as of 0.64mm width, with a confidence of 99%.

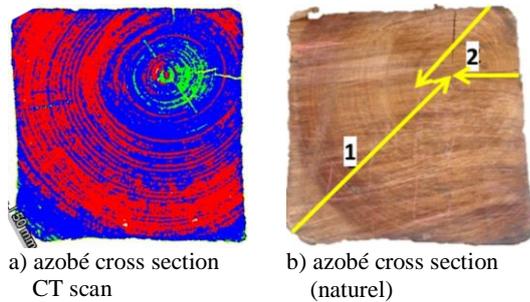
Figure 12: Azobé cross section: 3D CT scan, red=high density, blue and green low density (a); indication of drilling lines and drilling direction: yellow lines (b)

located which usually has a lower density than the mature wood. For control reasons, 2 pieces with a length of 350mm from the wooden pile were scanned in 3D using a computerized x-ray imaging (CT scanning). By means of the scans, zones in the wood with significant density variation could be identified (Figure 12). The colours in the picture symbolize grey values, which represent the density. The density of the red areas are about 30% higher than those of the blue zones. From this mapping it can be concluded that the core area is juvenile wood and decay is at the outer zones of the pile.

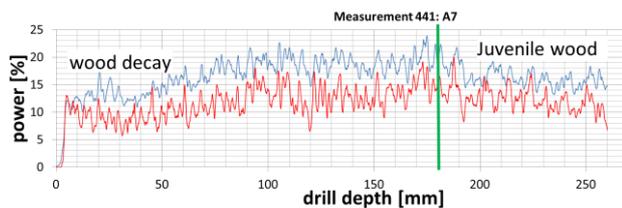
Figure 13: Resistance profile of azobé cross section along the yellow line in figure 12 b); red line = feed speed amplitude, blue line=drill speed amplitude.

These results of the CT scan are confirmed by the micro-drilling (Figure 13). The offset of the drilling, a few tenths of millimetres at the surface of the pile, can be neglected (Figure 13, left part). All drilling measurements were done perpendicular to the grain of the pile. In total 245 micro drillings were conducted on azobé.

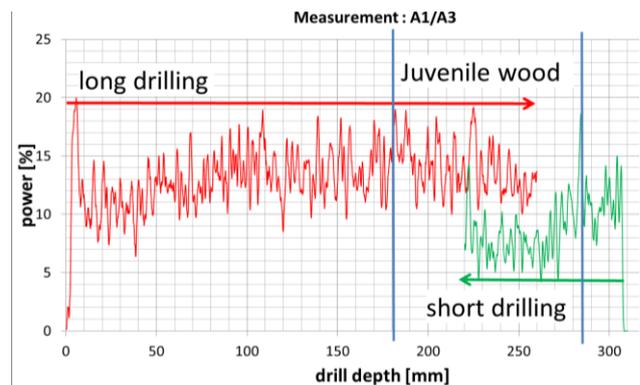
Figure 15: Resistance profile of azobé cross section: along the yellow and blue line in figure 14); red line = feed speed amplitude of drilling 1, green line = feed speed amplitude of drilling 2; arrowhead indicates the drilling direction; between the vertical blue lines the juvenile wood is located.

Shaft friction was detected during drilling in azobé. Firstly, a deep hole was drilled of 260mm (Figure 14, yellow line), which ran through both mature wood and juvenile wood. Secondly, a hole was drilled from the opposite side of the pole cross section of 90mm length (Figure 14). The second drilling ran mainly through juvenile wood which overlaps partly with the 'long drilling' in the area of juvenile wood (Figure 15).

In the area where the measurements overlap it shows that the drilling resistance of the shorter drilling distance is significantly lower than that of the longer drilling distance (Figure 15, green line). The resistances are almost twice as high for the 'long' drilling as for the 'short' one (Table 2). In the long drilling, the juvenile

wood cannot be identified based on the drilling resistance. The deviation of the juvenile wood is not significant with regard to the mature wood (Table 2).

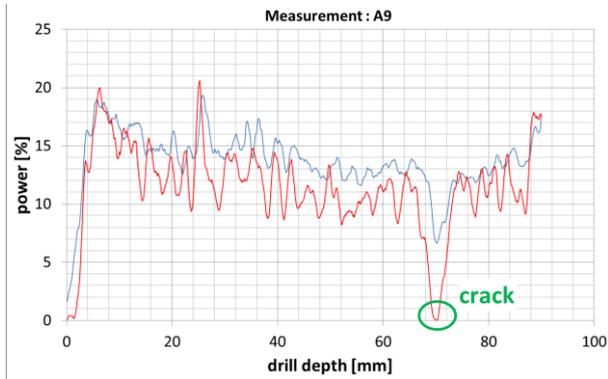
Figure 16: Resistance profile of azobé cross section with crack; red line = feed speed amplitude, blue line = drill speed amplitude.

Cracks detection with a resolution of 0.64mm was possible in azobé (Figure 16). The feed speed is most sensitive to crack detection than the drill speed (Figure 16). The high amplitude in the graphic caused by cracks can be recognized in most cases, even when shaft friction happens. That's because a 'gap' has no drilling resistance. But it is possible that the resolution of 0.64mm may decrease, because the crack can be clogged with chip parts.

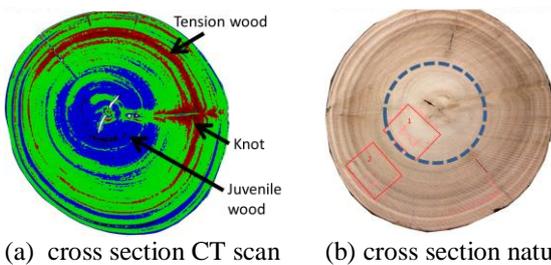
Figure 17: Eucalypt cross section: 3D CT scan, relative density: high density red>green>blue low density (a); indication of juvenile area, blue dashed line (b)

The eucalypt pile has a circular cross section with a distinct pith in the middle. Around the core, the juvenile wood is located (Figure 17) with a lower density than the mature wood. From the wooden pile 2 sections with a length of 500mm were scanned in 3D using a computerized x-ray imaging (CT scanning). By means of the scans, zones in the wood with significant density variation could be identified (Figure 17). The colours in the picture represent density levels. The density of the red areas are about 50% higher than those of the blue zones.

From this mapping the low dense juvenile wood can be identified. In addition, a semi-annular zone of high density is visible, surrounded by mature wood (Figure 17). This is probably tension wood, which has a significant higher density than 'normal' wood. Another high density zone can be spotted in radial direction. This is an offshoot of a knot.

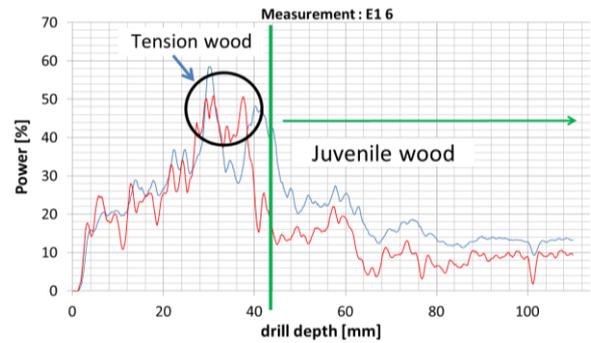
Figure 18: Resistance profile of eucalypt cross section; red line = feed speed amplitude, blue line = drill speed amplitude; high dense area (tension wood).

The micro drillings confirm the density profile of the cross section of the eucalypt pile (Figure 18). The high dense 'ring' (tension wood) surrounded by lower dense material in the pile cross section can be identified (Figure 18). The area of the juvenile wood has a low density and is clearly bordered from mature wood.

These areas can easily identified by micro drillings, because of the high density of tension wood (Figure 18).

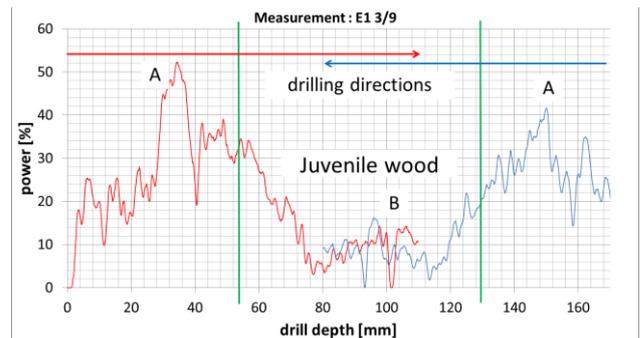
Figure 19: Resistance profile of eucalypt cross section:; red line = feed speed amplitude of drilling 1, blue line = feed speed amplitude of opposing drilling; arrowhead indicates the drilling direction; between the vertical green lines the juvenile wood is located; A = high dense area (tension wood), B=crack.

Shaft friction could not be observed during the drilling. Two opposing holes were drilled, which overlap in the juvenile wood area (Figure 19). The resistance levels of the two measurements are not significantly different in that area (Figure 19, Table 3).
