Widening a harbor basin, demolition of a deep sea quay wall in Rotterdam

Erik Broos, Rob Sibbes, Jarit de Gijt

Abstract: The rapid development in containership dimensions creates a huge challenge for ports. But for one port basin in Rotterdam this challenge was too big. The nautical restrictions for the Amazonehaven would start at such moderate conditions that the basin would be closed for Ultra Large Container Ships (ULCS) about a 100 days a year. As this basin contains more than 60 percent of the deep sea quay length at ECT, Europe's largest container terminal, the Port of Rotterdam Authority decided to widen the basin by demolishing the opposite iron ore bulk quay wall. In this way vessels up to 18.000 TEU have access up to 6 Beaufort wind speed.

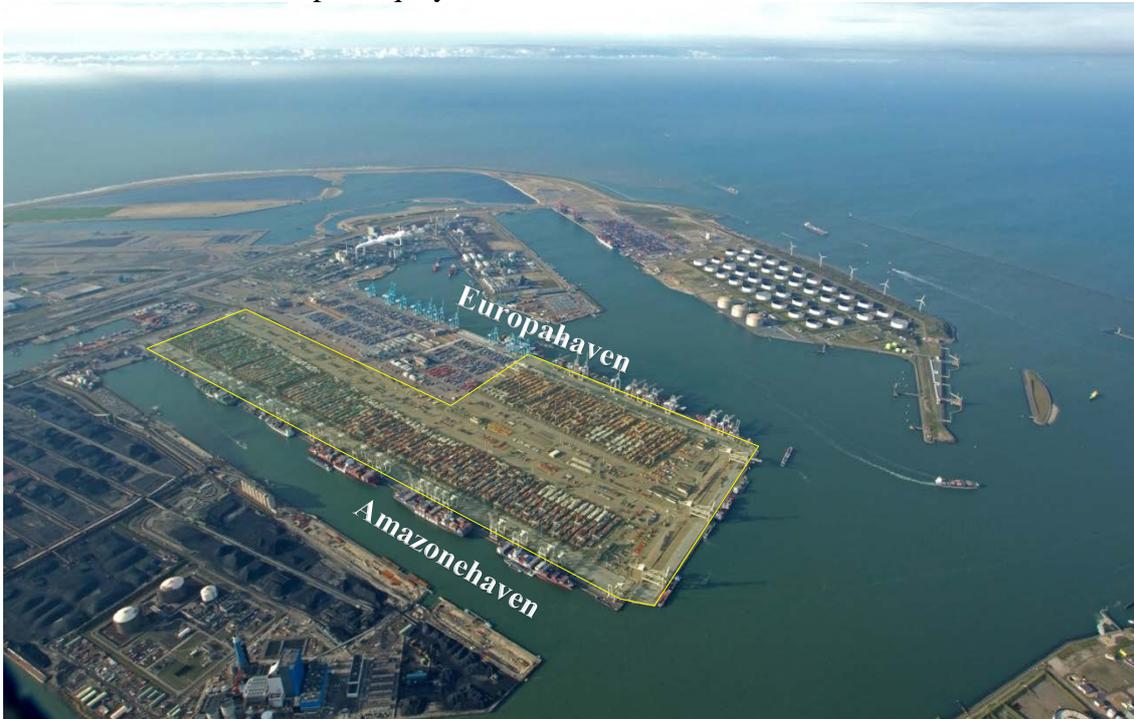
Figure 1: ECT Delta Terminal (yellow area), with Amazonehaven on the front

ECT Delta Terminal at the Maasvlakte in Rotterdam is the largest container terminal in Europe. All major shipping lines at ECT Delta started to use ULCS. The ECT Delta terminal uses two main deep sea quays. The Europahaven and the Amazonehaven (Figure 1). There are no nautical issues at the Europahaven side, smallest sailing path is 355 m wide, but there were major issues at the Amazonehaven side.

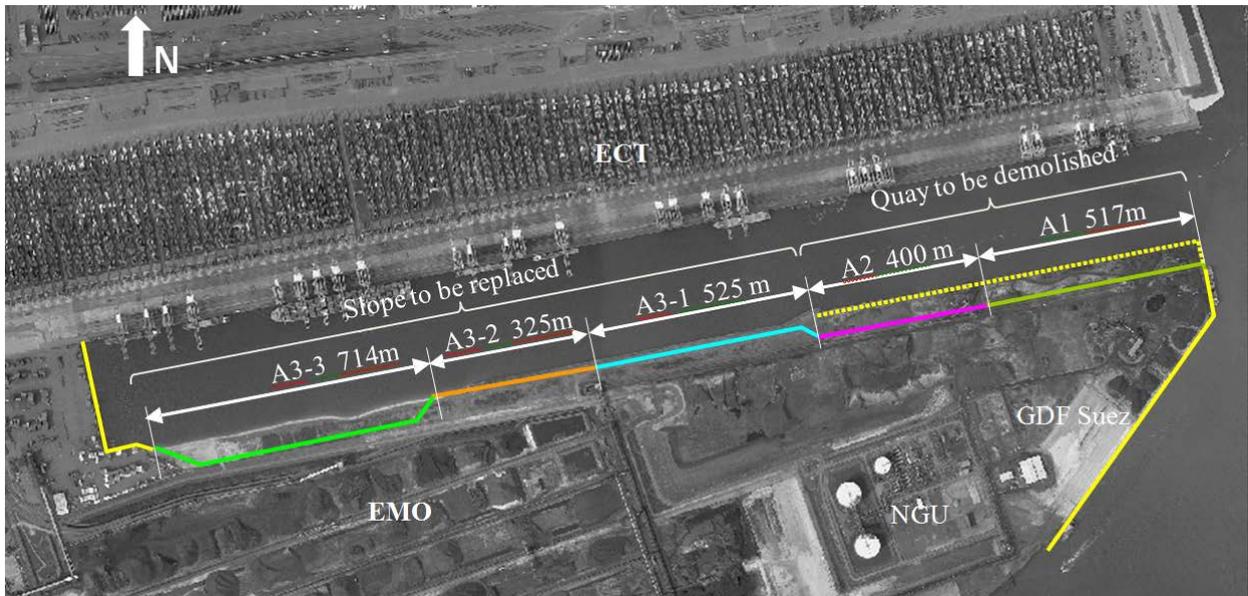
Figure 2: Aerial picture with in color the new basin shape & quay wall

The outcome of this study was that the EMO quay wall (EMO = Europese Massagoed Overslag) on the south of the Amazonehaven had to be removed (Figure 2). However, at the same time a new power plant was constructed at the south side of the basin and this created some extra challenges (Broos, 2014).

The ideal profile was a 275 m wide sailing path for the ULCS with additional 35 m maneuvering space for assisting tugs. This results in a 310 m wide basin. After 2 ship lengths i.e. 800 m, the width of the basin could be reduced down to 240 m plus additional tug maneuvering space. This profile fitted rather well with the coal mixing silos (section A3-1 in Figure 2) that were newly constructed just west of the EMO quay, about 1100 m from the entrance of the basin.

A3-3 in Figure 2). Although the other 1800 m are designed as a quay wall, this is in fact a very heavy earth retaining wall, as mooring is forbidden (sections A1 till A3-2 in Figure 2).

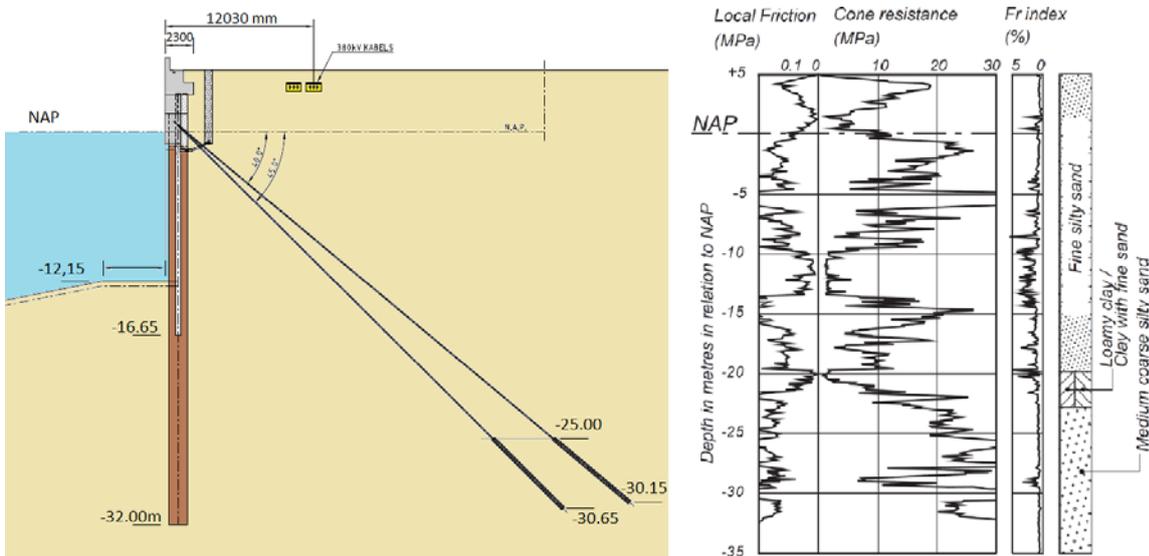
Figure 3: Cross section quay wall and typical CPT for Maasvlakte area

The new quay wall (Figure 3) is a rather simple construction with a retaining height of 20 m. It is a typical Rotterdam solution. There is a firm Pleistocene sand layer below NAP -20 m covered with silty sandy Holocene layers (see Cone Penetration Test (CPT) in Figure 3).

NAP means ‘Normaal Amsterdams Peil’ and is the Dutch reference level, it is roughly Mean Sea Level. Groundwater at the site is at NAP or above. The tubular king piles in the combi-wall bear the vertical loads and resist the bending moments. The intermediate sheet piles provide soil tightness. The drilled anchors provide horizontal stability and the concrete capping beam spreads the loads and provides a mooring surface. More can be found in Rijckaert (2014).

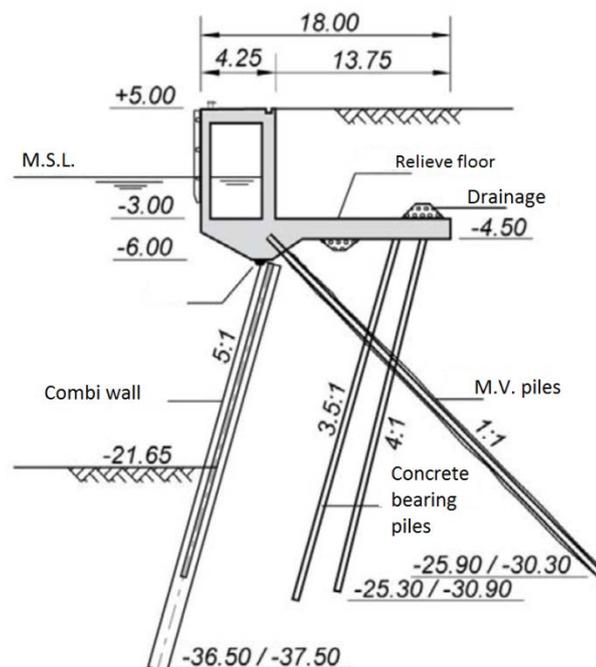
Figure 4: Cross section old quay to be demolished (Gijt, 2013)

The real challenge in the project appeared to be the removal of the old quay wall. The cross section is indicated in Figure 4. This quay wall was designed for the import of iron ore and had a length of 950 m and a retaining height of 32 m. The quay was constructed between 1988 and 1990 with:

- an inclined steel combi-wall (tubes Ø1420-19 mm with triple Larsen IIIs),
- concrete pre stressed bearing piles (450x450 mm),
- MV piles (PSt 370/153 (Peiner profile), design capacity 2,000 kN, and successfully tested up to 5,000 kN)
- and a massive concrete superstructure with a 18 m long relief floor and a tunnel structure on the water side. The entire height of the concrete structure is 11 m, the thinnest (front) wall is 750 mm tick, the thickest part (floor) is 3 m. The concrete is segmented in 40 m long sections each weighting 5000 tons.

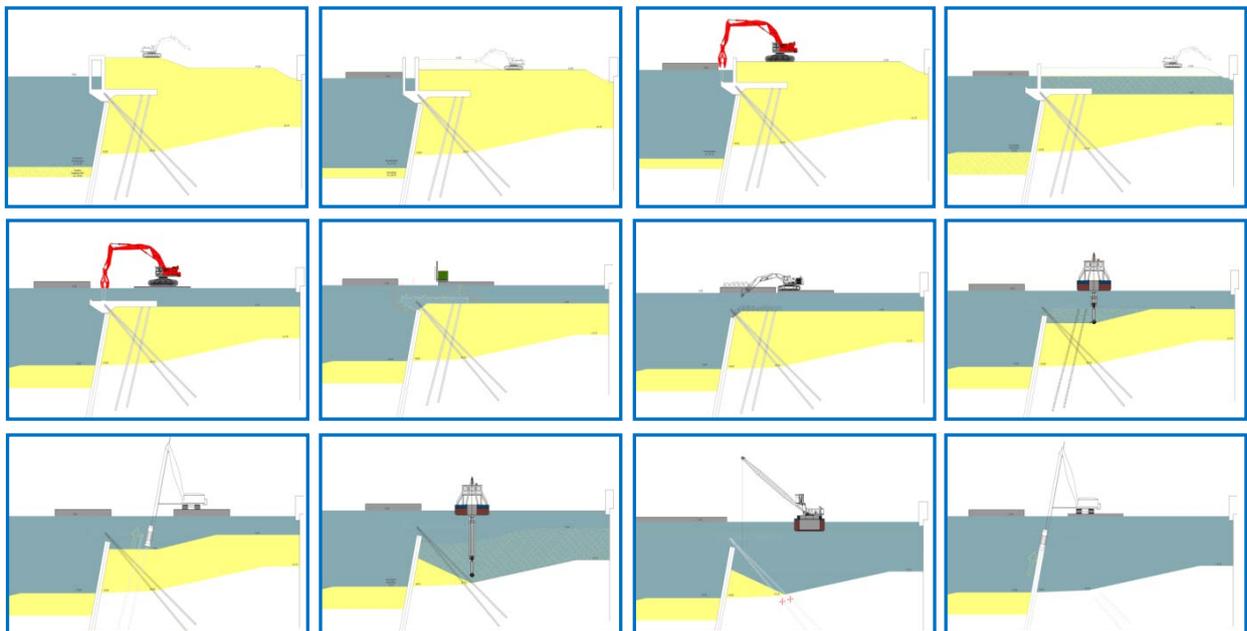
Figure 5: Demolition and excavation sequence.

The entire demolition was a sequence of demolition and excavation as indicated in Figure 5.

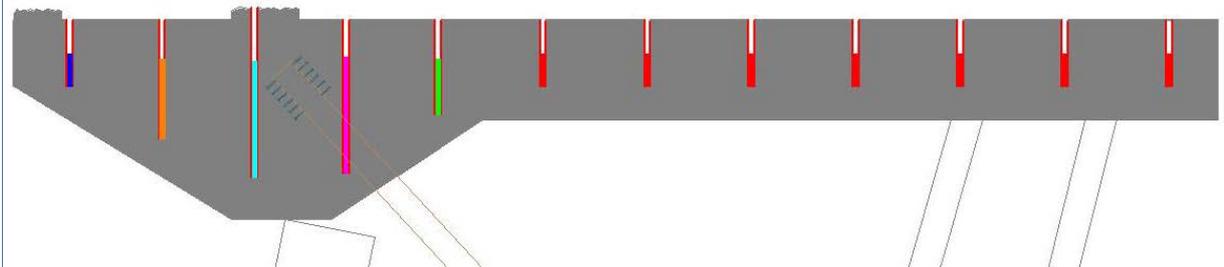
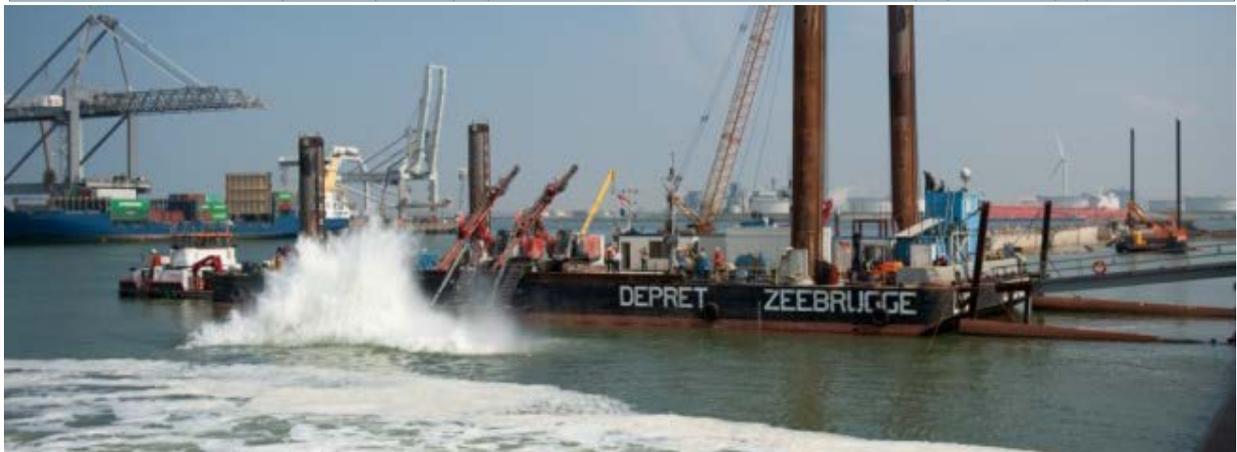
: lading TYPE A	$Q_s = 812 \text{ g/m}^3$, $Q_i = 2500 \text{ g}$, Eurodyn 2000, 1 x (65*500 mm)

: lading TYPE B	$Q_s = 937 \text{ g/m}^3$, $Q_i = 3500 \text{ g}$, Eurodyn 2000, 1 x (65*500 mm) + 1 x (50*350 mm)

: lading TYPE C	$Q_s = 966 \text{ g/m}^3$, $Q_i = 5000 \text{ g}$, Eurodyn 2000, 5 x (50*350)

: lading TYPE D	$Q_s = 918 \text{ g/m}^3$, $Q_i = 5000 \text{ g}$, Eurodyn 2000, 5 x (50*350)

: lading TYPE E	$Q_s = 1050 \text{ g/m}^3$, $Q_i = 4500 \text{ g}$, Eurodyn 2000, 1 x (65*500 mm) + 2 x (50*350 mm)

: lading TYPE F	$Q_s = 912 \text{ g/m}^3$, $Q_i = 2500 \text{ g}$, Eurodyn 2000, 1 x (65*500 mm)

Figure 6: Blast pattern and blast

After the removal of the concrete tunnel structure in a classical way using hydraulic demolition excavators, two mining drilling machines placed on a pontoon drilled holes according to an engineered pattern (Figure 6) and loaded the boreholes with dynamite. Every working day over roughly 20 weeks, the day production was blasted. Shipping in the Amazonehaven always continued, except for the first blast were a basin spanning transponder line proved that the blasts were harmless for sailing and moored ships.

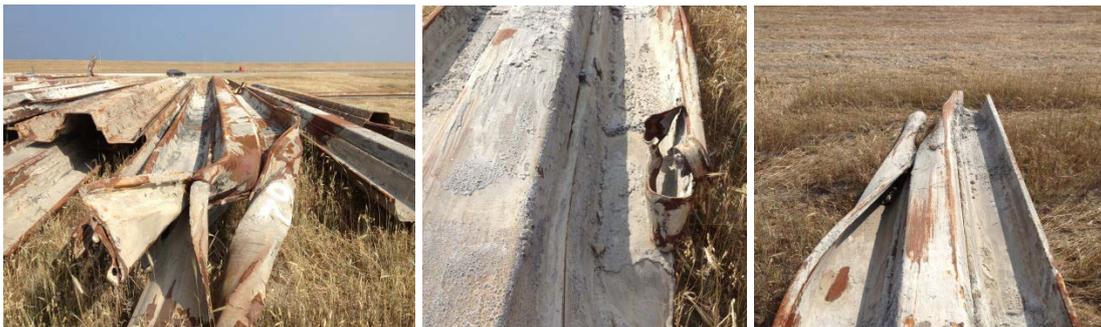
Figure 7: Sheet pile damages

During the dredging works in 1990, 62 interlock openings on 31 intermediate sheet piles were discovered and repaired. When the sheet piles were retrieved, they appeared to be heavily damaged. Almost 50% of the sheet piles were damaged at the last few meters (Figure 7). This damage was never discovered during construction of the wall. The quay wall was never dredged to its final depth and these meters were below the initial construction depth of the quay wall.

Research in old construction documents showed that the last 4 to 5 m were driven with a diesel hammer instead of a low frequency vibrator. Theory describes dense sand to plug inside the interlock under the action of a hammer, pushing the sheet pile out the interlock, creating the damage.

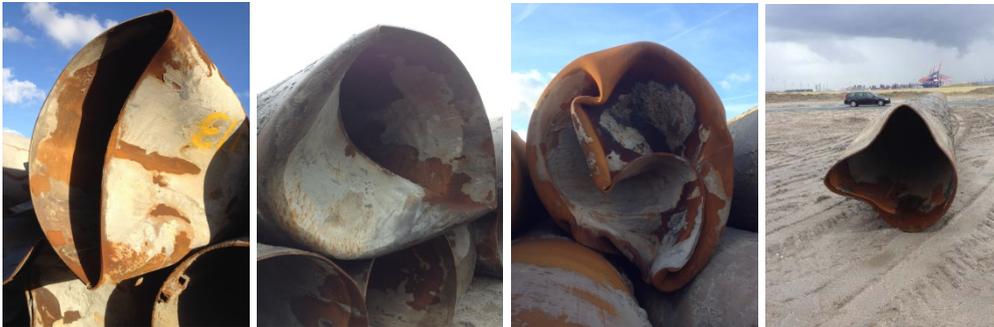
Figure 8: Pile toe damages

The worst discovery however was the condition of the tubular king piles. Over 20% of the pile toes appeared to be damaged (Figure 8). These piles were supposed to provide horizontal

Closer investigation of the piles indicated that soil was ‘burned’ on the pile toe. Apparently the steel has become that hot during installation. Steel strength reduces with temperature; perhaps this effect has played a role in the damage.

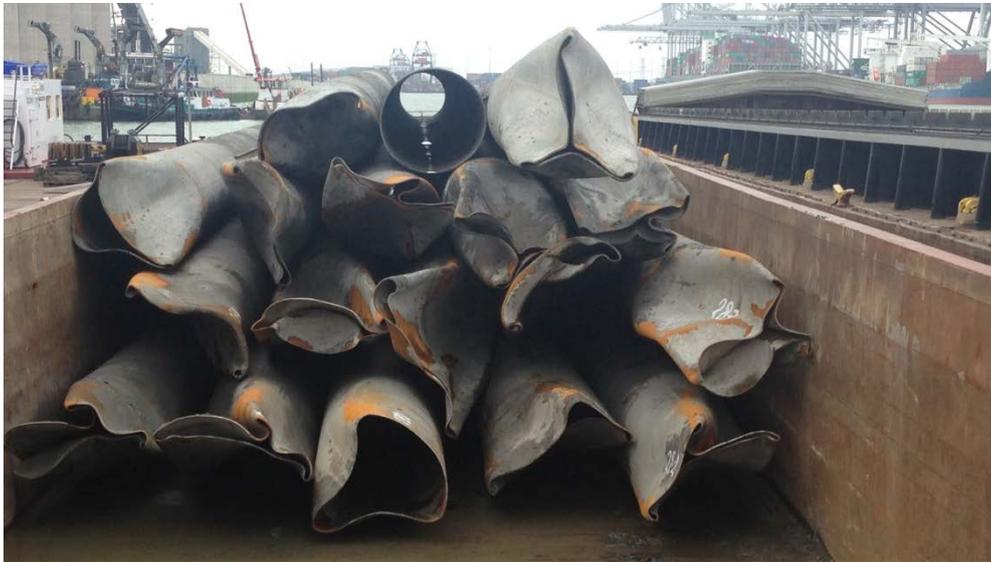
Figure 9: Heavily damaged pile toes

stability. Figure 9 shows piles that were placed next to each other. This cross section did not provide the designed safety. This was further examined by Mourillon (2015), but needs to be studied in more detail.

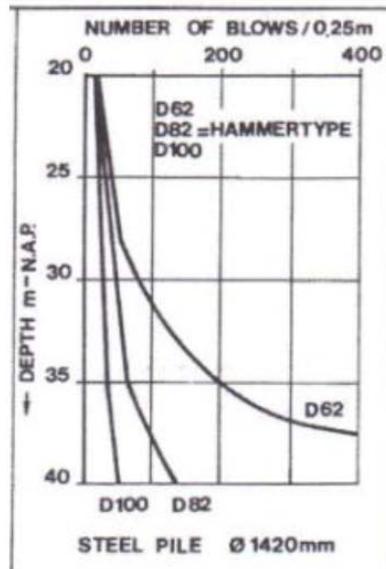
Figure 10: Results drivability of open steel tubular piles (Mourilon, 2015)

History showed (van Ast, de Gijt 1990) that on this project both a D62 and a D100 diesel hammers were used to drive the piles, probably also often both on the same pile a few days after each other. Figure 10 shows the driving analysis of both hammers under Amazonehaven conditions and indicates that the D62 is too light. This shift in hammer is obviously not done
