The Paintwork and the Colours of the Exterior

van Thoor, M.-T. (2019). The Paintwork and the Colours of the Exterior. In M.-T. van Thoor (Ed.), *Colour, Form and Space: Rietveld Schröder House Challenging the Future* (pp. 22-33). Delft University of Technology.

2 / THE PAINTWORK AND THE COLOURS OF THE EXTERIOR

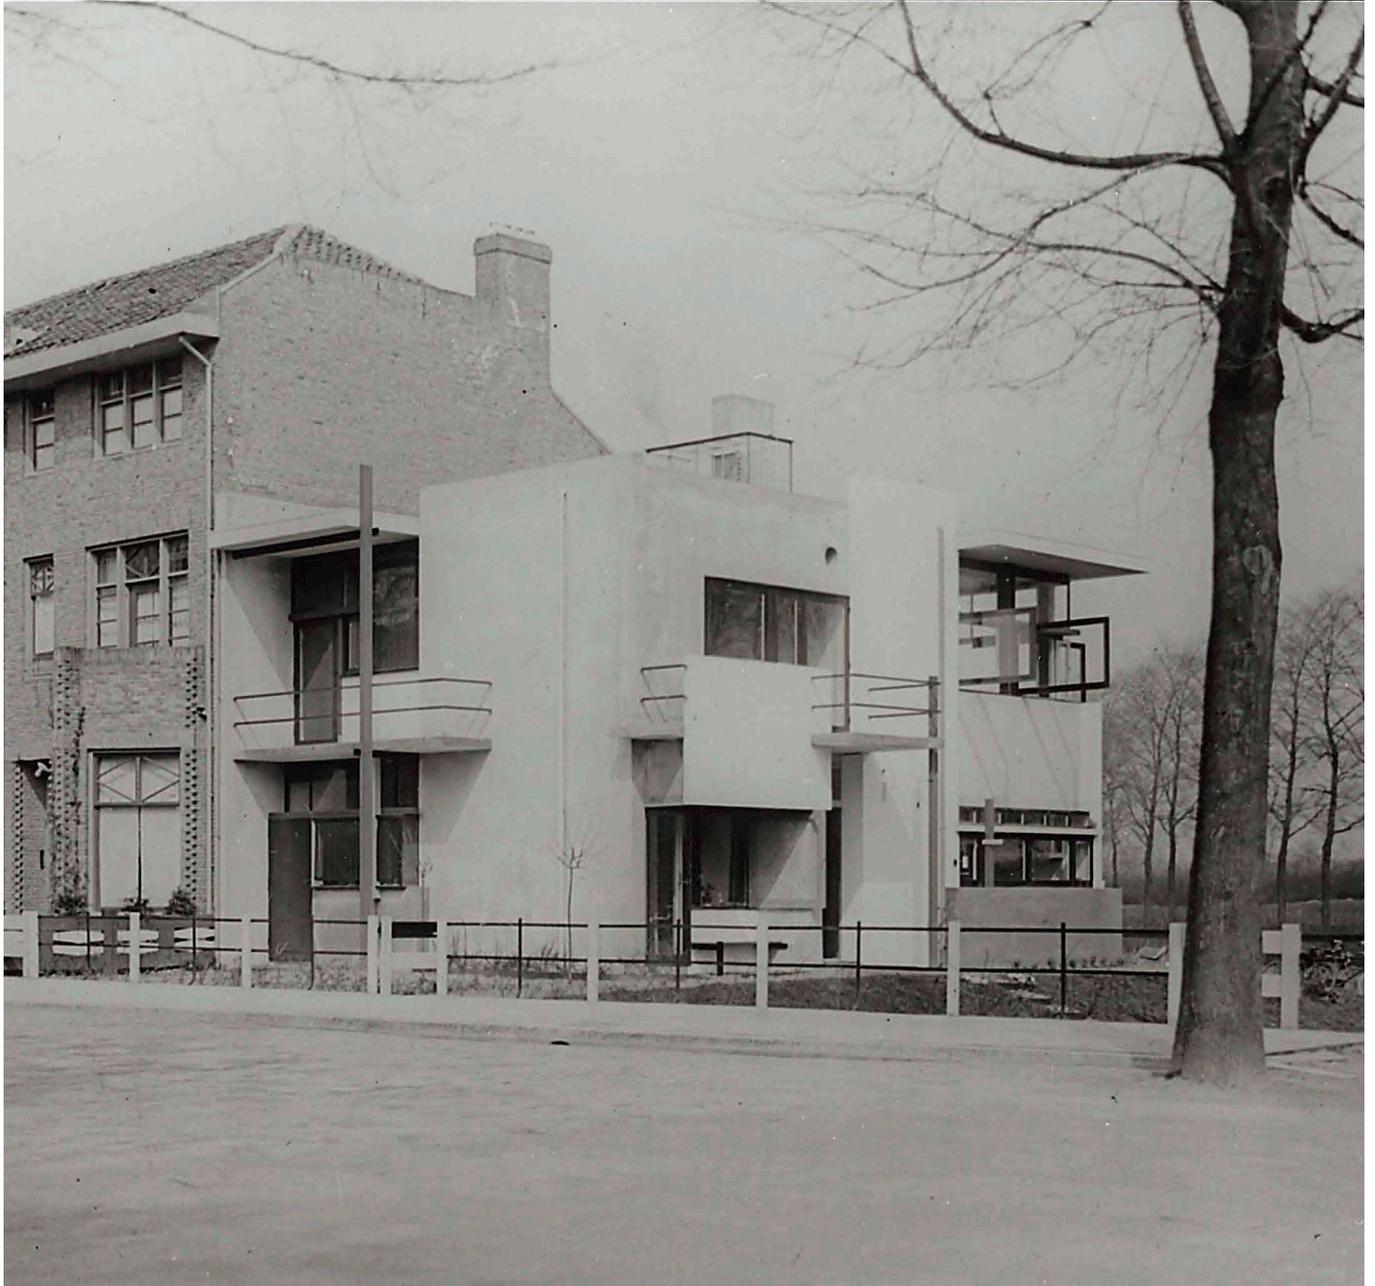
FIG. 2.1 One of the earliest photographs of the Schröder House, c. 1925

In the very first photographs taken directly or not long after construction, it is possible to see that various wall surfaces, as Truus Schröder had recalled, look very spotty [FIG. 2.1]. Apart from the spots, the photographs reveal that the walls were painted in white and shades of grey. But these images do not allow the number of greys to be ascertained – maybe four, maybe five. Looking at the photos from the next decade, there appear to be differences in the composition of the white and grey values of the various surfaces, but it may simply be a case of differences in nuance.

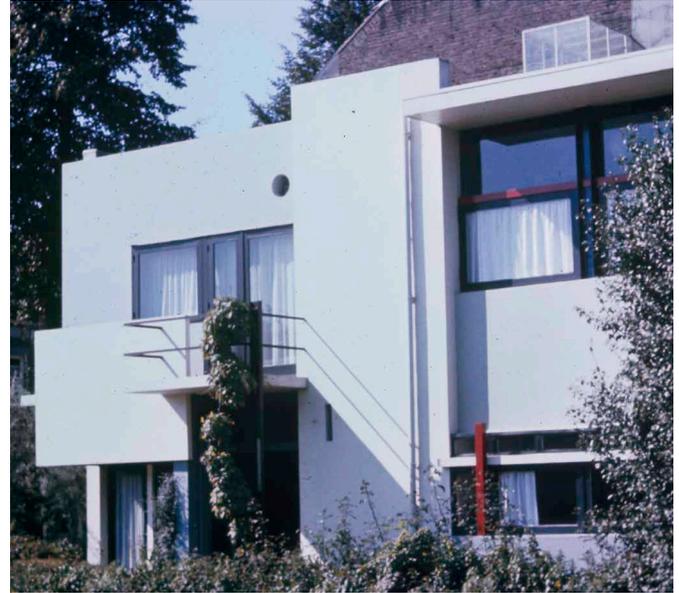
FIG. 2.5 A colour photograph from before the restoration shows that the greys had become bluish

Most of the photographs dating from the early 1970s show the damage and poor state of repair – or perhaps the mediocre outcome of the Van Poppel paintwork – of the Schröder House. The contrasts between the greys are barely discernible, even in the colour photographs. According to Mulder, the greys from the period before the restoration were bluish as well, because back then the greys were only mixed with black [FIG. 2.5].¹¹

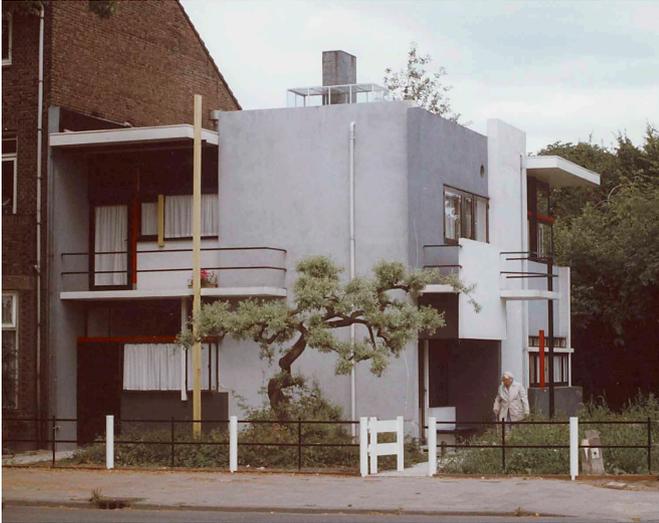
FIG. 2.6 The house in spring 1975, about a year after the first treatment of the exterior

According to Veroude's 1970 technical report, mentioned in the previous chapter, all existing coats of paint on walls, woodwork and steel were to be removed before the restoration. Before repainting, samples were to be taken, which would then be used as a guide to the new colours.¹⁵ Mulder asked the TNO's Paint Research Institute whether it would be possible to separate successive coats of paint so as to reveal the colour of each coat. That would be no problem at all, TNO replied.¹⁶ When the restoration was in full swing Mulder promised the foundation's board 'photos, specimens, colour samples and other relevant information' [FIG. 2.6].¹⁷

blue. Mrs Schröder recalled that when she first met Rietveld, many people considered black obtrusive, but according to Rietveld black actually receded into the background. He used it for elements – like door and window frames – that were not intended to obtrude, with the result that everything appears to be in the same plane and the composition is emphasized [FIG. 2.6/2.10].²⁵

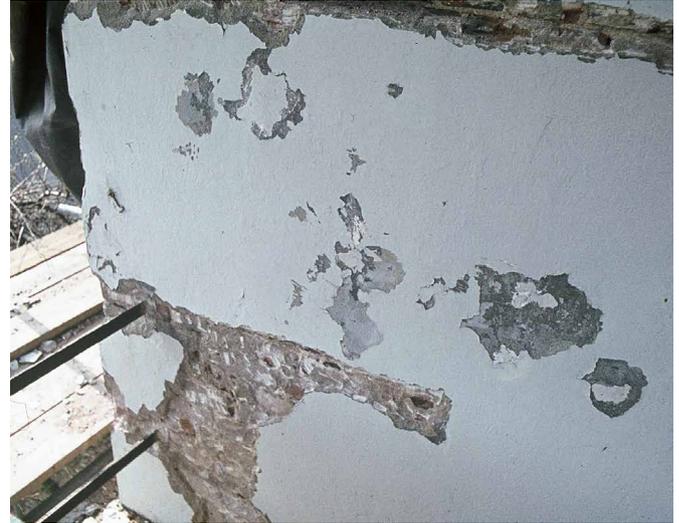
FIG. 2.7 In various places, such as the chimney, B. Mulder found still more finish coats and colours that he could include in his colour research

Despite the fact that the Schröder House had been regularly repainted (possibly as many as ten times), and colour coats had been removed on previous occasions, old paint was evidently still to be found in certain places, such as behind the prickly ivy or on the chimney [FIG. 2.7].¹⁸ Mulder included these remnants in his colour research, and investigated their composition [FIG. 2.8].¹⁹ Once the restoration was finished he threw the samples away.

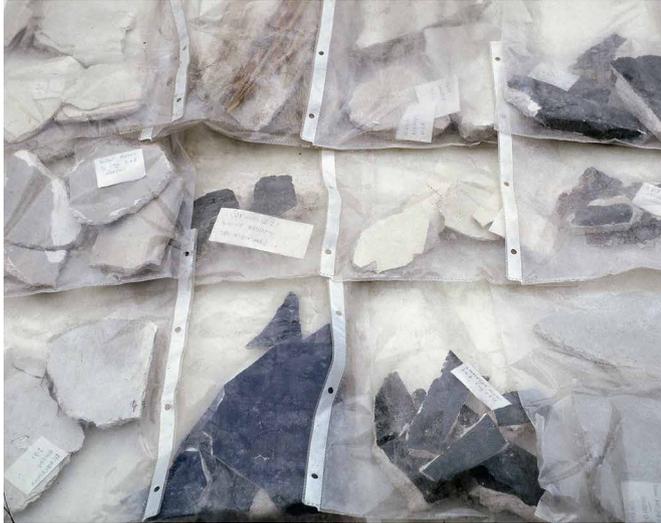
FIG. 2.8 Plaster and colour samples packed in plastic bags

During the restoration the colour formulas were not recorded: the colours were the result of intensive, on-site consultation between Mulder and the painter.³⁶ While the work was ongoing, Mulder kept the plaster samples properly organized and labelled, as can be seen in figure 2.8. Once it was finished he threw everything away. Colour samples from that period are also nowhere to be found, not in Mulder’s archive or that of the RSA, not even in that of the foundation. During the restoration the foundation’s board had regarded specimens, samples, photographs and other material relating to the restoration as important ‘safeguards’. After it was finished the matter was not referred to again and it seems that everyone assumed that the documentation was in good hands with the restoration architect. The foundation’s archive does not even contain a photographic record of the restoration process. That, too, is quite remarkable for board members with so much expertise and interest in modern architecture, as well as for the first major restoration of a ‘young monument’.

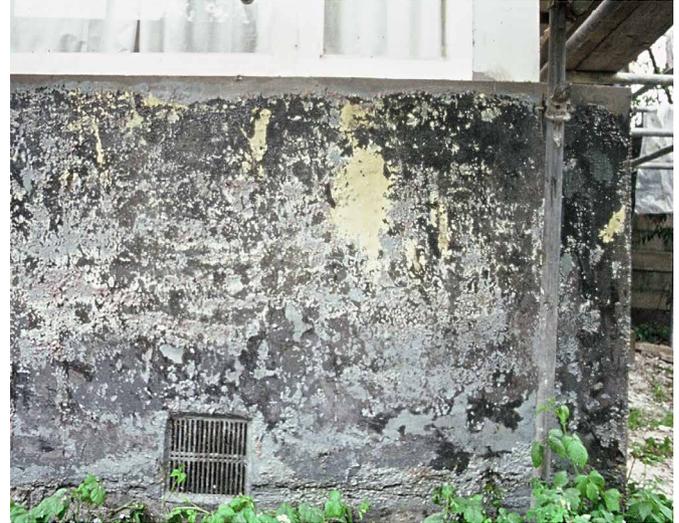
FIG. 2.9 Wall below the kitchen window in the east elevation; B. Mulder chose the dark grey of the top right corner for the new colour scheme

Upon inquiry Mulder turned out to have yet more information in the form of a series of slides and a set of colour samples.²⁰ Detail photos of the chimney show various finish coats and it appears possible to distinguish several colours. Even more interesting is a photo of the wall below the kitchen window in the east elevation [FIG. 2.9]. We can see various shades of grey, from light to dark, and between them the white of a base coat. Mulder's caption reads: 'I opted for a dark grey from top right corner.'²¹ This is one of the wall surfaces that were not repaired and on which the original plaster is still present, according to Mulder. Nevertheless, we are left guessing about the dates of these grey coats because there is simply no further documentation and also because references to other wall surfaces are lacking. The layers of paint on the walls, which were entirely stripped in 1979, were removed together with the old layers of render.

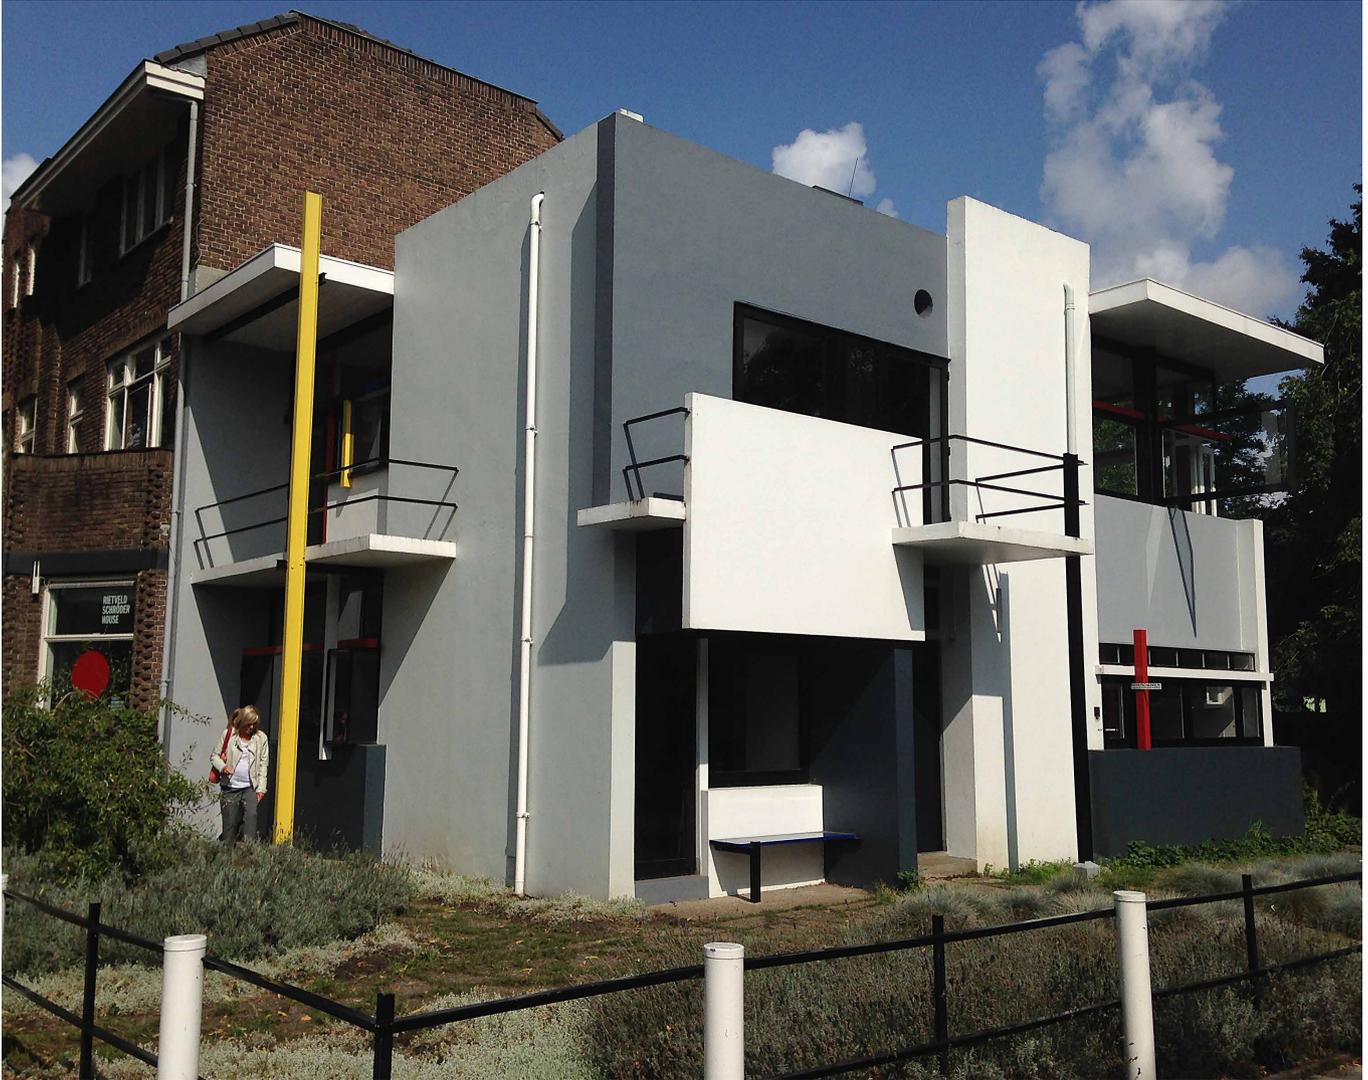
FIG. 2.10 The Rietveld Schröder House in 2017

Currently, the walls display not three, four or six, but five shades of grey, because that is what Mulder says he found during his on-site inspection [FIG. 2.10]. In consultation with the foundation he opted to return to the colour composition of the initial period. With that frame of reference, which involved mixing the greys on site with the painter, he made a composition with five greys (photo on page 22). For the record, Mulder said that making the different shades of grey was the most difficult part of the entire restoration and occasionally even drove him ‘to despair’.²⁶

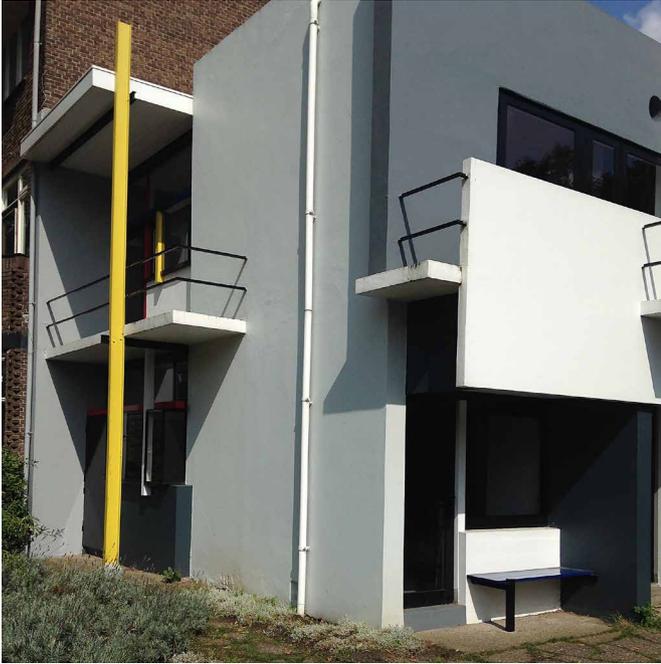
FIG. 2.11 Prins Hendriklaan wall, white rainwater pipe against pale grey background, 2017

The various rainwater pipes were eventually treated in different ways. We can see both white against a pale grey surface (large wall Prins Hendriklaan) [FIG. 2.11] and pale grey against a white surface (to the right of the front door) [FIG. 2.12]. The pipe on the rear elevation is white against a white wall, and that next to the neighbouring building at Prins Hendriklaan 48 is pale grey against an identical pale grey background. This does not appear to be in accordance with the earliest period of the house. In photographs, especially those taken straight after the construction, the rainwater pipes are a natural zinc-grey in colour. But Mulder did regard the drainpipes and their colours as important elements of the overall composition. In an interview with *Cobouw magazine* in November 1974, a few months after the letter from Han, he raised the question of the rainwater pipes himself, in particular the white-painted downpipe on the ‘side elevation’, against the grey background. This downpipe had been absent for a while, was then painted in a zinc colour, and thereafter ‘painted white as [was] intended against the grey background’.³⁰ Thus, even the colours of the rainwater pipes could completely alter the character of the walls.

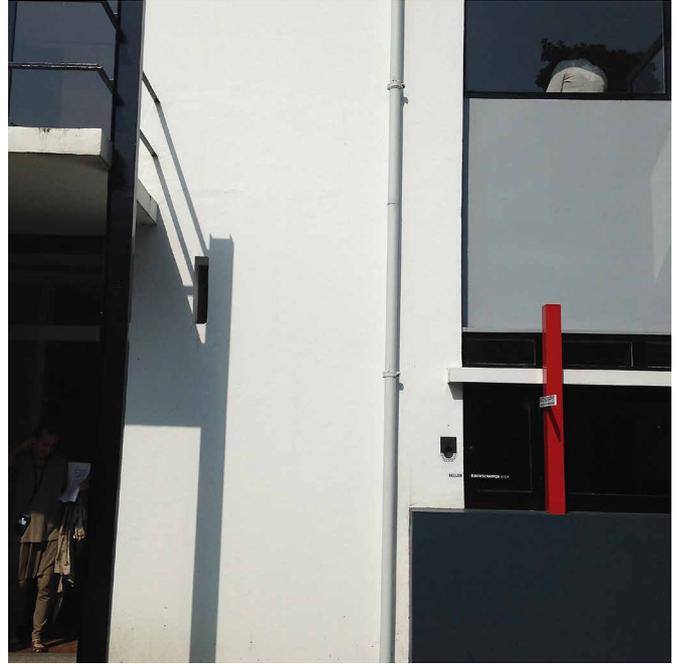
FIG. 2.12 East wall beside front door, pale grey rainwater pipe against white background, 2017
