**The Restorations of the Rietveld Schröder House
a reflection**

Bulletin KNOB: Koninklijke Nederlandse Oudheidkundige Bond

THE RESTORATIONS OF THE RIETVELD SCHRÖDERHUIS

A REFLECTION

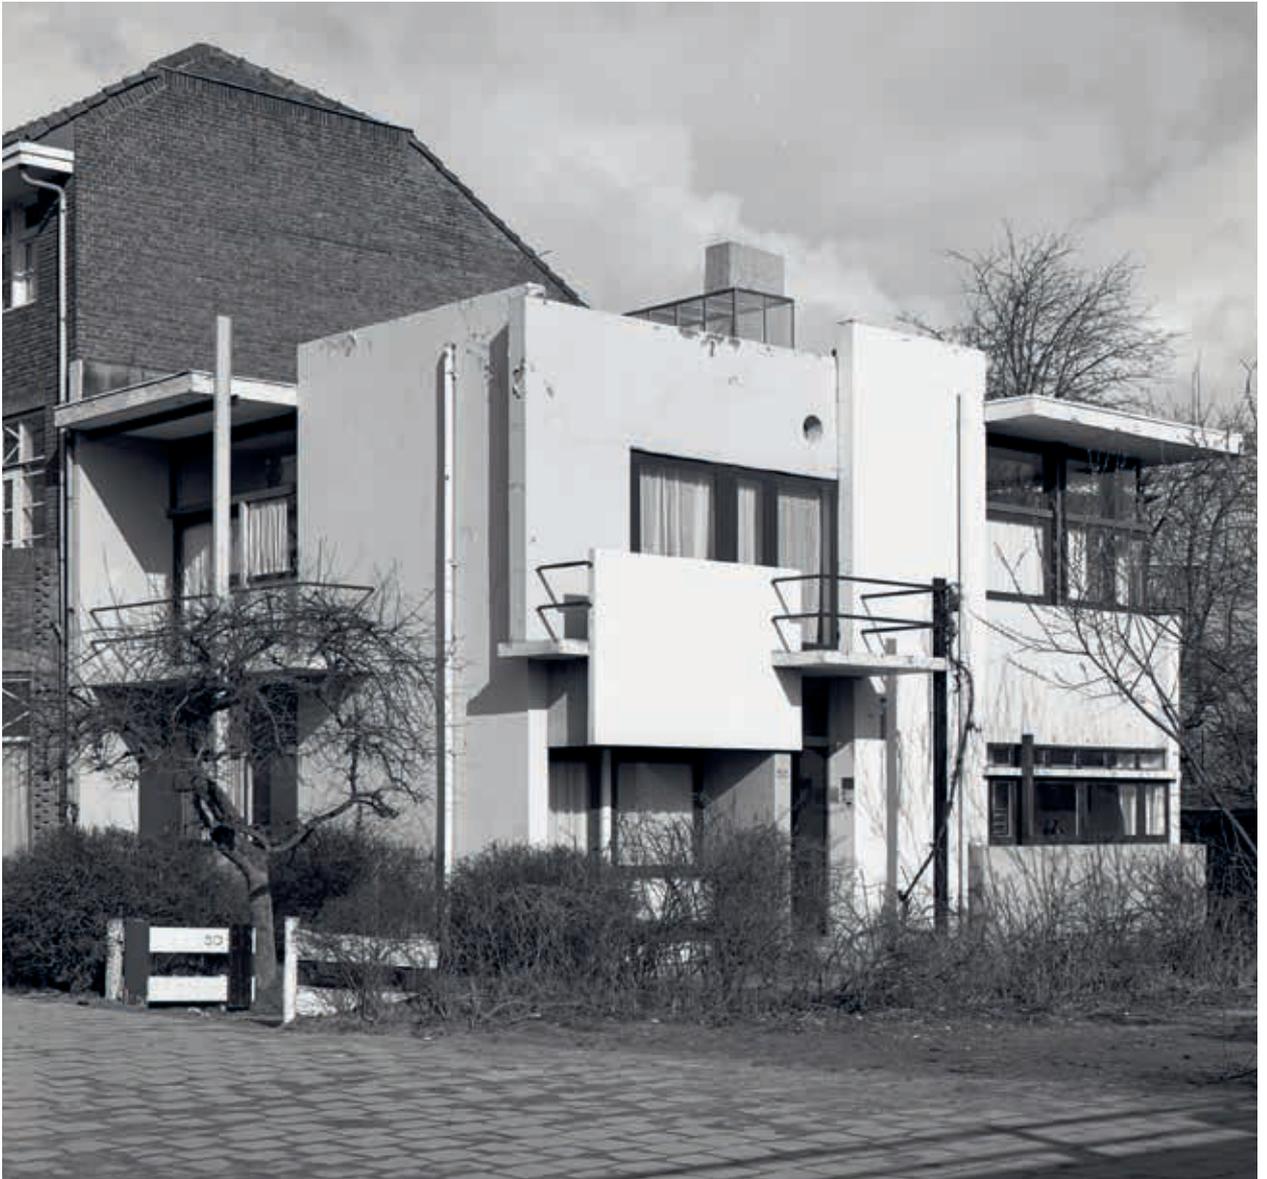
2. At the beginning of the 1970s the poor state of repair of the Rietveld Schröder House was clearly visible (Het Utrechts Archive)

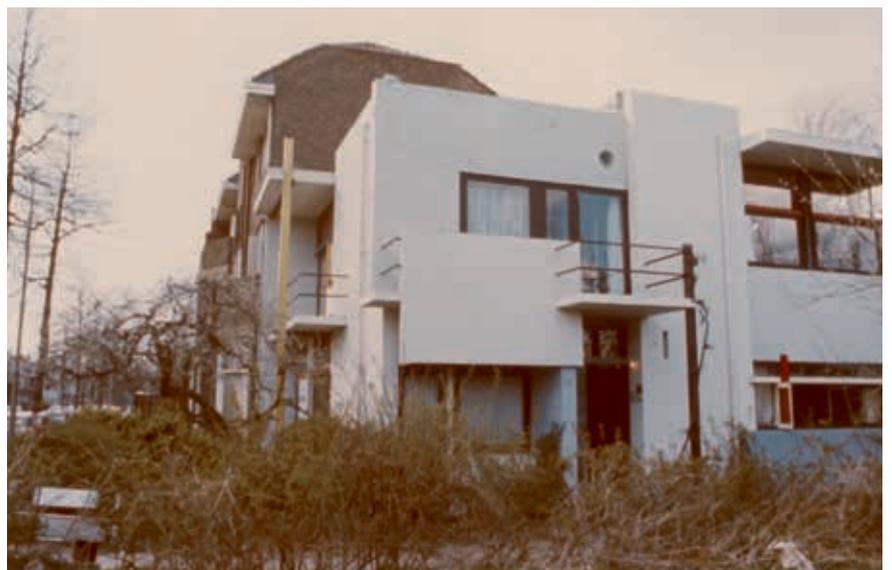
3. Just before the restoration the Rietveld Schröder House, the grey values and intensity of the exterior colour scheme were scarcely discernible; moreover, the greys had acquired a 'bluish' tinge (Rietveld Schröder Archive, CMU)

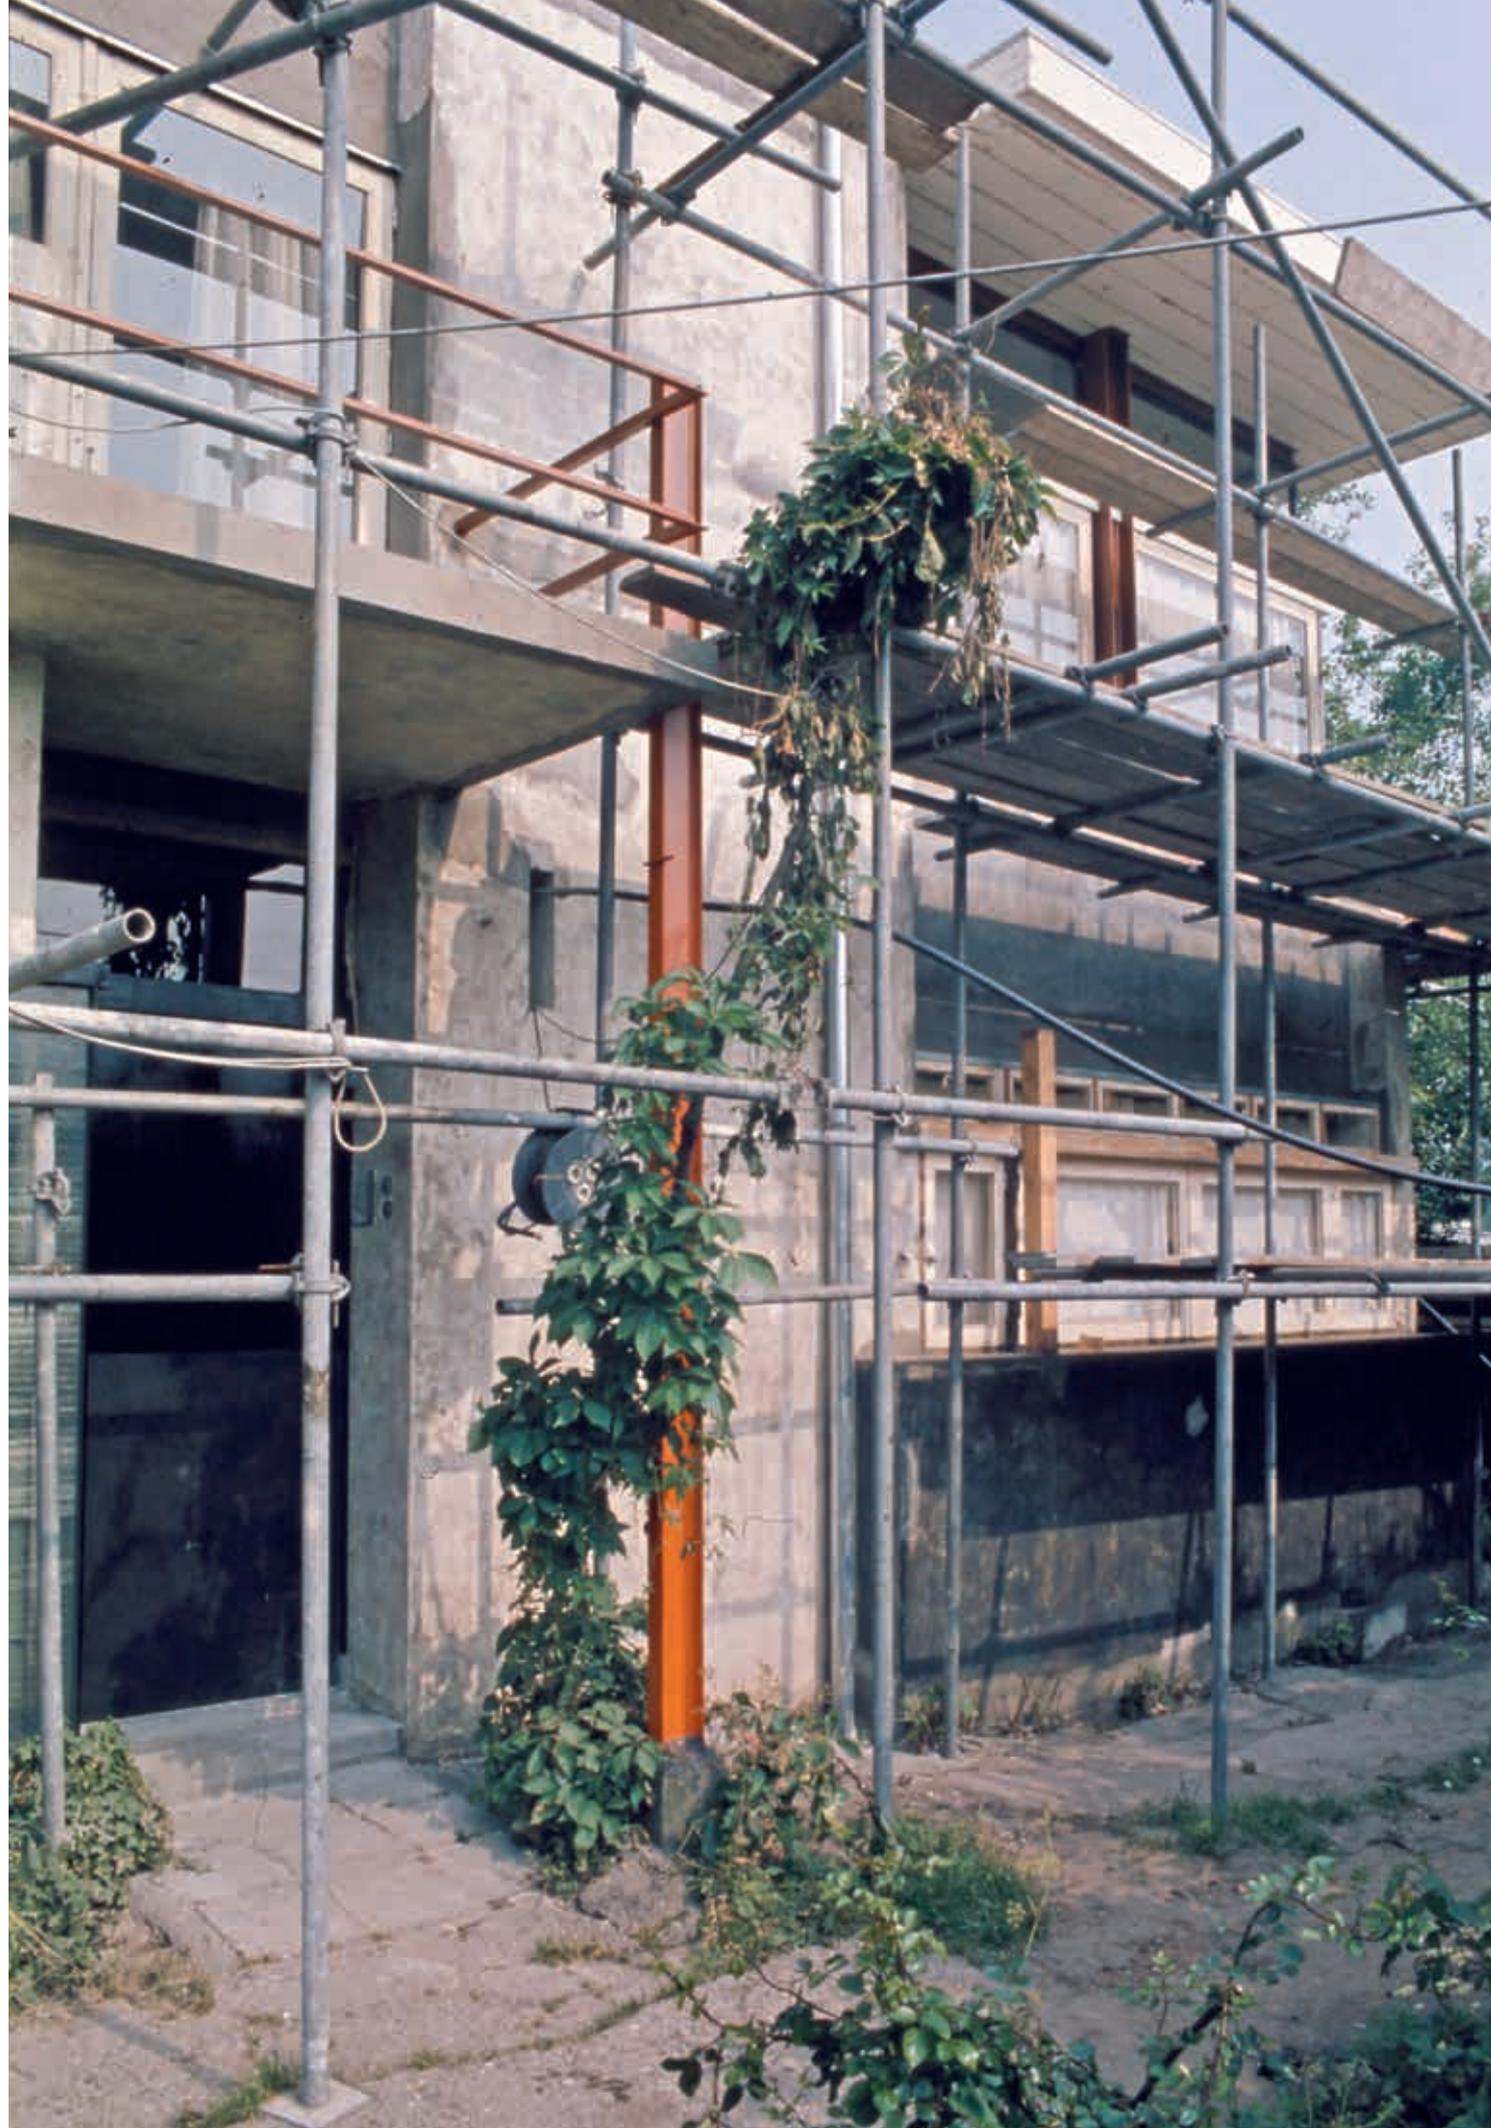
4. The Rietveld Schröder House in the scaffolding during the restoration of the exterior, 1974 (Rietveld Schröder Archive, CMU)

The restoration of the exterior was carried out between March and September 1974 (fig. 4). The house was not stable and was beset with problems that could be attributed to the unusual experiments with and combinations of traditional and modern materials (brick, steel, concrete) and to their properties. Moisture and rust had caused serious damage to walls and roof. In his contribution to *Het Rietveld Schröderhuis*

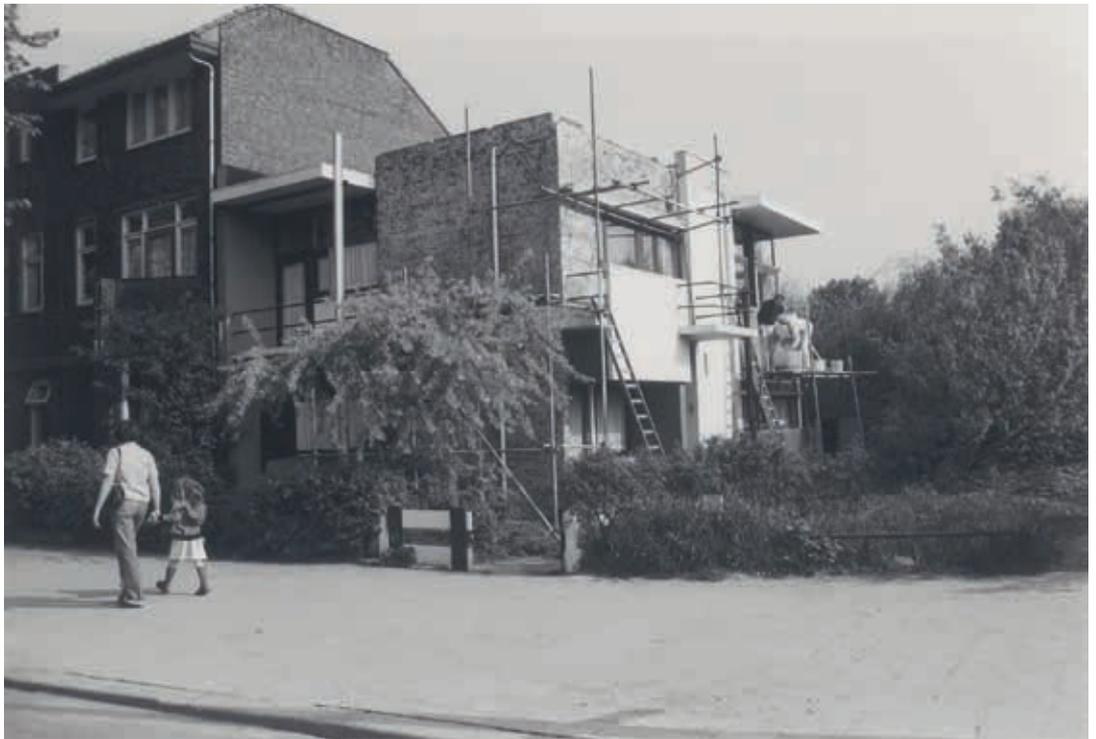
5. In 1979 the Rietveld Schröder House was once again scaffolded after the reappearance of the problems with the plasterwork. Large areas of render were first chipped away, after which a new coat was applied (Bertus Mulder archive)

Recent research has shown that the problems with the plasterwork soon returned. The paintwork was again exhibiting cracks, the new coat of render had failed to adhere, and there were dark patches in the coat of paint. In October 1975, therefore, the new plasterwork was partially removed and redone. But the hairline cracks returned once more. Eventually, in late 1978, Mulder and the client decided to strip the problematical wall back to the brickwork. That substrate proved to be homogeneous and of reasonably good quality. The earlier repairs with synthetic mortar had held up well. Mulder's report on this (1980) contained a notable sentence: 'The other plasterwork that had remained in place during the restoration had to be removed as well in order to obtain a single homogeneous layer of render and to avoid bonding problems between old and new work.'²¹ This statement would appear to imply that Mulder stripped all the walls and then had them replastered and repainted, which is what the photographs also appear to show (figs. 5 and 6). But if we examine the photographs more closely, we can also see areas with the render still intact, such as the wall below the ground-floor window overlooking Prins Hendriklaan. Mulder recently recalled that plaster remained in place on the wall beneath the kitchen window and on parts of the white surfaces of the front entrance wall and the rear wall (fig. 7)²²

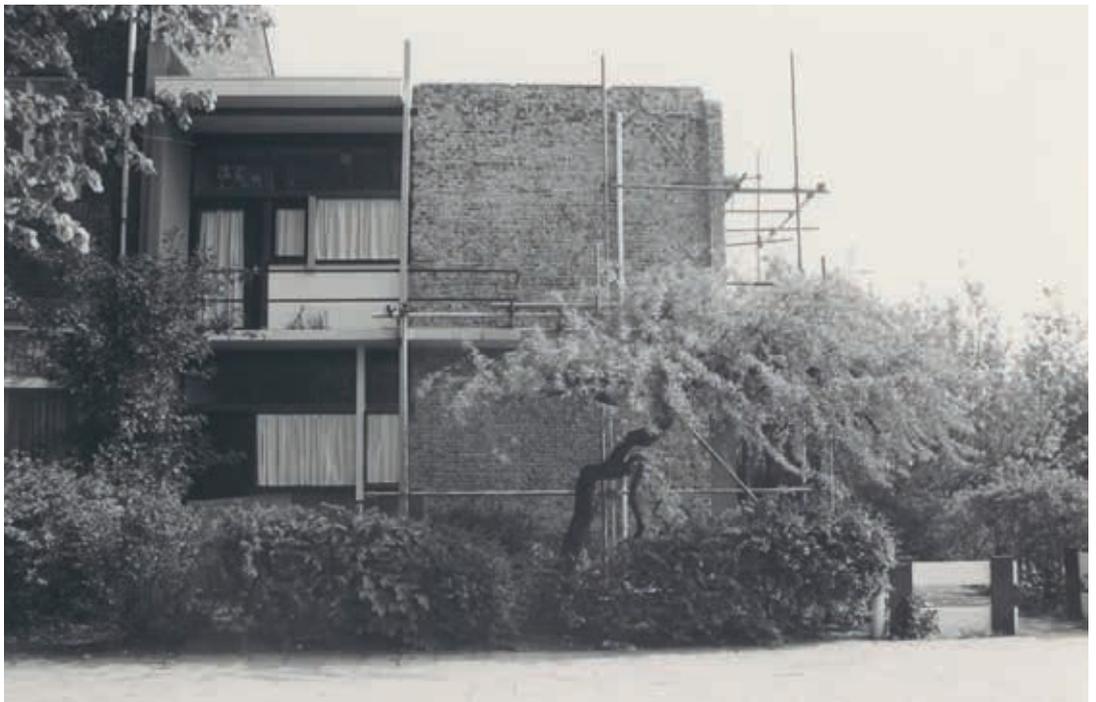
6. The bare brickwork of the wall on Prins Hendriklaan in 1979. On the wall below the window of Rietveld's former studio (bottom left) render is still visible (Bertus Mulder archive)

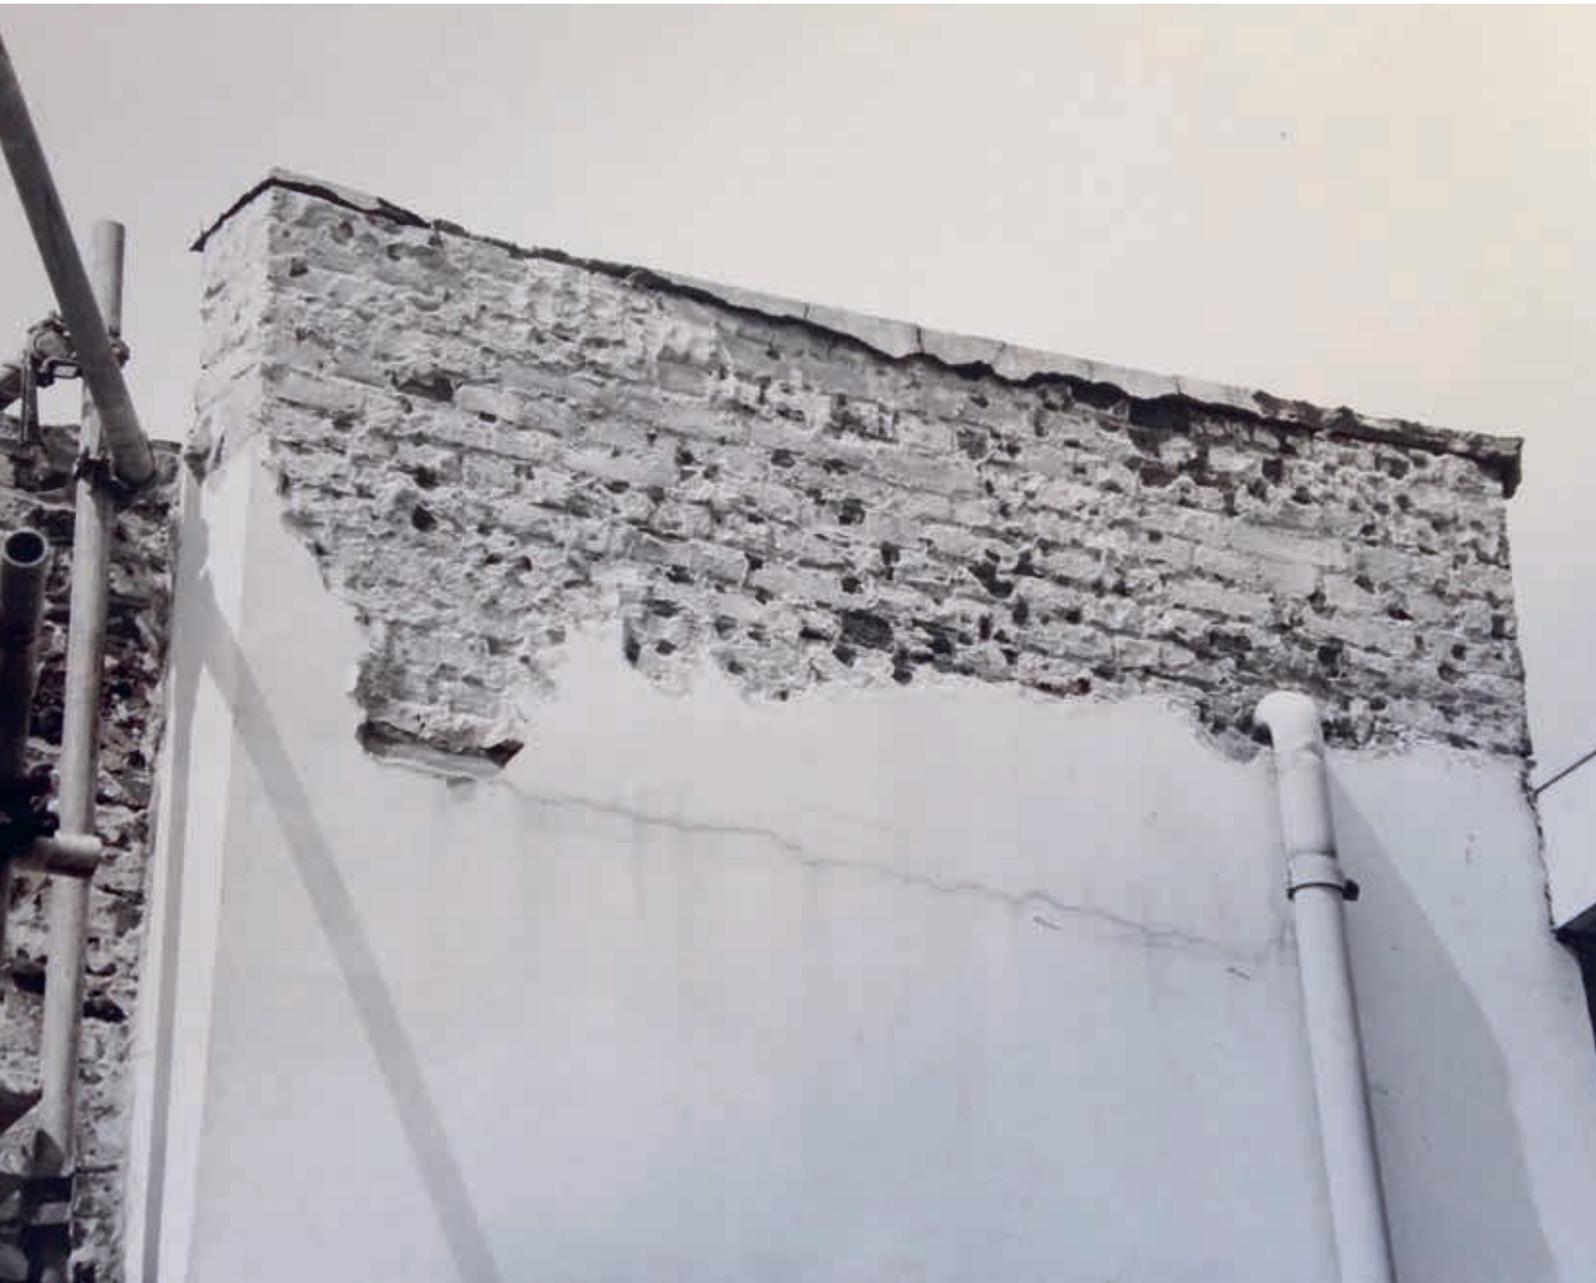
7. Only the render on the upper part of the white wall beside the front door of the Rietveld Schröder House was chipped away in 1979 (Bertus Mulder archive)

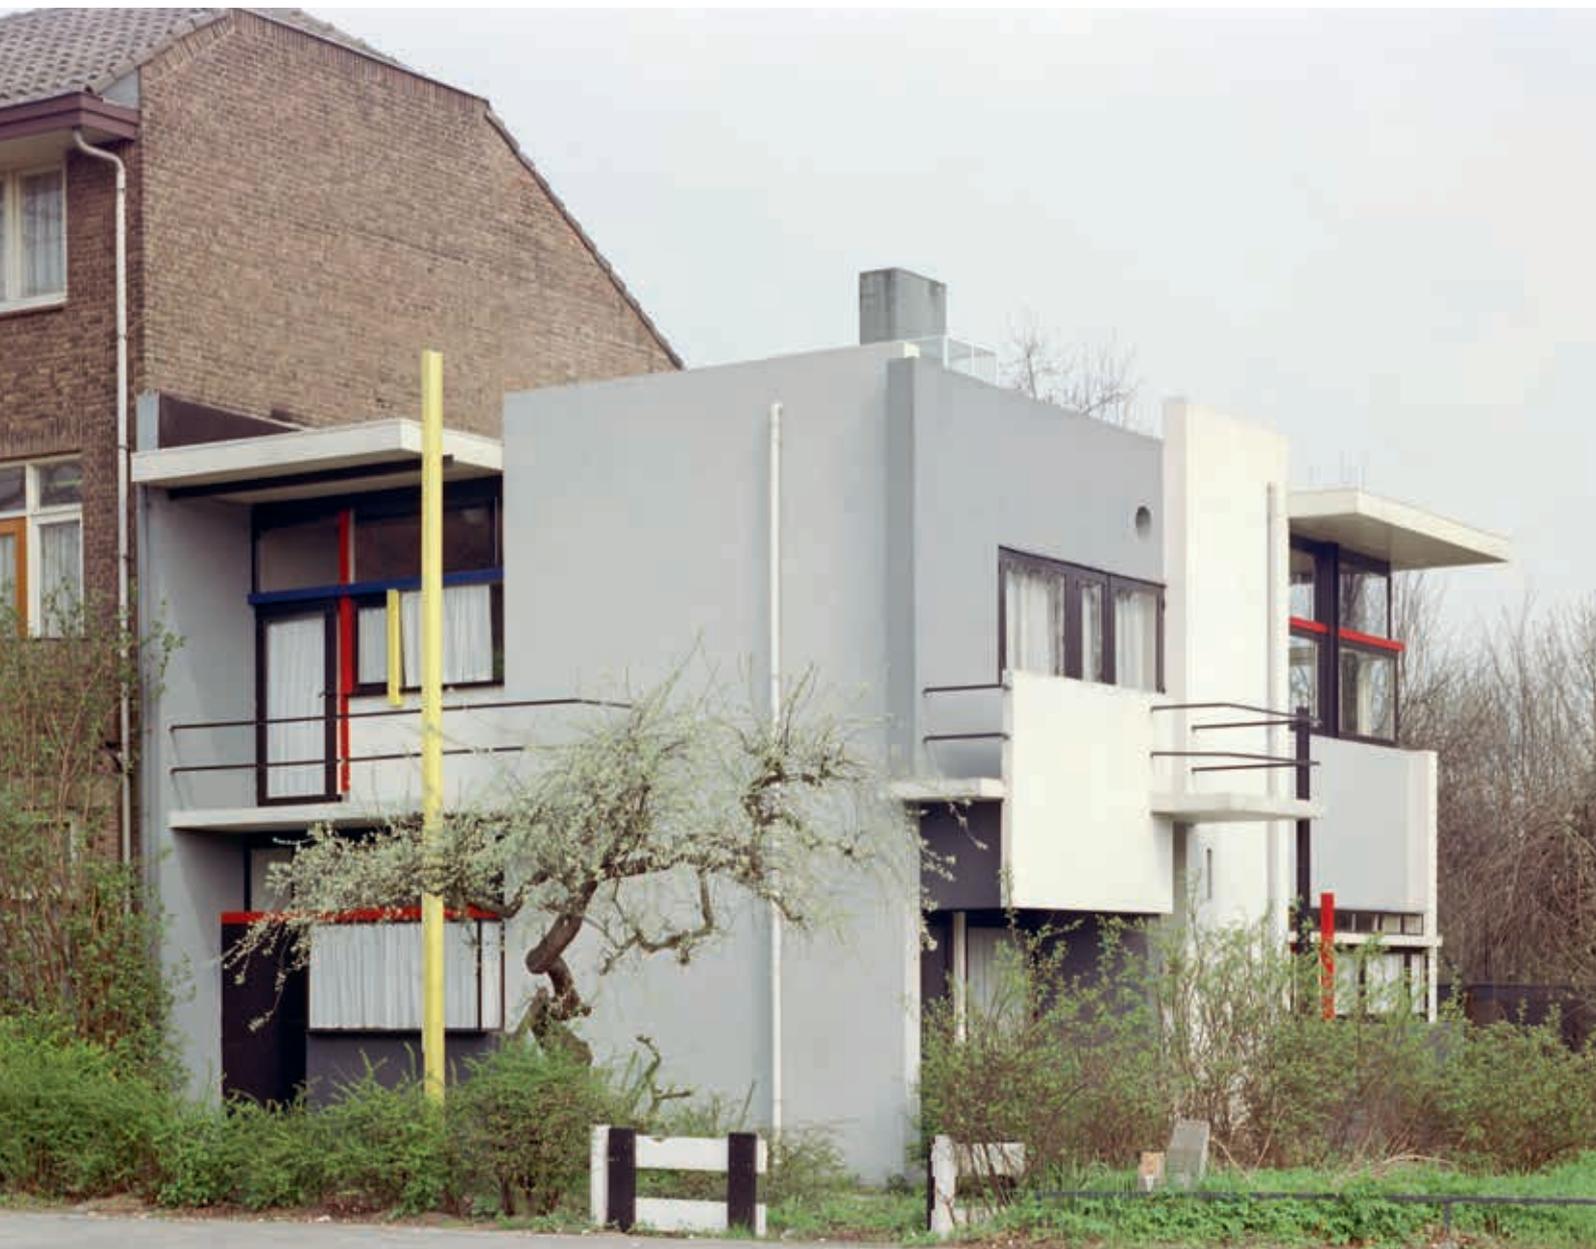
8. The exterior of the Rietveld Schröder House in a new colour composition to a design by Bertus Mulder, photo 1981 (Het Utrechts Archive)

After the problems with the plasterwork had been rectified, the house was repainted in 1979 (fig. 8). Mulder used a durable wall paint from Sikkens – Alphatex IQ – which he considered suitable for a house with single-leaf brick walls that ‘ventilate on all sides’.²³ After a bit of experimenting, Rietveld had opted for paint from Alphaverf, later taken over by Sikkens, which has supplied the paint for the (Rietveld) Schröder House ever since.²⁴ Mulder repeatedly stressed that deciding on the colour scheme, especially the shades of grey, was the most difficult task of the entire restoration.²⁵ The reflection of light on walls and in colours was very important for Rietveld. From the 1920s onwards he

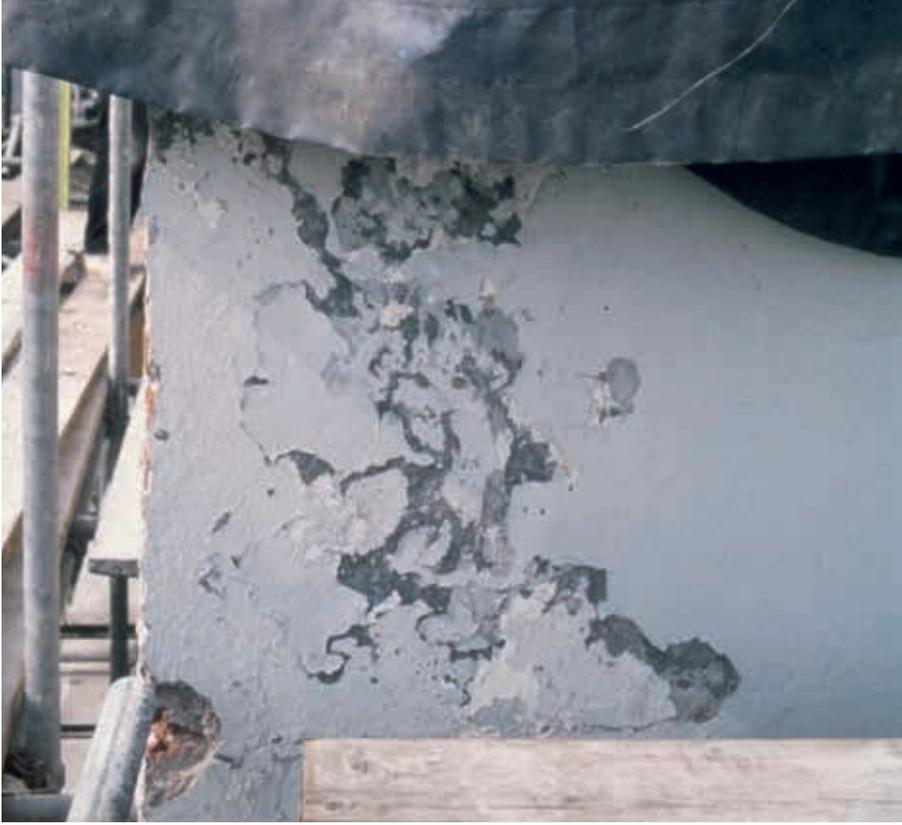
9. In several places, such as here on the chimney, Bertus Mulder discovered various remnants of render and finish coats (Bertus Mulder archive)

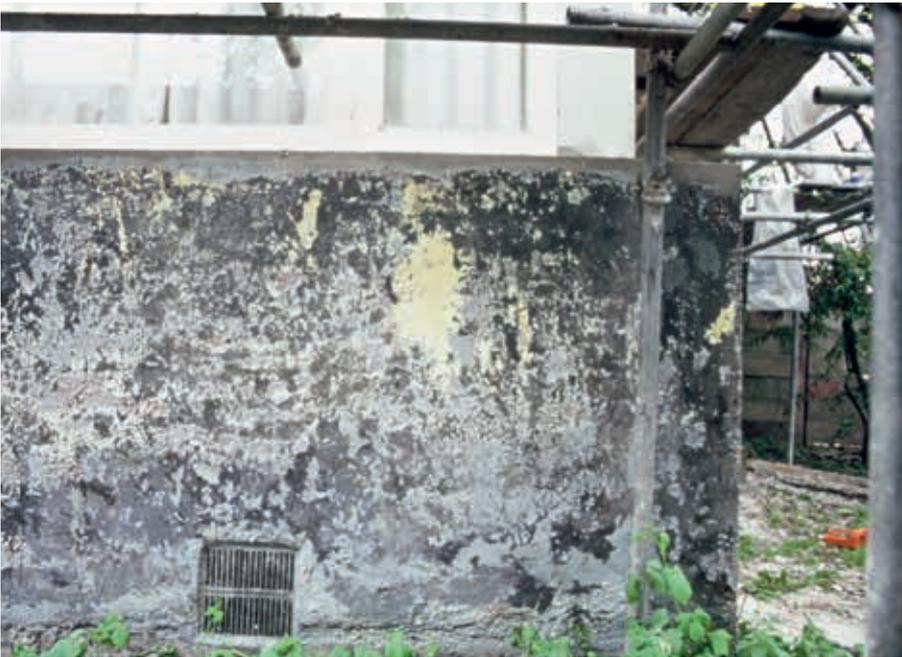
10. Various shades of grey came to light on the window below the kitchen window. Bertus Mulder based the grey for this surface on the dark grey in the top right corner (Bertus Mulder archive)

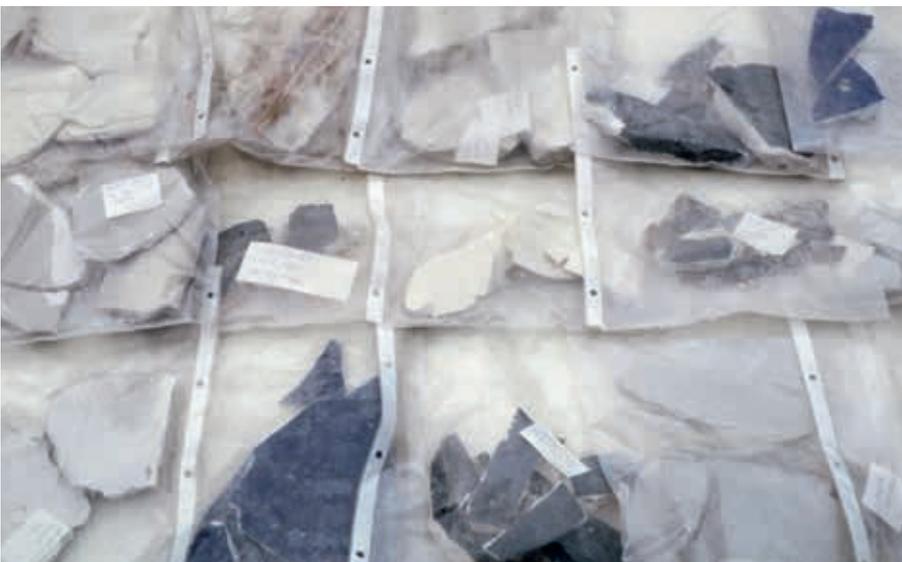
11. Samples of render and colour were initially collected and sorted for the colour research; afterwards they were thrown away (Bertus Mulder archive)

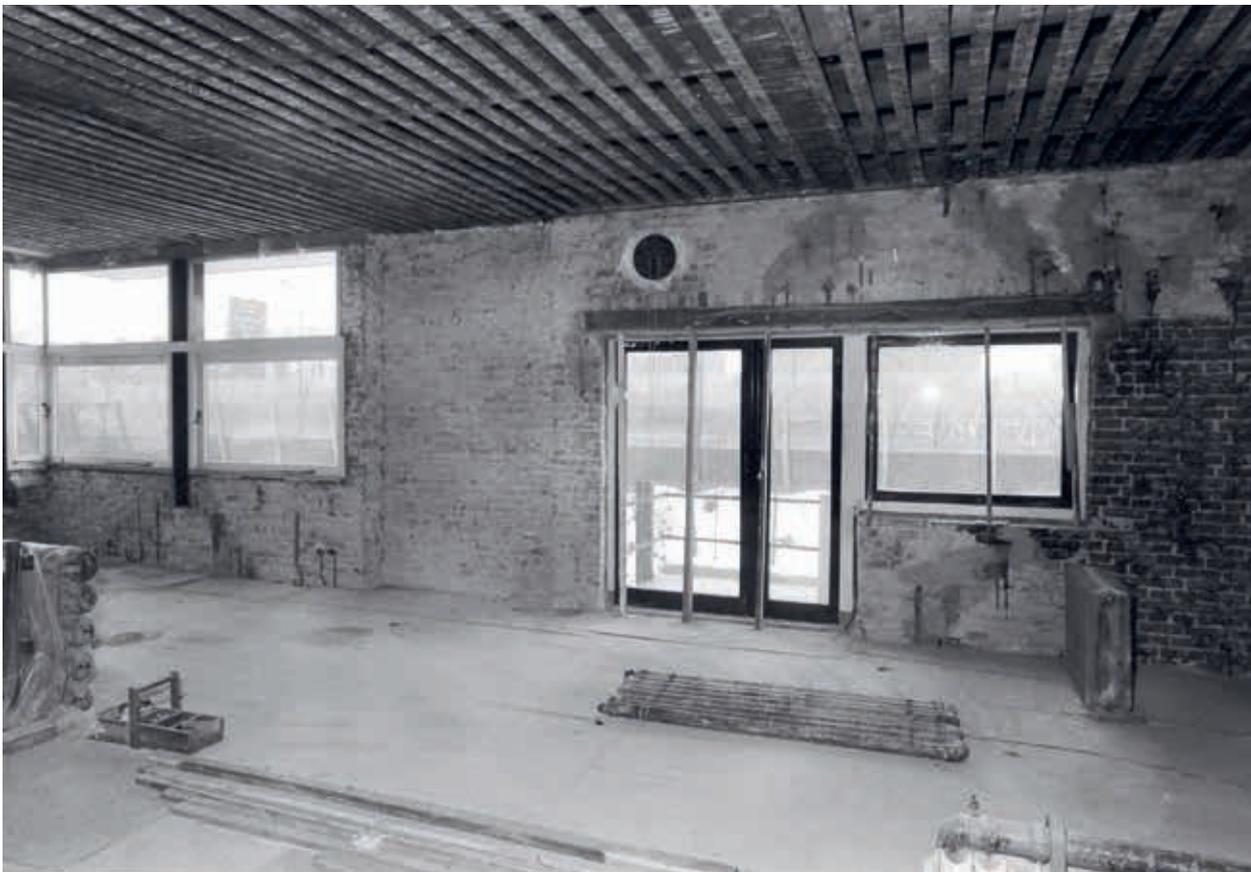
14. During the restoration of the upper floor of the Rietveld Schröder House in 1985-1986, Bertus Mulder completely stripped the walls and ceiling (Bertus Mulder archive)

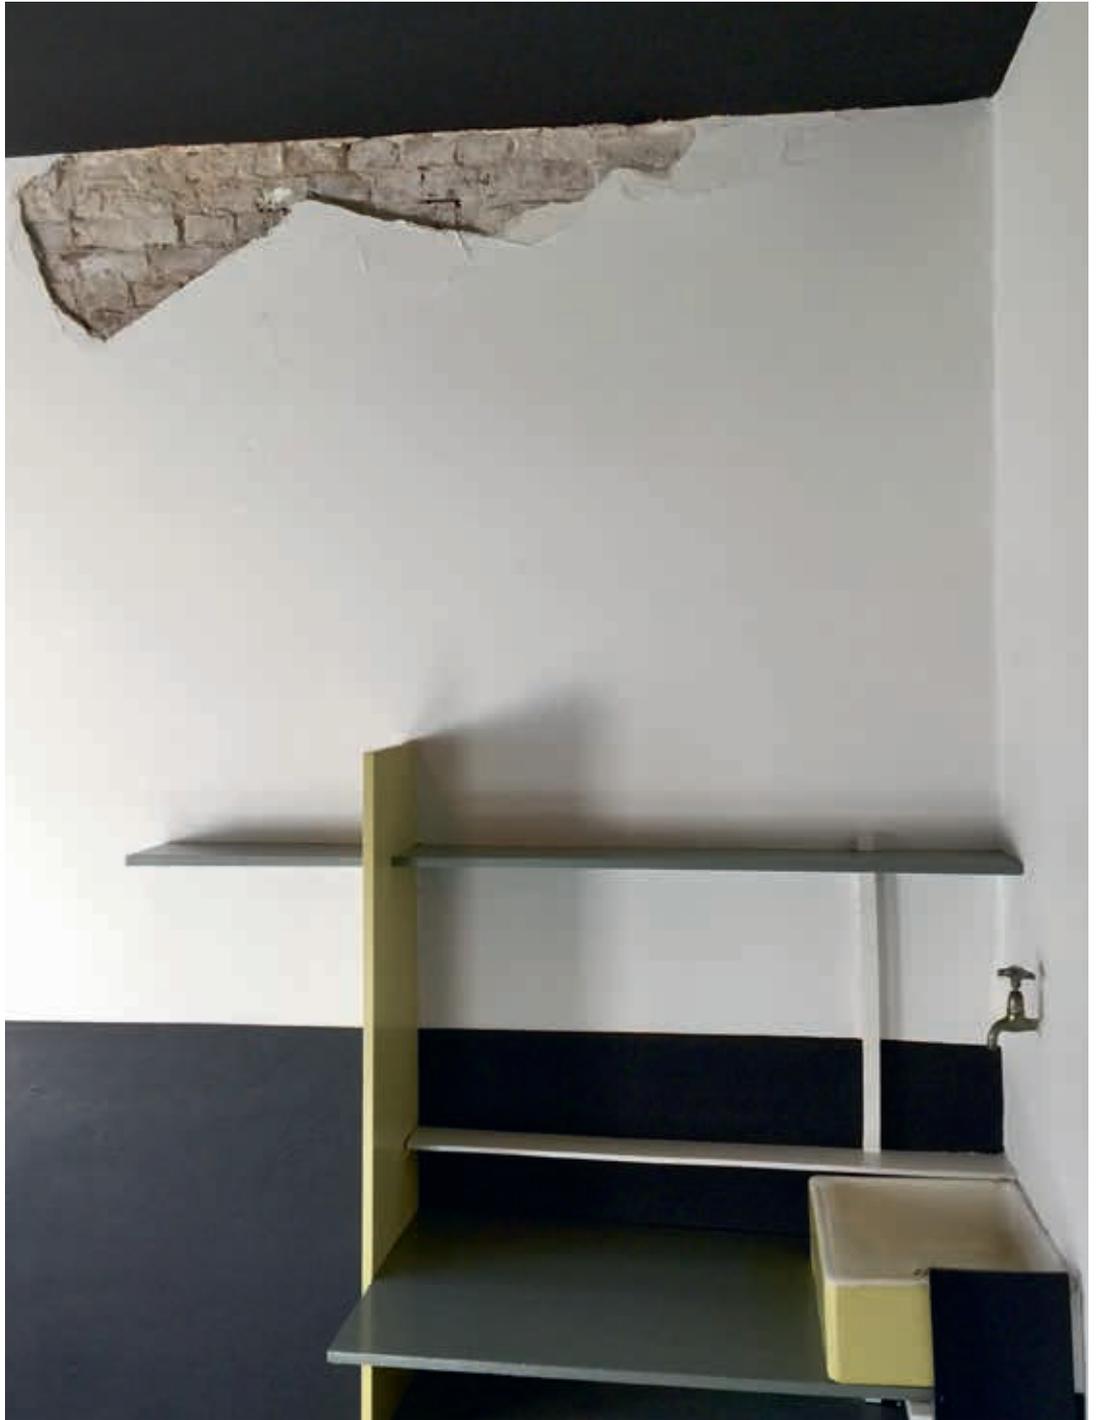
15. In October 2016 a piece of plaster came loose on the south wall of the study on the ground floor of the Rietveld Schröder House, photo Edgar Riessen (CMU)

repainted in the same colours that he encountered there. The ground floor was, in his eyes, of less importance for the architectural value.³⁹ In October 2016 a piece of plaster came loose from a wall in the study (fig. 15). This turned out to be a blessing in disguise because it provided an opportunity to have the plaster analysed by TU Delft and the TNO (Netherlands Organisation for Applied Scientific Research). TNO concluded that the sample could well be a remnant of the original plaster.⁴⁰

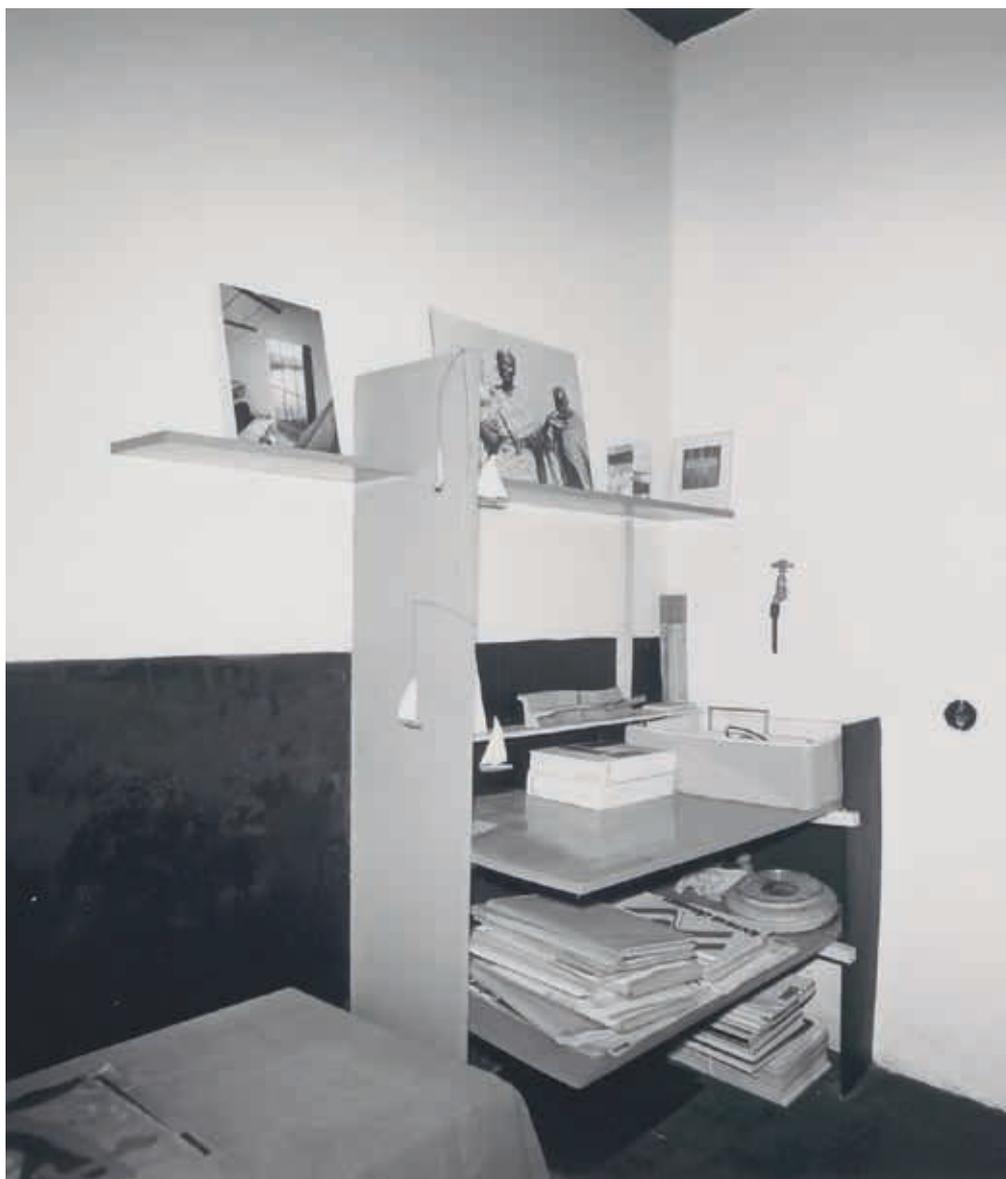
16. The south wall of the study on the ground floor of the Rietveld Schröder House, undated historical photo (Bertus Mulder archive)

reasonable to surmise the continued presence of some original plaster plus finish coats on both the exterior and the ground-floor interior (fig. 16). Accordingly, TNO and Stichting Restauratie Atelier Limburg (SRAL) conducted a limited follow-up investigation (fig. 17).⁴¹ The results confirmed the supposition: the Rietveld Schröder House still contains material remnants of the exterior and interior skin from the 'Rietveld period', be it highly concentrated in specific areas. SRAL was also able to state that parts of the ground floor had been repainted three times since the restoration, in colours that deviate from both the restoration period and the period(s) before that.⁴²

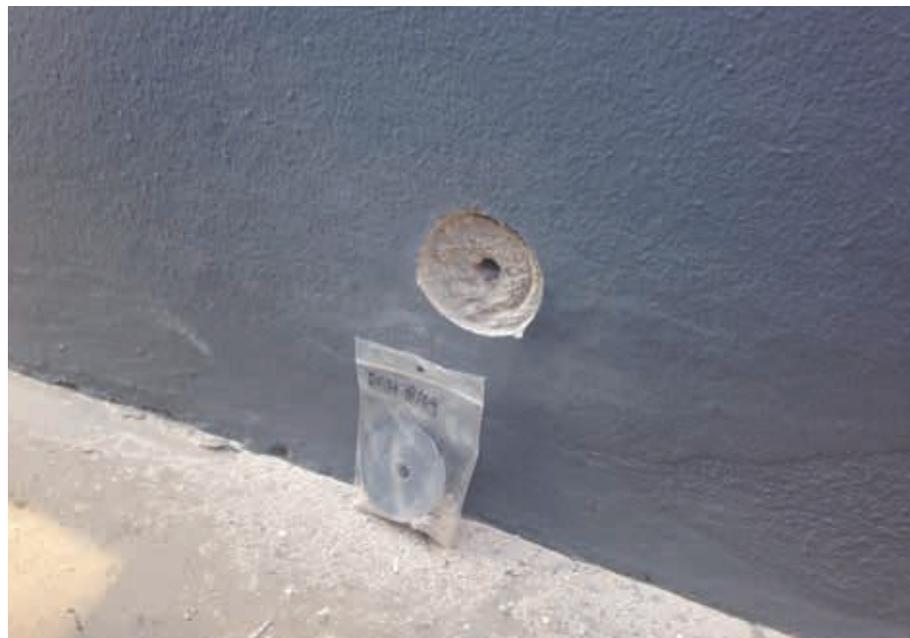
17. In 2018 TNO and Stichting Restauratie Atelier Limburg took samples from specific areas of the exterior and the interior of the Rietveld Schröder House. The photograph shows a sample from the balcony wall on the east elevation (photo author)
