Measuring damage in physical model tests of rubble mounds

Coasts, Marine Structures and Breakwaters 2017

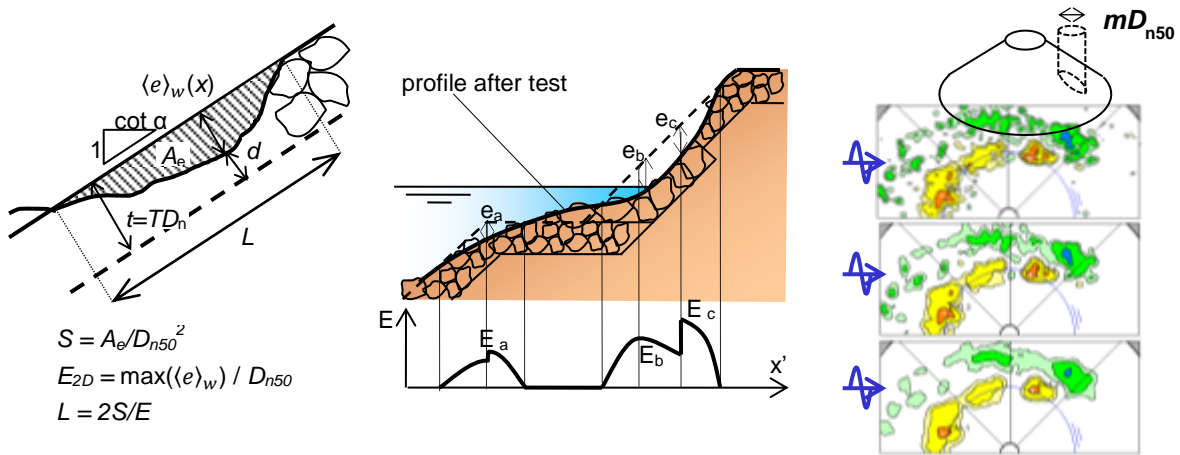
Figure 1. Left: definition of damage numbers S and E_{2D} on width-averaged 2D trunk profile. Middle: variation of E_{2D} on a non-standard cross-section. Right: pattern of E_{3D} on a roundhead smoothed with different filter size ($2D_{n50}$, $3D_{n50}$, $5D_{n50}$ – from top to bottom). From Hofland *et al.* (2011, 2014).

where α is the structure slope. In this definition, erosion of the profile is positive. Damage to rubble mound structures is classically based on either the number of rocks that are displaced during a test (storm), or by the area of the cross-section of the damage hole (dimensionless erosion area S , Broderick, 1983; Van der Meer, 1988; see left panel in Figure 1):

where $\langle \rangle_{mD_{n50}}$ indicates a spatial average over a circular area with mD_{n50} diameter. In the right panel of Figure 2 the influence of the filter size m on the determined damage depth at a roundhead is illustrated. The optimal size of the filter size, a compromise between accuracy and resolution, is not known yet, but is expected to be in the range of 3 to 5 times D_{n50} . As a flume test from which E_{2D} is determined is typically $20D_{n50}$ wide, the filter size for E_{3D} would have to be about $m=4$ or $m=5$, in order to obtain a similar accuracy (determined by the number of potentially moving rocks).

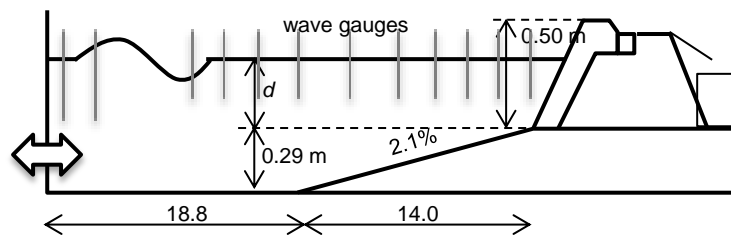
Figure 2. Model setup in LNEC flume.

A first test series was carried out to obtain damage scans for a standard wave flume case. These tests were done at the LNEC laboratory in a 50 m long, 1.2 m deep wave flume with an operating width of 0.8 m. The flume is equipped with a piston-type wave-maker that combines both irregular wave generation and dynamic absorption of reflected waves through the use of two wave gauges located in front of the paddle. Ten additional resistive-type wave gauges were deployed along the flume and an extra gauge was placed on the model armour layer slope to measure run-up levels (not analyzed presently). The breakwater model was built and operated according to Froude’s similarity law, with a geometrical scale of 1:30, to ensure reduced scale effects (the wave height-based Reynolds number was $D_{n50}\sqrt{gH_s}/\nu > 3 \times 10^4$). The reference breakwater cross section was built on a 14 m long and 0.29 m high foreshore. The breakwater model was 0.8 m ($18D_{n50}$) wide and composed of a main armour slope of 1:2, $2D_{n50}$ thick, with $D_{n50} = 0.0445$ m, with a single filter layer and permeable core below, as shown in Figure 2. The armour crest was 0.5 m above the structure toe. A concrete superstructure was also included, with its crest level 1.7 cm below the armour crest. The width of the armour layer crest seaward of the crest element was 19.7 cm.

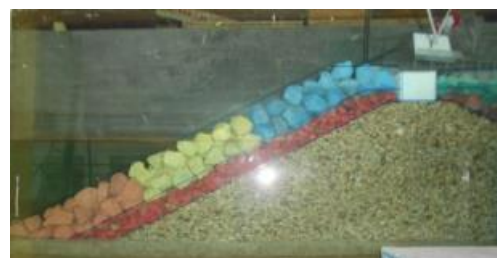
Figure 3. Model setup in LNEC flume.

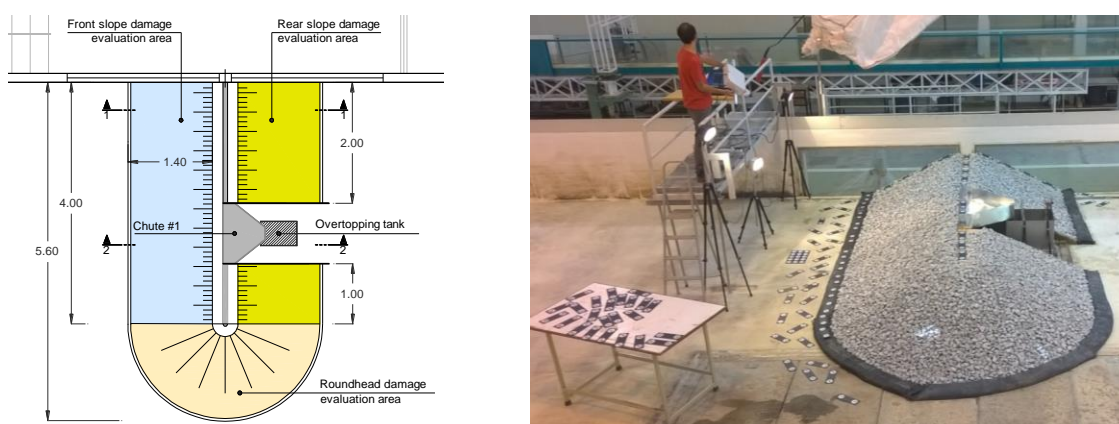
Figure 4. Model setup in FEUP basin. Left: plan view, right: damage measurement.

The tests were carried out in the multidirectional wave basin of the Hydraulics Laboratory of the Hydraulics, Water Resources and Environment Division of FEUP (28.0 m long, 12.0 m wide and 1.2 m deep), which is equipped with a 12.0 m wide segmented wavemaker with active reflection absorption. A reference rubble mound breakwater was reproduced on a geometric scale of 1:35. The breakwater model was 5.6 m long, 3.1 m wide and 0.68 m high, Figure 4. The armour layer was composed of a double layer of rock ($2D_{n50}$ thickness), with $D_{n50} = 32$ mm and $D_{n85}/D_{n15} = 1.25$, placed on a rubble mound core, with $D_{n50} = 11.6$ mm. The slope angle was 1:2. The overall crest width was 0.42 m and a 0.10 m wide superstructure was placed at its centre. The armour was supported by a toe materialized by cylindrical sand bags. The breakwater core was enclosed in a mesh to avoid movement of the core materials, while maintaining the desired level of permeability (~40-50%). A 4.0 m wide trunk section was placed perpendicularly against the straight sidewall of the basin, and a semi-circular roundhead was placed at its other side. The slope angle and the armour layer thickness were equal for all trunk and roundhead sections. The armour layer on the rear side was interrupted to allow the installation of a reservoir to collect the overtopped water, allowing the measurement of the overtopping discharges and volumes, which are treated in a companion paper (Silva *et al.*, 2017).

The water free surface elevation was measured using standard resistance-type wave gauges. A set of four aligned gauges was placed in front of the model in order to determine the characteristics of the incoming waves. For the tests with short-crested waves, a setup with six gauges in a CERC6 array was applied (Davis & Regier, 1977). The damage in the structure was measured using a stereo-photography technique (Raaijmakers *et al.* 2011). The structure was photographed with a set of hand-held double-cameras in a drained wave basin. Using a typical number of 50 photo pairs, point clouds of measurements were created before and after each test run. These point clouds were filtered and interpolated on a 1x1 mm grid. The post-processing steps are described in Hofland *et al.* (2011).

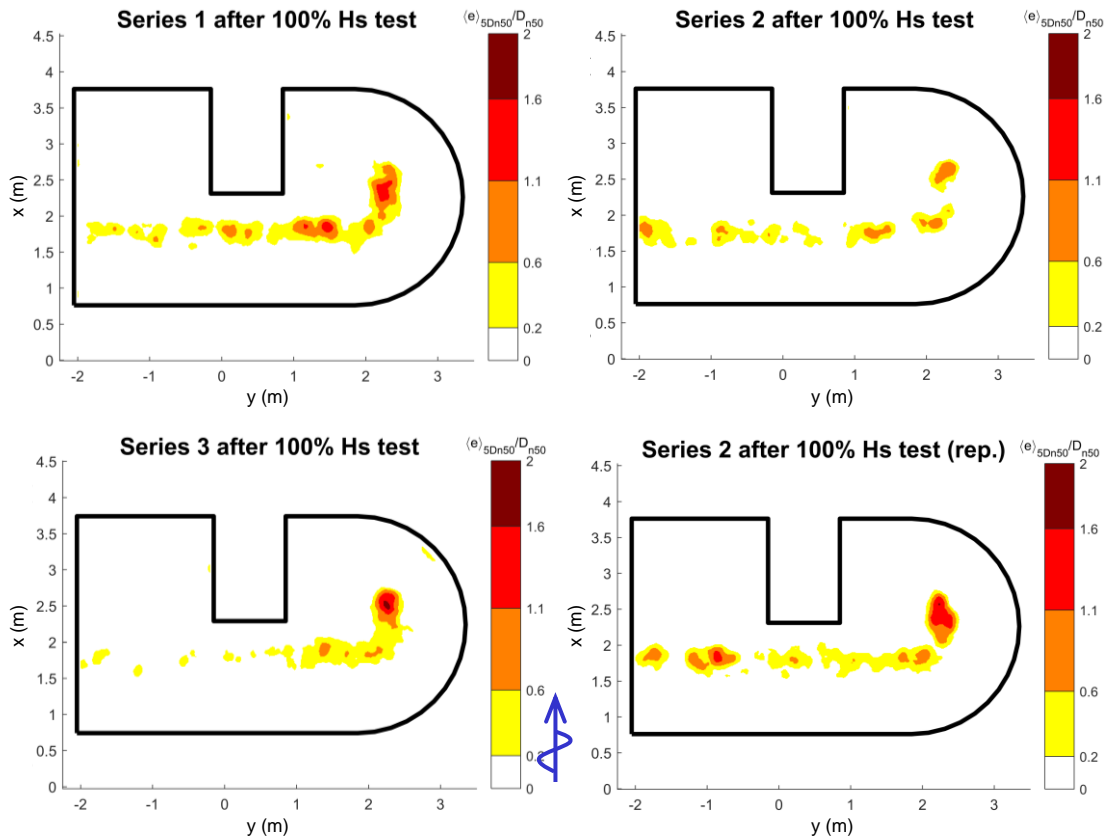
Figure 5. Erosion depth after the 100% test condition for Series 1, 2 (including repetition) and 3.

The trunk section of the breakwater model tested in FEUP wave basin was 4.0 m wide in order to get a large section where statistical convergence can be obtained for damage results. The damage after the 100% condition for the three test series and one repetition is depicted in Figure 5.

Some observations can be made based on Figure 5 results. On the seaward trunk slope adjacent to the roundhead, the damage is consistently larger for all test series. Therefore, this area is not taken into account for the analysis of the trunk section. Moreover, the two identical repetitions of the 100% condition of the second test series still give rather different results, so the scatter seems to be large. The results for Test Series 2 were obtained without the damage of two preceding tests (for 60% and 80% test conditions), while Test Series 4 was carried out with short-crested waves and in Test Series 3 the effect of SLR was already included.

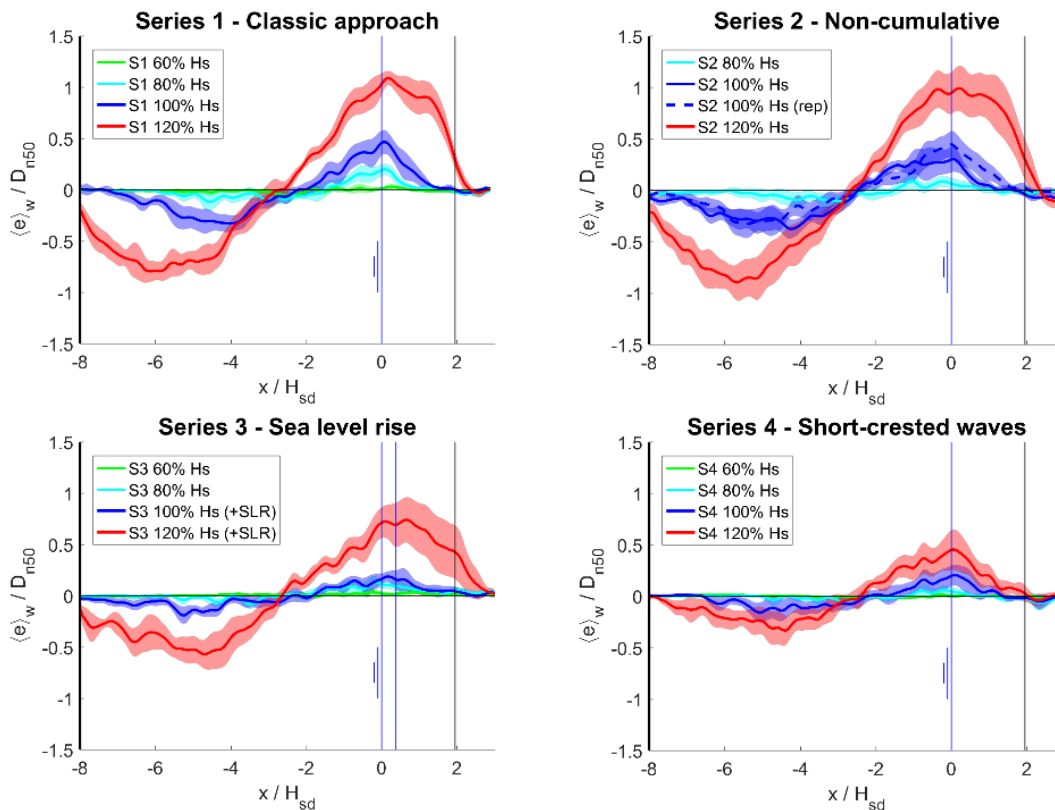
Figure 6. Width-averaged erosion profiles for the four test series with confidence band (shaded areas). Here x is the horizontal cross-shore coordinate, with its origin at the waterline.

It can be observed that the damage hole is deepest around the water line, see Figure 6. The size of the hole increases, as expected, with the wave height. For the last test (120% condition) the damage hole extends up to the crest (vertical black line). It can be noticed that for the wide measurement section that is applied, with a width of more than $100D_{n50}$, the confidence band of the results is narrow enough to clearly distinguish the damage stages for the various tests. For the test with the smallest wave height also the damage around the water line is determined with confidence, while at lower elevations (where rocks are both deposited and removed) the confidence band is wider.

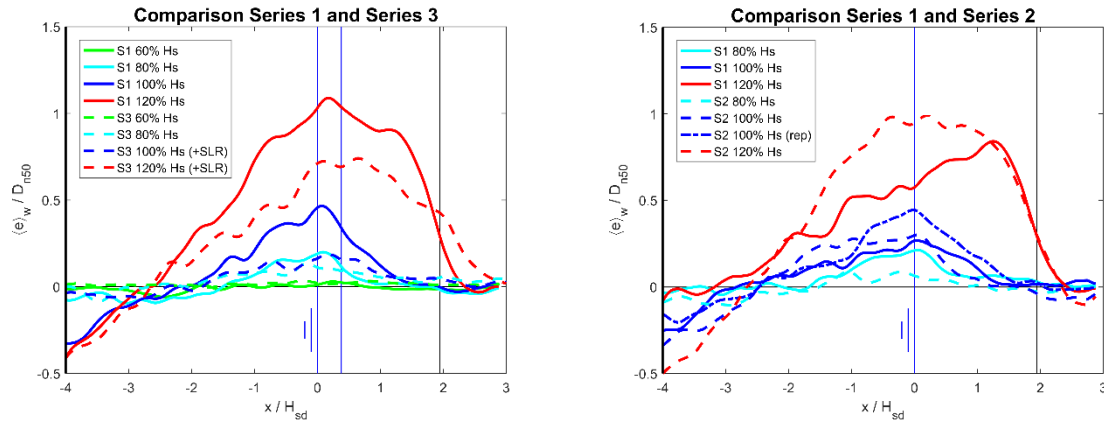
Figure 7. Left: width-averaged erosion profiles for Series 1 (constant WL) and 3 (SLR). Right: width-averaged erosion profiles for Series 1 (cumulative) and 2 (incremental).

The influence of a limited sea level rise (SLR) is demonstrated in the left panel of Figure 7 where Series 1 and 3 are compared. The first two tests (60% and 80%) are repetition tests with the same conditions. After the first two tests with a constant water level, the 100% and 120% tests are performed for a 2.3 cm higher water level in Series 3 (0.80 m SLR at prototype scale). The water level difference is relatively small (about 20% of the design H_s). Still a rather large difference might be observed in the results of Test Series 1 and 3: less damage in the tests carried out for the higher water level, while for the same water level very comparable damage levels were obtained.

The comparison of the cumulative damage case (no rebuilding after each test run) with rebuilding (a newly constructed slope for each test run) is shown in the right panel of Figure 7. As the damage in the model is not repaired before each test run in Test Series 1, the new inflicted damage is added to an already damaged slope. In this right panel only the additional damage that occurred during the specific test run is shown. There are clearly visible differences between the two test series. However, the test run that was repeated in Test Series 2 shows a much larger damage level.

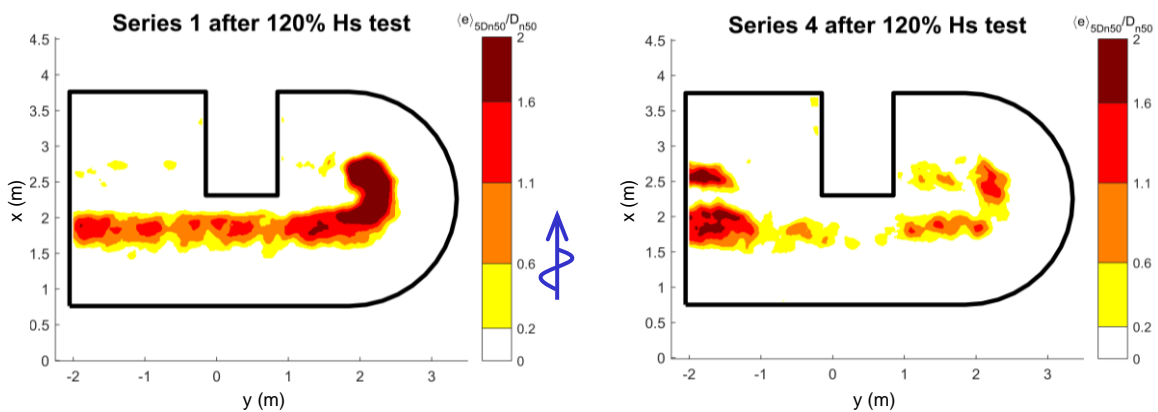
Figure 8. Erosion depth on breakwater trunk and roundhead after Test 4. Left: Series 1 (long crested waves). Right: Series 4 (short crested waves).

The damage to the structure for long-crested and short-crested waves is compared in Figure 8. In the tests with short-crested waves, extra damage occurred in the vicinity of the sidewall, due to the energy concentration resulting from the imperfect reflection on the sidewall of waves travelling with a direction not perpendicular to the breakwater. However, in the remainder part of the trunk, the wave conditions were similar and the results obtained can be considered valid. It can be concluded that the damage to the trunk is lower for the tests with short-crested waves. Also, the size of the damage hole created at the roundhead is smaller. The damage does seem to extend further around the roundhead.

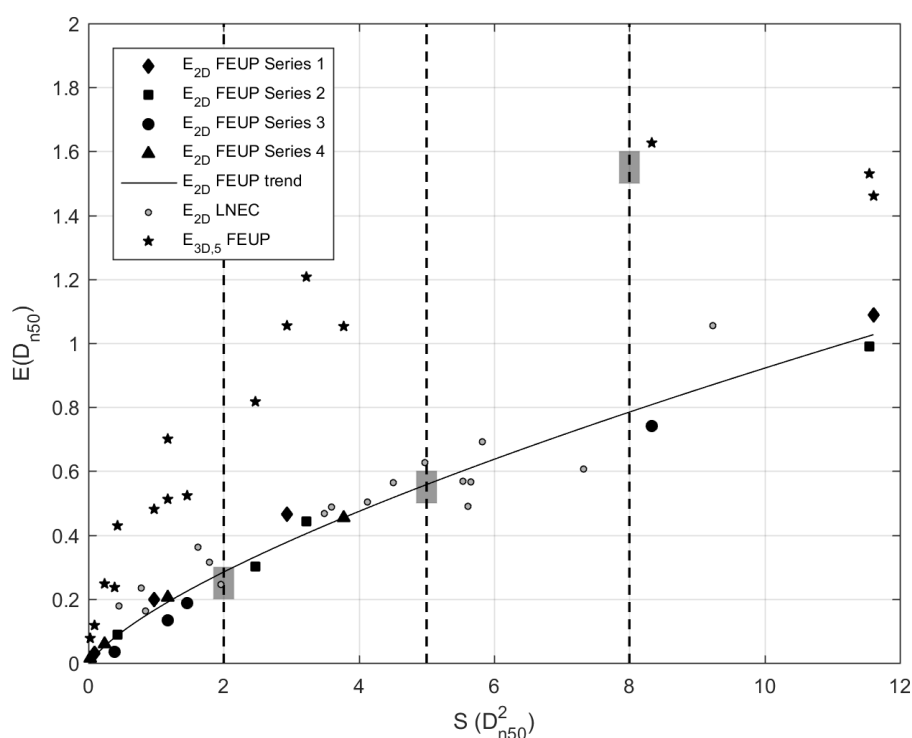
Figure 9. E_{2D} and $E_{3D,5}$ versus S . Dashed lines and grey areas: design values for S and previous design values for E_{2D} (Hofland *et al.*, 2011), respectively.

The results for FEUP and LNEC tests are depicted in Figure 9. The LNEC results, which were based on depth-limited conditions and varying wave steepness collapse with the deep water FEUP results. The scatter in the LNEC results seems somewhat larger. This might be due to the smaller width of the LNEC test section. Note that the parameter E_{2D} can be used for any slope angle, or combination of slope angles (*e.g.* berms). It can be seen that those tests give comparable values for E_{2D} as given in Hofland *et al.* (2011) for the initial and intermediate damage levels. Only the E_{2D} value for “failure” does not seem to match the definition of 2011. As the background of this definition is most objective, *i.e.* the exposure of the filter layer, this can be checked. Indeed for Test run 4 some locations were visible on the trunk where the erosion depth is $2D_{n50}$. Hence it seems that the design value for the mean erosion depth E_{2D} should be much stricter, around 0.8. It seems better to use this definition for

In addition to the E_{2D} values, $E_{3D,5}$ values for the trunk section are presented for all the test runs, obtained considering a circular spatial moving average of $5D_{n50}$ diameter. These values can also be used as design limits in 3D situations. It can be seen that these values are about two times larger.

Broderick stated that $S = 2$ (equivalent to $E_{2D} \approx 0.3$) was applied as start of damage, as that was the lowest discernible damage that could be measured. It can be seen that much lower damage quantities (i.e. $S \approx 0.5$ or $E_{2D} \approx 0.1$) can be measured using the presently used high-resolution techniques and wide test section.
