## Dealing with Heritage Assessment and Conservation

Lubelli, B.; Pottgiesser, U.; Quist, W.J.; Rextroth, Susanne; Naldini, S.

**Publication date**  
2021

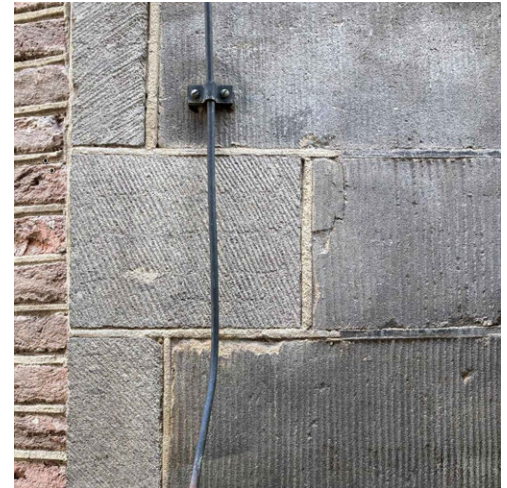
FIG. 2.7 Peperino Duro (left) used to replace Bentheim sandstone (right) in the Nieuwe Kerk in Amsterdam / Photo: W.J. Quist

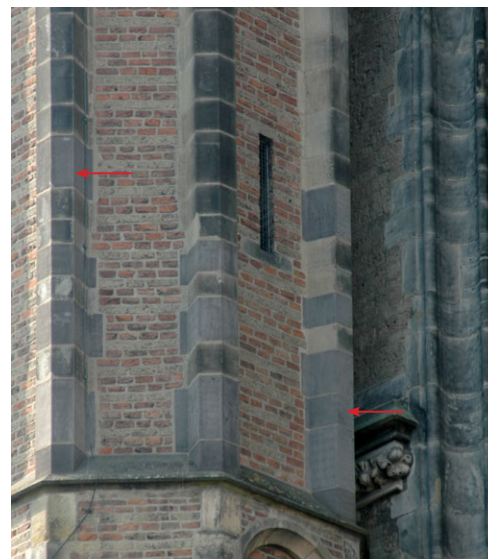
FIG. 2.9 Volvic basalt on the stair tower of the south transept of the Dom Church in Utrecht, as a replacement for Bentheim sandstone / Photo: W.J. Quist

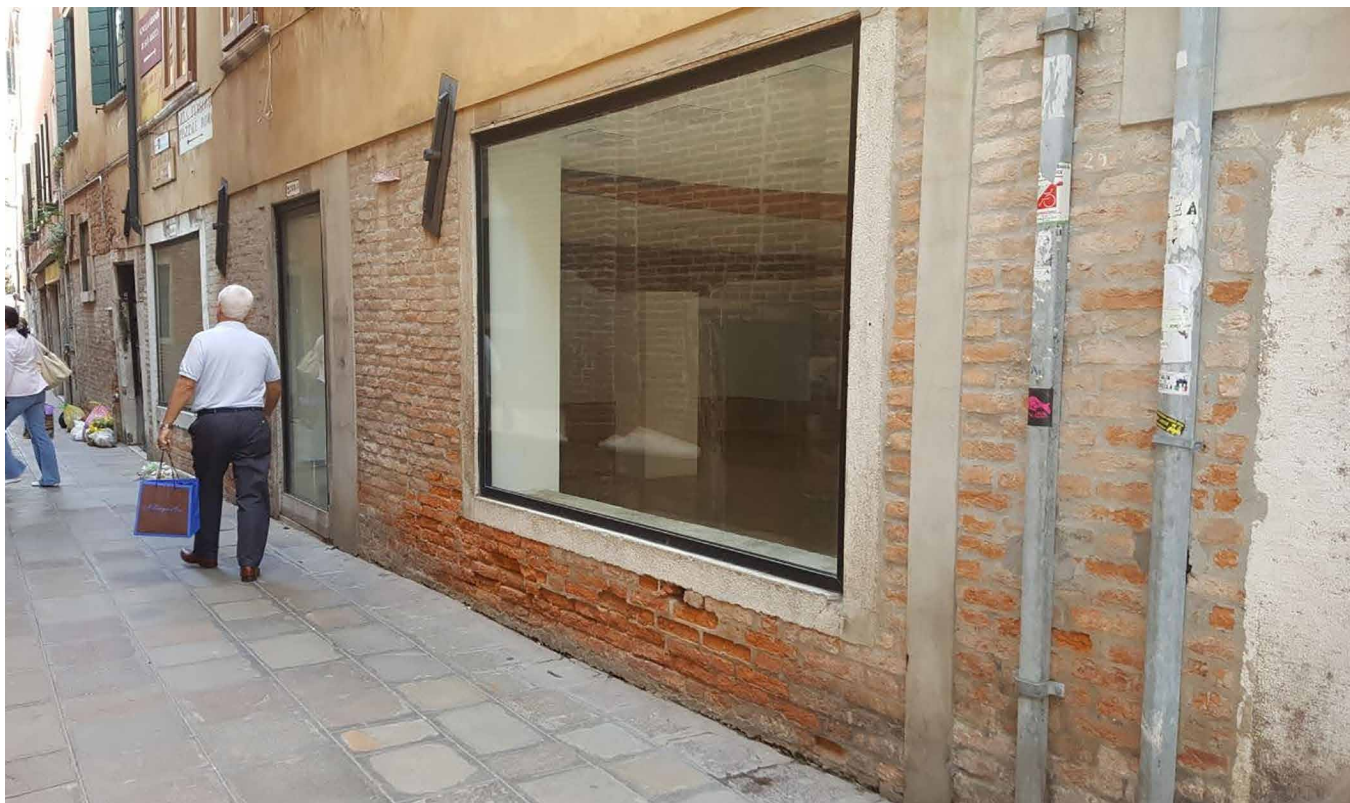
FIG. 3.1 Salt crystallization damage due to the presence of salts and rising damp, Venice, Italy / Photo: B. Lubelli

The phenomenon of rising damp is more common in old than in new constructions due to the fact that historic buildings often have masonry foundations and lack of a damp-proof course, i.e. a layer hindering the water transport from the ground to the upper part of the structure. The high moisture content deriving from the presence of rising damp does not only create an unpleasant and sometimes unhealthy climate in a building, but it also considerably enhances decay processes in the materials composing the wall, as for example the rotting of wooden beams and salt crystallization [FIG. 3.1]. and/or frost damage to brick and mortar. Unfortunately, due to climate changes (e.g. increased frequency of precipitation events with long and intense rainy periods, increased salinity of ground water), the occurrence and the relevance of rising damp will probably increase in the coming decades (Nijland et al., 2009; Brimblecombe, 2010; Sabbioni et al., 2010; Horowitz et al., 2016).

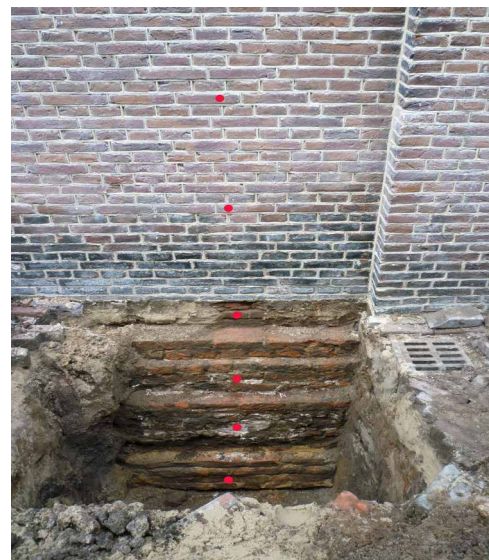
FIG. 3.13 Excavation of the ground around the foundation of the church and sampling, at different depths and heights in the wall along a vertical profile, for the measurement of the moisture content and distribution / Photo: B. Lubelli

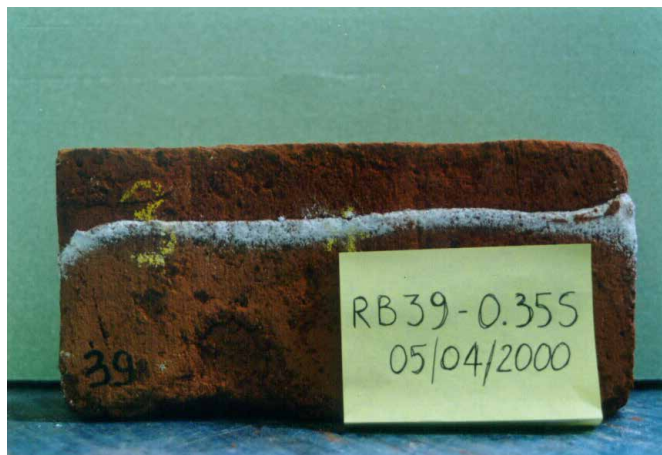
FIGS. 4.12/4.13 Salt accumulation beneath the layer treated with a water repellent (left) and subsequent spalling of the treated part (right) during a laboratory test / Photos: B. Lubelli

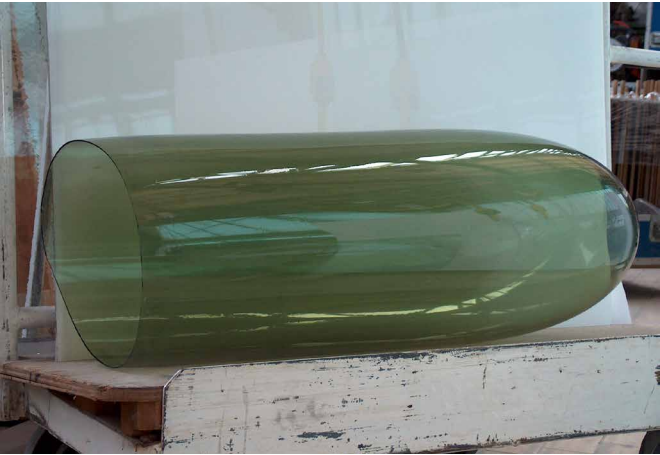
FIG. 5.5 Cylinder glass was another common glass types until 19<sup>th</sup> century / Photo: RCE

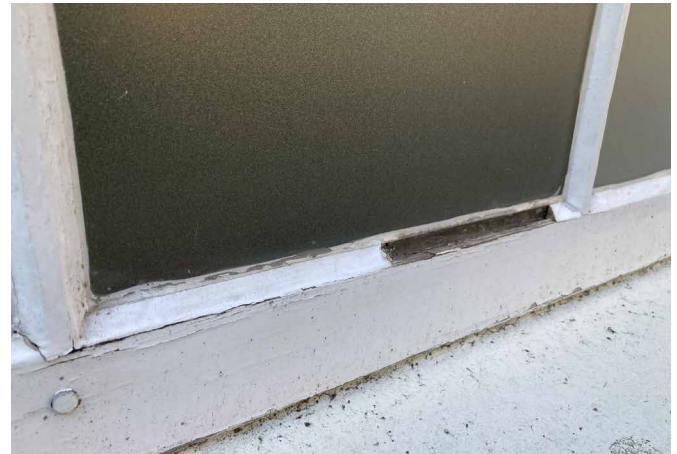
FIG. 5.18 Puttyed glass in wooden windowframe (in need of repair) / Photo: W. J. Quist

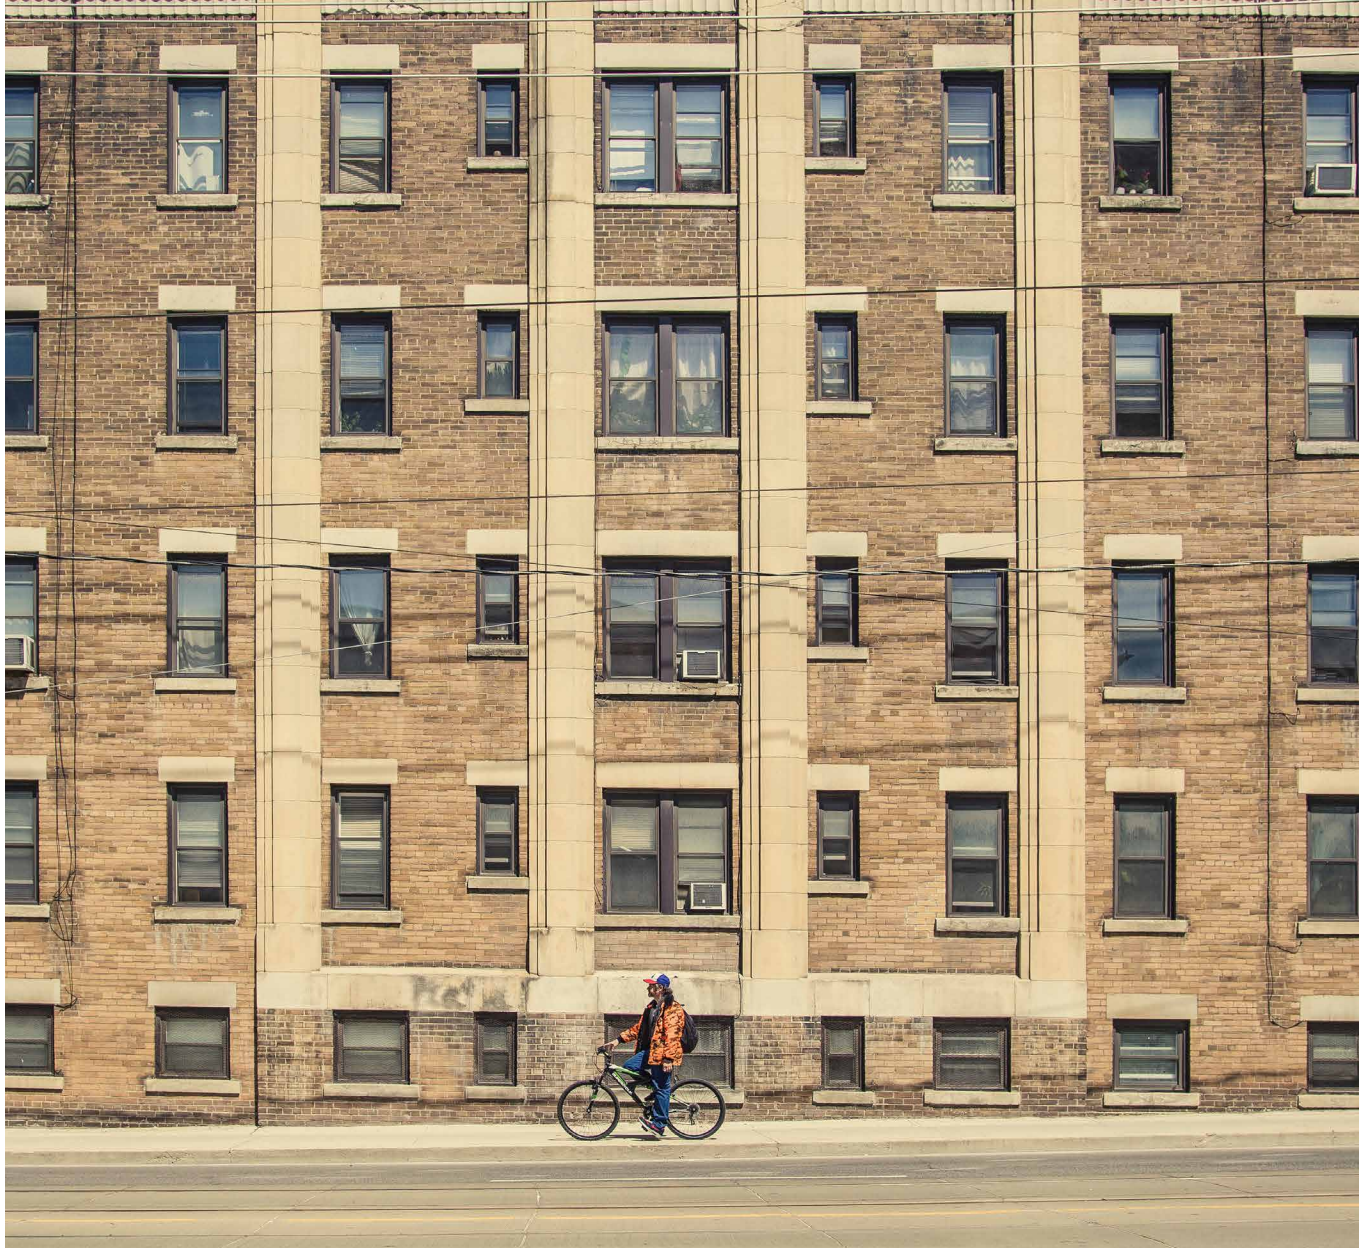
FIG. 5.19 Wooden frames were the most common material for residential buildings until mid 20<sup>th</sup> century. From early 20<sup>th</sup> century onwards larger glass panes were used in residential architecture / Photo: pxhere.com

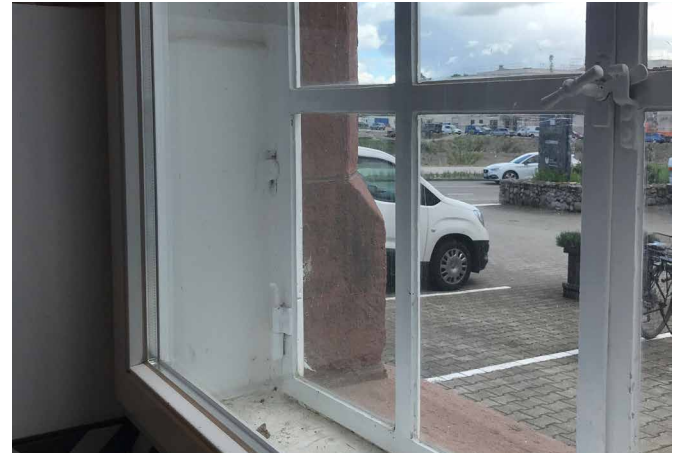
FIG. 5.37 a) Single steel windows with new secondary wood-framed glazing at the interior and b) scheme / Photo: S. Rexroth

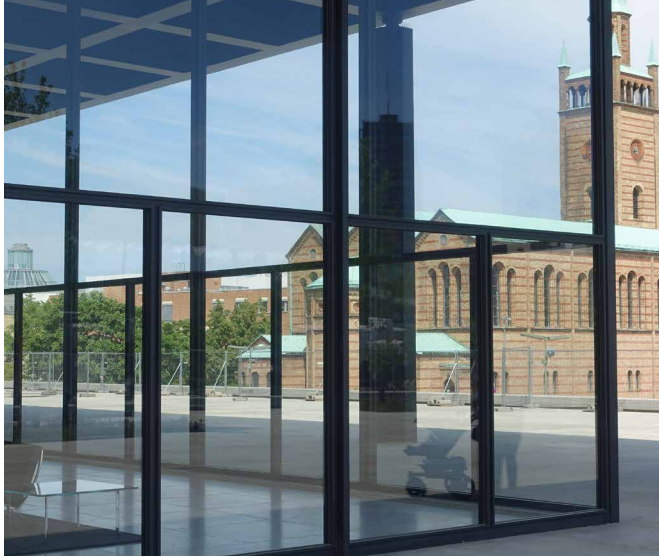
FIG. 5.39 New National Gallery, Berlin: original glazing (above) and three variants for the rehabilitation. In order to avoid glass breakage in the future, a double-thick laminated safety glass (2 x 12 mm) was used (second variant from above). The other two variants would have distorted the appearance of the construction too much. / Photo: F. May
