The Dutch Rhine branches in the Anthropocene – Importance of events and seizing of opportunities

Geomorphology

Erik Mosselman^{*}

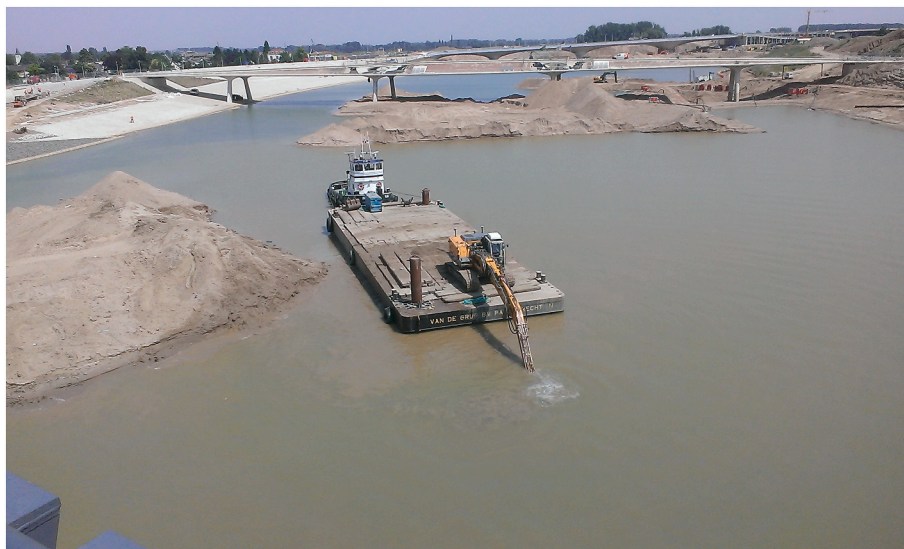
Fig. 7. Excavation of floodway at Nijmegen (July 2015).
