## Effects of composition on the durability and weathering of flat glass

Glass Structures and Engineering

# Effects of composition on the durability and weathering of flat glass

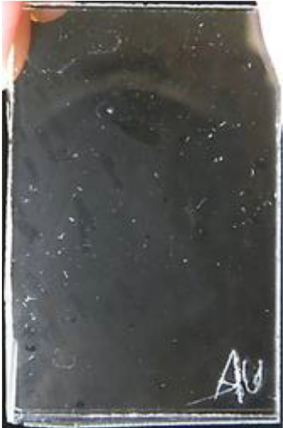
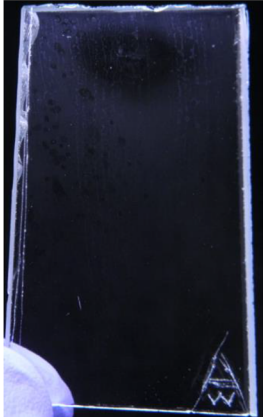
**Table 4** Visual appearance and haze rating of the samples after 4 weeks and 8 weeks of weathering in 75%RH/50°C

| Group 1 | | |
|---|---|---|
| 4 weeks, unwashed samples | 8 weeks, unwashed samples | 8 weeks, washed samples |
| B, good, one side | C, fair, one side | C, fair, one side |

The appearance of the unwashed samples after weathering for 4 weeks and 8 weeks and the appearance of the washed samples after 8 weeks is shown in Table 4. The weathering is visible as a whitish haze on the surface. The bright white specks are dust particles loosely adhered to the surface.
