**Published in**  
DOCOMOMO Journal

# FROM DETERIORATION TO REVIVAL

## Approaches to the Conservation of Plastic Buildings

Ashal Tyurkay, Uta Pottgiesser

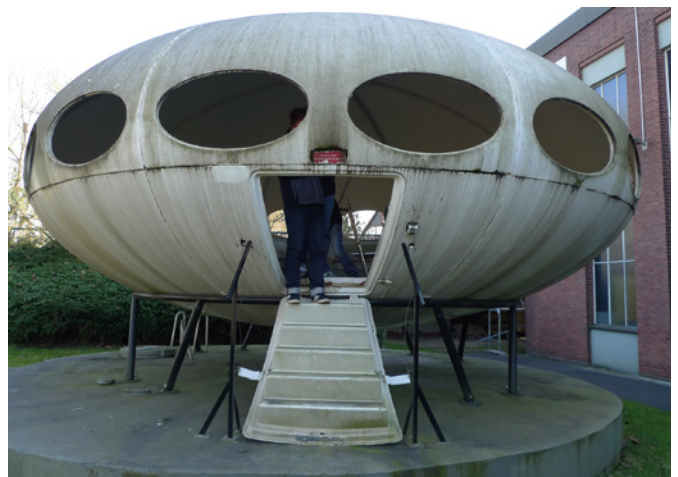
04 The *Munich-Futuro* in Witten (Germany) before transportation to Munich. © BAKU, P. Voigt, 2016.

In contrast to *Futuro No. 000*, the *Munich-Futuro* was restored for exterior exhibition to present its original surfaces and original configuration. Previous interventions to the GRP panels had altered its appearance with the change of color and had led to the reduction of its structural performance. The restoration of the surfaces back to their original appearance and construction had become the only viable
