The Dalle de Verre Lantern of Liverpool Metropolitan Cathedral: Composition and In-service Behaviour of the Epoxy Resin Mortar

Recent Advances in Glass and Ceramics Conservation 2022 6th Interim Meeting of the ICOM-CC Glass and Ceramics Working Group

The *Dalle de Verre* Lantern of Liverpool Metropolitan Cathedral: Composition and In-service Behaviour of the Epoxy Resin Mortar

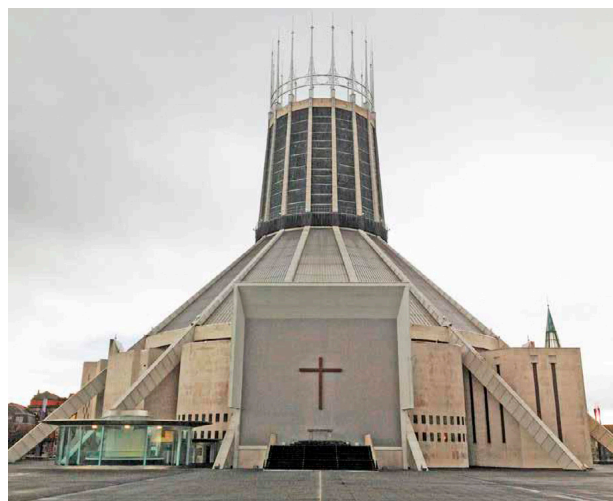
Figure 1. The *dalle de verre* lantern crowning Liverpool Metropolitan Cathedral, viewed from the north. Courtesy of Purcell UK

The main structure of the cathedral and lantern is a reinforced concrete frame comprising 16 concrete ribs bound by three ring beams; a lower ring beam at the junction of the nave wall and roof, a middle ring beam at the junction of the roof and lantern, and an upper ring beam at the lantern roof level. The overall form of the lantern is that of a tapered drum sitting on the cathedral roof, surmounted by a crown (Figure 1). The lantern is approximately 21 m in diameter and 22.5 m in height.

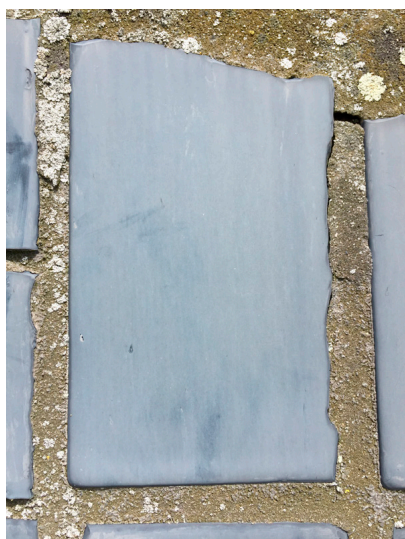
Figure 3. Detail of the lantern's exterior showing one *dalle de verre* slab with a residual coating of the 1990s remedial polymer treatment and, surrounding it, the embedding epoxy mortar with a prominent gap at the upper right. Courtesy of Norman Tennent

To date, the in-service behaviour of the epoxy has been unproblematic save for the ingress of rainwater through defects in the mortar at minor cracks, more significant gaps within the mortar, and, potentially, at voids at the epoxy/glass interface. Cracks and gaps within the mortar are readily visible from the building's exterior (Figures 3-5) and have, therefore, been well documented and quantified during the Purcell UK survey (2022). Any lack of epoxy-glass adhesion sufficient to allow water to penetrate into the cathedral is extremely difficult to observe and, as a result, the contribution of bonding defects to water ingress remains unquantified. The integrity of the individual *dalle de verre* slabs is excellent, so cracks in the glass are not contributing to water ingress.

Unfortunately, since this problem became apparent only a short time into the life of the cathedral, water management at the foot of the interior of the glass edifice has been a troublesome reality for several decades. In the 1990s, a polymer coating was applied extensively to the exterior of the lantern in order to seal defects in the mortar, but this attempt at remediation has had no long-term benefit. Figures 3-5 show the matt grey residues of this coating, thought to be a polyurethane elastomer. Whilst this failed polymer treatment merits further investigation, the primary concern which led to the current research was the possibility that degradation of the epoxy mortar and concomitant loss of adhesion at the epoxy-glass interface could eventually compromise the lantern's structural integrity. Accordingly, accelerated ageing tests, using mock-ups to explore long-term, in-service behaviour, were put in train. This paper is devoted to the research carried out to replicate the original mortar composition, a prerequisite to the weathering experiments. The results of these accelerated ageing assessments will be published in due course (Poulis et al. forthcoming).

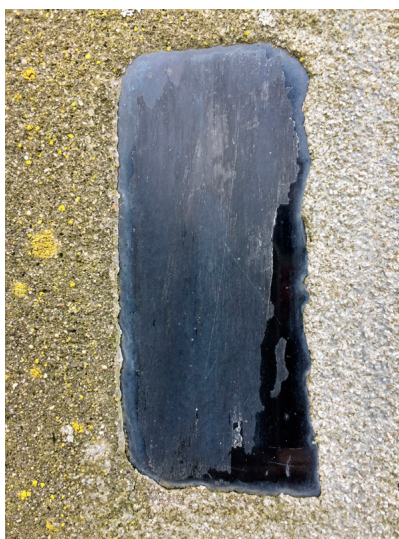
Figure 4. Weathering of the 1990s polymer coating on the exterior of one *dalle de verre* slab. Courtesy of Norman Tennent

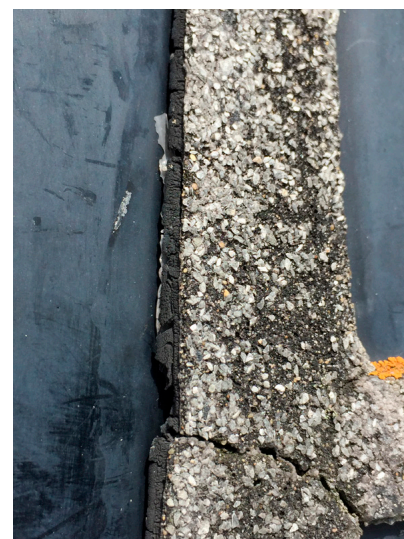
Figure 5. Exterior view of the glass-mortar interface at one *dalle de verre* slab, with a large adjacent mortar crack. Courtesy of Norman Tennent

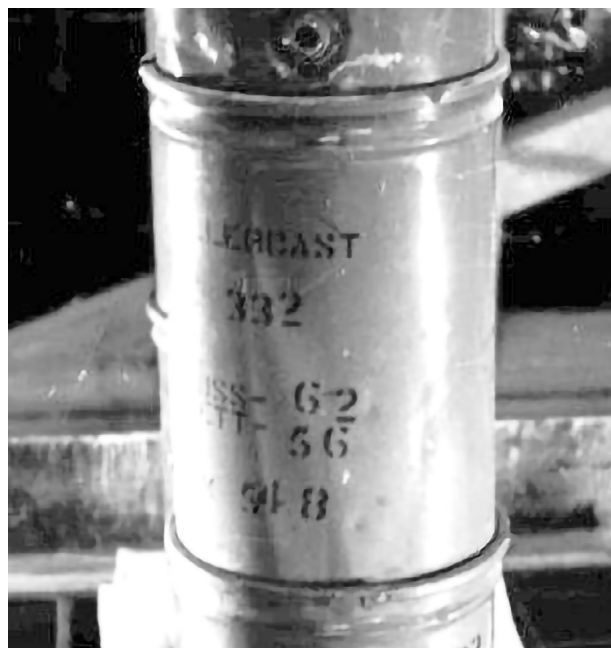
Figure 6. Drum of Kollercast 332 epoxy resin, photographed on site during the lantern's construction. Courtesy of David Kirby

The precise laboratory identification of epoxy resins used in past cultural heritage projects has been shown to be a very difficult scientific undertaking (Tesser, Lazzarini, and Bracci 2018; Tennent, de Groot, and Koob 2019). Therefore, in order to replicate the epoxy mortar accurately, extensive enquiries were made to locate documentation on the formulation used by Patrick Reyntiens, starting with the *Crown of Glass* film. In addition to the visual record of the viscous black epoxy being poured into the gaps between the *dalles de verre*, the film's commentary stated that an Epikote epoxy resin was used. Epikote is the brand name coined for Shell's epoxy resin range; however, the film does not refer to a specific product from within the range. Shell subsequently divested of its epoxy business and further company takeovers have taken place since, adding to the difficulty of locating further information on the purported use of Epikote epoxy resin for the lantern construction. Hexion is the company currently marketing the Epikote brand, but the possibility of locating information on the precise Epikote resin mentioned in the *Crown of Glass* film, by means of what was likely to be a tortuous sequence of investigations within international company records, was considered so unlikely to be successful that this route was not explored further. Searches in the archives of Liverpool Metropolitan Cathedral and of Gibberd Architects, the firm founded by Sir Frederick Gibberd, proved fruitless. However, with the knowledge that Patrick Reyntiens was still fit and active in 2019, contact was established with his daughter Edith and then, through her, with his son John, also a stained-glass artist. John Reyntiens was certain that his father would have no records or a precise recollection of the epoxy formulation used but suggested contacting David Kirby, project manager for the lantern construction, who indeed readily not only provided information on the resin, but was also able to locate photographs showing the epoxy resin drums on site during preparation of the *dalle de verre* panels (Figure 6). These photographs demonstrated that the brand name was Kollercast, not Epikote, and David

Kirby produced documentation that it was ordered from James Beadel & Co Ltd.
