Autonomous Sensor System for Low-Capacity Wind Turbine Blade Vibration Measurement

Abstract: This paper presents the design, implementation, and validation of an on-blade sensor system for remote vibration measurement for low-capacity wind turbines. The autonomous sensor system was deployed on three wind turbines, with one of them operating in harsh weather conditions in the far south of Chile. The system recorded the acceleration response of the blades in the flapwise and edgewise directions, data that could be used for extracting the dynamic characteristics of the blades, information useful for damage diagnosis and prognosis. The proposed sensor system demonstrated reliable data acquisition and transmission from wind turbines in remote locations, proving the ability to create a fully autonomous system capable of recording data for monitoring and evaluating the state of health of wind turbine blades for extended periods without human intervention. The data collected by the sensor system presented in this study can serve as a foundation for developing vibration-based strategies for real-time structural health monitoring.

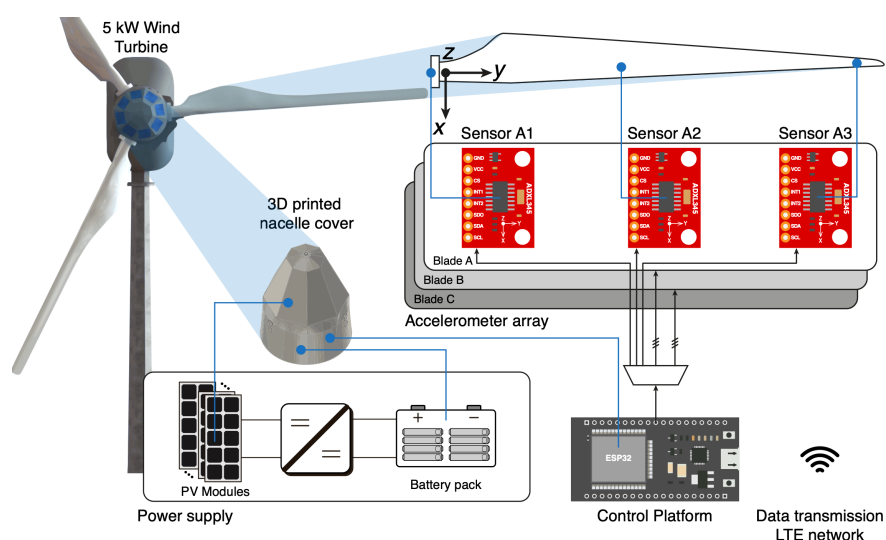
Figure 1. Hardware disposition overview of the embedded damage detection autonomous system for WT blades.

As described earlier in Figure 1, each of the turbine's blades is equipped with a set of three accelerometers. Each sensor requires five shared connections, since their measurements are transmitted through SPI, and a dedicated channel for chip selection, leading to a total of eight wires per blade. Consequently, a Cat7 LAN cable was utilized to connect the array of sensors. It is worth noting that future applications might consider having the accelerometers within the blade structure to minimize the aerodynamic disturbances caused by their size.

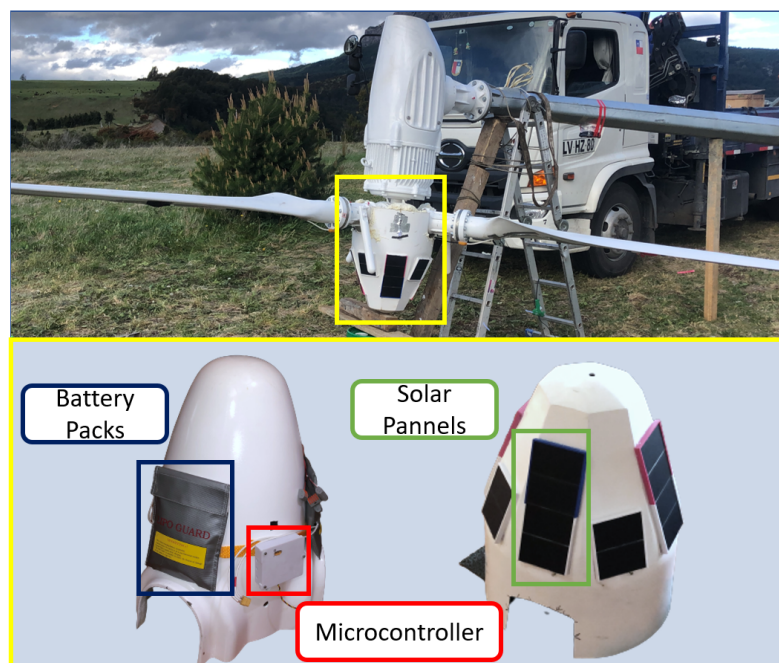
Figure 2. Overview of the nose hub and its components. They are distributed in such way that the hub maintains its balance while rotating. Most components are secured with bolts and a silicone-based glue to absorb vibrations.

To produce the necessary area for the sensors while avoiding changes to the WT, an additional fiberglass nacelle was fabricated. This structure, illustrated in Figure 2, would serve as the support for a series of solar panels that power the monitoring system. It also leaves a space between itself and the turbine which is big enough to accommodate an array of Li-ion batteries capable of storing extra solar energy and allows the system to operate continuously. To house the microcontroller, which was inserted into this same space, a polyethylene terephthalat glycol (PETG) container was printed.

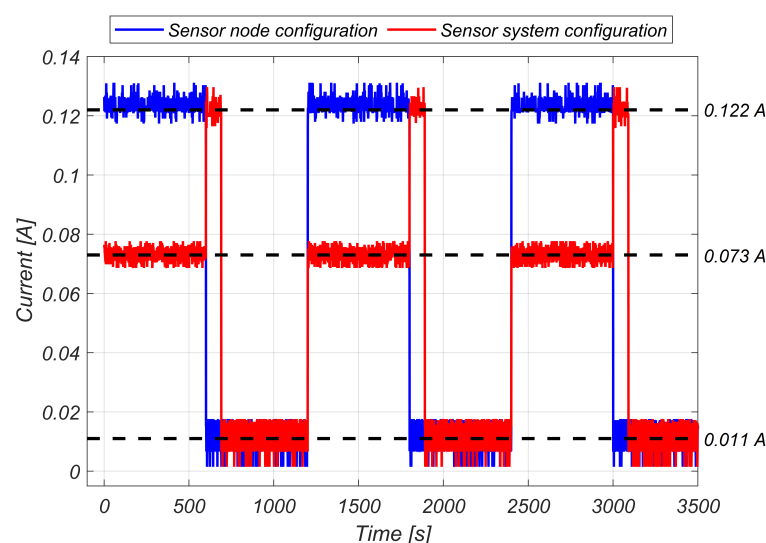
Figure 3. The graph shows the charge flow for both configurations. The higher consumption was due to the Wi-Fi module being used for data transmission. This led to an increase of 67.1% compared with normal operation using a base station. The lower consumption band shows the system in sleep mode, reducing consumption by 84.9%.

Comparing both architectures (refer to Figure 3), it is evident that a significant portion of power is consumed during data transmission. Additionally, transmitting the data in small packages at that frequency resulted in no significant difference in the maximum power utilized when sending the data to the main station compared with sending it directly from the node. This highlights the importance of minimizing the transmission time. Consequently, the most viable solution was to efficiently measure the data before transmission. To address this, the measurements were saved as binary data in text files, leading to a reduction in the total number of transmitted bits and subsequent power savings.

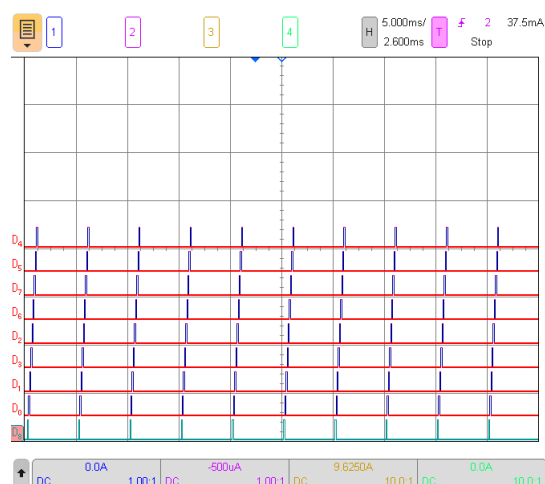
Figure 4. Oscilloscope capture illustrating sequential activation of nine digital channels with 5 ms division intervals.

Figure 4 demonstrates the synchronized engagement of each sensor at a precise 5 ms interval. The oscilloscope image illustrates the sequential activation of the nine sensors due to the usage of a common chip select channel in the SPI protocol, preventing simultaneous activation. Despite not being activated simultaneously, equal separation between measurements was maintained, enabling comprehensive data collection. The figure also reveals that sufficient time remained between sensor selections, allowing for potential inclusion of additional sensors in future implementations.

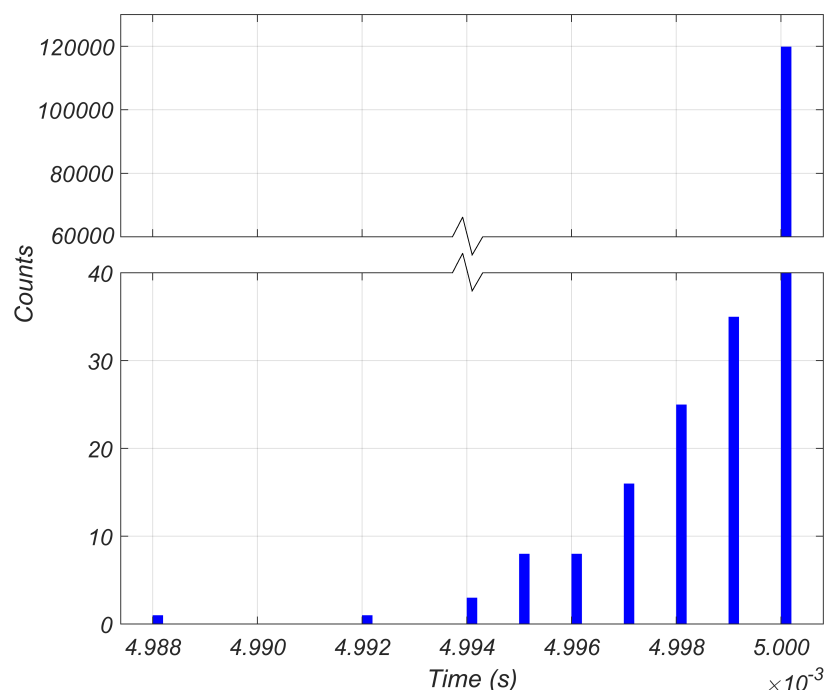
Figure 5. Histogram illustrating the timing of the conducted measurements.

To validate the 200 Hz sampling frequency, Figure 5 presents a histogram accompanied by a box plot visually depicting the precise timing of each measurement. The histogram provides a distribution of the measurement timings, with deviations not exceeding 0.24%. Additionally, the box plot offers key statistical insights, revealing that 99.9% of the measurements were captured with a 5000 μ s spacing, while a small fraction of the values was captured at slightly higher frequencies. This visual representation confirms that the majority of the measurements were acquired at a constant frequency of 200 Hz. The consistent time interval maintained throughout the measurements ensures uniformity and accuracy of the acquired vibration data.

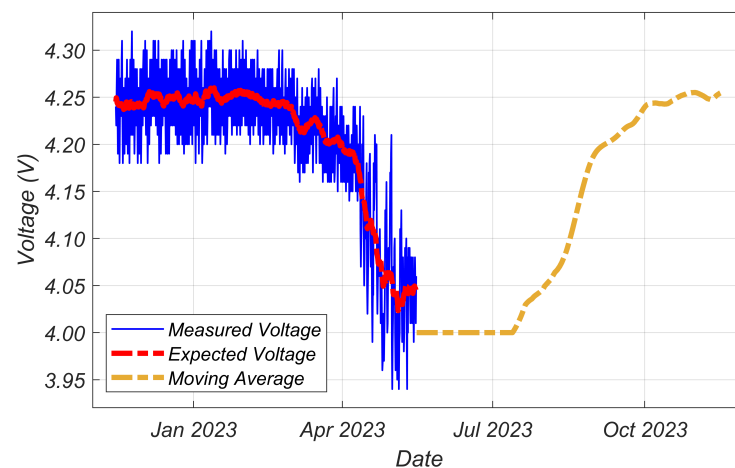
Figure 6. Battery voltage over time. The graph displays measurements taken up until the 15th of May. In addition to the raw measurements, the graph also features a moving average and the expected values for the remaining period of the year.

Since the installation of the system in Aysen, battery voltage measurements have been transmitted by the device to evaluate the reliability of PV panels as an energy source (Figure 6). Following installation, the battery remained fully charged, irrespective of frequent cloud coverage. Figure 7 provides evidence of the increasing cloud coverage during winter. Despite the reduced irradiance levels and temperatures, given the proximity of winter in the Southern Hemisphere, the developed system maintained enough energy to avoid entering the more stringent energy regimes, which implies a delay in file transmission. Hence, these results demonstrate the feasibility of year-round system operation without relying on conventional land connections, such as slip rings.

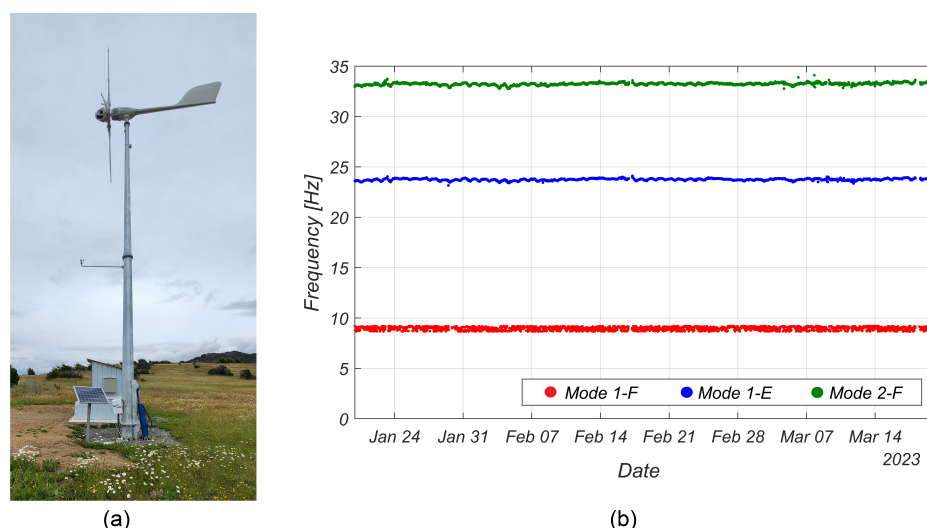
Figure 8. Low-capacity wind turbine installed in south Chile (WT1). (a) Image of the installed wind turbine. (b) Identified natural frequencies of three modes from mid-January to mid-March 2023.

Figure 8b illustrates three natural frequencies identified from the vibration data recorded on one of the blades of WT1 (see Figure 8a) using the deterministic-stochastic subspace identification method. In Figure 8b, 1-F and 2-F denote the first and second flapwise modes, respectively, while 1-E corresponds to the first edgewise mode. Subsequently, a comparison was made between these frequencies and the results obtained in [23]. Significantly, the extracted frequencies aligned closely with the previously reported results (which were obtained in a cantilever blade tested in a laboratory setting), providing compelling evidence of the system's high accuracy in capturing the dynamic behavior of WT blades while using a reduced number of sensors. It is noted that although no damage was induced in WT1, changes in the identified modal frequencies can be observed in Figure 8b, which were due to environmental and operational variability. A detailed investigation of these effects is beyond the scope of this paper.

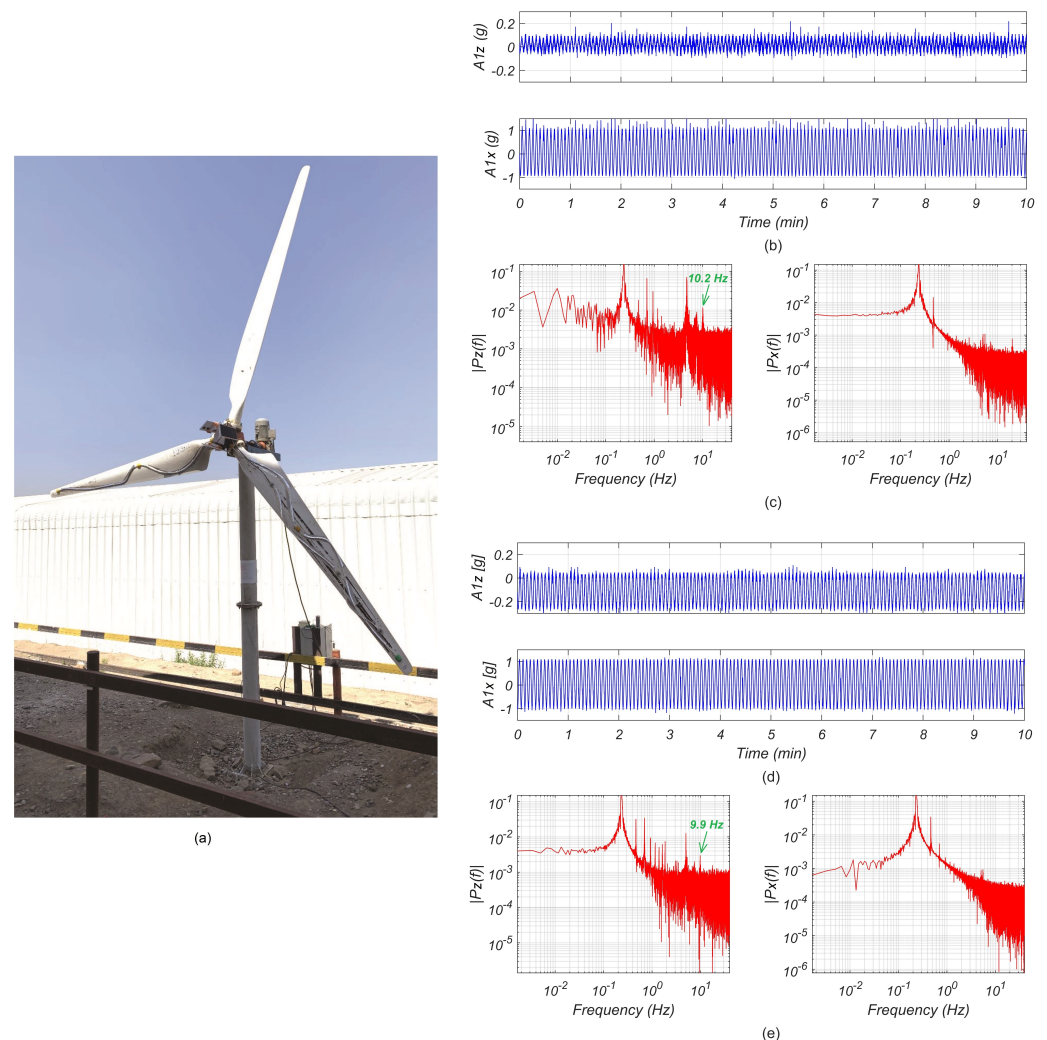
Figure 9. Vibration measurement sets for blades running at 15 r/min. (a) Image of the wind turbine simulation apparatus. (b) Healthy blade's vibration signals from the z axis (top) and x axis (bottom). (c) FFTs for the z axis signal (left) and for the x axis signal (right) for the blade with no damage. (d) Damaged blade's vibration signals from the z axis (top) and x axis (bottom). (e) FFTs for the z axis signal (left) and for the x axis signal (right) for the damaged blade.

Figure 9b,c illustrates a set of measurements conducted on the blade of the wind turbine replica at a rotational speed of 15 r/min without any damage compared with the same configuration but with induced damage (Figure 9d,e). It is noted that the damage induced in one of the blades of the replica consisted of artificial cuts of varying severity at two specific locations along the blade. The recorded measurements on the z axis (i.e., flapwise) exhibited a clear difference in the vibration modes exhibited in the time series, whereas the damaged blade exhibited higher accelerations along the z axis, indicating a potential

structural issue. This observation was further supported by conducting fast Fourier transform (FFT) analysis on the data. By comparing the FFTs of the undamaged and damaged cases, it can be observed that the peak corresponding to the frequency of the first flapwise mode (z axis) shifted from 10.2 Hz to 9.9 Hz, which was due to the loss of effective stiffness induced by the artificial cut in the blade.

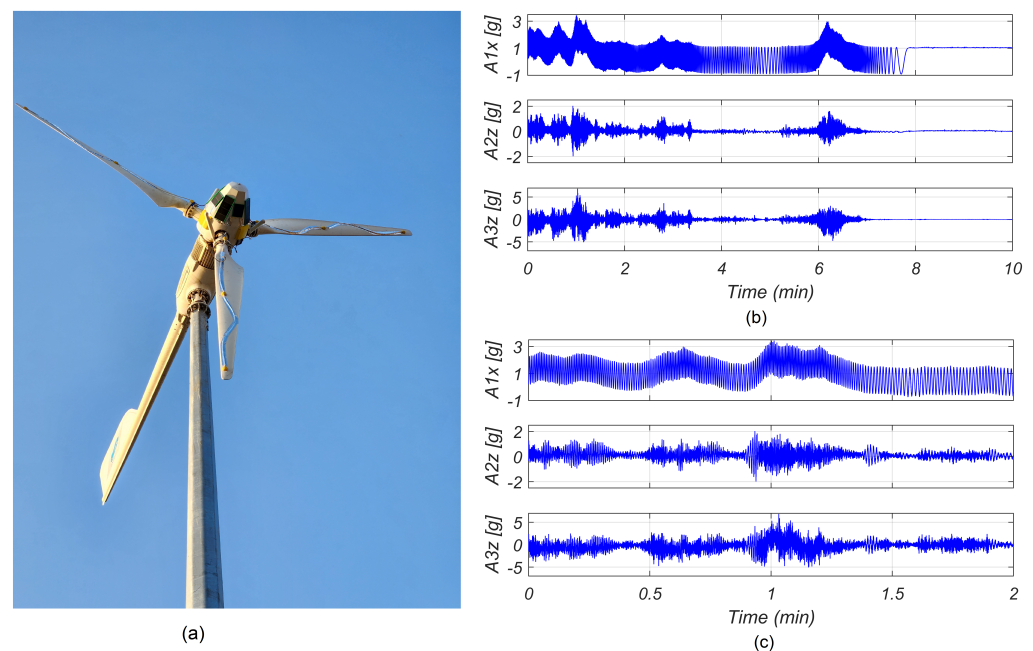
Figure 10. Acceleration measurements recorded on blades of WT2. (a) Image of the instrumented WT2. (b) The x axis acceleration of sensor A1 and z axis acceleration of sensors A2 and A3. (c) Zoomed-in version of signals in (b).

Figure 10 depicts the vibrations measured in WT2 on a particularly windy day. Notably, the turbine achieved high rotational speeds, exceeding 170 r/min. Of particular interest is the observation made by sensor A1, located at the root of the blade, along the x axis. A slight change in the offset can be observed as the speeds increased beyond a certain threshold. Due to the implementation of blade pitch speed control in the 5 kW turbines, when the speed surpassed the mentioned threshold, the blade adjusted its angle to modify the blade's aerodynamic properties and decelerate the rotation. This change in angle results in an offset in the readings of the aforementioned sensor. The abrupt angle change is also evident on the z axis, where it abruptly reversed during the deceleration phase.
