**A Novel Method for the Non-Destructive Assessment of Strength Degradation and Re-Use Potential of Weathered Float Glass From Facades
A Proof of Concept Study**

International Journal of Structural Glass and Advanced Materials Research

A Novel Method for the Non-Destructive Assessment of Strength Degradation and Re-Use Potential of Weathered Float Glass From Facades: A Proof of Concept Study

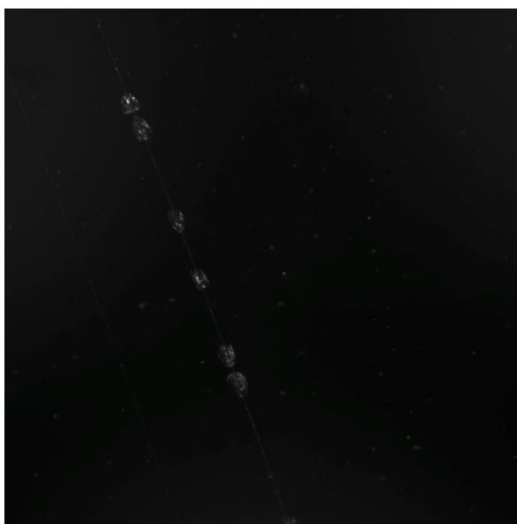
Fig. 3: TRACEiT image of weathered glass, left top lighting, right transmitted lighting

An optical profile scanner (TRACEiT manufactured by Innowep) was used in this study. It is an optical system that measures surface profiles by combining a lighting source, an optical camera, and software to make an accurate 3D assessment of a surface. The device was not specifically developed for scanning glass surfaces and no references could be found for using it on glass, so the settings had to be determined with support from the manufacturer and by trial and error, a full description is given in Sofokleous (2022). No physical changes were made to the scanner, only the software options were optimized for glass. The new glass specimens and the interior face of the weathered specimens showed no significant response to the optical profile scanner indicating that any defects present are smaller than the resolution of the scanner. Thus only the specimens with the weathered outside face in tension during the co-axial ring-on-ring test were fully scanned within the area of the loading ring. Figure 3 shows examples of images obtained from the optical profile scanner. The transmitted light image shows a linear scratch and localized damage zones along the scratch. To improve the image quality, the optical profile images were post-processed in PAINT.Net software or using MATLAB image processing algorithms. The results are shown in Fig. 4.

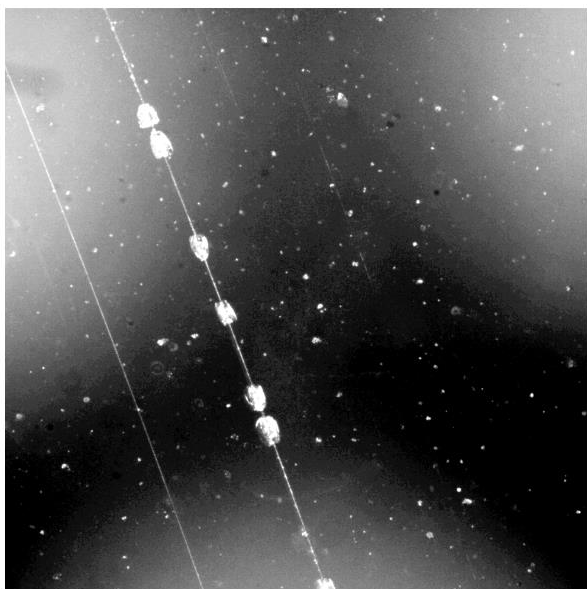
Fig. 4: Enhanced TRACEiT image using transmitted lighting after image processing, left with Paint.net software and right with Matlab histogram equalization

The system software of the optical profile scanner was used to determine the depth of defects based on the non-post-processed images, details are in Appendix C (Sofokleous, 2022). The post-processing thus only shows that major improvement in accuracy can be made, but the current scanner software does not allow for this. Large defects observed with the optical profilometer were marked on the glass with a marker pen prior to testing. The correlation between optical profile results and mechanical tests is discussed later in this study.

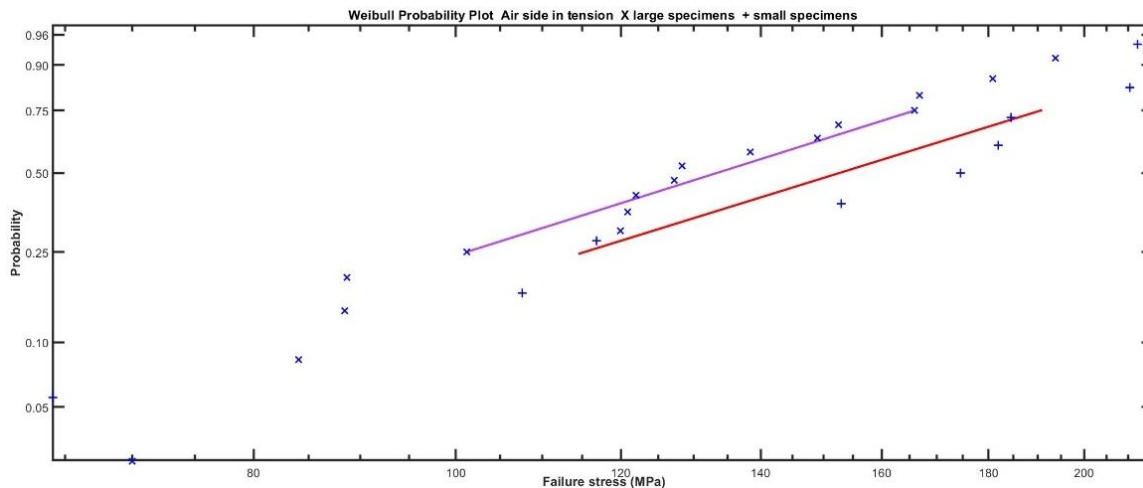
Fig. 11: Weibull plot of new glass, airside in tension

In what initially seems a paradox, the new glass specimens with the air side in tension, Fig. 11, have very little size dependency. However as the air side was not in contact with the rollers during the annealing phase of float glass production it is also the least damaged side, which is confirmed by the higher strength. A pristine glass surface should show no side effects. The new glass specimens with the air side in tension thus approximate such an “undamaged” surface.
