Critical state behaviour of anthropogenic clay in a direct simple shear test

Proceedings of the XVIII ECSMGE 2024

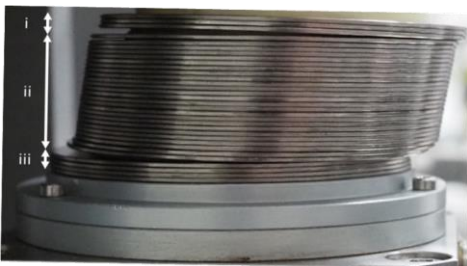
Figure 1. A result at the end of an OC DSS test with slippage.

In a typical DSS test the stack of rings is sheared uniformly. Figure 1 shows an example where slip between the sample and bottom plate has occurred. Three separate zones can be distinguished: i) at the top platen, ii) in the middle, and iii) at the bottom platen. The negative influence of the boundaries on the sample in DSS testing is well acknowledged. However, it is assumed that the centre of the sample is sheared in simple shear and governs the overall behaviour (i.e. DeGroot et al., 1992, Den Haan and Grognet, 2014). The deformation pattern depicted in Figure 1 indicates that, at least at the end of the test, the mobilized resistance is influenced by friction between the sample and the bottom plate, which raises questions regarding the validity and application of the test results.
