## Measuring damage in physical model tests of rubble mounds

Coasts, Marine Structures and Breakwaters 2017

# Measuring damage in physical model tests of rubble mounds

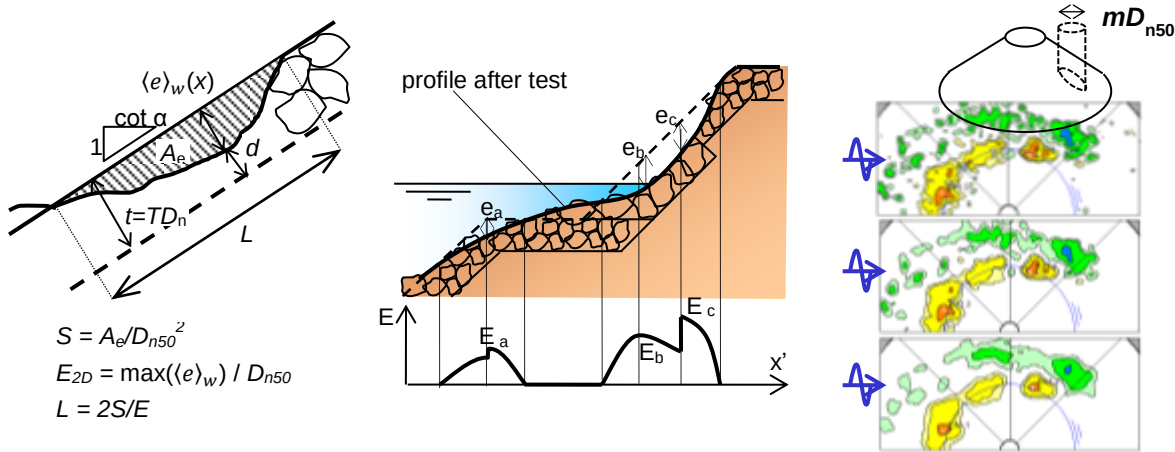
Figure 1. Left: definition of damage numbers  $S$  and  $E_{2D}$  on width-averaged 2D trunk profile. Middle: variation of  $E_{2D}$  on a non-standard cross-section. Right: pattern of  $E_{3D}$  on a roundhead smoothed with different filter size ( $2D_{n50}, 3D_{n50}, 5D_{n50}$  – from top to bottom). From Hofland *et al.* (2011, 2014).

where  $\alpha$  is the structure slope. In this definition, erosion of the profile is positive. Damage to rubble mound structures is classically based on either the number of rocks that are displaced during a test (storm), or by the area of the cross-section of the damage hole (dimensionless erosion area  $S$ , Broderick, 1983; Van der Meer, 1988; see left panel in Figure 1):

where  $\langle \rangle_{mD_{n50}}$  indicates a spatial average over a circular area with  $mD_{n50}$  diameter. In the right panel of Figure 2 the influence of the filter size  $m$  on the determined damage depth at a roundhead is illustrated. The optimal size of the filter size, a compromise between accuracy and resolution, is not known yet, but is expected to be in the range of 3 to 5 times  $D_{n50}$ . As a flume test from which  $E_{2D}$  is determined is typically  $20D_{n50}$  wide, the filter size for  $E_{3D}$  would have to be about  $m=4$  or  $m=5$ , in order to obtain a similar accuracy (determined by the number of potentially moving rocks).

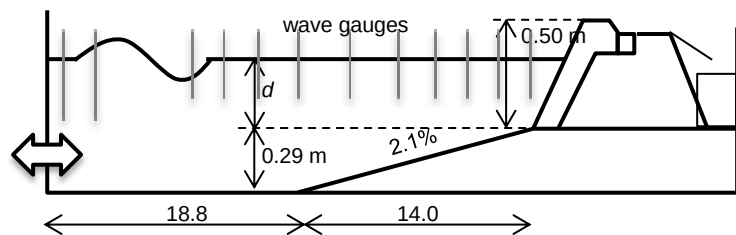
Figure 2. Model setup in LNEC flume.

A first test series was carried out to obtain damage scans for a standard wave flume case. These tests were done at the LNEC laboratory in a 50 m long, 1.2 m deep wave flume with an operating width of 0.8 m. The flume is equipped with a piston-type wave-maker that combines both irregular wave generation and dynamic absorption of reflected waves through the use of two wave gauges located in front of the paddle. Ten additional resistive-type wave gauges were deployed along the flume and an extra gauge was placed on the model armour layer slope to measure run-up levels (not analyzed presently). The breakwater model was built and operated according to Froude's similarity law, with a geometrical scale of 1:30, to ensure reduced scale effects (the wave height-based Reynolds number was  $D_{n50}\sqrt{gH_s}/\nu > 3 \times 10^4$ ). The reference breakwater cross section was built on a 14 m long and 0.29 m high foreshore. The breakwater model was 0.8 m ( $18D_{n50}$ ) wide and composed of a main armour slope of 1:2,  $2D_{n50}$  thick, with  $D_{n50} = 0.0445$  m, with a single filter layer and permeable core below, as shown in Figure 2. The armour crest was 0.5 m above the structure toe. A concrete superstructure was also included, with its crest level 1.7 cm below the armour crest. The width of the armour layer crest seaward of the crest element was 19.7 cm.

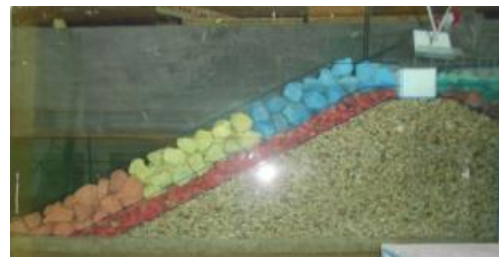
Figure 3. Model setup in LNEC flume.

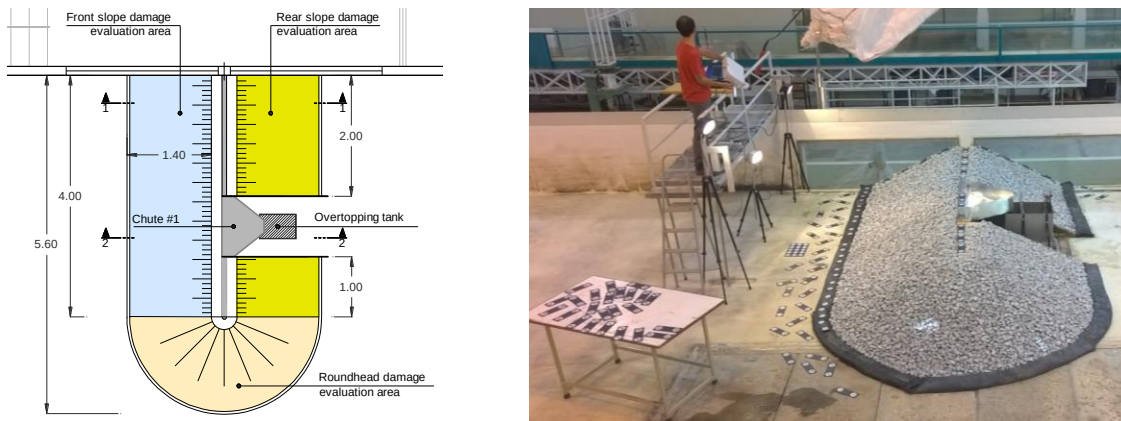
Figure 4. Model setup in FEUP basin. Left: plan view, right: damage measurement.

The tests were carried out in the multidirectional wave basin of the Hydraulics Laboratory of the Hydraulics, Water Resources and Environment Division of FEUP (28.0 m long, 12.0 m wide and 1.2 m deep), which is equipped with a 12.0 m wide segmented wavemaker with active reflection absorption. A reference rubble mound breakwater was reproduced on a geometric scale of 1:35. The breakwater model was 5.6 m long, 3.1 m wide and 0.68 m high, Figure 4. The armour layer was composed of a double layer of rock ( $2D_{n50}$  thickness), with  $D_{n50} = 32$  mm and  $D_{n85}/D_{n15} = 1.25$ , placed on a rubble mound core, with  $D_{n50} = 11.6$  mm. The slope angle was 1:2. The overall crest width was 0.42 m and a 0.10 m wide superstructure was placed at its centre. The armour was supported by a toe materialized by cylindrical sand bags. The breakwater core was enclosed in a mesh to avoid movement of the core materials, while maintaining the desired level of permeability (~40-50%). A 4.0 m wide trunk section was placed perpendicularly against the straight sidewall of the basin, and a semi-circular roundhead was placed at its other side. The slope angle and the armour layer thickness were equal for all trunk and roundhead sections. The armour layer on the rear side was interrupted to allow the installation of a reservoir to collect the overtopped water, allowing the measurement of the overtopping discharges and volumes, which are treated in a companion paper (Silva *et al.*, 2017).

The water free surface elevation was measured using standard resistance-type wave gauges. A set of four aligned gauges was placed in front of the model in order to determine the characteristics of the incoming waves. For the tests with short-crested waves, a setup with six gauges in a CERC6 array was applied (Davis & Regier, 1977). The damage in the structure was measured using a stereo-photography technique (Raaijmakers *et al.* 2011). The structure was photographed with a set of hand-held double-cameras in a drained wave basin. Using a typical number of 50 photo pairs, point clouds of measurements were created before and after each test run. These point clouds were filtered and interpolated on a 1x1 mm grid. The post-processing steps are described in Hofland *et al.* (2011).

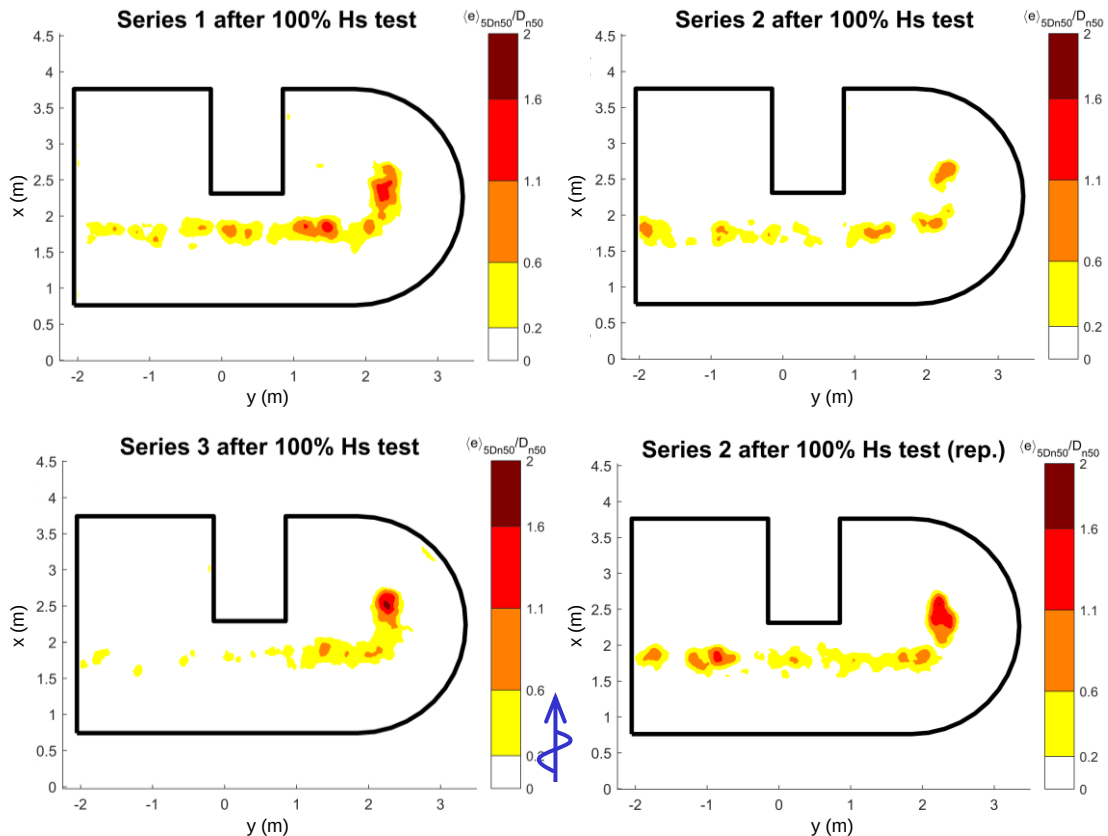
Figure 5. Erosion depth after the 100% test condition for Series 1, 2 (including repetition) and 3.

The trunk section of the breakwater model tested in FEUP wave basin was 4.0 m wide in order to get a large section where statistical convergence can be obtained for damage results. The damage after the 100% condition for the three test series and one repetition is depicted in Figure 5.

Some observations can be made based on Figure 5 results. On the seaward trunk slope adjacent to the roundhead, the damage is consistently larger for all test series. Therefore, this area is not taken into account for the analysis of the trunk section. Moreover, the two identical repetitions of the 100% condition of the second test series still give rather different results, so the scatter seems to be large. The results for Test Series 2 were obtained without the damage of two preceding tests (for 60% and 80% test conditions), while Test Series 4 was carried out with short-crested waves and in Test Series 3 the effect of SLR was already included.

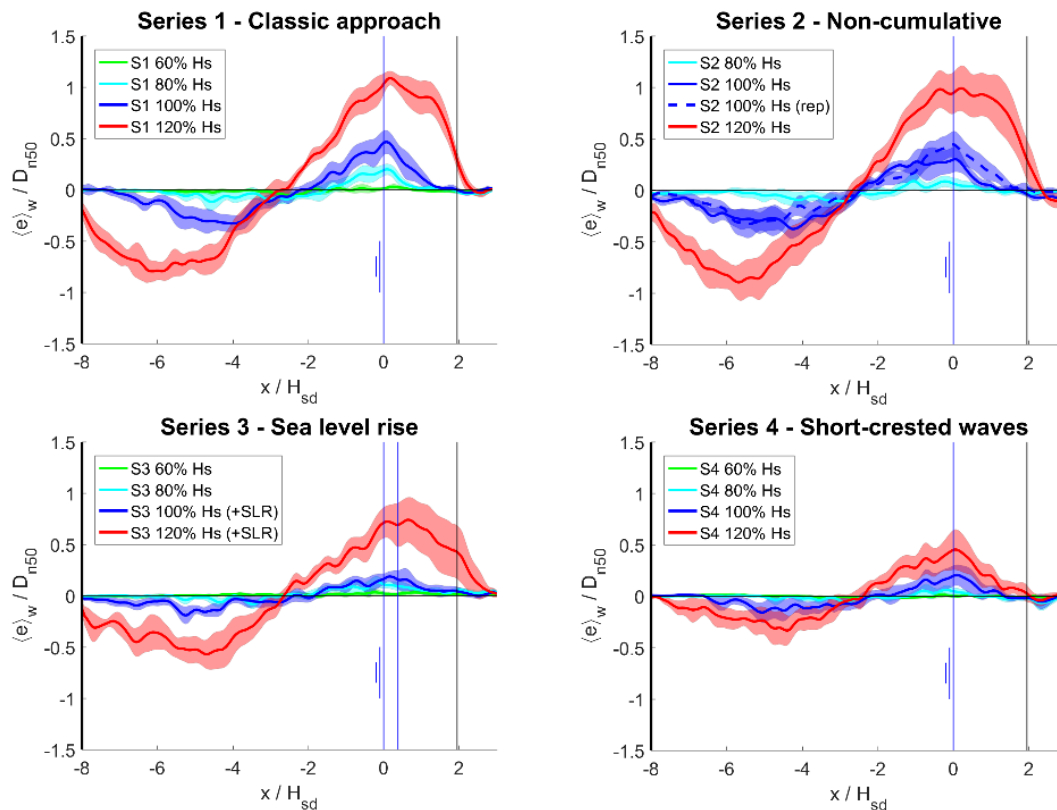
Figure 6. Width-averaged erosion profiles for the four test series with confidence band (shaded areas). Here  $x$  is the horizontal cross-shore coordinate, with its origin at the waterline.

It can be observed that the damage hole is deepest around the water line, see Figure 6. The size of the hole increases, as expected, with the wave height. For the last test (120% condition) the damage hole extends up to the crest (vertical black line). It can be noticed that for the wide measurement section that is applied, with a width of more than  $100D_{n50}$ , the confidence band of the results is narrow enough to clearly distinguish the damage stages for the various tests. For the test with the smallest wave height also the damage around the water line is determined with confidence, while at lower elevations (where rocks are both deposited and removed) the confidence band is wider.

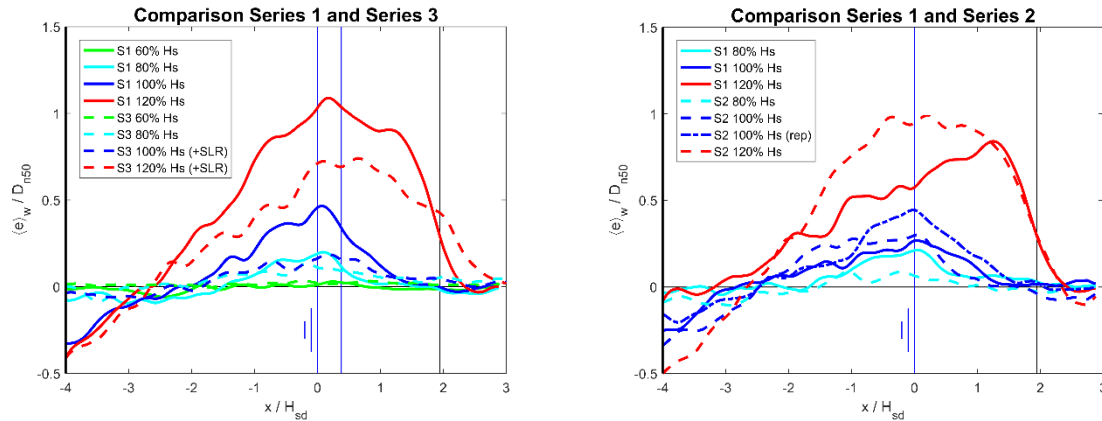
Figure 7. Left: width-averaged erosion profiles for Series 1 (constant WL) and 3 (SLR). Right: width-averaged erosion profiles for Series 1 (cumulative) and 2 (incremental).

The influence of a limited sea level rise (SLR) is demonstrated in the left panel of Figure 7 where Series 1 and 3 are compared. The first two tests (60% and 80%) are repetition tests with the same conditions. After the first two tests with a constant water level, the 100% and 120% tests are performed for a 2.3 cm higher water level in Series 3 (0.80 m SLR at prototype scale). The water level difference is relatively small (about 20% of the design  $H_s$ ). Still a rather large difference might be observed in the results of Test Series 1 and 3: less damage in the tests carried out for the higher water level, while for the same water level very comparable damage levels were obtained.

The comparison of the cumulative damage case (no rebuilding after each test run) with rebuilding (a newly constructed slope for each test run) is shown in the right panel of Figure 7. As the damage in the model is not repaired before each test run in Test Series 1, the new inflicted damage is added to an already damaged slope. In this right panel only the additional damage that occurred during the specific test run is shown. There are clearly visible differences between the two test series. However, the test run that was repeated in Test Series 2 shows a much larger damage level.

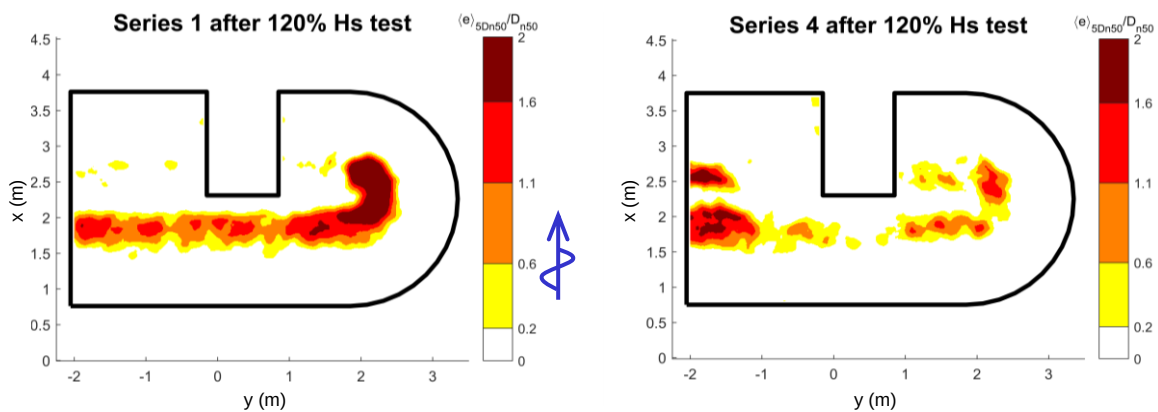
Figure 8. Erosion depth on breakwater trunk and roundhead after Test 4. Left: Series 1 (long crested waves). Right: Series 4 (short crested waves).

The damage to the structure for long-crested and short-crested waves is compared in Figure 8. In the tests with short-crested waves, extra damage occurred in the vicinity of the sidewall, due to the energy concentration resulting from the imperfect reflection on the sidewall of waves travelling with a direction not perpendicular to the breakwater. However, in the remainder part of the trunk, the wave conditions were similar and the results obtained can be considered valid. It can be concluded that the damage to the trunk is lower for the tests with short-crested waves. Also, the size of the damage hole created at the roundhead is smaller. The damage does seem to extend further around the roundhead.

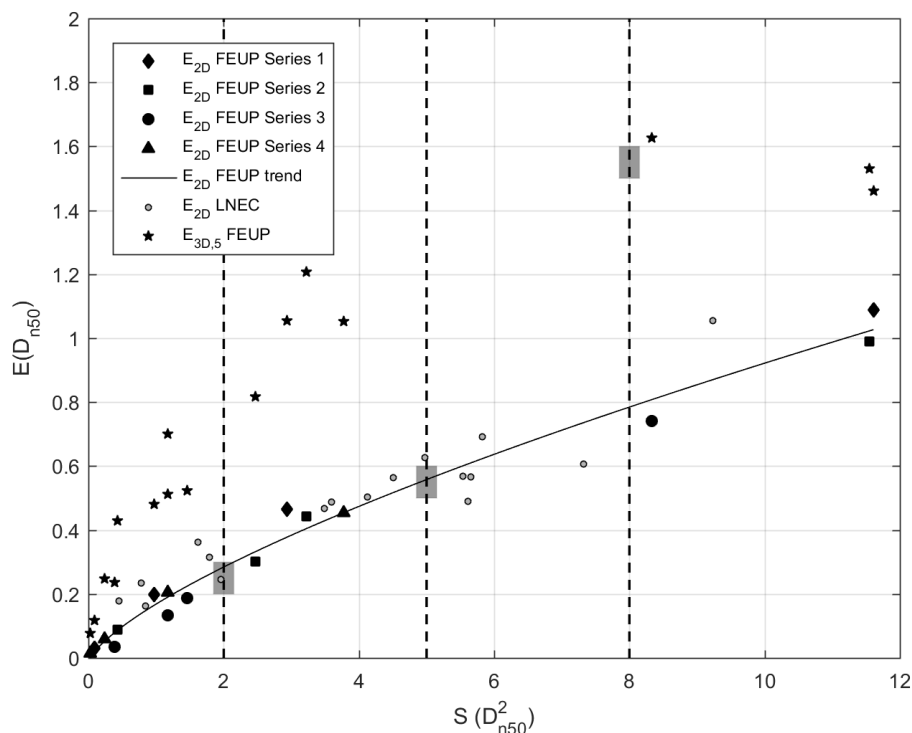
Figure 9.  $E_{2D}$  and  $E_{3D,5}$  versus  $S$ . Dashed lines and grey areas: design values for  $S$  and previous design values for  $E_{2D}$  (Hofland *et al.*, 2011), respectively.

The results for FEUP and LNEC tests are depicted in Figure 9. The LNEC results, which were based on depth-limited conditions and varying wave steepness collapse with the deep water FEUP results. The scatter in the LNEC results seems somewhat larger. This might be due to the smaller width of the LNEC test section. Note that the parameter  $E_{2D}$  can be used for any slope angle, or combination of slope angles (e.g. berms). It can be seen that those tests give comparable values for  $E_{2D}$  as given in Hofland *et al.* (2011) for the initial and intermediate damage levels. Only the  $E_{2D}$  value for “failure” does not seem to match the definition of 2011. As the background of this definition is most objective, i.e. the exposure of the filter layer, this can be checked. Indeed for Test run 4 some locations were visible on the trunk where the erosion depth is  $2D_{n50}$ . Hence it seems that the design value for the mean erosion depth  $E_{2D}$  should be much stricter, around 0.8. It seems better to use this definition for

In addition to the  $E_{2D}$  values,  $E_{3D,5}$  values for the trunk section are presented for all the test runs, obtained considering a circular spatial moving average of  $5D_{n50}$  diameter. These values can also be used as design limits in 3D situations. It can be seen that these values are about two times larger.
