## Fatigue strength of repaired welded connections made of very high strength steels

Akyel, Abdulkadir; Kolstein, Henk; Bijlaard, Frans

Engineering Structures

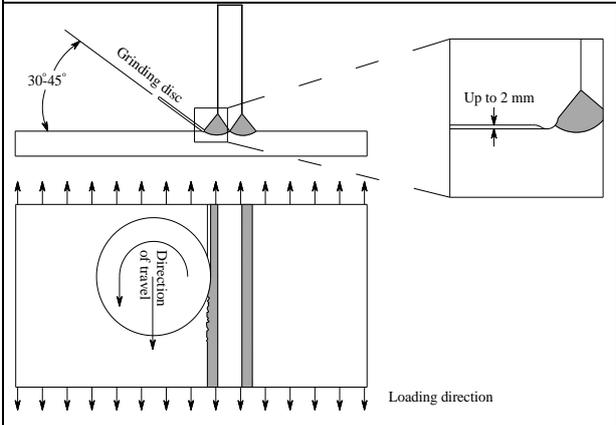
<p><b>Grinding:</b></p> <p>Applicable for the fatigue cracks with the depth up to 2 mm.</p> <ol style="list-style-type: none"> <li>1. Advantageous <ul style="list-style-type: none"> <li>▪ improve weld toe, reducing stress concentration</li> <li>▪ cost effective</li> </ul> </li> <li>2. Disadvantageous <ul style="list-style-type: none"> <li>▪ not possible to apply for complex joints</li> <li>▪ risk to mask the crack tip</li> </ul> </li> </ol>

the repair methods for shallow fatigue cracks. The grinding process is also used as a fatigue strength improvement method for welded connections by removing discontinuities at the weld toe and reshaping the weld to create a smooth transition between the weld material and the base material for the stress concentration reduction. According to Dexter, et al. (2013), the grinding method can be applied for the repair of fatigue cracks with a depth up to 2 mm. In addition, the execution of the grinding procedure for the fatigue strength improvement of welded connections is described by Haagensen et al. (2001) in the IIW recommendations. Peening is a cold working process which creates a plastic deformation at the surface of the material by impacting a tool or metal balls and it is mainly used as a fatigue strength improvement method. The application process and quality control procedure are extensively given in the IIW recommendations [Haagensen et al., 2001]. Peening is an effective method for repair of surface cracks with a depth up to 3 mm [Dexter et al., 2013]. The GTA process remelts a small amount of the weld toe and the base material by using a gas-shielded tungsten electrode to liquefy material and to re-establish the connection after the solidification. This method is effective for the repair of the surface cracks with a depth up to 5 mm. In addition, the GTA remelting process is also used as a fatigue strength improvement method by reshaping the weld toe to create smooth transitions between the base material and the weld material. The effectiveness of the method depends on the penetration of the remelting zone. Fisher, et al, (1994) concluded that the application with the argon helium shielding gas and a cone angle applied with 60° respect the material surface results in the most effective penetration of the remelting zone.

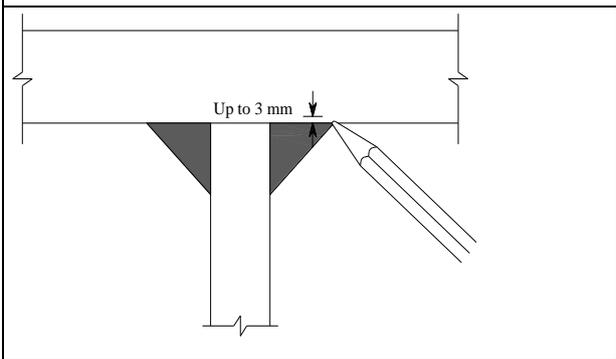
<p><b>Peening:</b></p> <p>Applicable for the fatigue cracks with the depth up to 3 mm.</p> <ol style="list-style-type: none"> <li>1. Advantageous <ul style="list-style-type: none"> <li>▪ improve weld toe, reducing stress concentration</li> <li>▪ introduce compressive stresses</li> </ul> </li> <li>2. Disadvantageous <ul style="list-style-type: none"> <li>▪ required highly skilled professionals</li> <li>▪ difficult to apply to complex joints</li> </ul> </li> </ol>

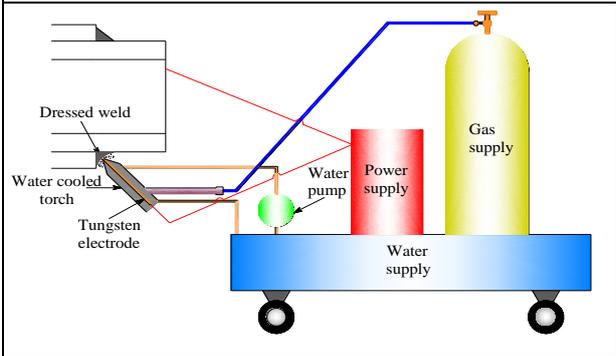
<p><b>Gas Tungsten Arc melting:</b></p> <p>Applicable for the fatigue cracks with the depth up to 5 mm.</p> <ol style="list-style-type: none"> <li>1. Advantageous <ul style="list-style-type: none"> <li>▪ improve weld toe, reducing stress concentration</li> <li>▪ no additional filler material required</li> </ul> </li> <li>2. Disadvantageous <ul style="list-style-type: none"> <li>▪ required highly skilled welders</li> <li>▪ difficult to apply to complex joints</li> </ul> </li> </ol>

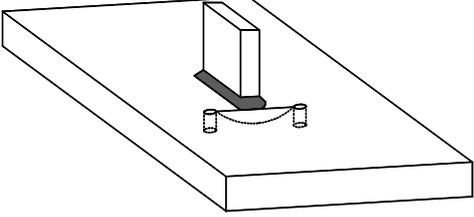
<p><b>Hole Drilling:</b></p> <p>Applicable for the fatigue cracks with the depth above 5 mm.</p> <ol style="list-style-type: none"> <li>1. Advantageous <ul style="list-style-type: none"> <li>▪ easy to apply</li> <li>▪ appropriate solution for cracks in the base material</li> </ul> </li> <li>2. Disadvantageous <ul style="list-style-type: none"> <li>▪ cause inconvenience for users</li> <li>▪ required good accessibility to crack position</li> </ul> </li> </ol>

The hole drilling method, the splice plate method and re-welding are commonly used processes for the repair of the deep fatigue cracks. The summary of these methods is given in Table 2. The application principle of the hole drilling method is to drill a hole at the crack tip to remove the sharp notch at the crack tip to inhibit further crack propagation. According to Dexter, et al. (2003), as a rule of thumb, holes with larger diameters show better performance in terms of fatigue strength retrofit. Based on field experience, Dexter, et al. (2013) recommends typical hole diameters in the range of 50 to 102 mm for steel bridge applications. However, the reduction in stiffness, the strength of the structures and the uncomfortable effects on the user of structures need to be taken into account for drilling larger holes. Haagenen (1994) recommended a formula for practical estimation of hole diameter and it was concluded that putting an entire fully tensioned high strength bolt into the hole improves the fatigue strength of the repaired section. This method is more suitable for fatigue cracks in the base material. With the splice plate method, the crack contained sections are covered with additional plates from both sides. The main principle of the method is to increase the cross sectional area at the concentrated sections to reduce stress range at the crack locations and consequently to prevent crack propagation. For the attachment of the additional plates, high strength bolts are preferable rather than welding from a fatigue strength point view. Yamasaki et al. (1984) concluded that the combination of the hole drilling method with the splice plate method can lead to a higher fatigue life extension than the fatigue life extension with only the splice plate method. The repair by welding is an effective method for the repair of long fatigue cracks in welded connections. The detected fatigue cracks are removed along the crack length up to the crack depth by preparing a suitable weld groove and filling the prepared groove by weld material. Borrego et al. (2009) concluded that the repair by welding is an effective method for fatigue cracks in welded connections. In case of fatigue cracks in the base material, the repair by welding is not preferable due to the deleterious effects of the welding process on the material properties and the residual tensile stress occurrence after welding application. Yamasaki et al. (1984) focused on the effects of the

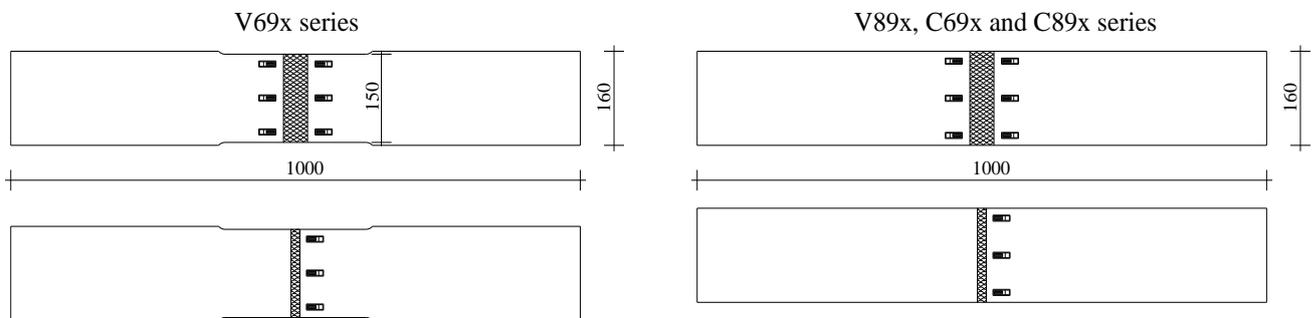
Figure 1. Geometry and dimensions of the test specimens.

The G10MnMoV6-3 and G18NiMoCr3-6 steel plates were cast with a thickness of 40 mm. The plates were quenched and tempered after casting and the thickness was reduced to 25 mm by machining from both sides of the plates. The cast plates satisfy the NDT requirements of SM1/LM1/AM1 for magnetic particle inspection according to EN 1369 (1996) and class 1 for ultrasonic inspection according to EN 12680-1 (2000).

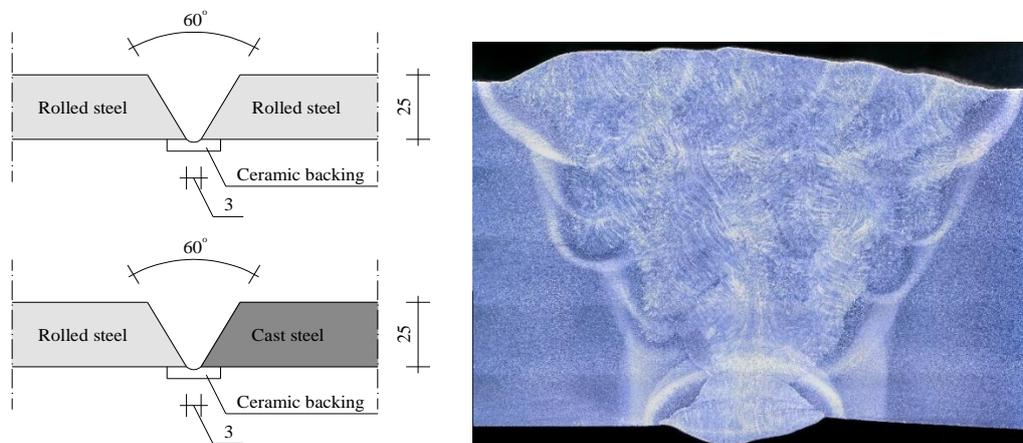
Figure 2. Weld configuration of the test specimens and a macro of the weld.

The rolled steel plates were flame cut and the weld edges of the rolled plates and the cast plates were machined to prepare a bevel angle of 60°. The prepared plates were welded by the FCAW process with a ceramic backing at the weld root. The individual test strips were plasma cut from the welded plates with a width of 160 mm and a length of 1000 mm (see Figure 1). Table 5 summarises the materials, weld parameters and geometry of the specimens for the test series of the current experimental program. Figure 2 illustrates the weld shape of the test specimens and a macro photo of the cross section of the weld, indicating the weld layers. Codes V69x and V89x are used for the specimens with rolled - rolled steel connections made of S690 and S890 respectively. Codes C69x and C89x denominate the hybrid specimens, cast - rolled steel connections, made of the steels with the nominal yield strength 690 MPa and 890 MPa respectively.

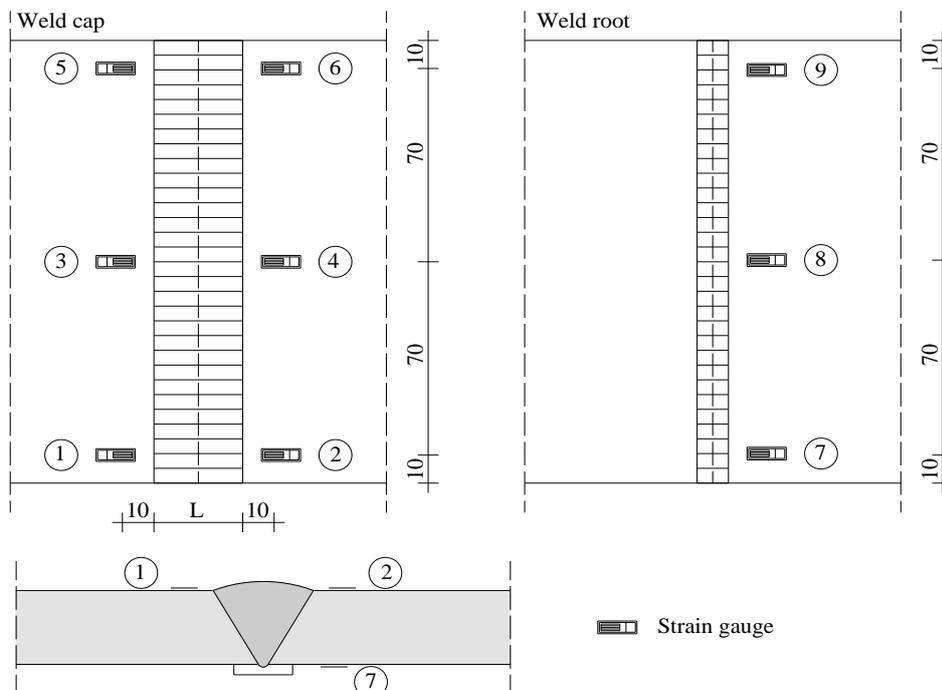
Figure 3. Strain gauge configuration on a test specimen.

Strain gauges are attached to the specimens to measure the strain distribution at the surrounding of the weld and to determine the fatigue crack initiation life of the specimens. By using these strain gauges, an alarm system has been set up to shut off the test rigs in case of 50  $\mu$ strain deviations of strain range measurements. Accordingly, the region of the strain gauge is visually inspected to discover the location of possible fatigue cracks. The strain gauges were applied 10 mm from the weld toe of the weld cap and the weld root. Three strain gauges were attached to each side of the weld toe of the cap and 3 strain gauges at one side of the weld toe of the weld root (see Figure 3).

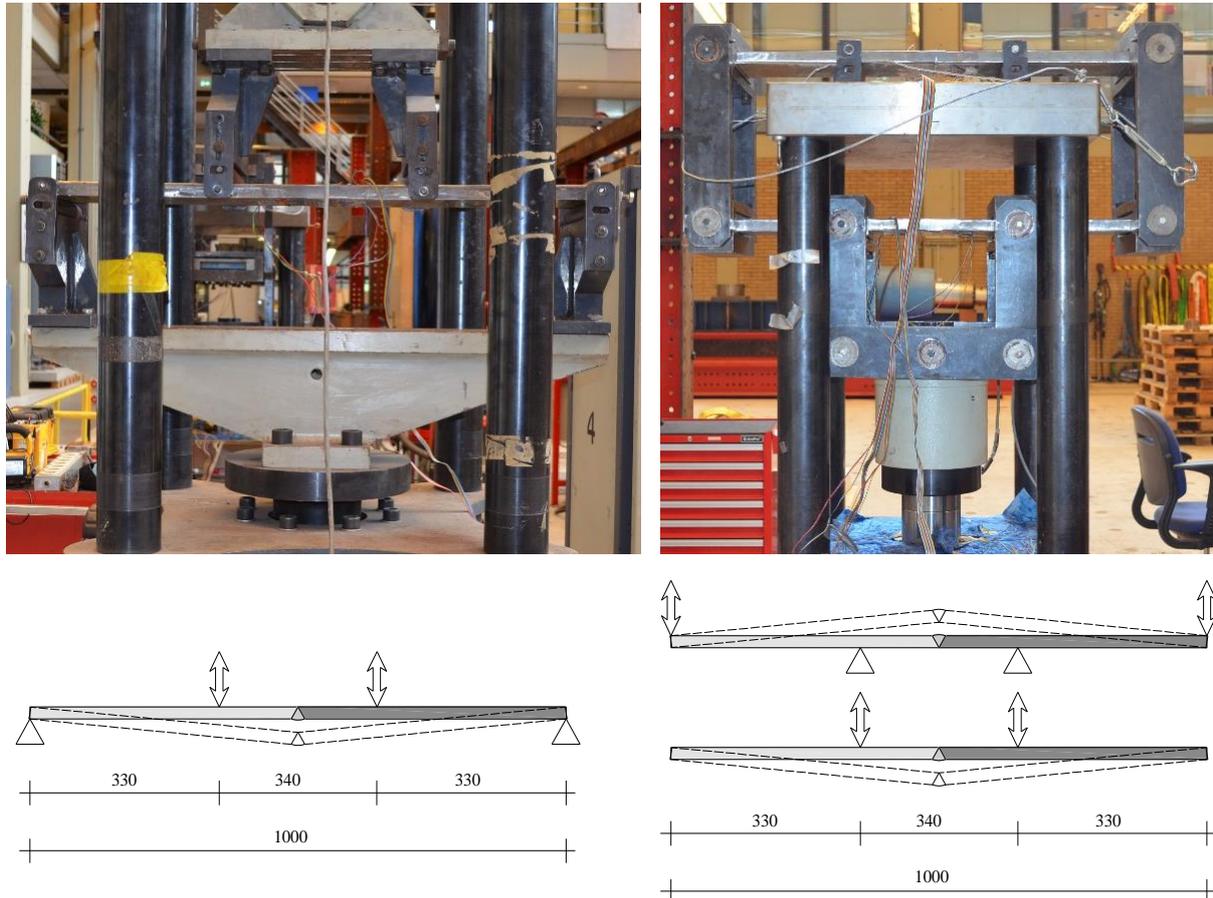
Figure 4. Four point bending test rigs for fatigue tests and the loading condition of the test specimens.

In the Stevin II laboratory of the Delft University of Technology, two four point bending test frames have been set up for the fatigue tests on the V-shape welded plate specimens. Figure 4 shows the fatigue test rigs where on the left side, a single plate setup is illustrated and on the right side, a twin plate setup is presented. By using these test setups simultaneously, a large number of tests can be performed in a relative short time. As the plates are loaded in the four point bending test frames, a continuous bending moment is present on the weld area, resulting in a compressive and a tension zone. The specimens are loaded such as the weld cap exposes to the tensile stresses. The fatigue test specimens are tested with stress ration  $R = 0.1$  and with the loading frequency of 3 Hz.

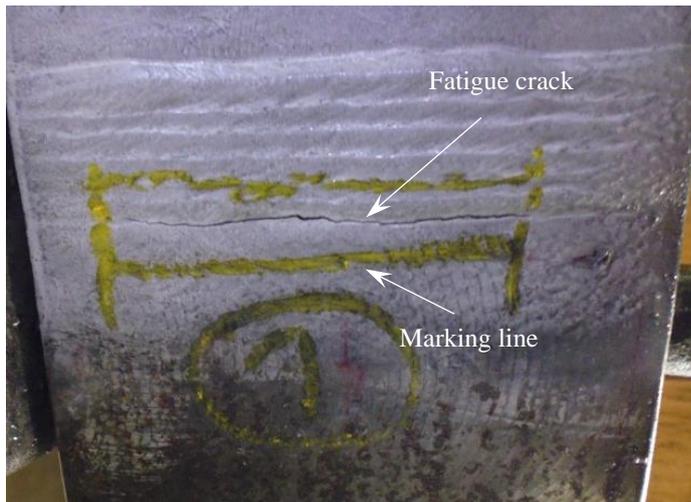
*Figure 5. Detected fatigue crack in a specimen and marking line.*

The performed visual inspection during the fatigue crack creation stage may lead to inaccurate crack length detection which depends on the visibility of cracks, accessibility to the crack locations and the person who performs the inspection. For the detection of an accurate crack length and all possible other small cracks, the application of a NDT method is essential. Accordingly, all fatigue damaged V-shape welded specimens were examined by a magnetic particle inspection and the detected cracks were marked to specify the crack boundary for the crack removal process (see Figure 5).

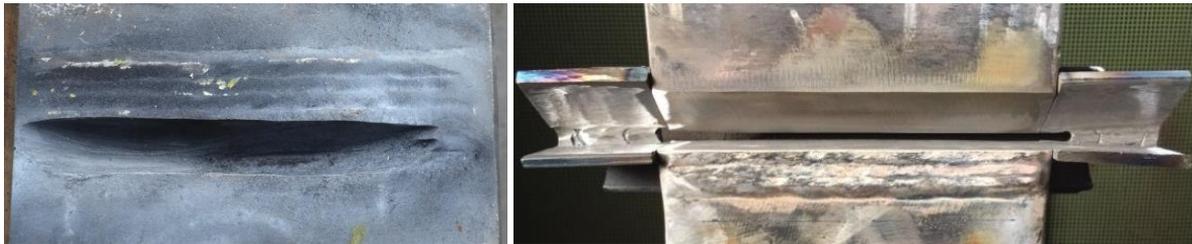
*Figure 6. A weld groove after crack removal process and attached temporary plate at the edge of a specimen.*

The fatigue crack removal process was executed with a disk and a burr grinder. The crack removal process was performed gradually and magnetic particle inspection took place regularly to avoid unessential material removal and a too deep weld groove. In the case of shallow cracks, the crack removal process was continued up to at least 1/3 of the material thickness to create an appropriate weld groove for a suitable weld quality. After the complete crack removal, the prepared weld groove was filled with the weld material by using the welding procedure of the original weld. For the repair of a weld toe fatigue crack at the edge of the plate, a temporary plate was attached to the specimen for providing a continuous welding and the temporary plate was removed after welding (see Figure 6).

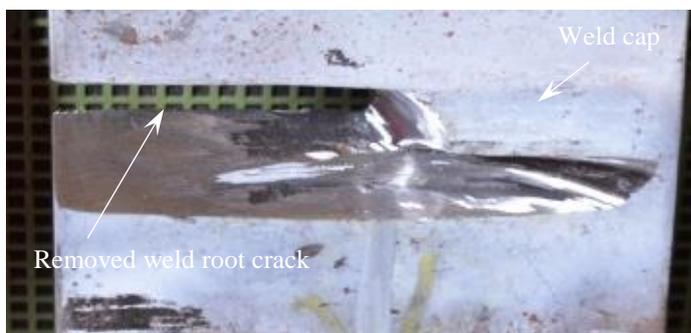
*Figure 7. Removal of the crack at the weld toe of the weld root.*

In general, V-shape welds are utilised for connections that are not possible to perform welding from both sides. It also means that the weld root is inaccessible for the fatigue crack inspections and these cracks may be visible when the cracks reach the weld cap. Consequently, the repair of these cracks can also be performed from the weld cap. During the fatigue crack creation stage, fatigue cracks were observed at the weld toe of the weld root, although the root of the weld was subjected to the compression stresses due to the loading. The fatigue cracks in the weld root have been repaired from the weld cap side by removing the material from the weld cap through the thickness of the weld.

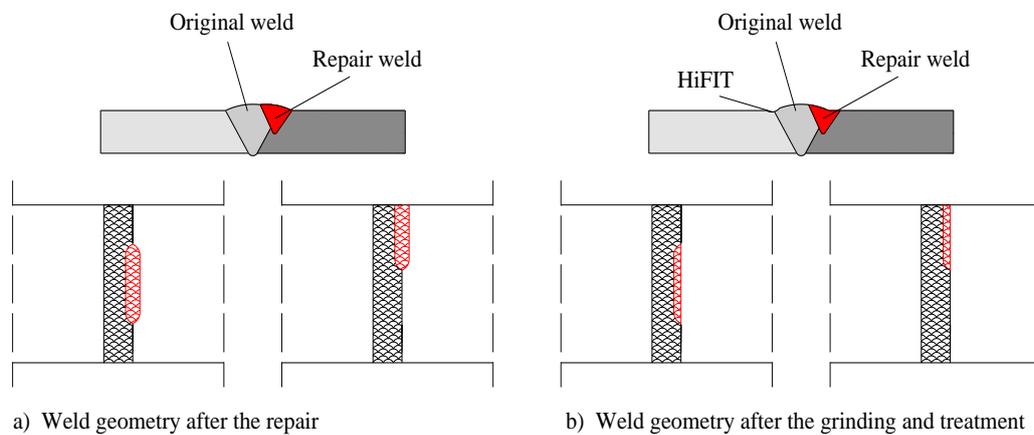
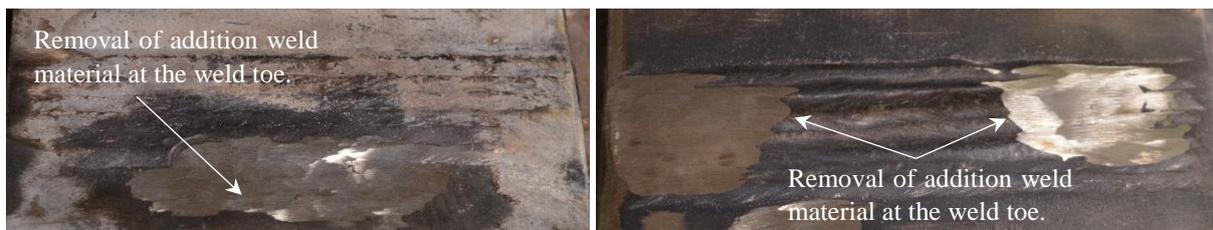
c) Boundary of the reshaping by the grinding process

Figure 8. Weld shape after the repair and the repaired weld geometry after reshaping and HiFIT.

In practice, repair of fatigue cracks in structures is carried out at service conditions where the repaired connections are constrained by the surrounding structural elements. For the simulation of realistic repair conditions, the specimens were constrained during the application of the repair weld. The repair welds were examined by a magnetic particle and ultrasonic inspection for the weld qualification. After the repair of the weld toe cracks, the repair welds cause geometrical changes of the welded connection and it consequences a disruption of the stress distribution around the welded connection (see Figure 8a). Especially, the intersection between boundaries of the repair weld and the original weld cause a sharp geometrical change and consequently a high stress concentration. For the elimination of these undesired effects of the stress concentration, the repaired welded connections were reshaped by grinding to smooth transition between the original and repair weld (see Figure 8b). The grinding process is limited with the removal of the start-stop points of the repair weld and additional weld material at the weld toe (see Figure 8c). Furthermore, after the fatigue crack repair, the repaired side of the connection has a new weld toe and the other side of the weld contains the weld toe of the original weld which still contained the cyclic load history from the fatigue crack creation stage. According to the cumulative damage rule of Miner, fatigue crack initiation in the original weld toe is highly possible after the repair. The main purpose of the research is to investigate the fatigue strength of the repaired welded connections made of very high strength steels. Therefore, the cracks initiation in the original weld toe needs to be prevented. For this purpose, the weld toe of the original weld was treated by the high frequency impact treatment (HiFIT) weld toe improvement method.

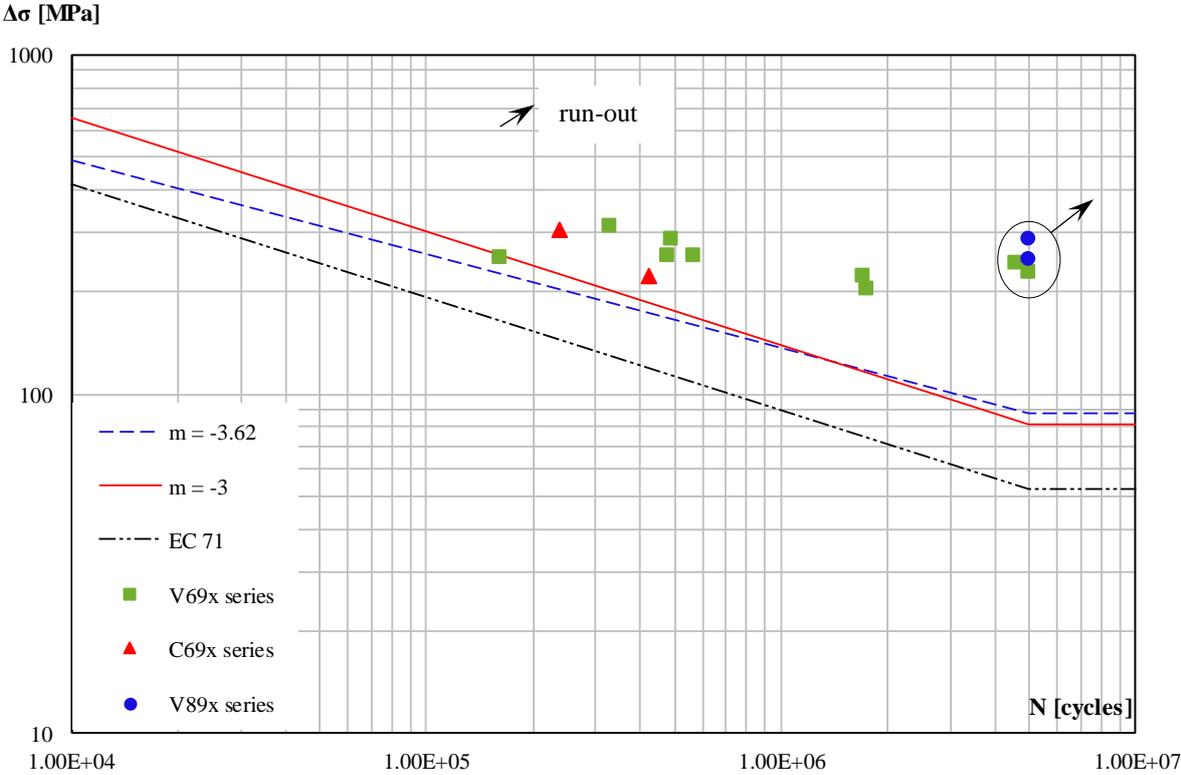
Figure 9. S-N curves of weld toe cracks in rolled steels of the repaired V-shape welded specimens.

Figure 9 presents the fatigue strength curves of the weld toe cracks in the rolled steel parts of the repaired V-shape welded specimens compared to the detail category 71 of EN 1993-1-9 (2006) which is recommended for the fatigue design of V-shape welded connections. The comparison shows that the recommended fatigue design curve of EN 1993-1-9 (2006) seems to be very conservative. Using a fixed slope of  $m = -3$ , the fatigue strength at  $2 \cdot 10^6$  cycles is 111 MPa while the design value of EN 1993-1-9 (2006) is 71 MPa and analysing the test results for a free slope of  $m = -3.62$  the fatigue strength at  $2 \cdot 10^6$  cycles leads to 114 MPa.

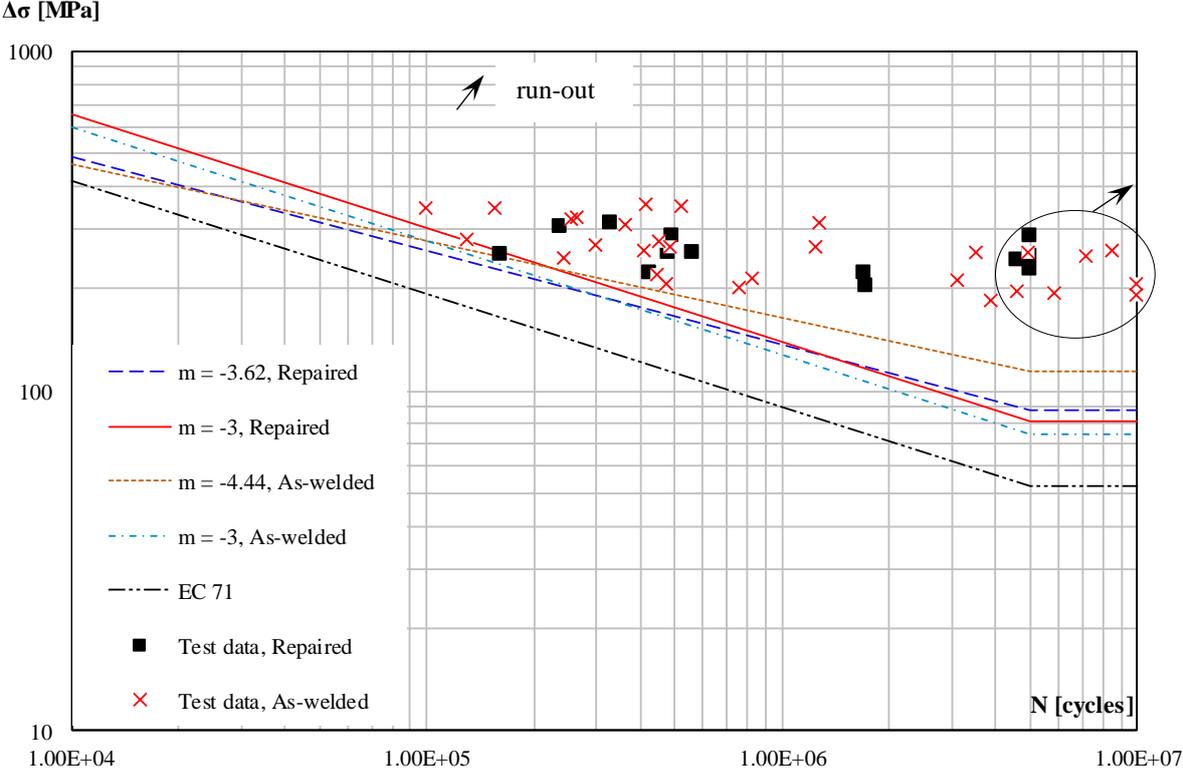
Figure 10. Comparison between S-N curves of weld toe crack in rolled steels of repaired and in the as-welded specimens.

Figure 10 compares the fatigue strength curves of repaired welded connections with the fatigue strength curves of welded connections in the as-welded condition. Due to a large number of run-outs in the test data of Pijpers (2011), a large deviation is determined between the fatigue strength curves with the free slopes. The fatigue strength at  $2 \cdot 10^6$  cycles is 102 MPa for the fixed slope of  $m = -3$  and 141 MPa for the free slope of  $m = -4.44$ . The fatigue strength curve with the slope of  $m = -3$  of the repaired V-shape welded specimens ( $\Delta\sigma_c = 111$  MPa) reasonably matches with the fatigue strength curve of V-shape welded specimens in the as welded condition ( $\Delta\sigma_c = 102$  MPa).

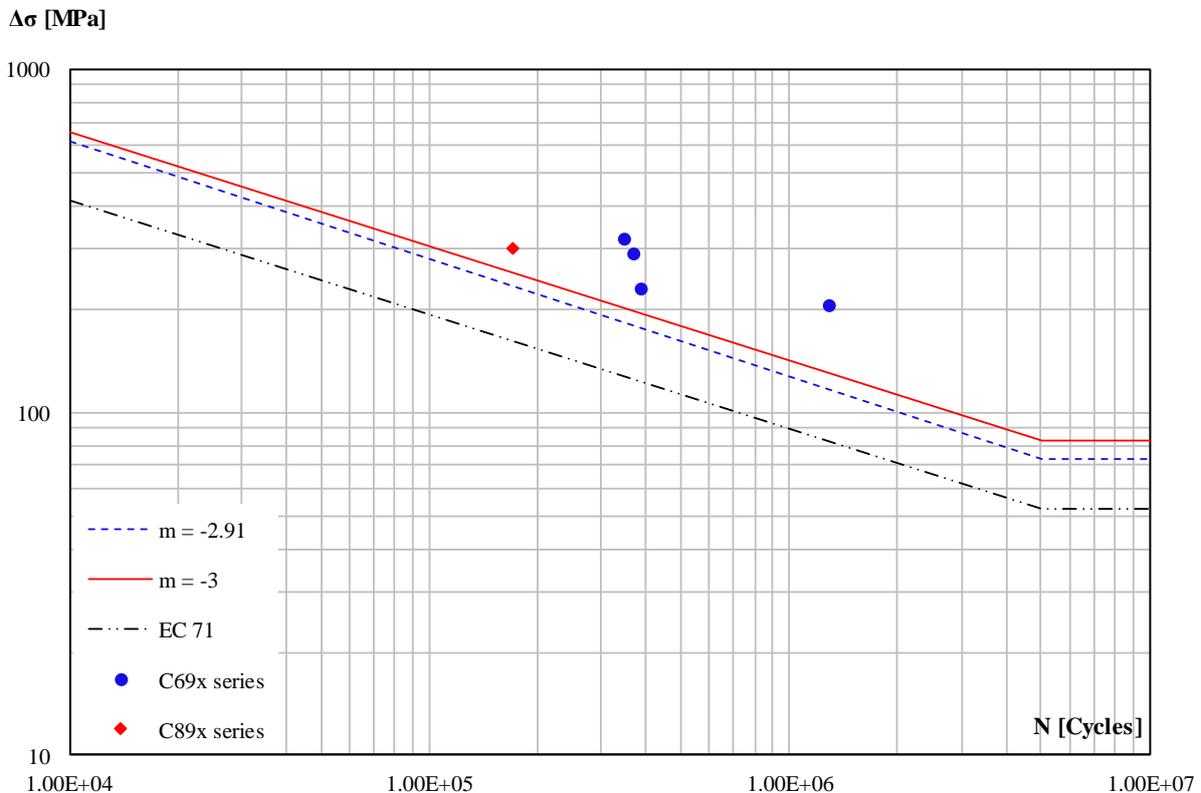
Figure 11. S-N curves of weld toe cracks in cast steels of the repaired V-shape welded specimens.

Figure 11 presents the fatigue strength curves of weld toe cracks in G10MnMoV6-3 and G18NiMoCr3-6 cast steel of the repaired V-shape welded connections. The comparison is made with the detail category 71 of EN 1993-1-9 (2006) and it was found that the design curve leads to conservative fatigue strength. For the fixed slope of  $m = -3$ , the fatigue strength at  $2 \cdot 10^6$  cycles is 112 MPa and the fatigue strength leads to 100 MPa at  $2 \cdot 10^6$  cycles for analysing the test results with a free slope of  $m = -2.91$ .

EN 1993-1-9 (2006) does not distinguish between the fatigue design of cast steels and rolled steels. The fatigue design recommendations for welded connections made of cast steels are given in DNVGL-RP-C203 (2016). According to this design recommendation, the fatigue design category of rolled steels can be used for the cast steels as well. The recommended design class in DNVGL-RP-C203 (2016) for V-shape welded connections is the same as detail category 71 of EN 1993-1-9 (2006). Consequently, the fatigue strength curves of the repaired specimens satisfy the requirements of DNVGL-RP-C203 (2016).

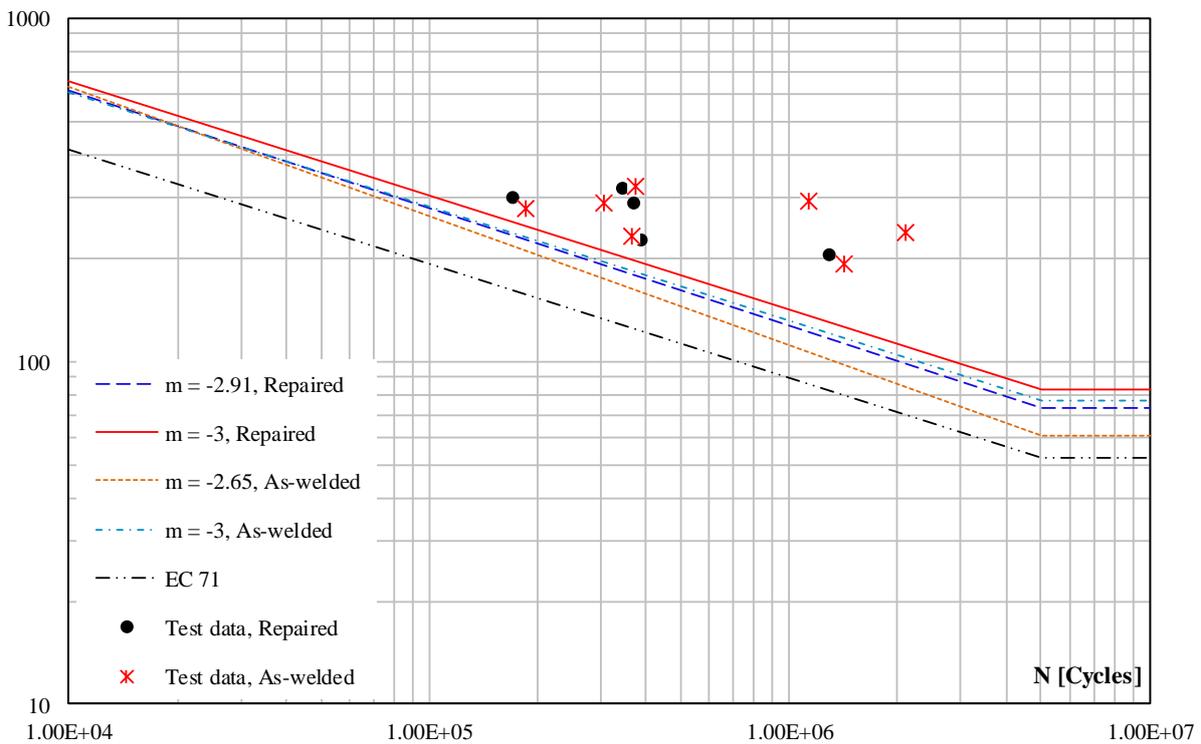
Figure 12. Comparison between  $S-N$  curves of weld toe crack in cast steels of repaired and in the as-welded specimens.

Figure 12 shows the comparison between the fatigue strength curves of the weld toe cracks in the cast steels side of the repaired specimens and specimens in the as-welded condition. The fatigue strength curves with the free slope show slight deviation due to different slope values. The fatigue strength curve of the repaired specimens with the fixed slope  $m=-3$  shows a good agreement with the fatigue strength curve in the as-welded condition with the fixed slope of  $m = -3$ . At  $2 \cdot 10^6$  cycles, the fatigue strength for the fixed slope of  $m = -3$  is 105 MPa and 86 MPa for the free slope of  $m = -2.65$ . In accordance with this, the fatigue strength of the fatigue damaged connection made of cast steels can be recovered with the established repair procedure.

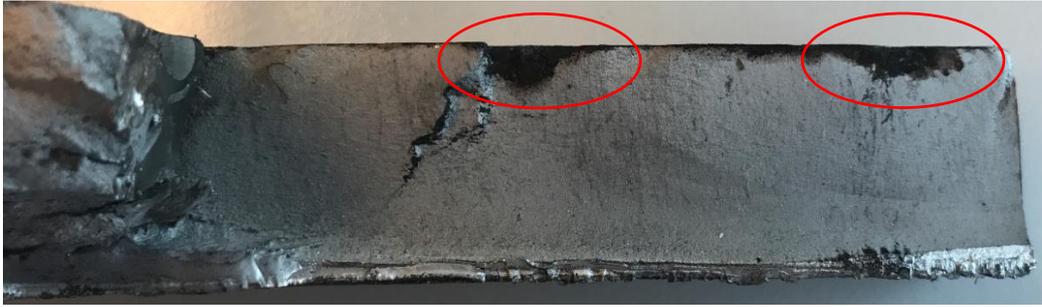
Figure 13 Highly corroded areas at the crack initiation locations on the fracture surface of base material failure in S890.

Base material cracks in rolled steel were observed in the majority of the test specimens containing S890. Using visual inspection, very highly corroded areas have been observed at the crack initiation locations (see Figure 13). It is assumed that the corrosion pits at the surface of the specimens caused the crack initiation. The base material failures were observed after the repair of the cracks in the welded connections. Therefore, the number of cycles at the crack creation stage is also included in the number of cycles at failure of specimens during the statistical analysis. The results of the statistical analysis on the base material failure in the rolled steel are given in Table 11.

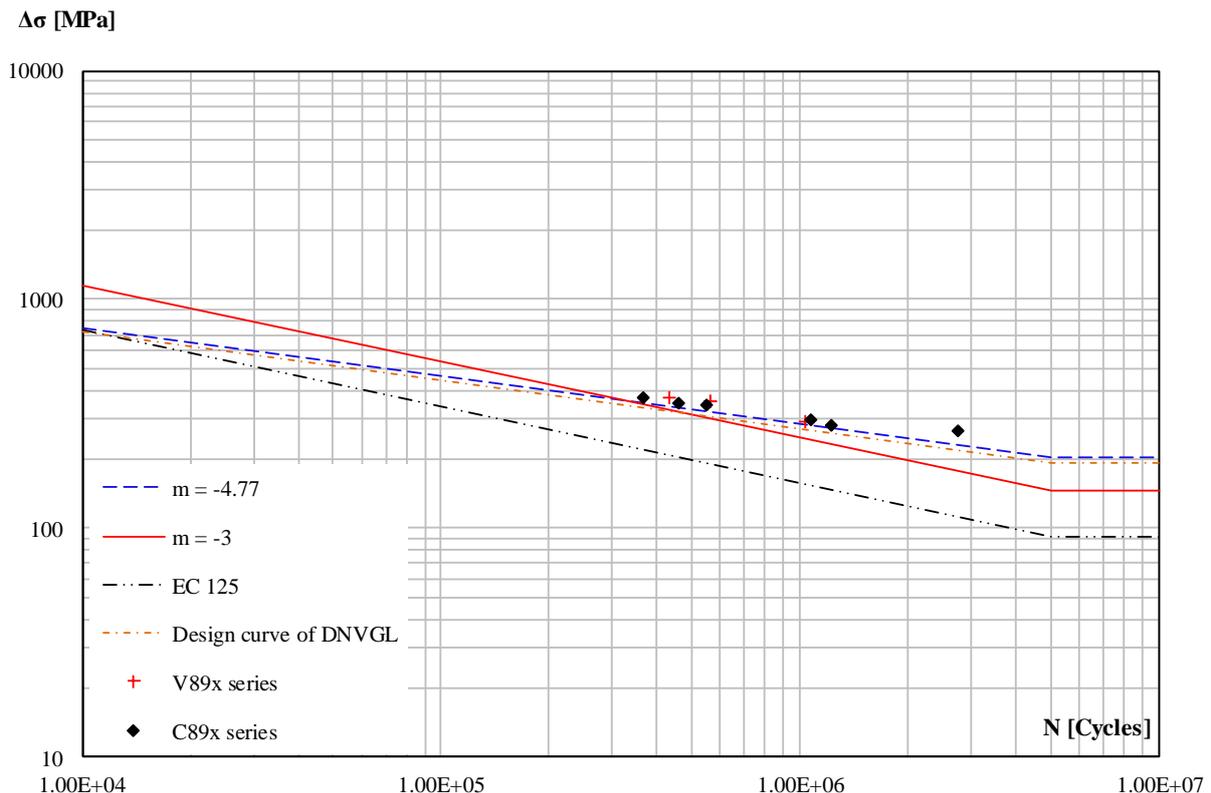
Figure 14. S-N curves of base material cracks in rolled steels of the repaired V-shape welded specimens.

Figure 14 compares the fatigue strength curves of the base material cracks in S890 rolled steel with the detail category 125 of EN 1993-1-9 (2006) which is recommended for the fatigue design of the base material. The design curve of EN 1993-1-9 (2006) is found to be conservative. The fatigue strength at  $2 \cdot 10^6$  cycles is 197 MPa for the fixed slope of  $m = -3$  and 246 MPa for the free slope of  $m = -4.77$ .

In EN 1993-1-9 (2006), no distinction is made between the fatigue strength of various steel grades and the given design curves are also used for the fatigue design of steels with the yield strength up to 700 MPa. However, DNVGL-RP-C203 (2016) proposes a fatigue design curve for the base material of high strength steels with yield strength above 500 MPa. The design curve has a slope  $m = -4.7$  and the characteristic stress range value at 2 million cycles  $\Delta\sigma_c = 235$  MPa. Figure 14 additionally compares the fatigue strength curve of the base material

crack in S890 rolled steel with the design curve of DNVGL-RP-C203. The fatigue strength curve with the free slope exactly matches with the design curve and the slope of the design curve,  $m = -4.70$  is very close to the slope of the fatigue strength curve of the test data,  $m = -4.77$ .

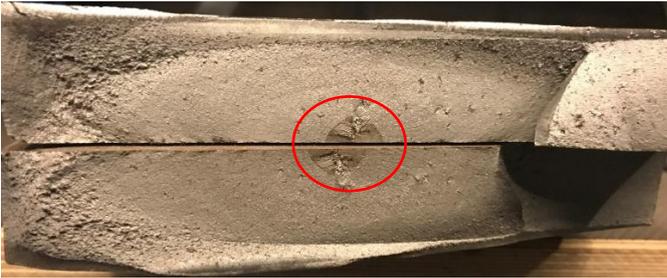
Figure 15 Internal imperfection at the crack initiation location of the base material failure in cast steels.

In the repaired hybrid specimens, the fatigue cracks were observed in the base material of G10MnMoV6-3 and G18NiMoCr3-6 cast steel grades. Internal imperfections were detected at the crack initiation region of these specimens (see Figure 15). The test data from both cast steel grades were combined and the statistical analysis performed on the test data with the inclusion of the number of cycles at the fatigue crack initiation. From the collected data, it can be seen that the base material failure of all these specimens took place at a similar stress range and number of cycles at fracture, which makes it difficult to determine a free slope for the data scatter. For this reason, the emphasise was put on the fatigue strength curves with the fixed slope  $m = -3$ . The results of the statistical analysis are given in Table 12.

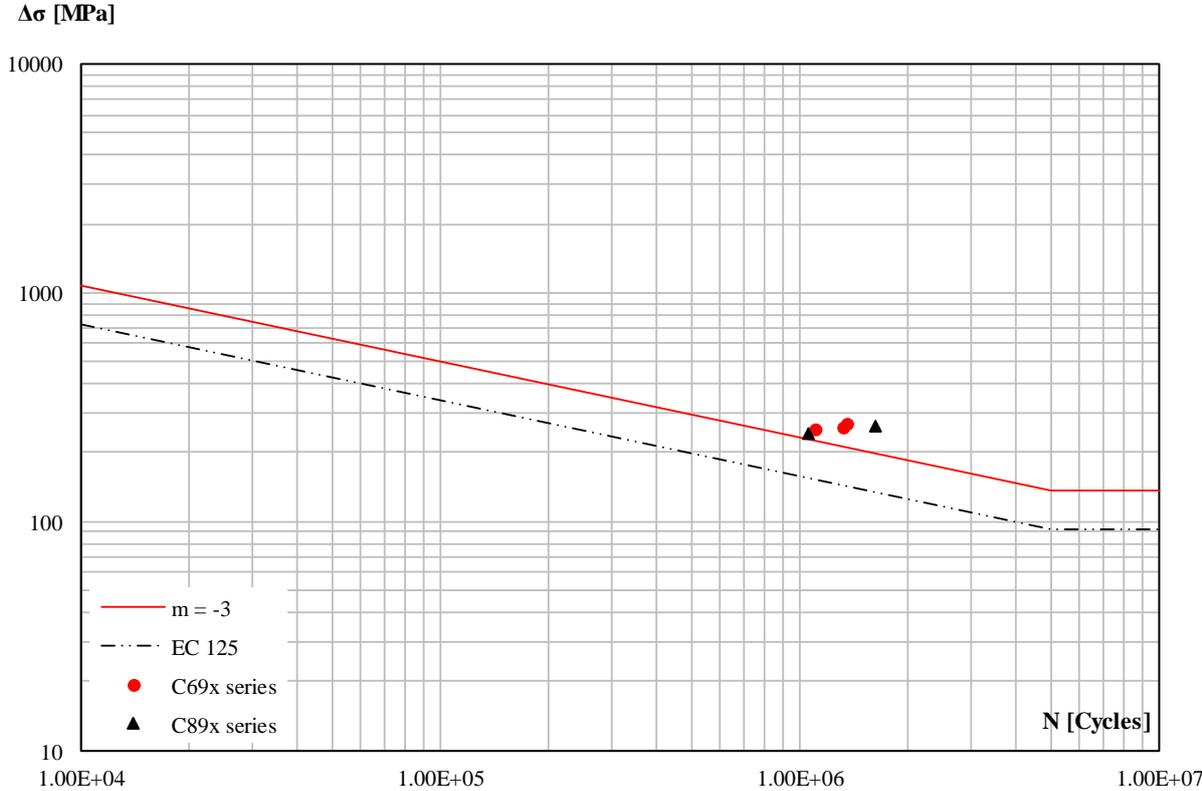
Figure 16. S-N curves of base material cracks in cast steels of the repaired V-shape welded specimens.

Figure 16 presents the fatigue strength curve of the base material cracks in the cast steels compared to the detail category 125 of EN 1993-1-9 (2006). The fatigue strength curve of the test data is located at the above of the design curve of EN 1993-1-9 (2006), which means that the design curve is conservative. The fatigue strength at  $2 \cdot 10^6$  cycles is 185 MPa for the fixed slope of  $m = -3$ .

EN 1993-1-9 (2006) states that the standard is applicable for structural steels and no distinction is made for rolled and cast steel grades. However, DNVGL-RP-C203 recommends the design curve C for the fatigue design of the base material of cast nodes. The design curve C is identical with detail category 125 of EN 1993-1-9 (2006). In accordance with this, the fatigue strength of the base material in the tested cast steels complies with the requirements of DNVGL-RP-C203 (2016).
