## Damage Characterisation of Rock Armoured Slopes

De Almeida Sousa, Ermano; van Gent, Marcel; Hofland, Bas

Proceedings of the 7th International Conference on the Application of Physical Modelling in Coastal and Port Engineering and Science (Coastlab18)

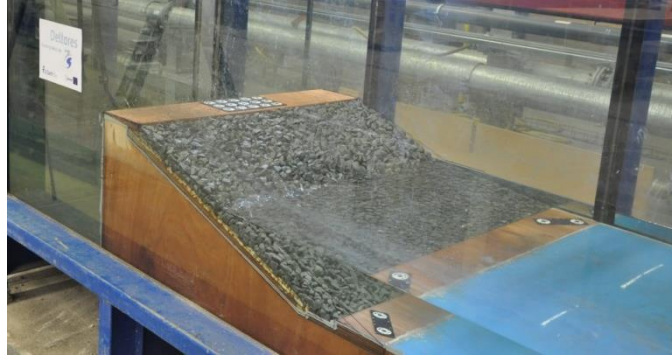
Figure 2. Deltares shallow water tests set-up.

This set-up consisted of a non-overtopped rubble mound structure with an impermeable core, a filter ( $D_{n50} = 9.4$  mm), a 1:3 two-layer rock armoured slope ( $D_{n50} = 16.3$  mm and  $D_{n85}/D_{n15} = 1.19$ ) and a foreshore (see Figure 2). In addition, the main particularity of these tests for shallow coastal areas is that the generated wave was equal for all test runs, and only the change in the water depth at the toe of the structure defined the incident wave height. This way, the effect of the sea level rise in the damage to the structure was clearly represented. Thus, this set-up provided a large amount of complementary data given the number of tests carried out, which allowed the testing of different slope configurations and a number of repetition tests. The testing conditions included the following:
