## **Influence of the behaviour of calcium silicate brick and element masonry on the lateral capacity of structures**

10th Australasian Masonry Conference

**R. Esposito<sup>1</sup>, S. Jafari<sup>2</sup>, G.J.P. Ravenshorst<sup>3</sup>, H.R. Schipper<sup>4</sup> and J.G. Rots<sup>5</sup>**

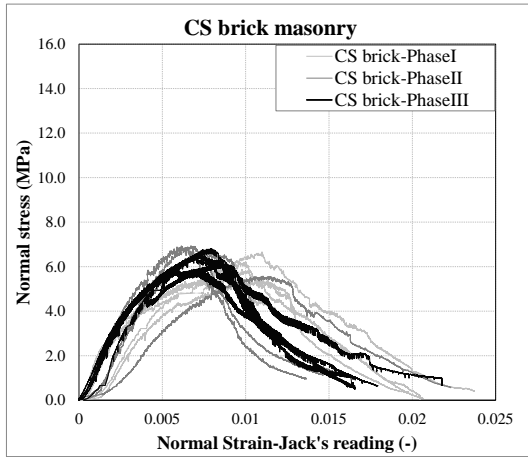
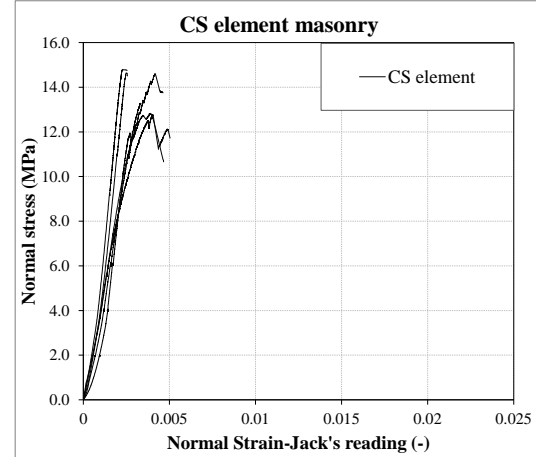
**(b)****Figure 2: Stress-strain relationship in compression: (a) CS brick masonry; (b) CS element masonry.**

The material properties of calcium silicate masonry were selected to represent Dutch masonry used in the construction of terraced house before and after 1980. The compression, bending and shear properties of both masonry specimens were investigated in dedicated experimental campaigns (Esposito et al. 2016, Jafari et al. 2017). The test were mainly performed by following the European standard EN 1052, however a displacement controlled procedure was adopted to obtain an indication of the post-peak behaviour. Table 1 lists the mean material properties for the CS brick and element masonry and their constituents. The CS element masonry showed a higher compressive strength and Young's modulus with respect to the CS brick masonry. In both cases, the pre-peak stage was characterised by linear-elastic followed by a hardening behaviour until the peak. After the maximum stress was reached, a softening behaviour was observed for the calcium silicate brick masonry, while a brittle failure was reported for the element masonry. Both the out-of-plane masonry flexural strength parallel to the bed joint and the initial shear strength resulted higher for the CS element masonry with respect to the CS brick masonry. Consequently the bond between masonry unit and mortar can be considered stronger in the case of CS element masonry.

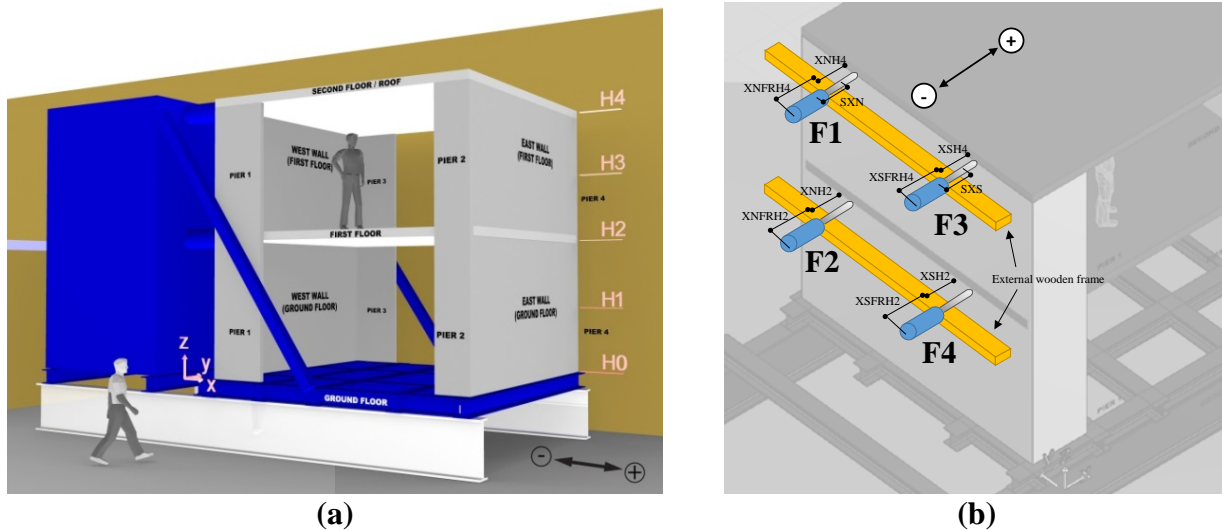
### Figure 3: Test set-up

A quasi-static cyclic pushover test was performed on both assembled structures. The masonry structure was loaded by four actuators (Figure 3b), two per each floor, positioned at approximately 1.1 m inwards from the facades. A displacement was imposed at the second floor level, while a ratio 1:1 was maintained between the forces at the two floor levels ( $F_1 + F_3 = F_2 + F_4$ ). To impose a constant ratio between the forces at the two floor levels, the forces in the actuators No. 1 and 3 at the second floor level were mechanically coupled to the forces at the first floor level ( $F_1 = F_3$ ,  $F_2 = F_4$ ).

The deformation of the specimen was measured in absolute sense from a stiff wooden frame, which was connected neither to the steel reaction frame nor to the foundation beams (Figure 3b). The displacements along the X-axis, at the point of application of the loading, have been measured with draw wires with length of 150 mm.

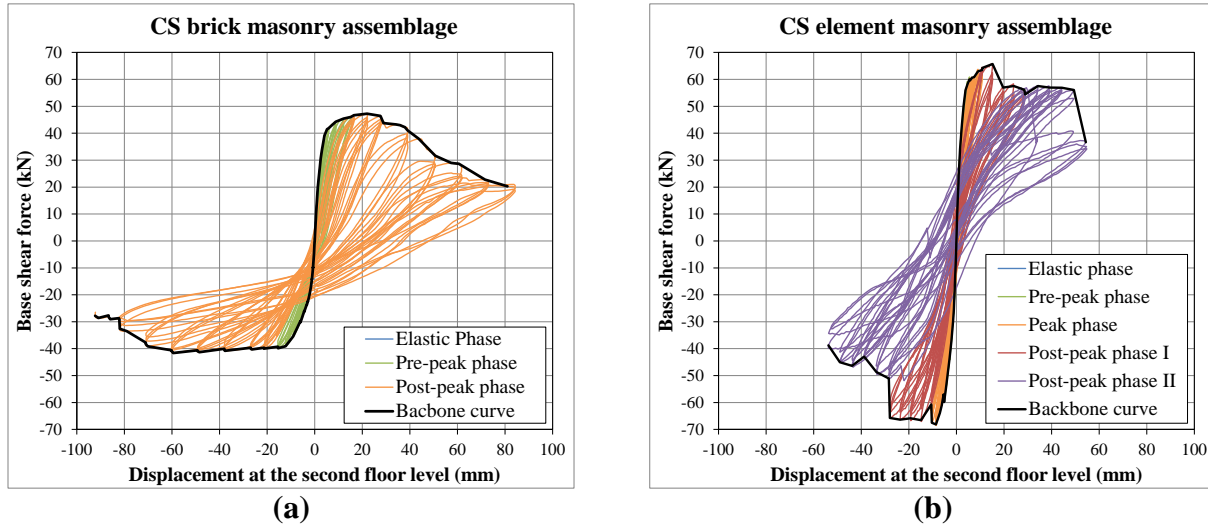
**Figure 4: Capacity curve: (a) CS brick masonry; (b) CS element masonry.**

Figure 4 shows the response of the CS brick and element masonry assemblages in terms of base shear force versus displacement at the second floor level  $d_2$ . By comparing the two curves, it is possible to note that the CS brick masonry assemblage shows an higher displacement capacity, while the CS element masonry assemblage shows an higher maximum base shear force. In both cases a reduction of 20% in base shear force was achieved during the post-peak phase, but the test was continued until major damage (or even collapse) in the wide piers was observed. For the

CS brick masonry assemblage the 20% reduction in base shear force was obtained at a displacement of  $d_2 = +43$  mm and  $d_2 = -80$  mm, while for the CS element masonry assemblage it was reached at a displacement of  $d_2 = -28$  mm and  $d_2 = +50$  mm.

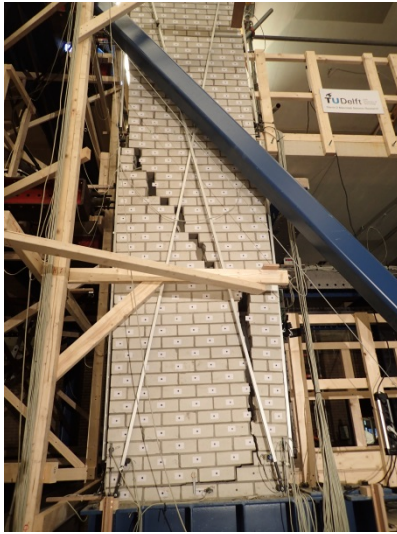
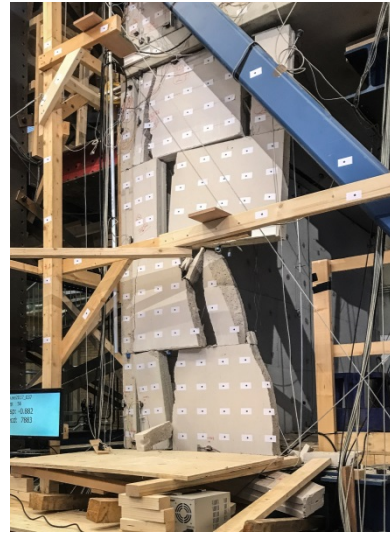
**Figure 5: Main damage in the wide piers at the ground floor: (a) CS brick masonry assemblage ( $d_2 = 82$  mm); (b) CS element masonry assemblage ( $d_2 = 54$  mm).**

In both cases, the failure mechanism was mainly governed by the in-plane damage of the facades piers at the ground floor (Figure 5, Figure 6). First, cracks occurred at the joint between the concrete floor and the masonry walls. Subsequently, diagonal/vertical cracks occurred in the wide pier P1 and P3 at the ground floor, while the rest of the structure was only slightly damaged. During the post-peak phase and prior to major damage in the narrow piers, the wide piers were subject also to a reduction in cross section that led to a further reduction in capacity. Both for the brick and element masonry the diagonal/vertical cracking occurred first in the head and bed joints. However, in the case of the CS element masonry assemblage, large out-of-plane deformation up to collapse of the piers occurred; this is caused by the large size of the masonry units.

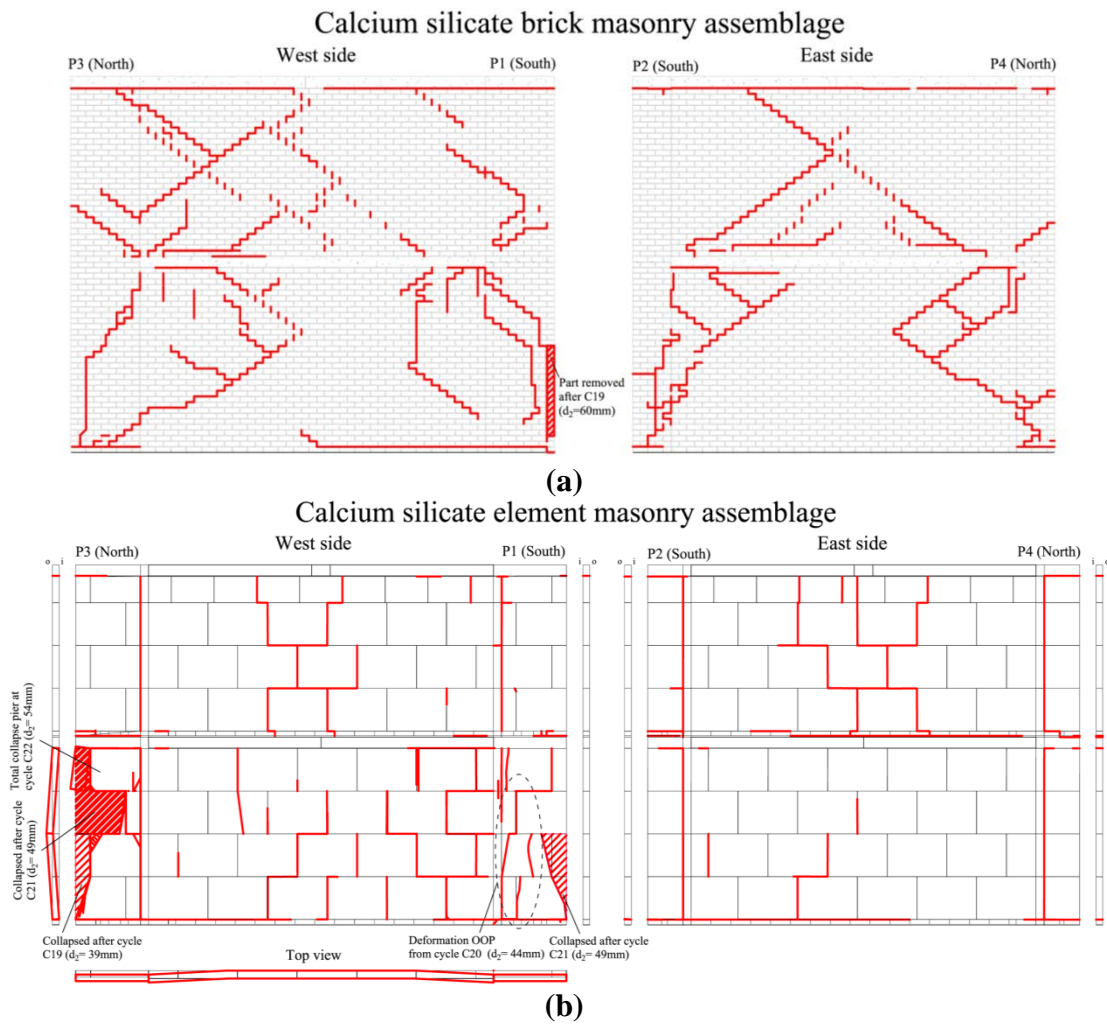
**Figure 6: Crack pattern: (a) CS brick masonry; (b) CS element masonry.**

By accommodating the in-plane deformation of the piers, the transversal walls deformed out-of-plane showing the effectiveness wall-to-wall connection in both cases. In the case of the CS brick masonry assemblage the running bond allowed a strong connection between the piers and the transversal walls and promoted the flange effect, which is of importance for the base shear capacity (Esposito et al., 2017a). In the case of the CS element masonry assemblage, although cracking occurred in correspondence of the vertical joints at approximately the peak load, the connection was still effective. This was caused by the presence of the steel ties and by the sliding friction mechanism at the vertical joint governed by the high friction coefficient of the CS element masonry. Additionally, the extensive damage of the pier and the detachment of masonry pieces that interlocked within the open cracked promoted local deformation at the end of the transversal wall for a length of approximately 1 m from each wide pier (Figure 6b).

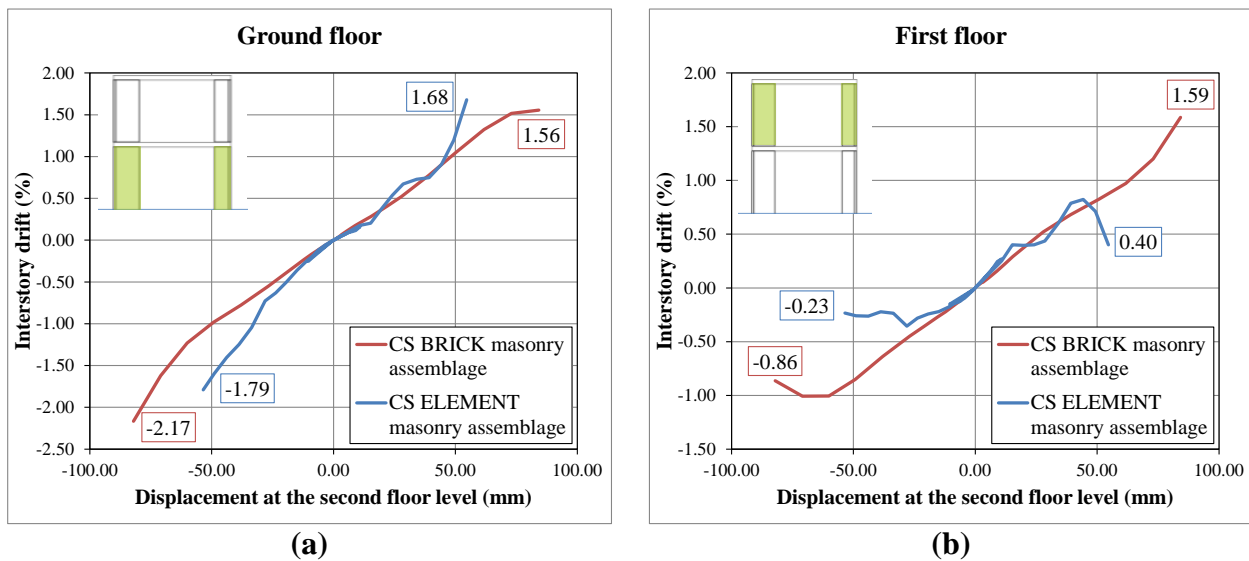
**Figure 7: Comparison in terms of interstory drift: (a) Ground floor; (b) First floor.**

Figure 7 shows the behaviour of the structure in terms of interstory drifts as a function of the displacement at the second floor level. They are calculated as the ratio between the relative floor displacement and the interstory height, which is 2.7 and 2.6 m for the first and second floor level, respectively. Although the CS brick masonry assemblage reached larger displacement at the second floor level (82 mm in comparison with the 54 mm of the CS element masonry assemblage), the two structures showed a similar interstory drift for the ground floor varying between 1.6% and 2.2%. A substantial different behaviour is observed at the first floor, where at the onset of damage of the wide pier the CS element masonry assemblage showed a nearly constant drift. This difference can be caused by the different load redistribution on the piers at the level of the first floor slab, which is consequence of the different construction detail. In the case of the CS brick masonry assemblage the piers are only horizontally connected to the floor by anchors, while for the CS element masonry assemblage the floor is laid on top of the piers. Although in both cases the piers do not bear the floor in the undamaged configuration, for relative large displacement the load transferred by the first floor slab is directly redistributed to the piers in the case of the CS element masonry assemblage, while it is indirectly transferred via the transversal walls in the case of the CS brick masonry assemblage. Consequently, in the former case a concentration of displacement is observed at the ground floor leading to a soft-story mechanism.
