Crack initiation and propagation in unreinforced masonry specimens subjected to repeated in-plane loading during light damage

Korswagen, Paul A.; Longo, Michele; Meulman, Edwin; Rots, Jan G.

Bulletin of Earthquake Engineering

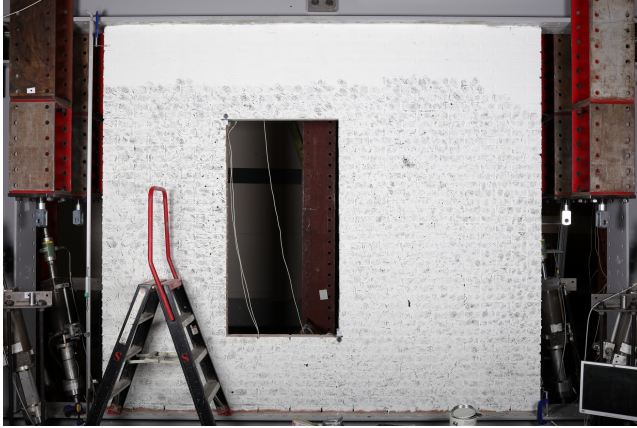
Figure 5. Photograph of one of the experimental walls, before the application of the DIC pattern has been finished.

Three specimens of a full-scale wall (Figure 1 and Figure 5) were tested in the laboratory, first with a repetitive (one-way cyclic) quasi-static loading, later with a cyclic (two-way) loading, also quasi-statically. During the tests, a constant overburden was maintained.
