## The Paintwork and the Colours of the Exterior

van Thoor, M.-T. (2019). The Paintwork and the Colours of the Exterior. In M.-T. van Thoor (Ed.), *Colour, Form and Space: Rietveld Schröder House Challenging the Future* (pp. 22-33). Delft University of Technology.

## 2 / THE PAINTWORK AND THE COLOURS OF THE EXTERIOR

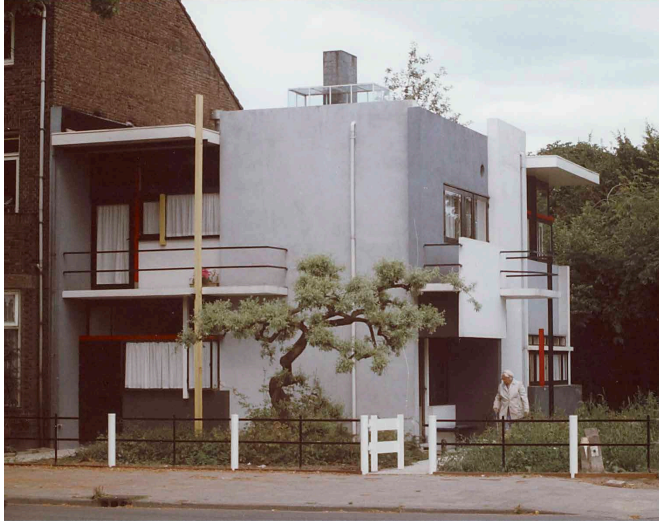
FIG. 2.6 The house in spring 1975, about a year after the first treatment of the exterior

According to Veroude's 1970 technical report, mentioned in the previous chapter, all existing coats of paint on walls, woodwork and steel were to be removed before the restoration. Before repainting, samples were to be taken, which would then be used as a guide to the new colours.<sup>15</sup> Mulder asked the TNO's Paint Research Institute whether it would be possible to separate successive coats of paint so as to reveal the colour of each coat. That would be no problem at all, TNO replied.<sup>16</sup> When the restoration was in full swing Mulder promised the foundation's board 'photos, specimens, colour samples and other relevant information' [FIG. 2.6].<sup>17</sup>

blue. Mrs Schröder recalled that when she first met Rietveld, many people considered black obtrusive, but according to Rietveld black actually receded into the background. He used it for elements – like door and window frames – that were not intended to obtrude, with the result that everything appears to be in the same plane and the composition is emphasized [FIG. 2.6/2.10].<sup>25</sup>

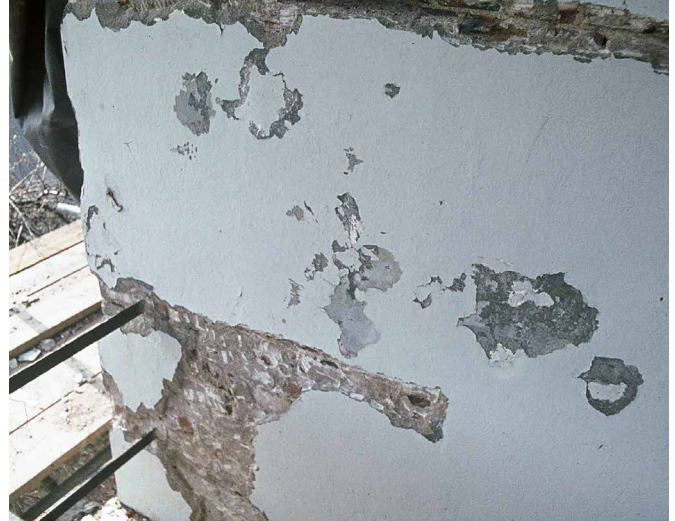
FIG. 2.7 In various places, such as the chimney, B. Mulder found still more finish coats and colours that he could include in his colour research

Despite the fact that the Schröder House had been regularly repainted (possibly as many as ten times), and colour coats had been removed on previous occasions, old paint was evidently still to be found in certain places, such as behind the prickly ivy or on the chimney [FIG. 2.7].<sup>18</sup> Mulder included these remnants in his colour research, and investigated their composition [FIG. 2.8].<sup>19</sup> Once the restoration was finished he threw the samples away.

Upon inquiry Mulder turned out to have yet more information in the form of a series of slides and a set of colour samples.<sup>20</sup> Detail photos of the chimney show various finish coats and it appears possible to distinguish several colours. Even more interesting is a photo of the wall below the kitchen window in the east elevation [FIG. 2.9]. We can see various shades of grey, from light to dark, and between them the white of a base coat. Mulder's caption reads: 'I opted for a dark grey from top right corner.'<sup>21</sup> This is one of the wall surfaces that were not repaired and on which the original plaster is still present, according to Mulder. Nevertheless, we are left guessing about the dates of these grey coats because there is simply no further documentation and also because references to other wall surfaces are lacking. The layers of paint on the walls, which were entirely stripped in 1979, were removed together with the old layers of render.

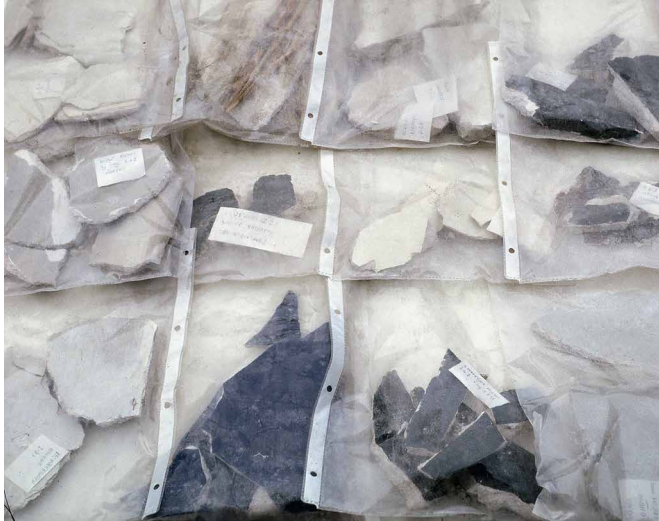
FIG. 2.8 Plaster and colour samples packed in plastic bags

During the restoration the colour formulas were not recorded: the colours were the result of intensive, on-site consultation between Mulder and the painter.<sup>36</sup> While the work was ongoing, Mulder kept the plaster samples properly organized and labelled, as can be seen in figure 2.8. Once it was finished he threw everything away. Colour samples from that period are also nowhere to be found, not in Mulder’s archive or that of the RSA, not even in that of the foundation. During the restoration the foundation’s board had regarded specimens, samples, photographs and other material relating to the restoration as important ‘safeguards’. After it was finished the matter was not referred to again and it seems that everyone assumed that the documentation was in good hands with the restoration architect. The foundation’s archive does not even contain a photographic record of the restoration process. That, too, is quite remarkable for board members with so much expertise and interest in modern architecture, as well as for the first major restoration of a ‘young monument’.

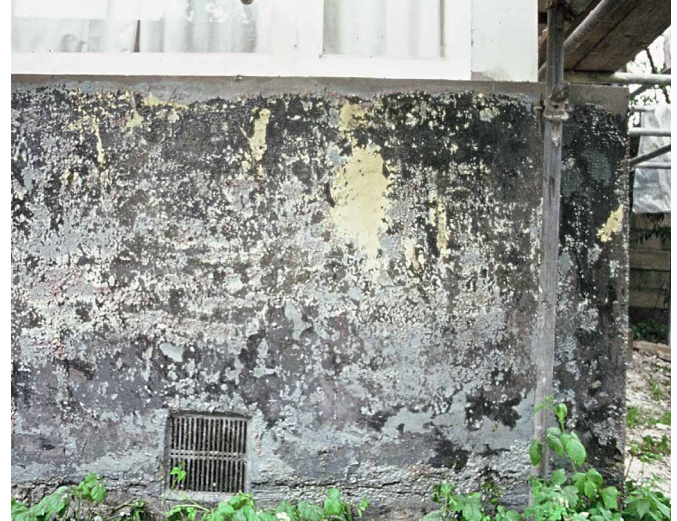
FIG. 2.9 Wall below the kitchen window in the east elevation; B. Mulder chose the dark grey of the top right corner for the new colour scheme

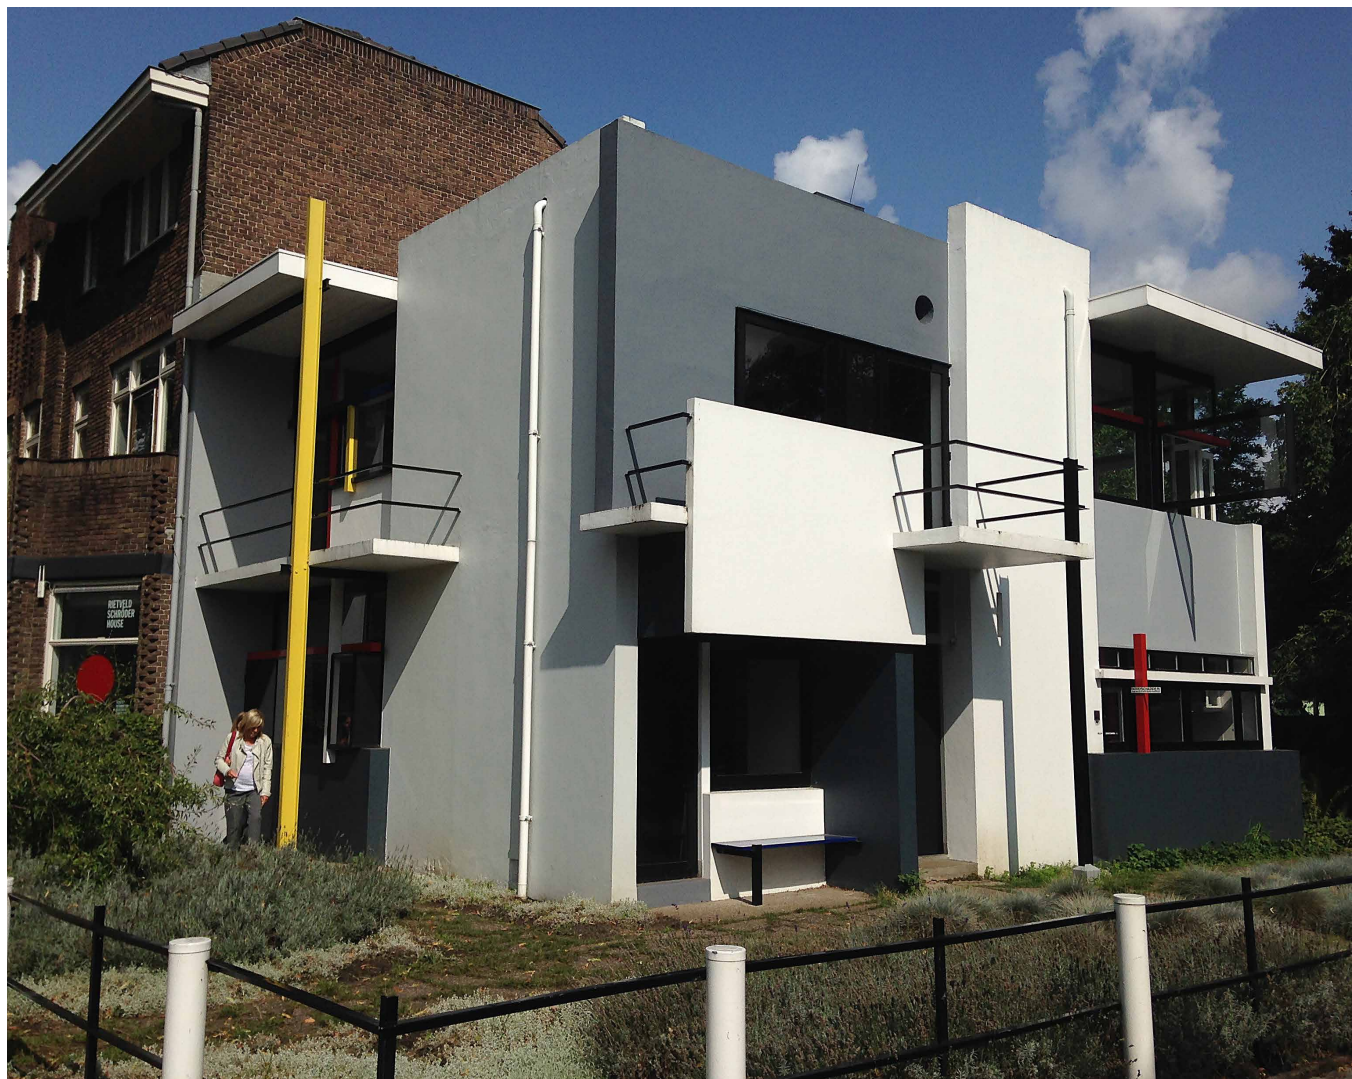
FIG. 2.10 The Rietveld Schröder House in 2017

Currently, the walls display not three, four or six, but five shades of grey, because that is what Mulder says he found during his on-site inspection [FIG. 2.10]. In consultation with the foundation he opted to return to the colour composition of the initial period. With that frame of reference, which involved mixing the greys on site with the painter, he made a composition with five greys (photo on page 22). For the record, Mulder said that making the different shades of grey was the most difficult part of the entire restoration and occasionally even drove him ‘to despair’.<sup>26</sup>

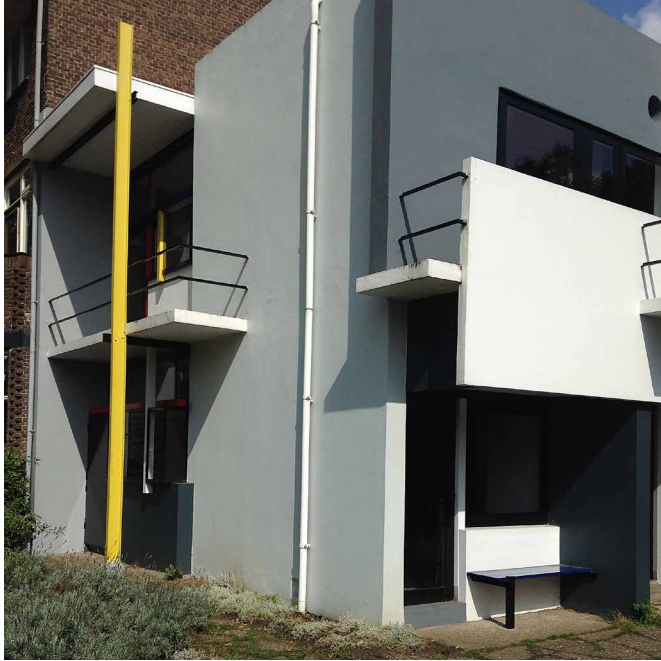
FIG. 2.11 Prins Hendriklaan wall, white rainwater pipe against pale grey background, 2017

The various rainwater pipes were eventually treated in different ways. We can see both white against a pale grey surface (large wall Prins Hendriklaan) [FIG. 2.11] and pale grey against a white surface (to the right of the front door) [FIG. 2.12]. The pipe on the rear elevation is white against a white wall, and that next to the neighbouring building at Prins Hendriklaan 48 is pale grey against an identical pale grey background. This does not appear to be in accordance with the earliest period of the house. In photographs, especially those taken straight after the construction, the rainwater pipes are a natural zinc-grey in colour. But Mulder did regard the drainpipes and their colours as important elements of the overall composition. In an interview with *Cobouw magazine* in November 1974, a few months after the letter from Han, he raised the question of the rainwater pipes himself, in particular the white-painted downpipe on the ‘side elevation’, against the grey background. This downpipe had been absent for a while, was then painted in a zinc colour, and thereafter ‘painted white as [was] intended against the grey background’.<sup>30</sup> Thus, even the colours of the rainwater pipes could completely alter the character of the walls.

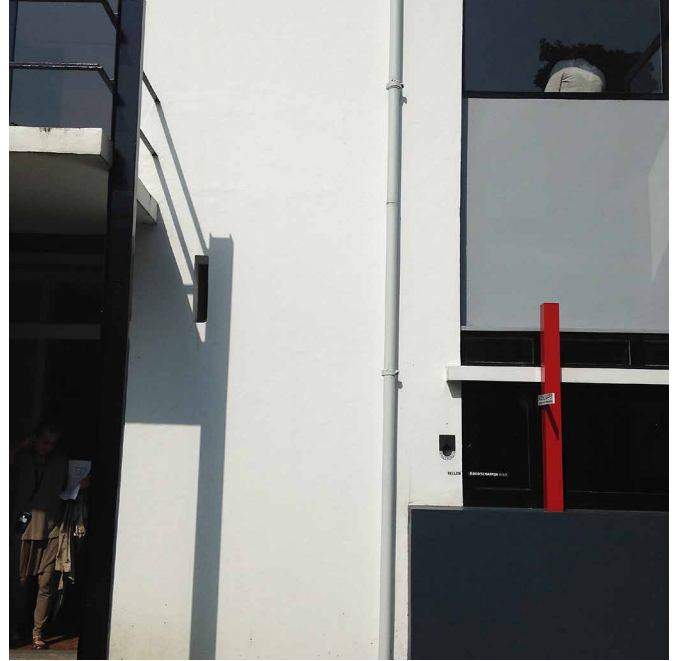
FIG. 2.12 East wall beside front door, pale grey rainwater pipe against white background, 2017
