10th International Conference on Multiphase Flow (ICMF 2019)

Experimental study of cavitation erosion around a surface-mounted semi-circular cylinder

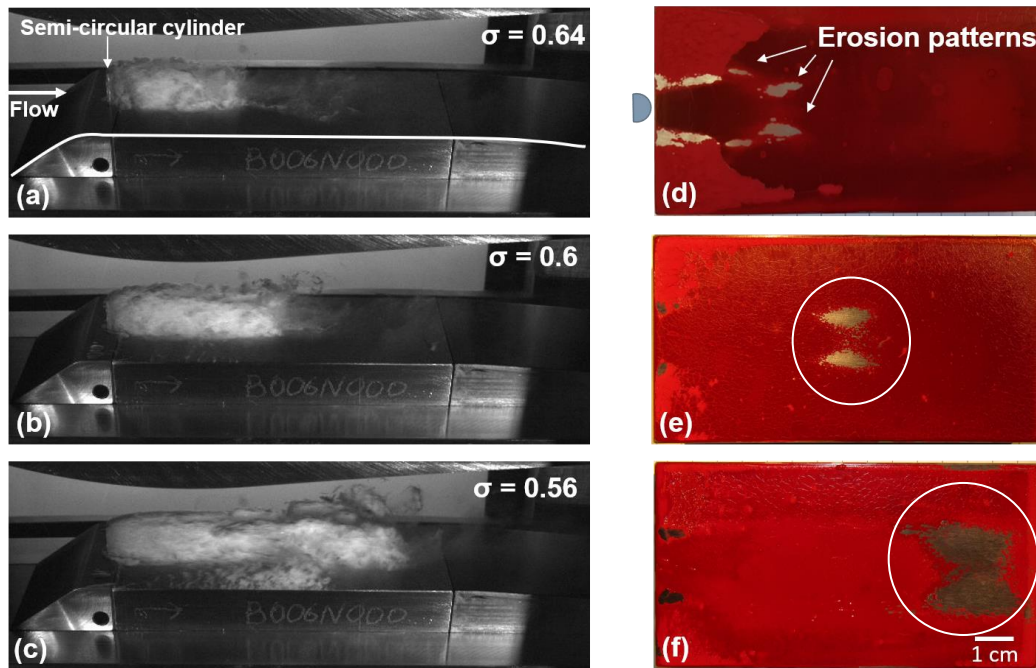
Figure 1: (Left) Video frames of cavitating flow behind the semi-circular cylinder. The flow is from left to right and light grey represents the cavitation region. (Right) Photographs representing the corresponding erosion patterns after 40-60 mins of operation.

Three erosive cases at different cavitation numbers are shown in Figure 1 (a) – (c). The flow is from left to right and light grey represents the cavitation region. At lower cavitation number more intense cavitation can be seen. In Figure 1 (d) – (f), the erosion patterns (removal of paint) after 40-60 mins of operation can be seen for the corresponding cavitation numbers. At a high cavitation number, one would expect less erosion due to less intense cavitation as compared to the other two cases. However, a large number of Karman-vortex-like cavities are shed downstream of the obstacle. This results in a higher number of collapse events and ultimately more erosion (Figure 1 (d)). On the other hand, at the lower cavitation numbers ($\sigma = 0.56, 0.6$), most of the erosion took place at the closure

line of the cavity (Figure 1 (e) and (f)). This is mainly because the vapor cavities are just shed at the closure line of the cavity, hence the collapse of vapor takes place in the same region but not upstream.
