# THE RESTORATIONS OF THE RIETVELD SCHRÖDERHUIS

A REFLECTION

MARIE-THÉRÈSE VAN THOOR

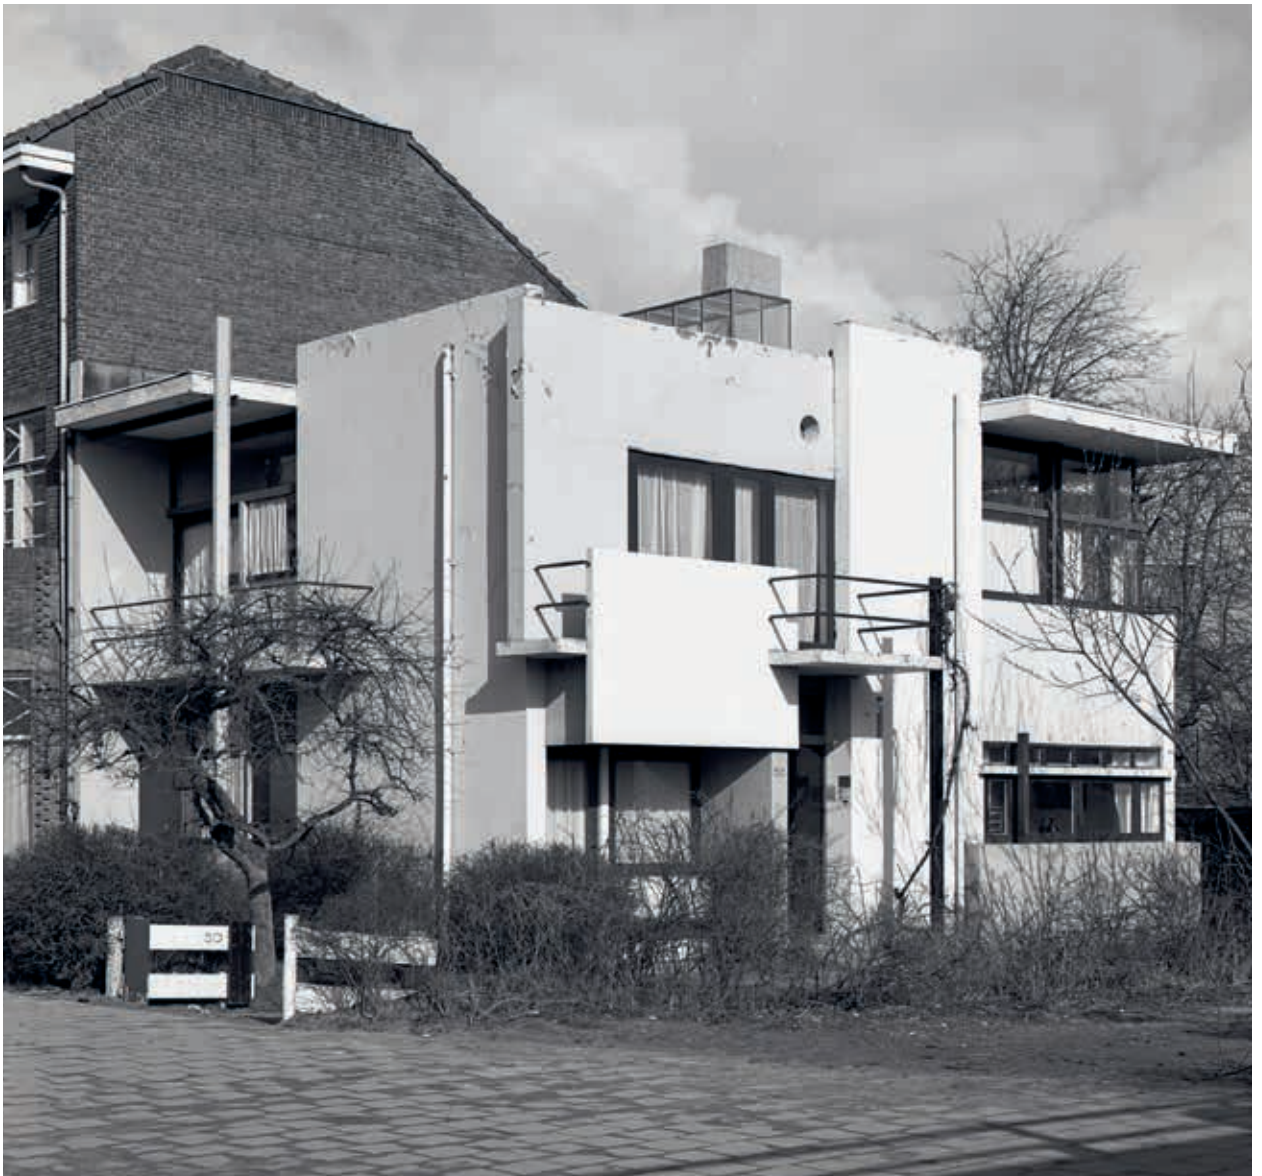
2. At the beginning of the 1970s the poor state of repair of the Rietveld Schröder House was clearly visible (Het Utrechts Archive)

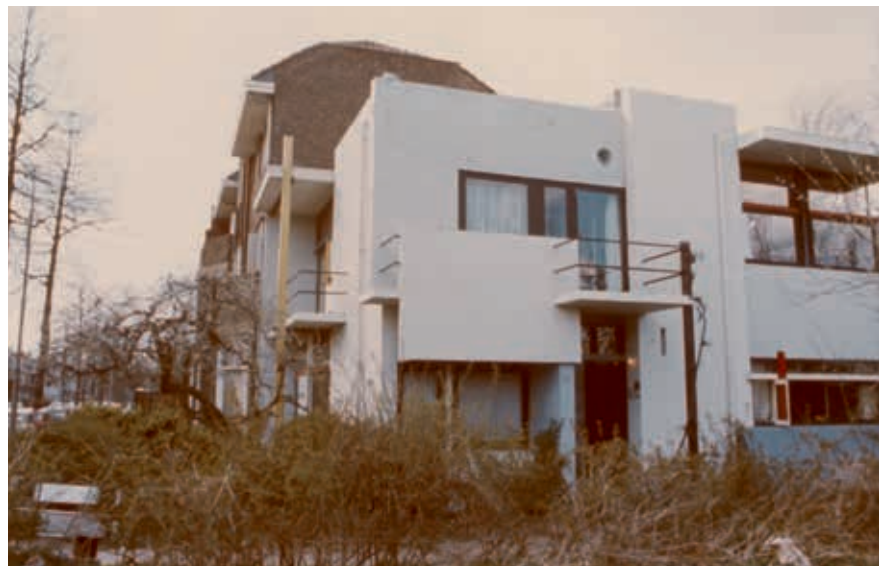
3. Just before the restoration the Rietveld Schröder House, the grey values and intensity of the exterior colour scheme were scarcely discernible; moreover, the greys had acquired a 'bluish' tinge (Rietveld Schröder Archive, CMU)

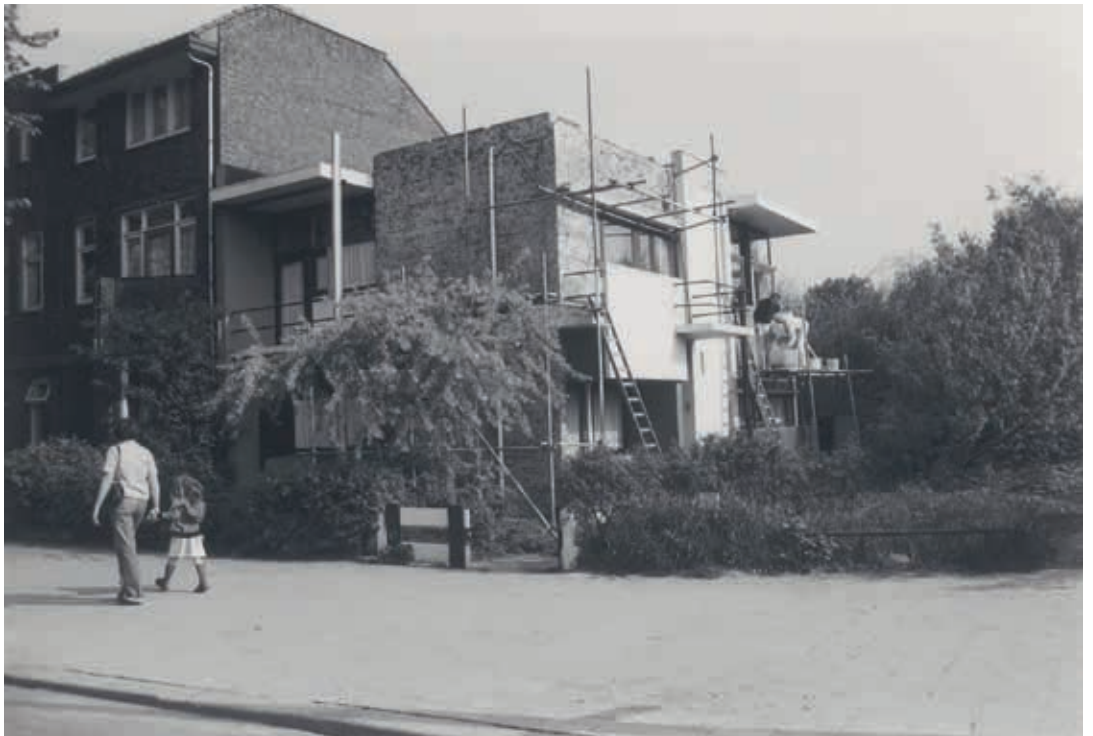
Recent research has shown that the problems with the plasterwork soon returned. The paintwork was again exhibiting cracks, the new coat of render had failed to adhere, and there were dark patches in the coat of paint. In October 1975, therefore, the new plasterwork was partially removed and redone. But the hairline cracks returned once more. Eventually, in late 1978, Mulder and the client decided to strip the problematical wall back to the brickwork. That substrate proved to be homogeneous and of reasonably good quality. The earlier repairs with synthetic mortar had held up well. Mulder's report on this (1980) contained a notable sentence: 'The other plasterwork that had remained in place during the restoration had to be removed as well in order to obtain a single homogeneous layer of render and to avoid bonding problems between old and new work.'<sup>21</sup> This statement would appear to imply that Mulder stripped all the walls and then had them replastered and repainted, which is what the photographs also appear to show (figs. 5 and 6). But if we examine the photographs more closely, we can also see areas with the render still intact, such as the wall below the ground-floor window overlooking Prins Hendriklaan. Mulder recently recalled that plaster remained in place on the wall beneath the kitchen window and on parts of the white surfaces of the front entrance wall and the rear wall (fig. 7)<sup>22</sup>

5. In 1979 the Rietveld Schröder House was once again scaffolded after the reappearance of the problems with the plasterwork. Large areas of render were first chipped away, after which a new coat was applied (Bertus Mulder archive)

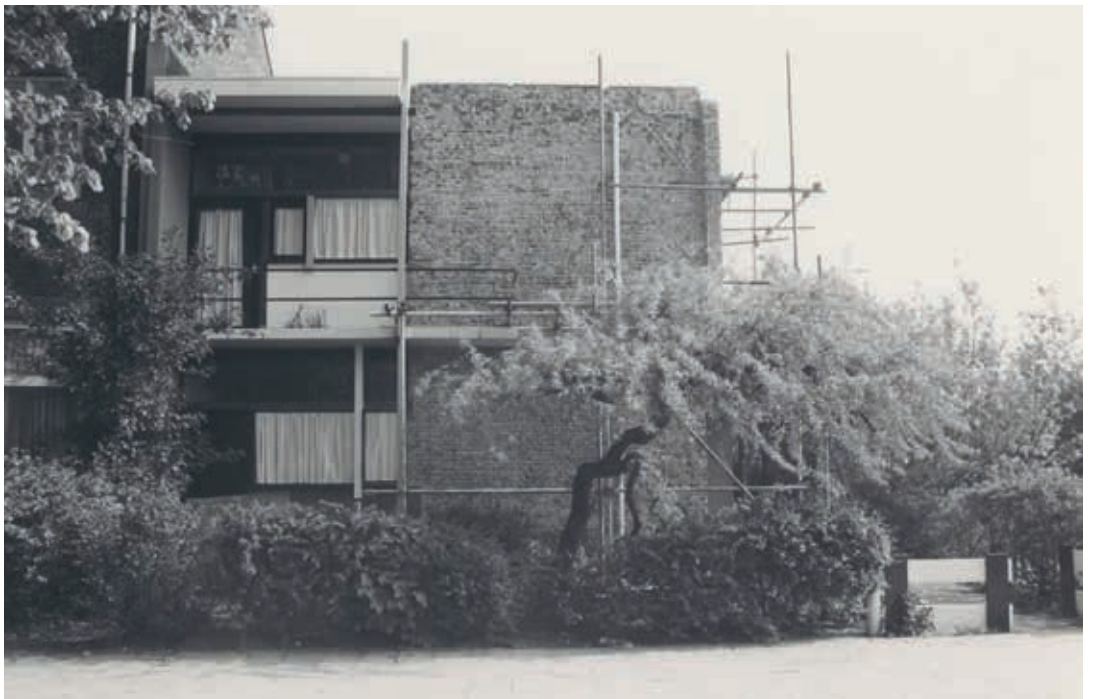
6. The bare brickwork of the wall on Prins Hendriklaan in 1979. On the wall below the window of Rietveld's former studio (bottom left) render is still visible (Bertus Mulder archive)

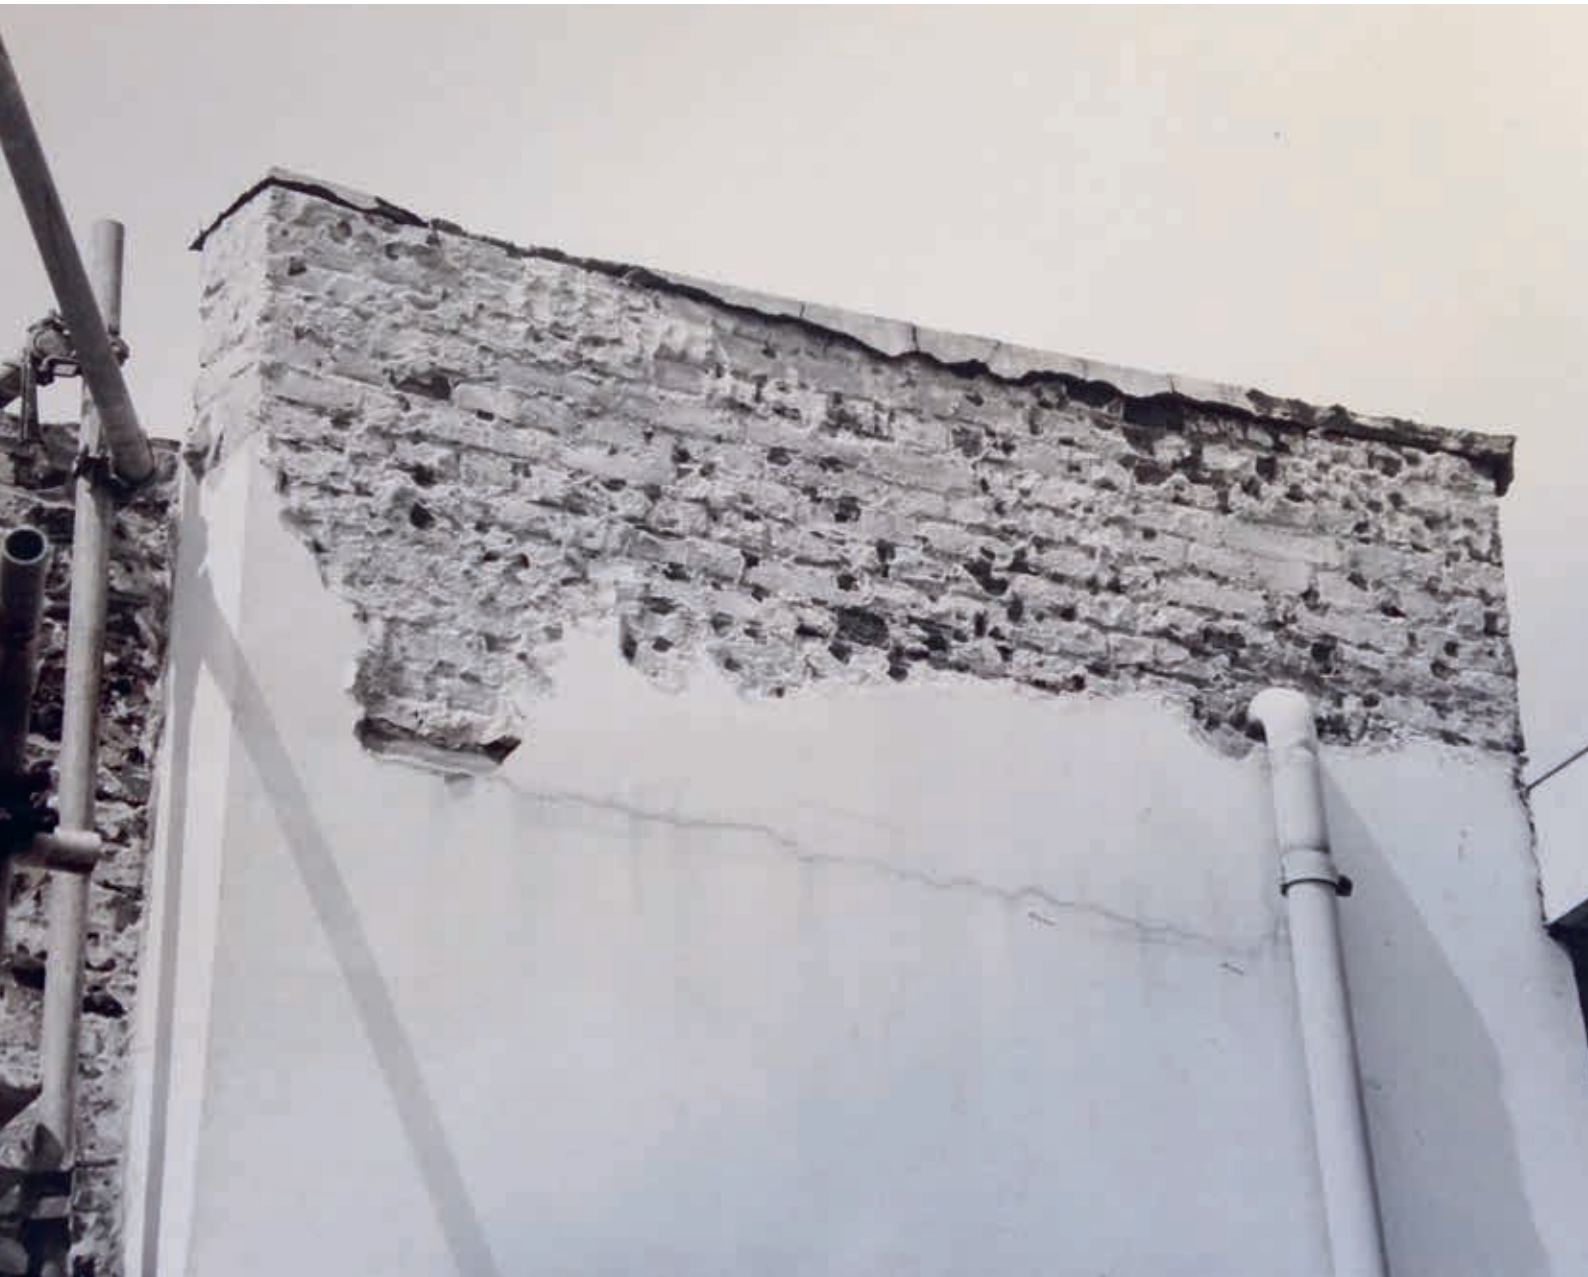
7. Only the render on the upper part of the white wall beside the front door of the Rietveld Schröder House was chipped away in 1979 (Bertus Mulder archive)

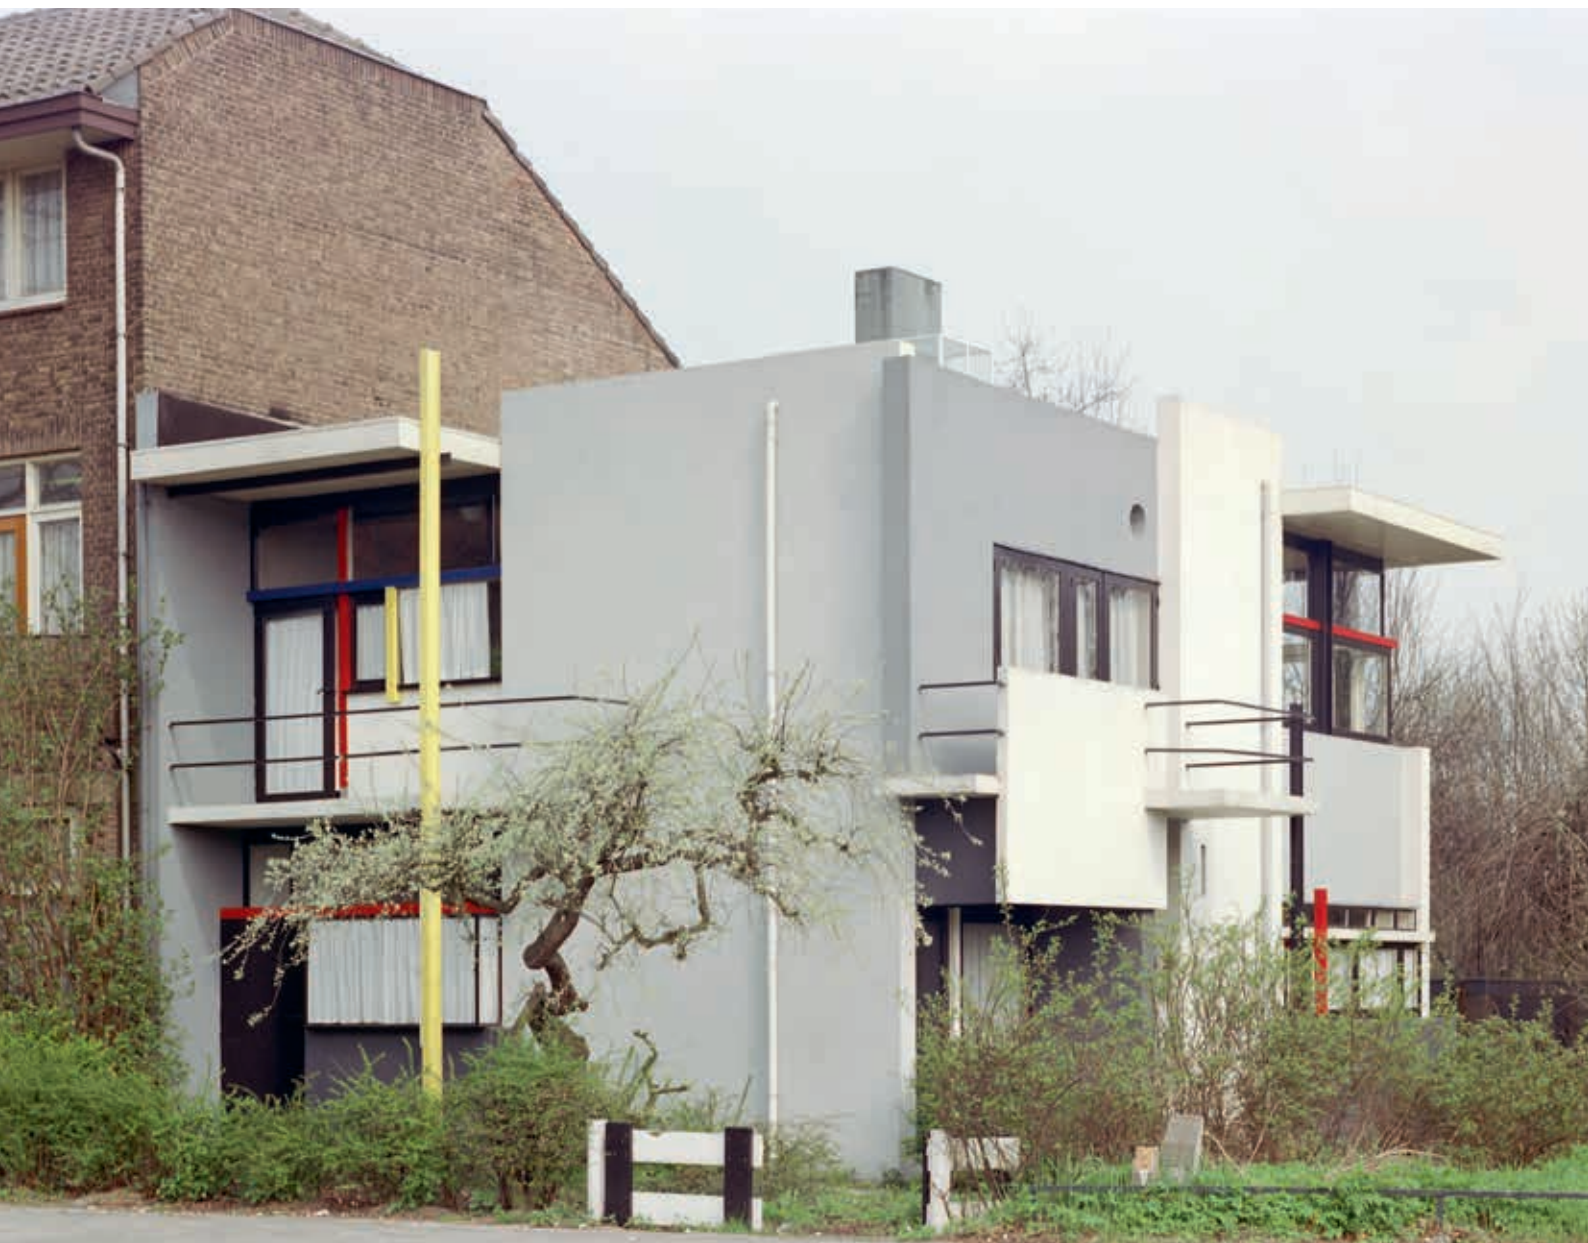
8. The exterior of the Rietveld Schröder House in a new colour composition to a design by Bertus Mulder, photo 1981 (Het Utrechts Archive)

After the problems with the plasterwork had been rectified, the house was repainted in 1979 (fig. 8). Mulder used a durable wall paint from Sikkens – Alphetex 1Q – which he considered suitable for a house with single-leaf brick walls that ‘ventilate on all sides’.<sup>23</sup> After a bit of experimenting, Rietveld had opted for paint from Alphaverf, later taken over by Sikkens, which has supplied the paint for the (Rietveld) Schröder House ever since.<sup>24</sup> Mulder repeatedly stressed that deciding on the colour scheme, especially the shades of grey, was the most difficult task of the entire restoration.<sup>25</sup> The reflection of light on walls and in colours was very important for Rietveld. From the 1920s onwards he

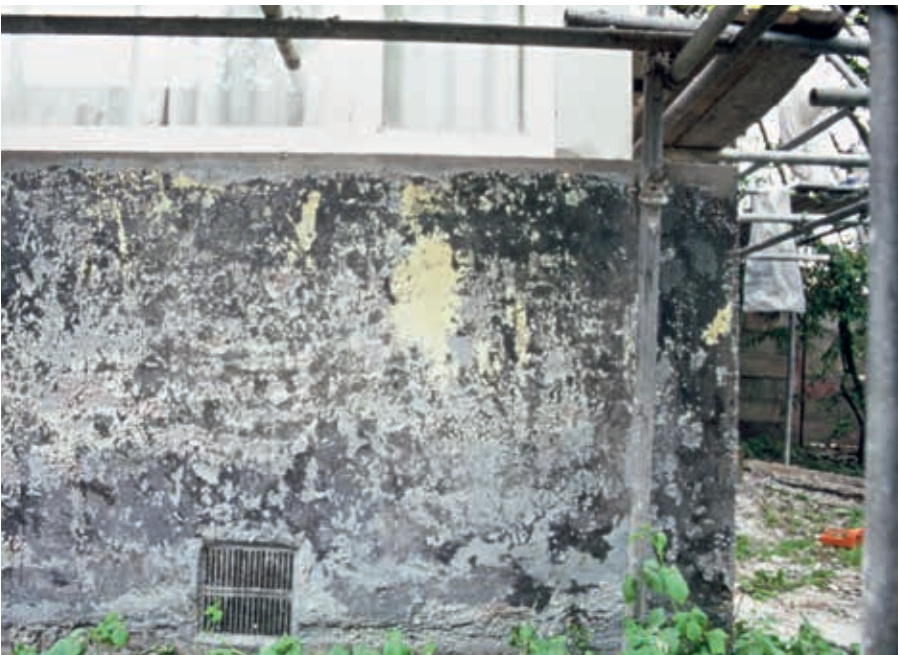
10. Various shades of grey came to light on the window below the kitchen window. Bertus Mulder based the grey for this surface on the dark grey in the top right corner (Bertus Mulder archive)

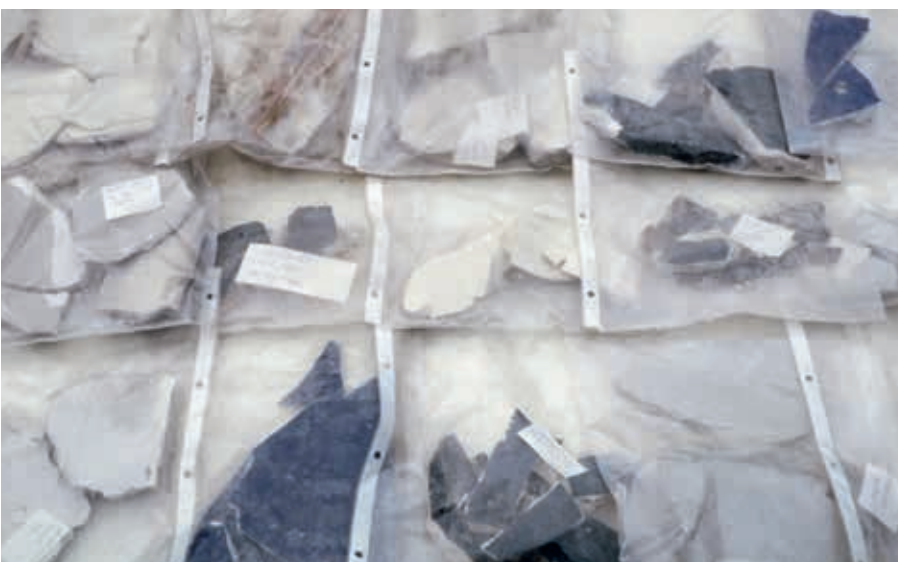
11. Samples of render and colour were initially collected and sorted for the colour research; afterwards they were thrown away (Bertus Mulder archive)

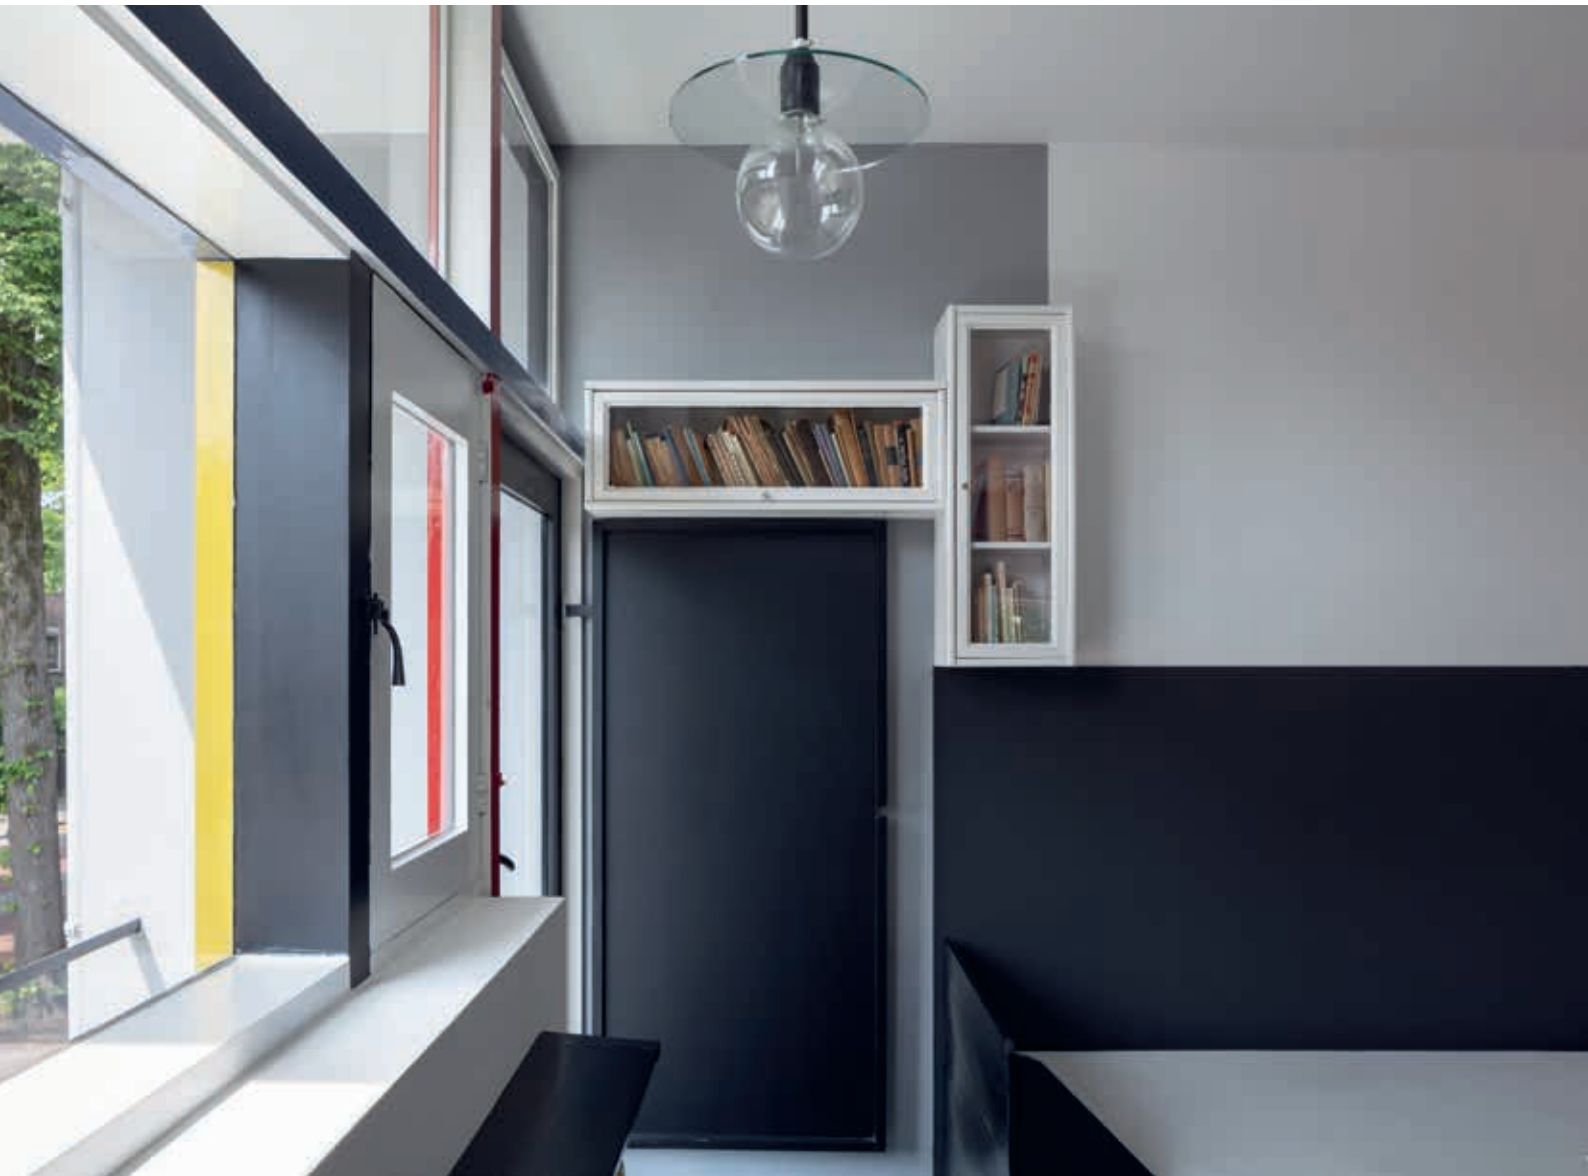
13. The Schröder daughters' bedroom in 2018, photo Stijn Poelstra (CMU)

In 1986, while stripping back the walls on the upper floor of the house, Mulder discovered below a layer of white paint in what had been the daughters' bedroom, a different shade of grey from the one he had used in 1979 for the adjoining balcony. Because this wall was supposed to run from inside to outside in the same colour, as can be seen in historical photographs, he had the exterior of this wall repainted (figs. 12 and 13). This meant that he ended up redoing the entire composition of greys on the exterior.<sup>32</sup> Mulder's aim was to create a balanced, harmonious and impeccable image with colours and surfaces that would restore the original spatial impression. In 1981 the Stichting Rietveld Schröder Huis had decided that the guiding principle for the restoration of the interior should be 'to return the house in an abstract manner to the situation of 1925-1930'.<sup>33</sup> Truus Schröder, too, believed that after her death the house should not be presented 'as if she had just left', but as a manifesto of a new architecture and a new way of living. Initially there was some resistance to this from RDMZ. Wim Denslagen argued that the future museum house would in that case ignore the history of Schröder's occupancy and of Rietveld's

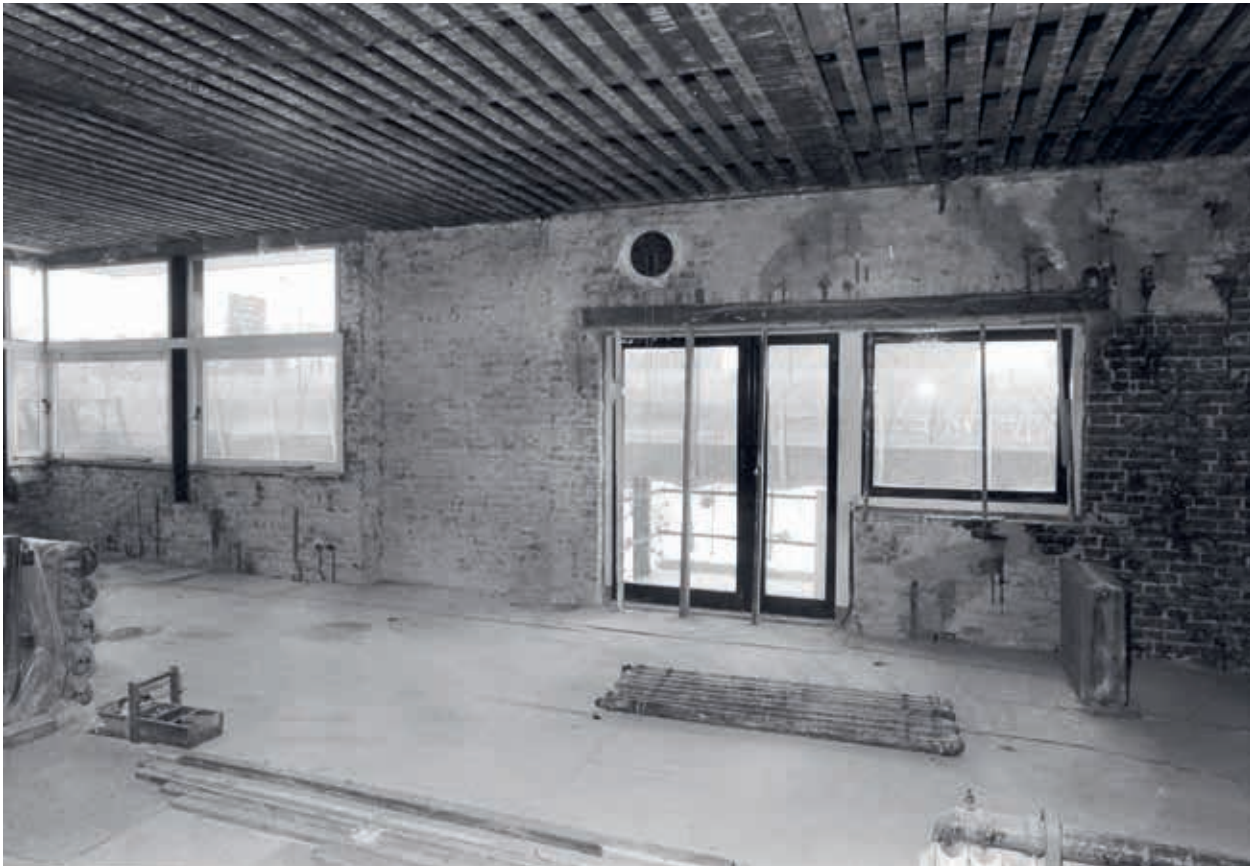
14. During the restoration of the upper floor of the Rietveld Schröder House in 1985-1986, Bertus Mulder completely stripped the walls and ceiling (Bertus Mulder archive)

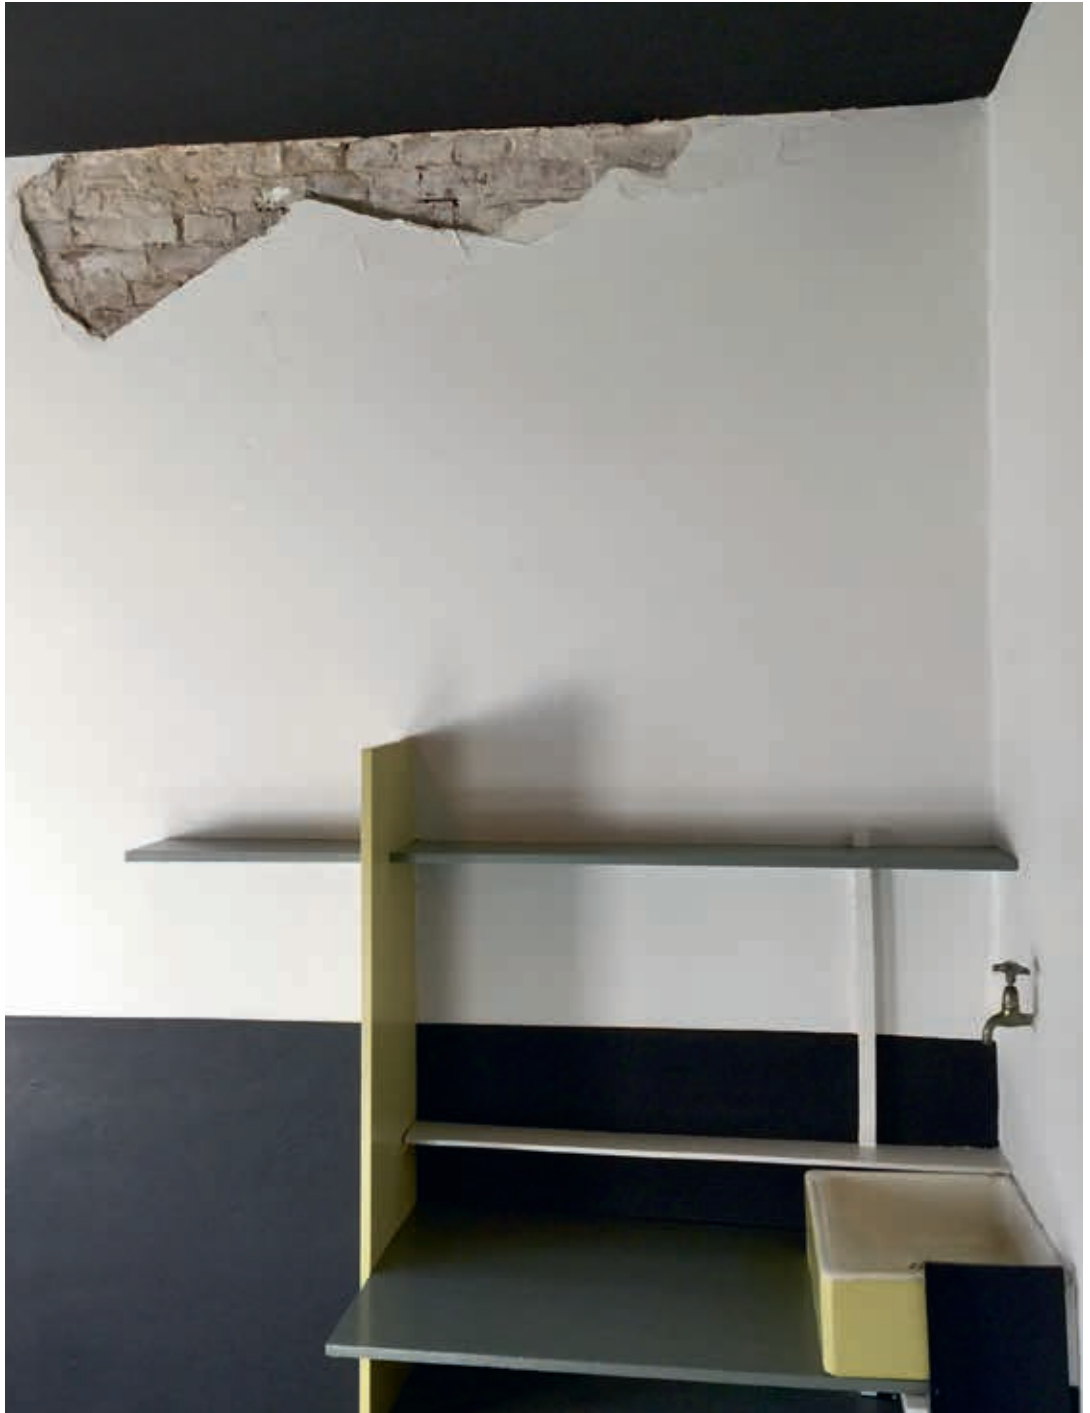
15. In October 2016 a piece of plaster came loose on the south wall of the study on the ground floor of the Rietveld Schröder House, photo Edgar Riessen (CMU)

repainted in the same colours that he encountered there. The ground floor was, in his eyes, of less importance for the architectural value.<sup>39</sup> In October 2016 a piece of plaster came loose from a wall in the study (fig. 15). This turned out to be a blessing in disguise because it provided an opportunity to have the plaster analysed by TU Delft and the TNO (Netherlands Organisation for Applied Scientific Research). TNO concluded that the sample could well be a remnant of the original plaster.<sup>40</sup>

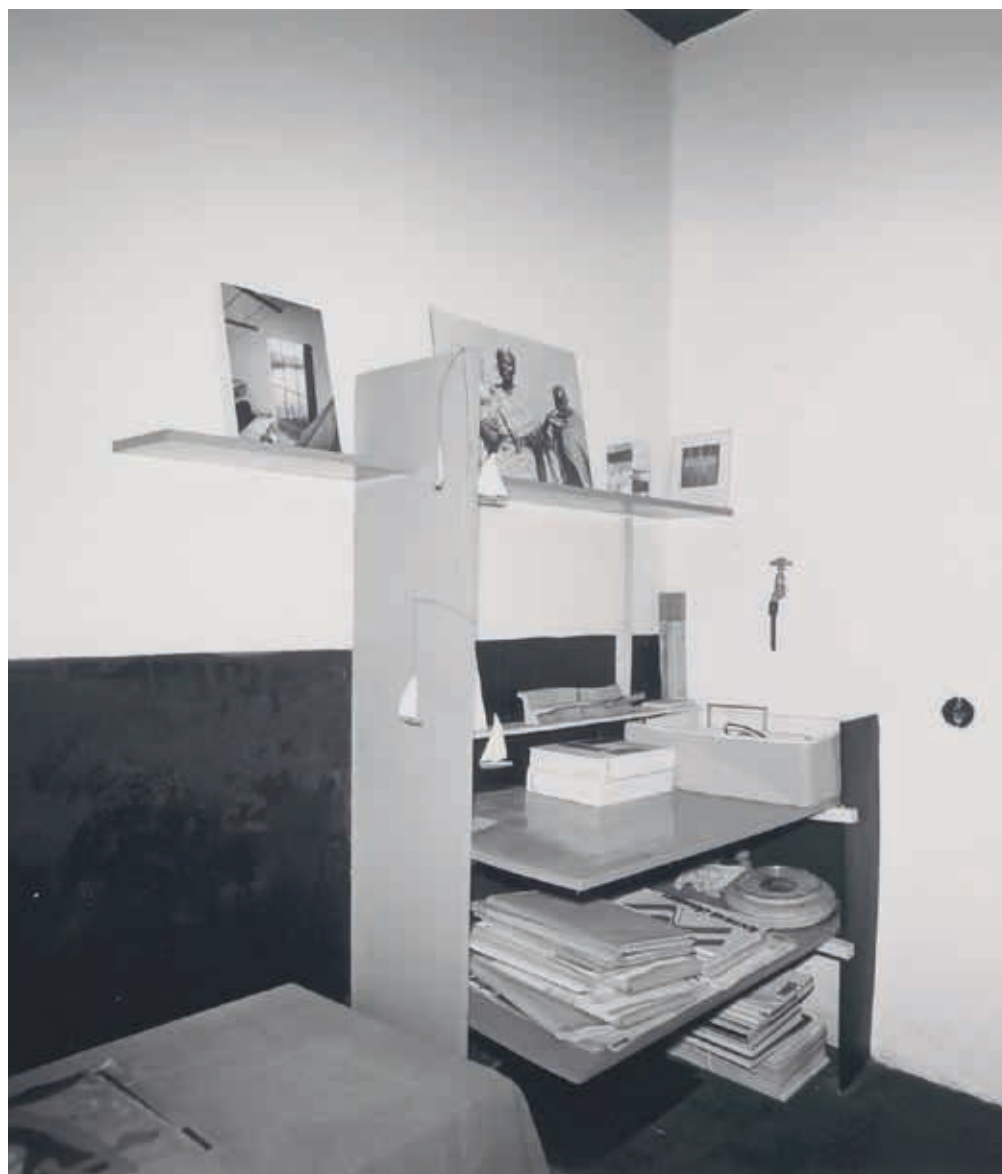
reasonable to surmise the continued presence of some original plaster plus finish coats on both the exterior and the ground-floor interior (fig. 16). Accordingly, TNO and Stichting Restauratie Atelier Limburg (SRAL) conducted a limited follow-up investigation (fig. 17).<sup>41</sup> The results confirmed the supposition: the Rietveld Schröder House still contains material remnants of the exterior and interior skin from the 'Rietveld period', be it highly concentrated in specific areas. SRAL was also able to state that parts of the ground floor had been repainted three times since the restoration, in colours that deviate from both the restoration period and the period(s) before that.<sup>42</sup>

16. The south wall of the study on the ground floor of the Rietveld Schröder House, undated historical photo (Bertus Mulder archive)

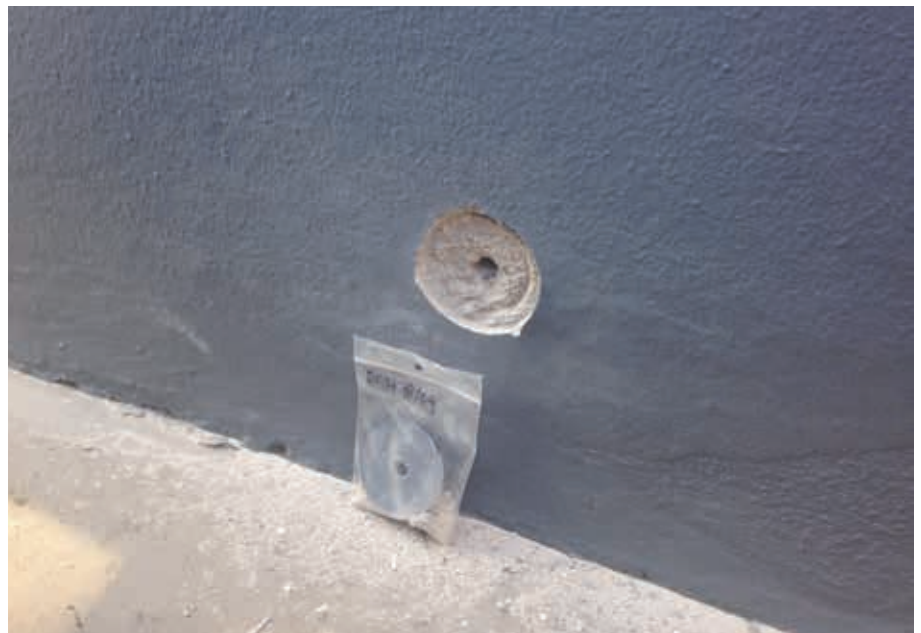
17. In 2018 TNO and Stichting Restauratie Atelier Limburg took samples from specific areas of the exterior and the interior of the Rietveld Schröder House. The photograph shows a sample from the balcony wall on the east elevation (photo author)

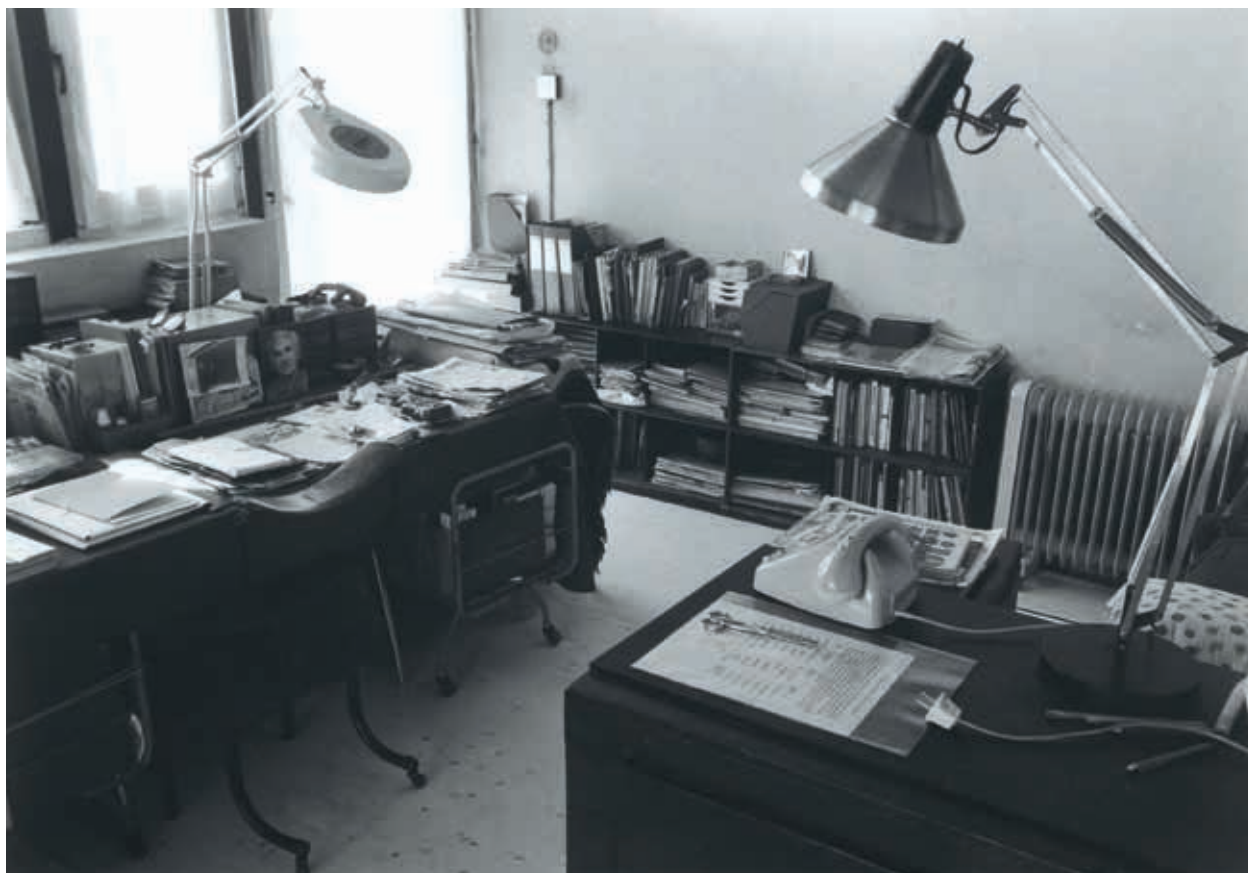
18. Interior photograph of the upper floor of the Rietveld Schröder House in the 1970s; the objects are indicative of the way Truus Schröder lived in the house at that time (Bertus Mulder archive)
